Property Inspection Report  
Prepared for: *Sample*

3009 Sample Dr., Anywhere, AZ 85000

Type	Est. Age	Main Entry	Occupancy
Single Family Home	1971	North	Vacant without Furniture
Inspection

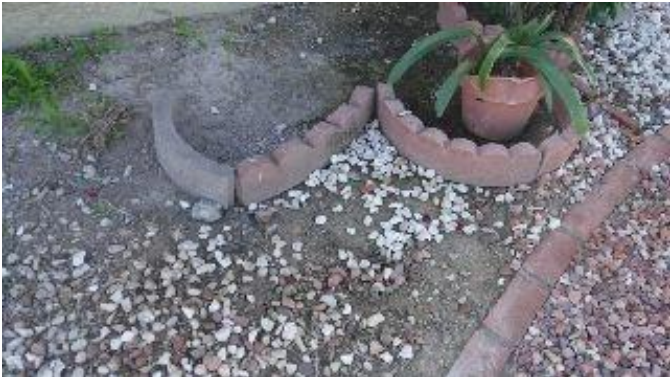
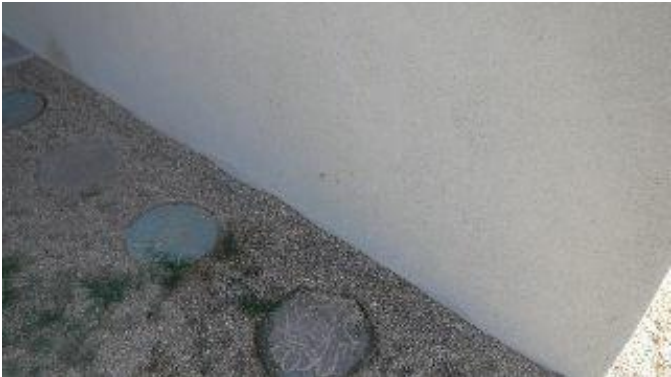
B.1. Grading and Drainage

Grounds and Site	Grounds Corrective Action
<i>Low spots/holes noted at the side of the structure [ front east side ].</i>

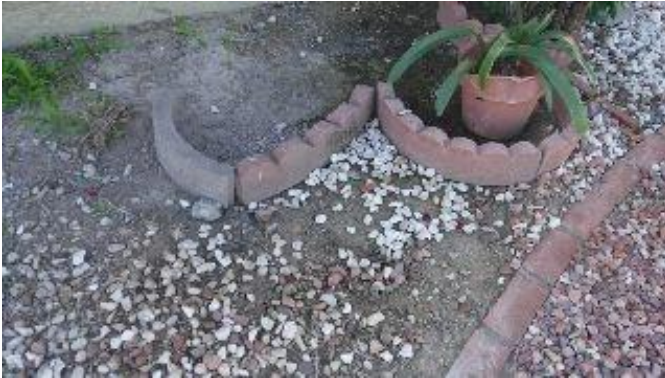
B.1. Grading and Drainage

Grounds and Site	Grounds Corrective Action
<i>Evidence of moisture buildup/ponding noted in the yard may be an indication of adverse drainage [ ].</i>

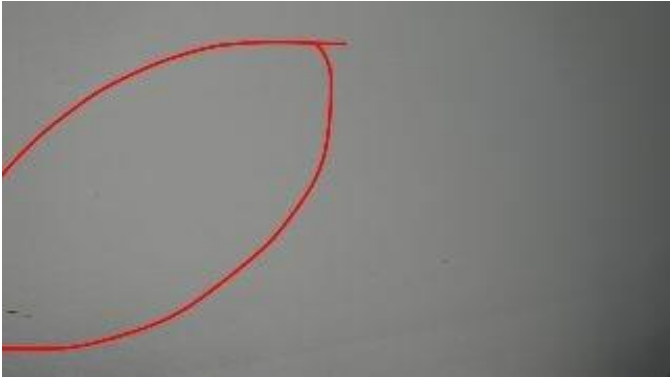
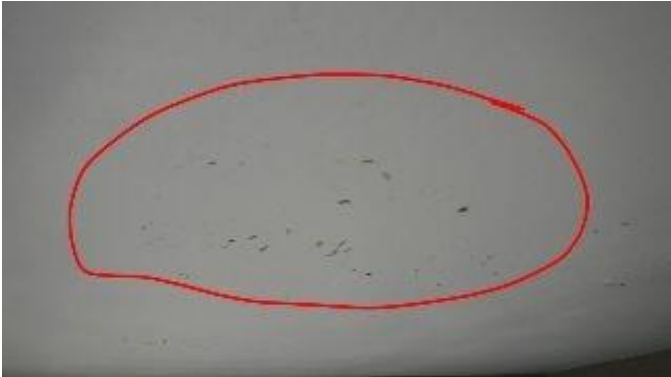
Grounds and Site	Grounds Corrective Action
<i>Water stains/damage, peeling or discolored paint observed on the patio ceiling. We recommend that you speak with the current homeowner regarding this condition or consult a licensed contractor.</i>

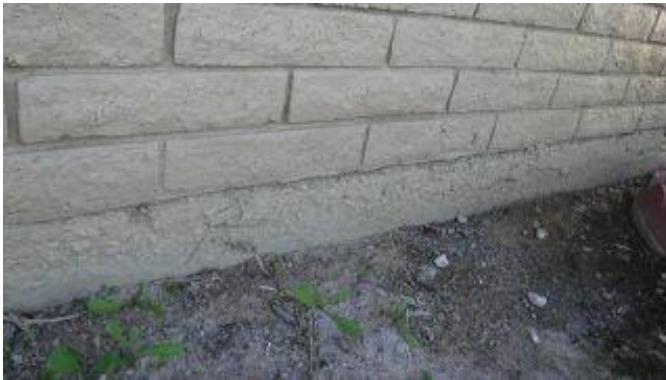
## C.1. Foundation

*Portions of the visible stemwall are deteriorated likely due to excessive moisture. [ northeast front side of house ]*

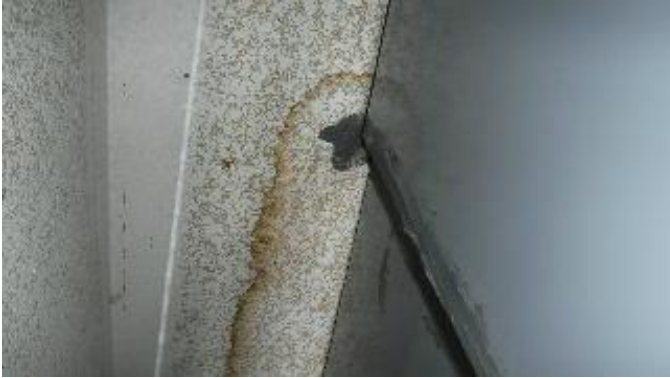
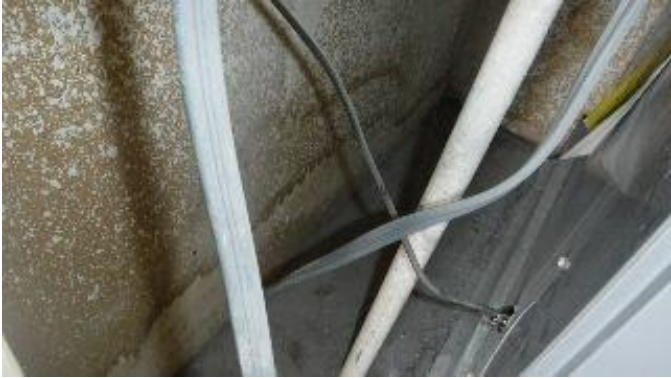
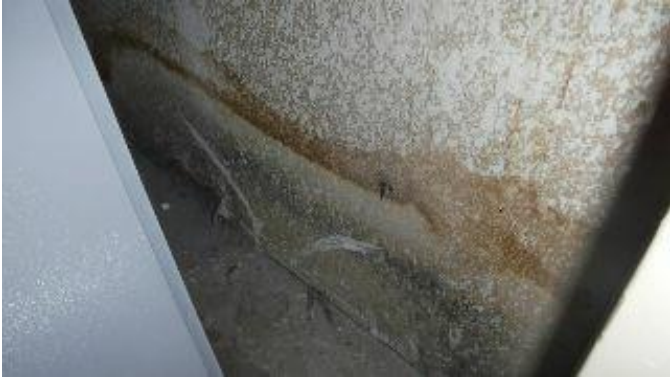
C.3. Interior Walls

Building Structure	Interior Corrective Action
<i>Water stains/damage or discolored paint observed in the utility closet. We recommend that you speak with the current homeowner regarding this condition or consult a licensed contractor.</i>	
<div>

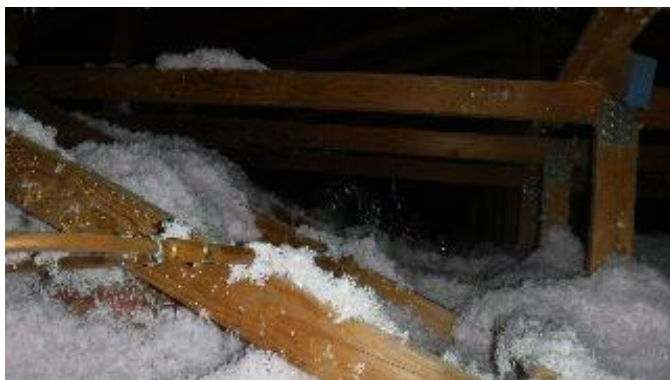
*Truss/Rafter has been cut/removed/alterd We recommend that you speak with the current homeowner regarding this condition or consult a licensed contractor.*

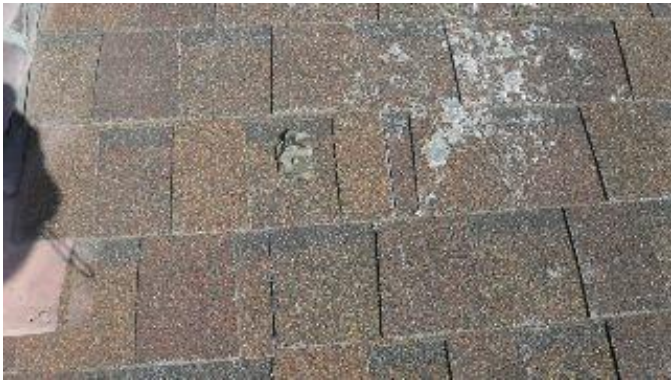
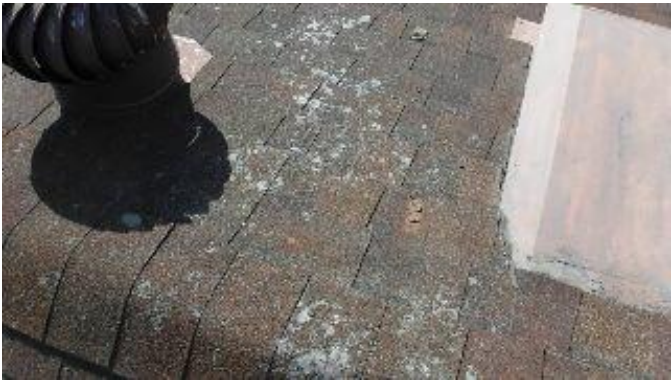
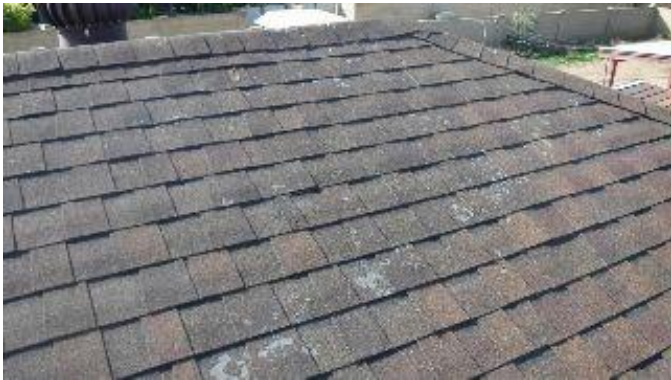
D.1. Decking and Covering

Roof System	Roof Corrective Action
<i>The roof covering is damaged worn in a few areas [ west side top of peak area ].</i>

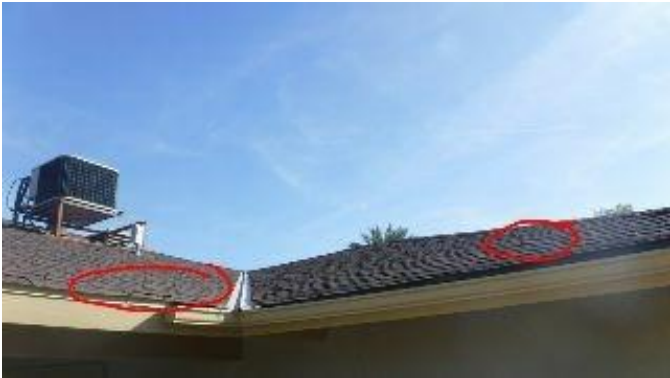
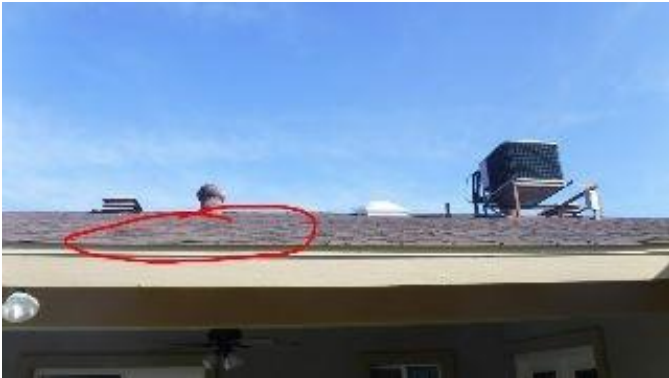
Roof System	Comment Corrective Action
<p>There are two layers of shingles installed. The newest is installed over the older roof covering. This is an acceptable practice for shingled roofs. The shingles are uneven and do not lay flat possibly due to the lower layer of shingles.</p>

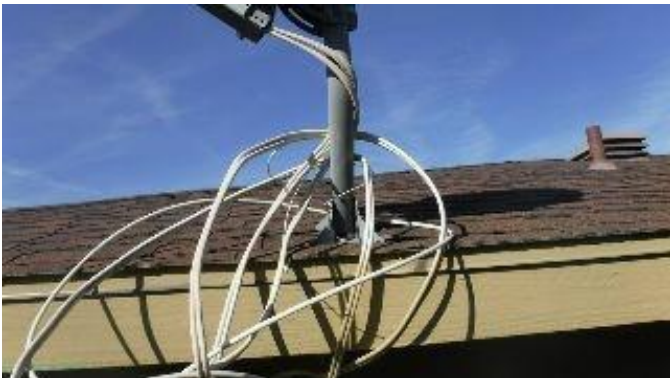
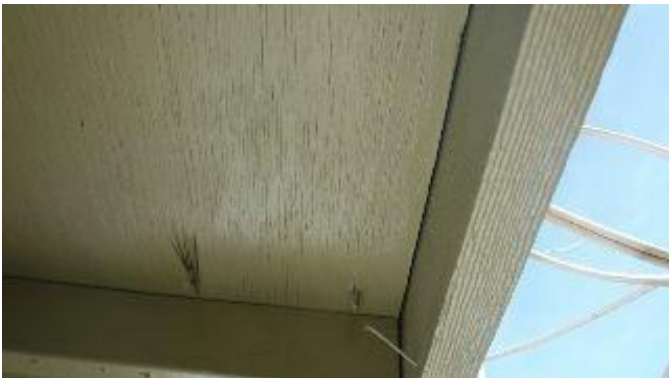
Roof System	Roof Corrective Action
<p>Penetrations have been made through the roof covering to mount a satellite dish. We suggest these penetrations be checked for proper sealant at the lag bolt locations.</p>

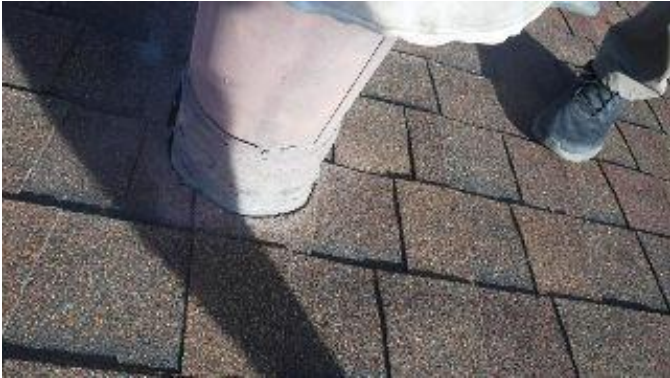
Roof System	Roof Corrective Action
<i>Storm collar(s) is missing at the furnace vent pipe.</i>

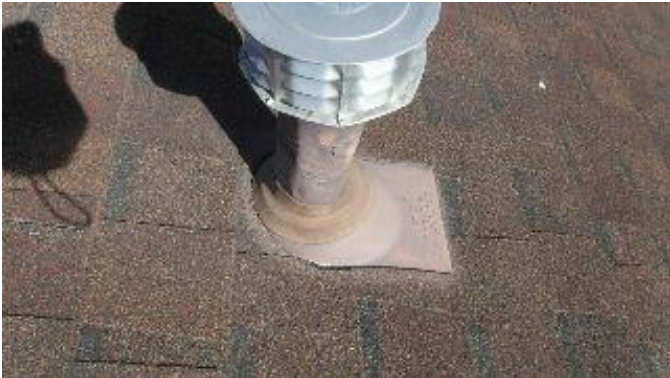
D.2. Flashing and Penetrations

Roof System	Roof Corrective Action
<i>Storm collar(s) seal at the water heater vent pipe is not approved for sealing around a vent for a heating appliance.</i>

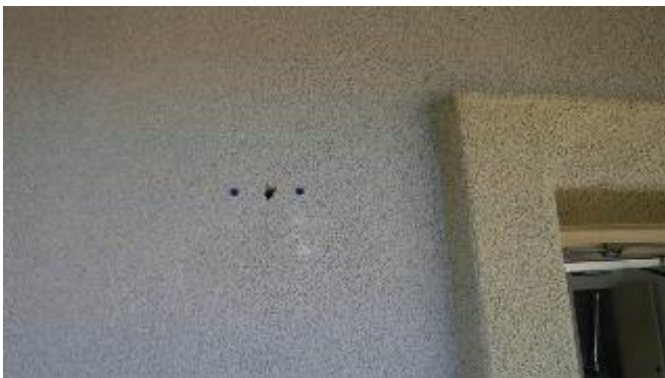
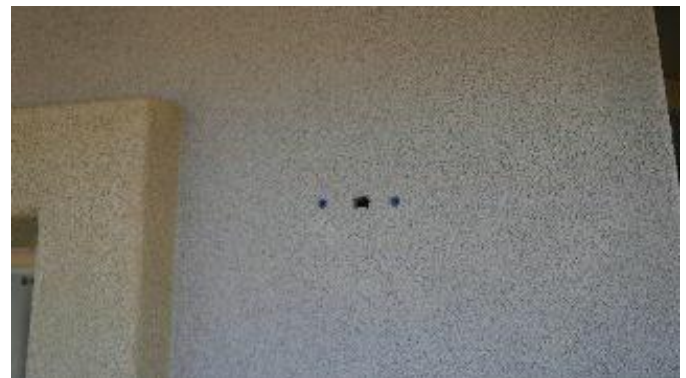
*Openings in exterior wall should be sealed to reduce the potential for moisture or pest intrusion [ coach lights removed each side of garage ] .*

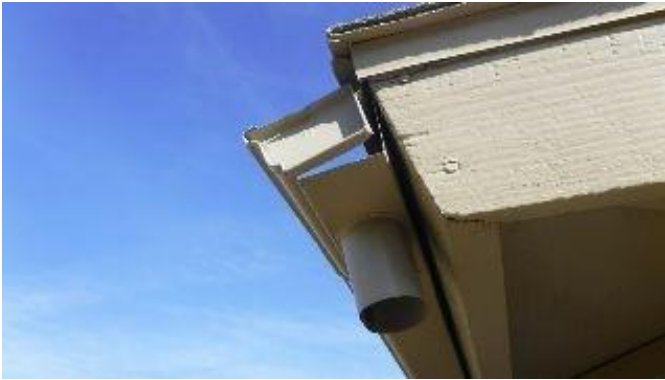
*Down spout is missing.*

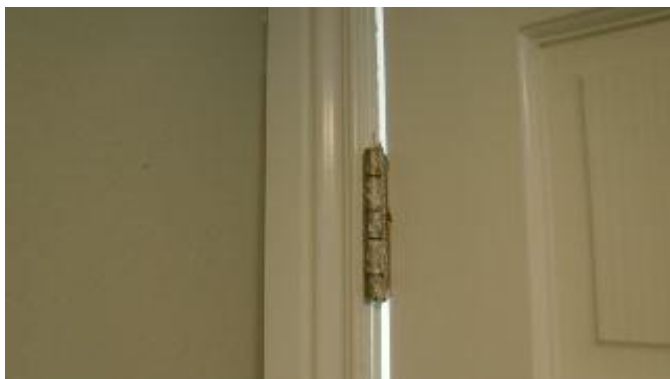
*The Garage House Entry door does not have a self-closing mechanism installed and does not conform to current approved fire barrier requirements. You may wish to consider upgrading to an approved, fire rated self closing device to comply with current construction practices.*

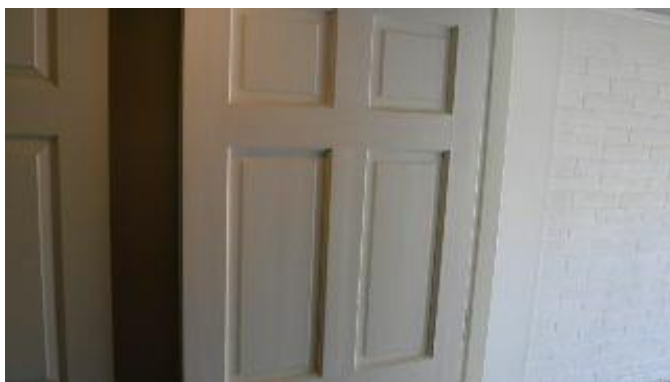
*The Garage House Entry door is wood or hollow core and does not appear to be a fire rated door. We recommend replacing the door with one that is approved for fire rate use.*

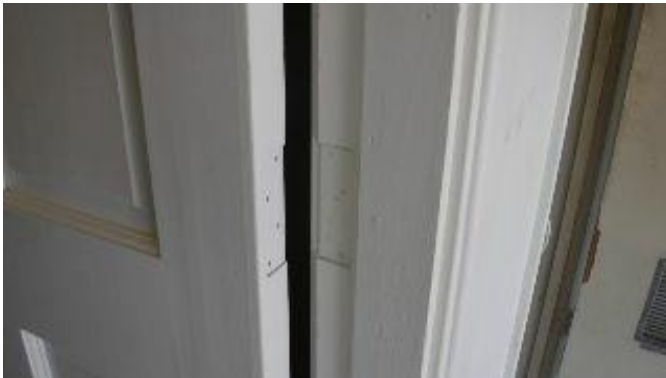
*The door hinges are missing [garage door].*

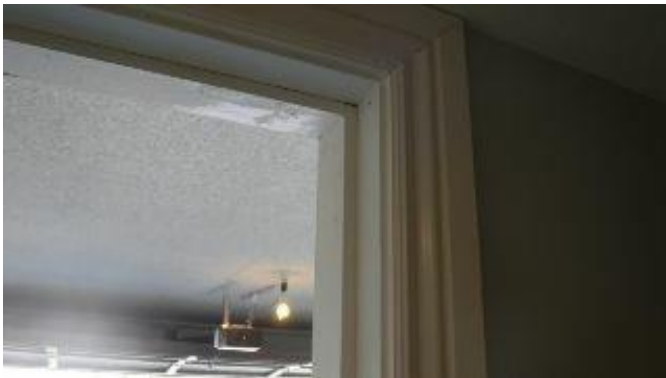
Exterior Corrective  
Action*The door weather stripping is missing/damaged [garage door].*

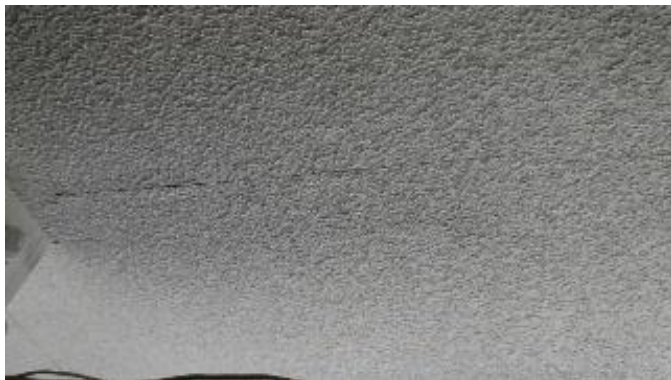
*Popcorn ceiling finish was noted on the garage ceiling. This type of finish could be indicative of asbestos being present.*

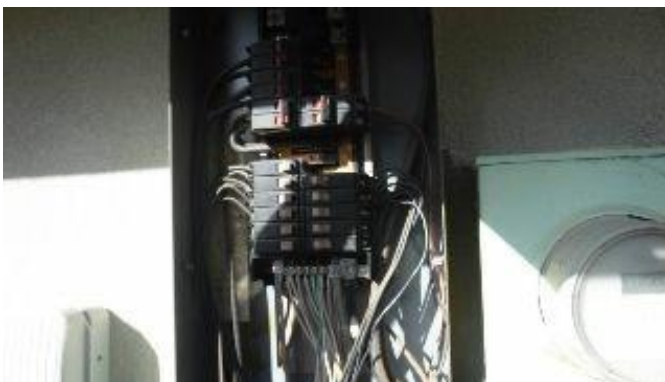
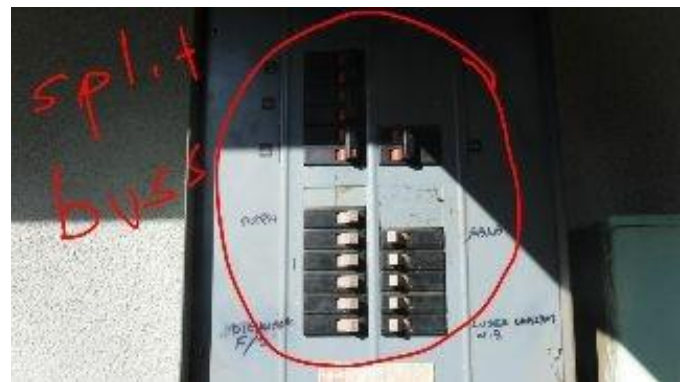
*We were unable to determine the electrical capacity size. The main electrical panel is not properly labeled and there is more than one disconnect. The panel is a split buss panel.*

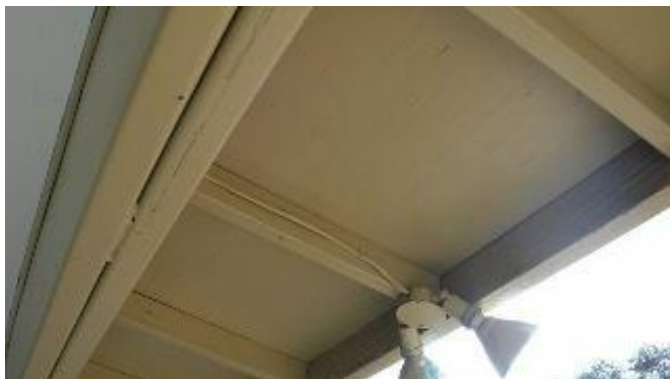
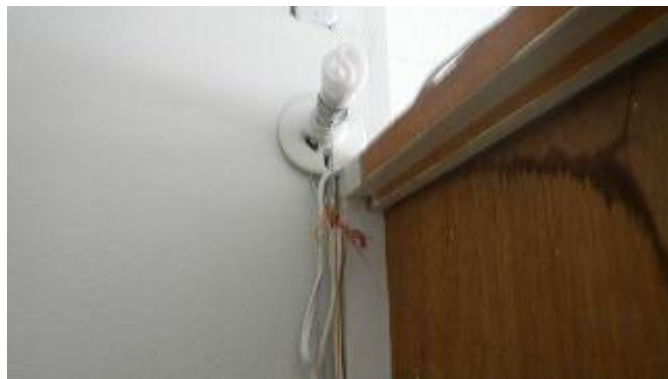
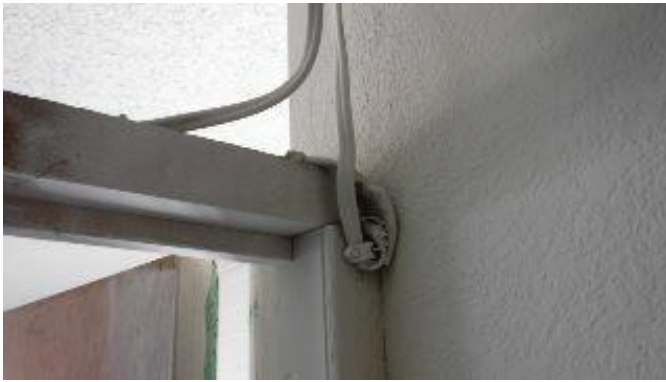
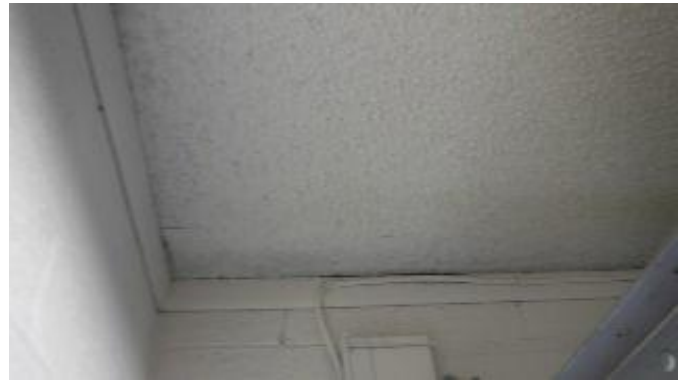
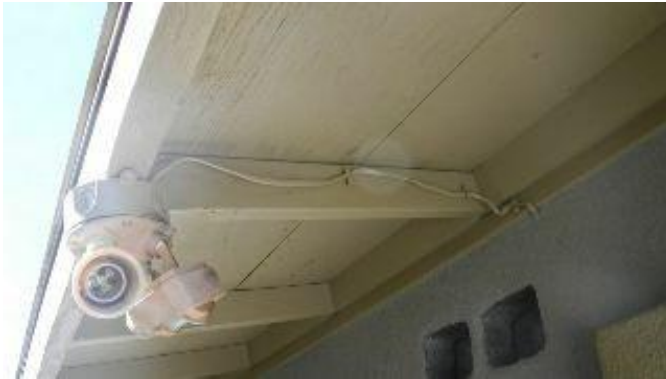
*Exposed and live wires noted [ at multiple locations in garage, garage storage area and under roof soffits at multiple locations] . Exposed and live wires should be de-energized for safety purposes or installed in conduit by a licensed electrical contractor.*

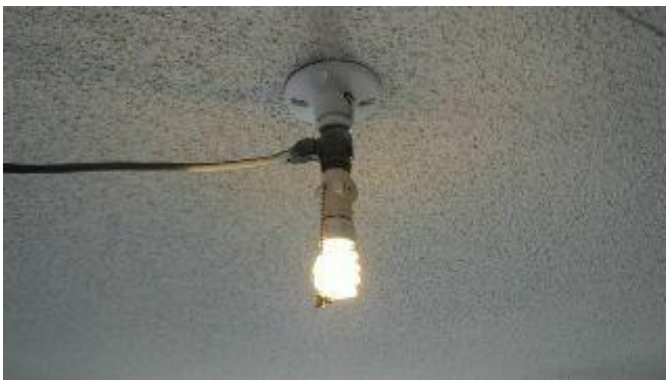
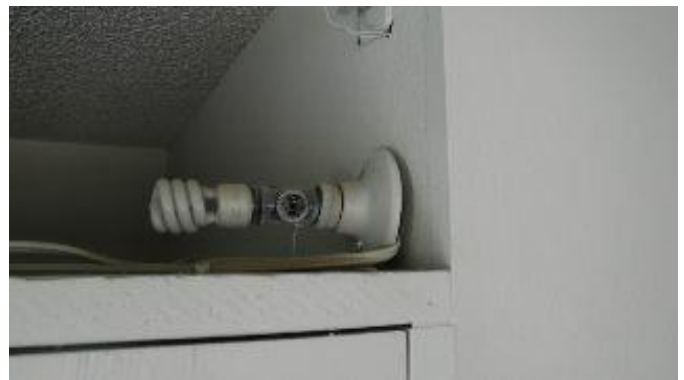
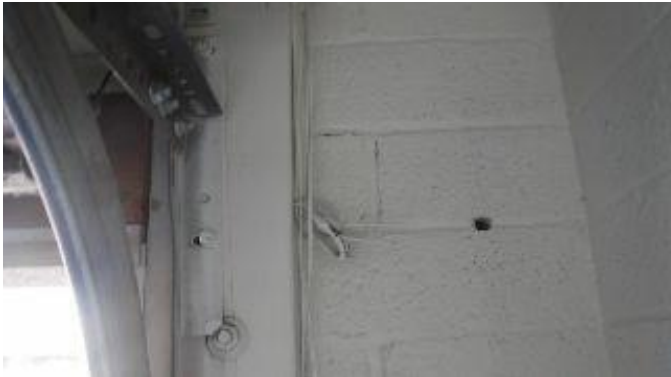
*The electrical wiring does not conform to current construction standards [ Garage, rear patio, front coach light (where removed)] . Exposed wiring and exposed splices. Garage opener is tied into lighting socket. Suggest you consult with an electrical contractor to correct. Garage door is disabled when the garage light switch is turned off.*

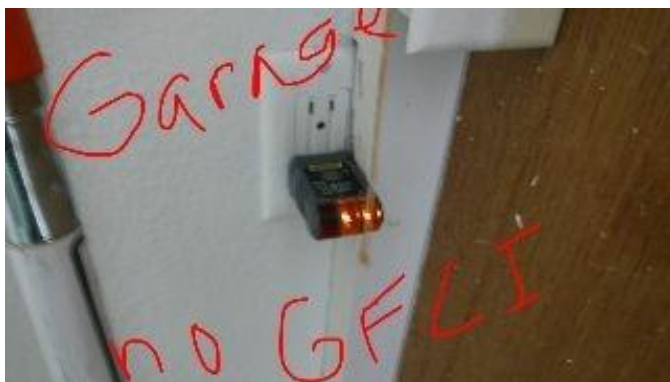
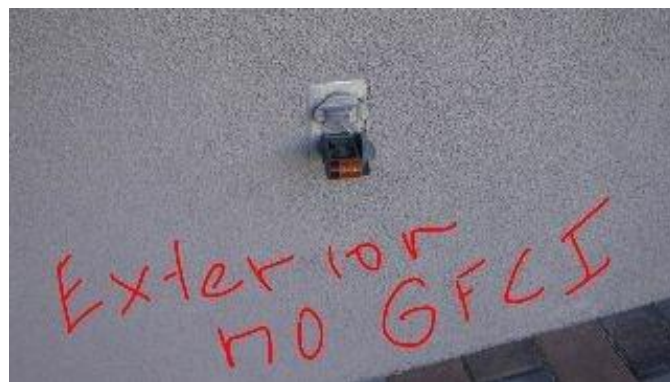
Electrical	Electrical Corrective Action
<p><i>GFCI not installed on exterior outlet. GFCIs are not installed on the kitchen Island or in Garage. We suggest consulting an licensed electrical contractor to install GFCIs to these areas for life safety reasons.</i></p>

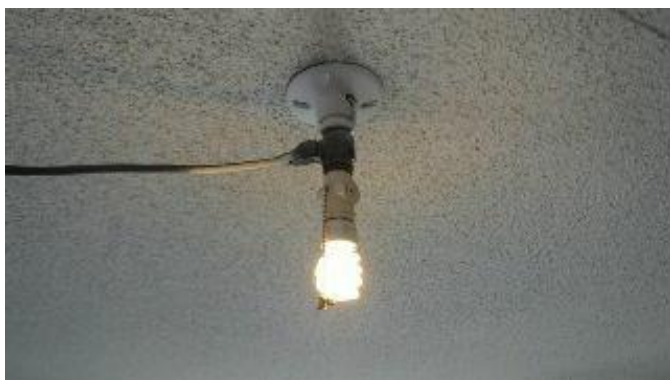
*Garage light switch disables the garage door operation. We suggest adding an outlet to provide power to the garage door by a licensed electrical contractor.*

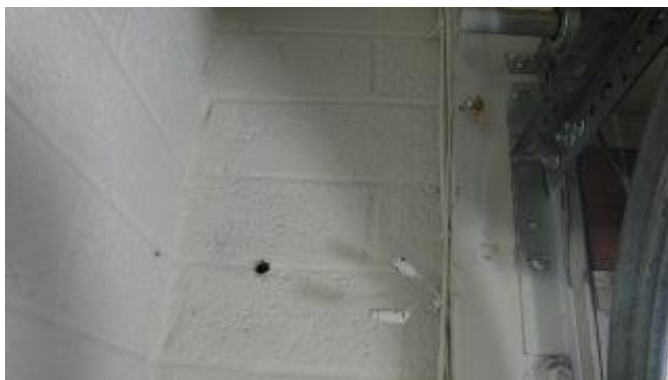
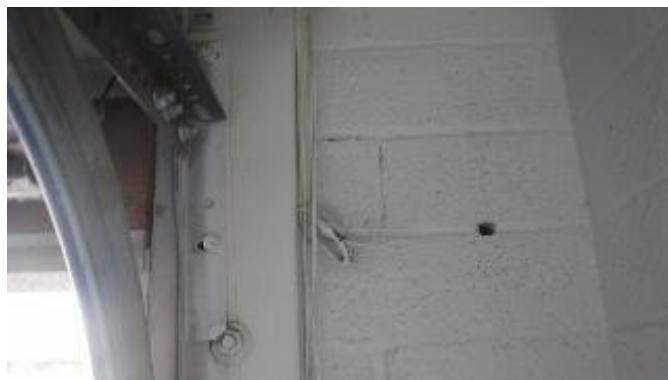
*Fixture is missing exposing wires [garage coach lights have been removed ].*

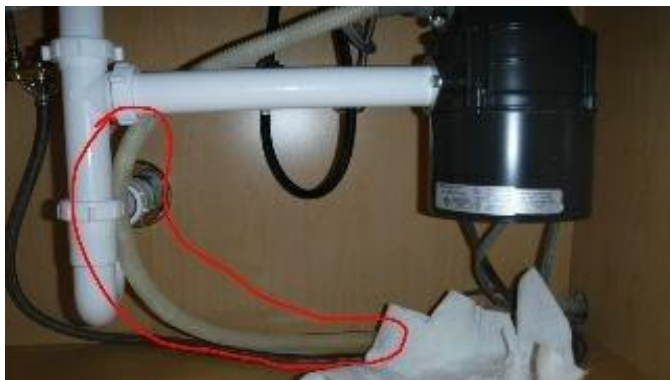
*An air gap device is not visible/installed. Raising and securing the drain line to its highest point to prevent wastewater from draining back into the dishwasher may form an air gap.*

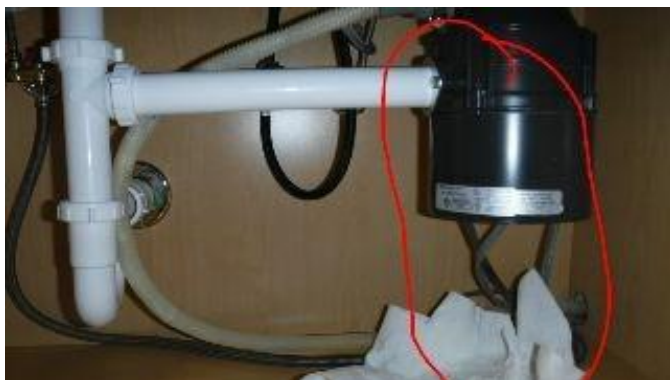
*The Disposal is leaking.*

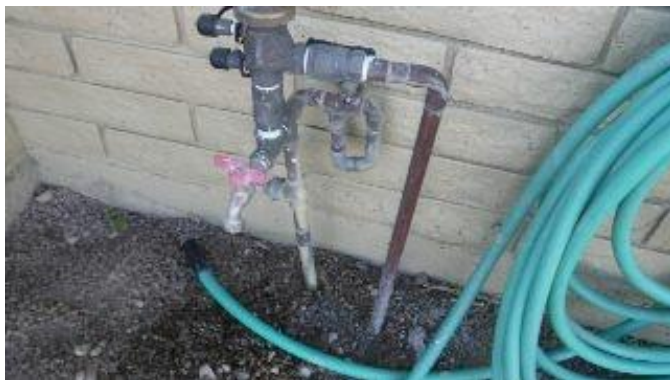
*The water main shut of valve is a gate valve and prone to failure. We suggest you consider installing a ball valve.*

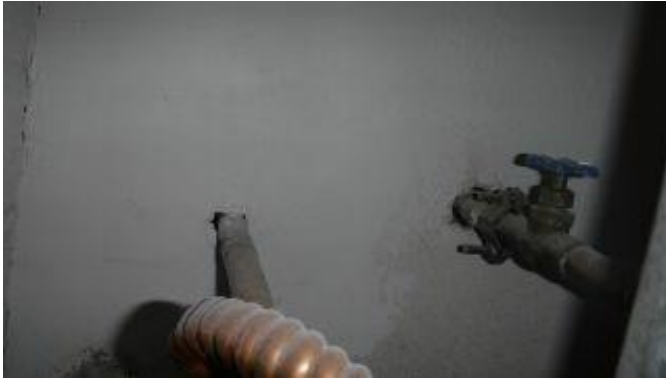
*The plumbing requires continuity of bonding throughout. The water heater requires a jumper bond across the supply and return lines due to dielectric insulation in the connections.*

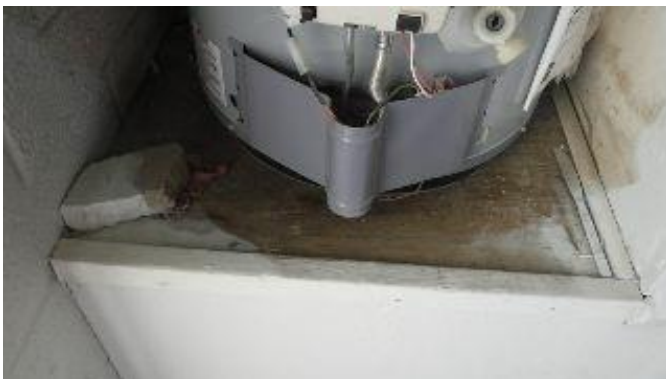
*The water heater does not appear to be level. The structure below the water heater appears to sag. This may be due to a heavier/larger water heater or from previous water damage [ ].*

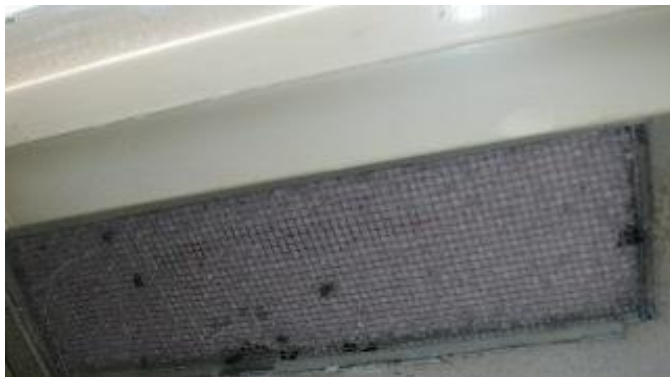
*Combustion air vents are blocked/restricted [ upper ceiling vent covered with attic insulation ]. Suggest clearing away insulation to clear vent.*

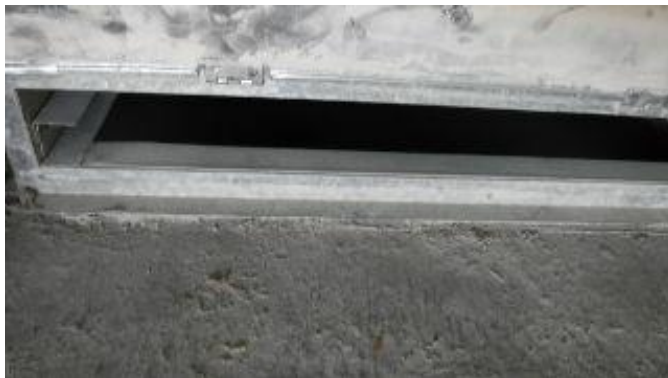
*The filters are installed behind the return air vents. There is also a location for a filter in the furnace that is redundant and there is no filter installed.*
