******* HOME INSPECTION REPORT *******

Somewhere St.
Park Ridge, NJ 07656
Prepared for: Ms. Jane Smith

Prepared By:
Kerr Home Inspections LLC
34 Madison Ave.
River Edge, N.J. 07661
PHONE: (201)261-0456 FAX: (201)262-0297
www.kerrhomeinspections.com

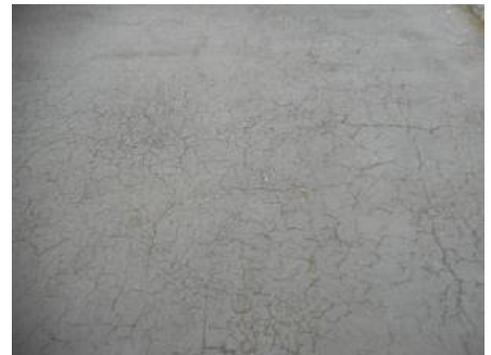
TYPE: Asphalt.
CONDITION: Repair/Replace- Driveway asphalt is deteriorated in areas and needs to be repaired and sealed to prevent further damage from water and ice intrusion. Recommend contacting a driveway contractor to evaluate the deterioration and recommend repairs and related costs prior to closing.

Repair/Replace- Driveway asphalt is deteriorated in areas and needs to be repaired and sealed to prevent further damage from water and ice intrusion. Recommend contacting a driveway contractor to evaluate the deterioration and recommend repairs and related costs prior to closing.

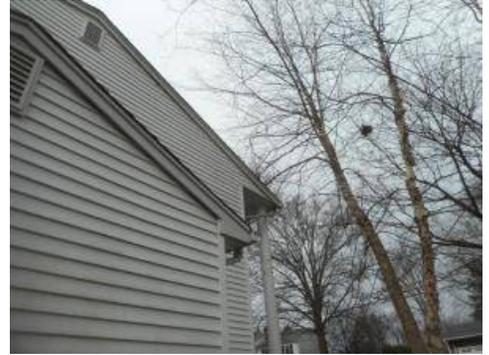
Needs Attention- Trees are touching or overhanging the roof. Damage is possible and will shorten the life of the roof. Recommend trimming or removal.

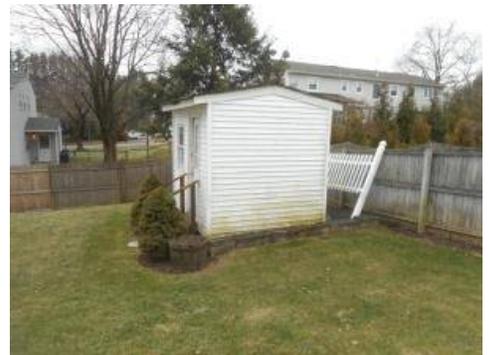
TYPE: Wood Shed.

CONDITION: Out buildings are not part of this inspection.

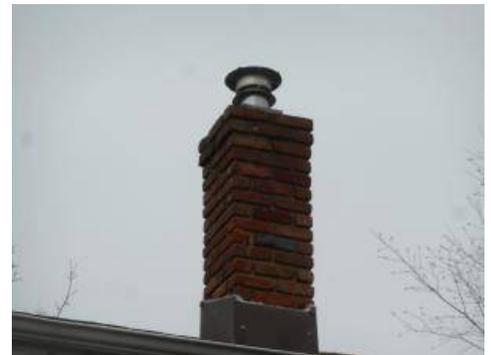
<i>FLASHING:</i>	Serviceable.
<i>CHIMNEY(S):</i>	Chimney services: Utilities, Chimney Type: Brick, The internal elements of the chimney servicing the heating and/or fireplace (flues/dampers/liners, etc) could not be visually evaluated at the time of inspection. These areas are concealed and fall outside the scope of this inspection. As per the N.F.P.A. 211 (National Fire Protection Agency standards for Chimneys and Fireplaces), a Level II Inspection is required whenever a house is bought or sold. Internal damage (cracking, holes, separation) may be present and is common in many chimneys. Consultation with a qualified Chimney Inspector is advised to conduct a Level II internal camera evaluation of the Chimney flue(s) prior to the expiration of your Home Inspection Contingency Period to help ensure that you are fully informed.
<i>CHIMNEY CONDITION:</i>	Viewed from ground with binoculars. Needs Attention- Minor cracks noted. Caulk, seal, or point as necessary to prevent water intrusion and concealed damage. Recommend repairs by a qualified chimney sweep.

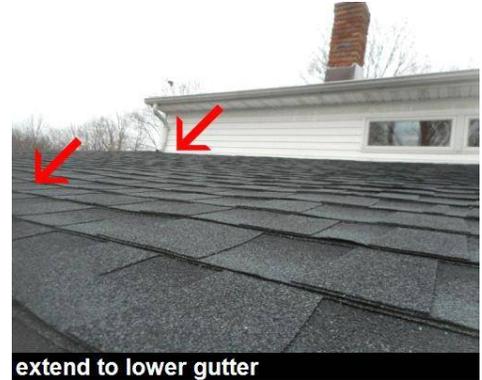
General condition is serviceable with the following exceptions; Direct downspouts from upper gutters to flow directly into lower gutters to reduce constant flow into lower roofs which will deteriorate this water impacted area.

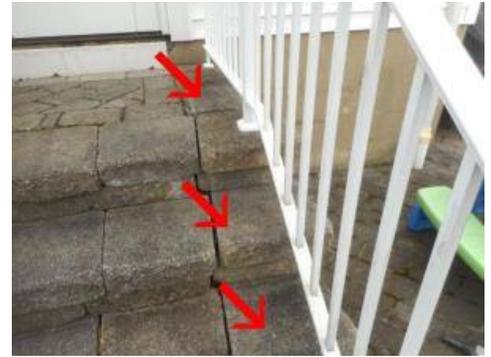
CONDITION: *Repair/Replace-* Loose pavers where the handrails are attached. Recommend repair by a qualified contractor.

HANDRAIL(S): Handrail(s) loose. Recommend repair. This is a Safety Concern.

Repair/Replace- Loose pavers where the handrails are attached. Recommend repair by a qualified contractor.

Handrail(s) loose. Recommend repair. This is a Safety Concern.

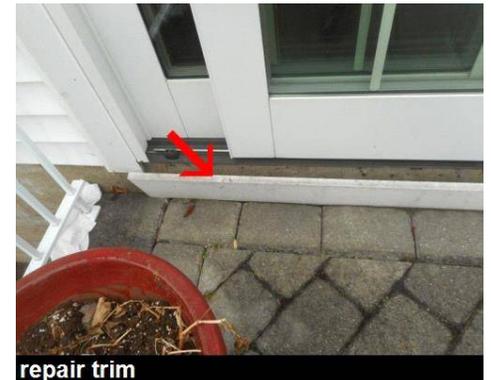
LOCATION/TYPE: Rear, Sliding glass.
CONDITION: General condition is serviceable with the following exceptions; Exterior trim below the door is loose. Recommend repair.

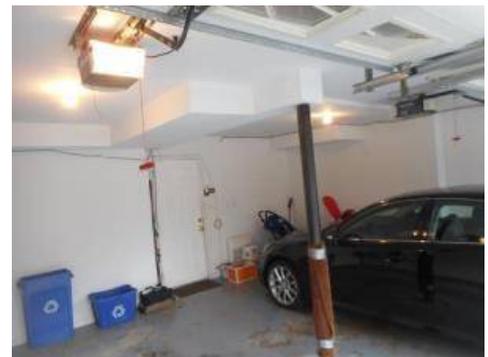
GENERAL CONDITION: Serviceable- Visible portions of garage structure appear serviceable.

FLOOR: Painted concrete, *Repair/Replace-* Spalling/deterioration in many portions of the floor found. Repair/resurfacing needed by a qualified contractor. Obtain pricing by a qualified contractor prior to closing.

Painted concrete, Repair/Replace- Spalling/deterioration in many portions of the floor found. Repair/resurfacing needed by a qualified contractor. Obtain pricing by a qualified contractor prior to closing.

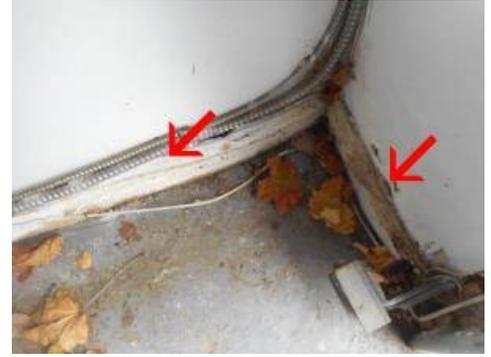
Drywall, fire rating not known. *Needs Attention-* Fibrous type baseboard material is damaged in areas. Consider replacement with a standard wood baseboard.

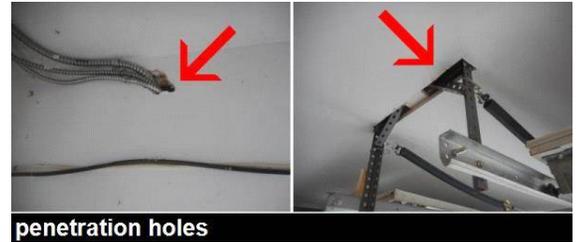
Drywall. Fire rating not known. Small holes noted in the ceiling. All penetration holes need to be sealed with the proper fire rated material to maintain a fire rating in the garage.

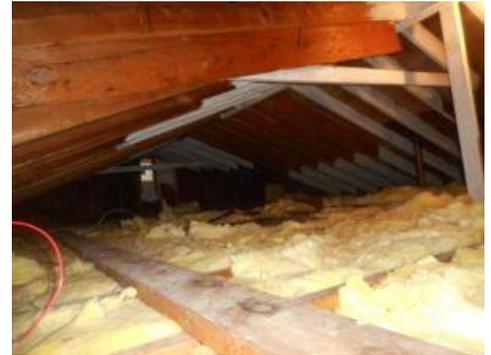
LOCATION: Upper roof area.
ATTIC ACCESS: Bedroom closet.
METHOD OF INSPECTION: Viewed the attic area from the attic hatch with a high powered light. Closet shelving prevented full access. Limited or no floor decking present. Inspector does not traverse floor beams without flooring. Use caution if entering the attic area.

ROOF SHEATHING: Plywood where visible.
WALL SHEATHING: Plywood where visible.
FRAMING/STRUCTURE: Standard dimensional lumber.
RAFTER SYSTEM: 2x6"s- 16 inches on center.
COLLAR TIES: Serviceable.
JOISTS: Not fully visible. Insulation prevents viewing of floor joists, 2x6"s- 16 inches on center.
ATTIC FLOOR: None.
CHIMNEY(S): Not visible.
ATTIC LIGHT: Exposed light bulb. Recommend installing a light fixture that has a cover for the light bulb. This is a safety hazard.
ATTIC INSULATION: Type: Fiberglass batts. Location: Within the floor system. Depth and approximate R-FACTOR: 5-6 inches R-19. Condition: Serviceable.
ATTIC VENTILATION: Types of attic venting found: Gable end louvers. *Needs Attention-* Appears to be a roof fan as seen from the exterior. Could not verify from the hatch opening. It is recommended to have a thermostatically controlled exhaust fan with a humidistat. This will help to reduce the temperature and moisture in the attic. Reducing the temperature and moisture in the attic will keep the space below cooler as well as stopping shingles from deteriorating prematurely and moisture damage to the roof structure. Verify prior to closing.

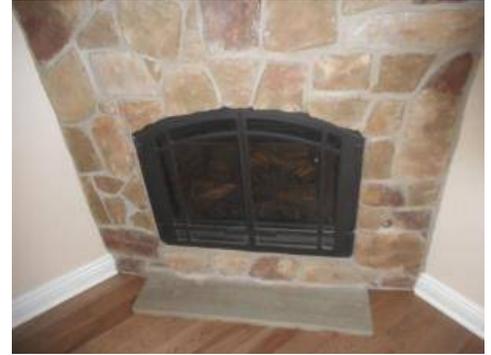
TYPE OF UNIT: There is a sealed gas fireplace installed.

OVERALL CONDITION: Serviceable.

TYPE OF FUEL: Gas.
GAS SHUT OFF: A gas shut off Dante type valve adjacent to the fireplace as an emergency shut off is installed.
DAMPER: Direct vent.
COMBUSTIBLE CLEARANCE: Clearance to combustibles is sufficient.

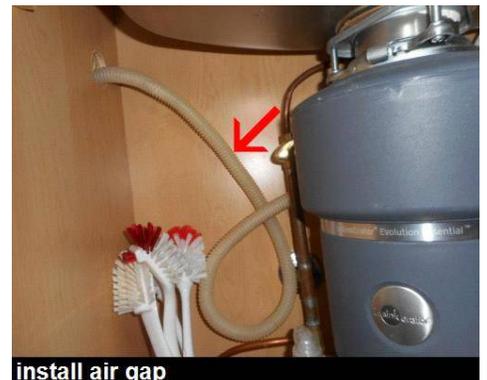
install air gap

SINK TYPE: Stainless Steel.
SINK CONDITION: Serviceable.
RANGE/COOK TOP: Gas, Serviceable.
OVEN: Electric, Serviceable.
EXHAUST FAN: Stove hood.
FAN CONDITION: Serviceable.
REFRIGERATOR: Did not evaluate. The evaluation of a refrigerator/freezer/ice maker is beyond the scope of this inspection. Check operation of unit during final walkthrough.
DISHWASHER: Serviceable- Ran dishwasher through rinse cycle to check for supply line/drain leaks. How well the dishwasher performs is beyond the scope of this inspection. A proper air gap IS NOT installed in the dishwasher drain line. Drain line should have a loop that extends up to underside of counter. Correction is recommended.

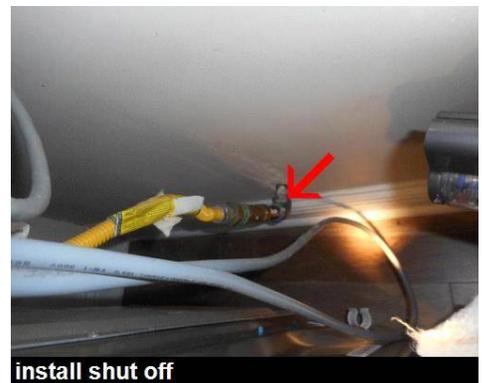
LOCATION: Ground floor.
 WASHING MACHINE: Washing machine installed. Did Not Evaluate. The evaluation of washing machines is beyond the scope of this evaluation.
 WASHER HOOK UPS: Did not test. Plumbing connections appear to be serviceable.
 WASHER DRAIN: Serviceable. Washer drains into a standpipe and trap to the sewer system. This is the preferred method.
 DRYER: Gas dryer installed. Did not test, evaluation of the performance of the dryer is beyond the scope of this inspection.
 DRYER HOOK UPS: Gas hook-up provided for dryer, 110 volt electric outlet provided for gas dryer.
 GAS HOOK-UP: *Needs Attention-* No local gas shut off noted. Recommend an easy to operate hand shut-off valve be installed near dryer unit. This is a SAFETY CONCERN.

Needs Attention- No local gas shut off noted. Recommend an easy to operate hand shut-off valve be installed near dryer unit. This is a SAFETY CONCERN.

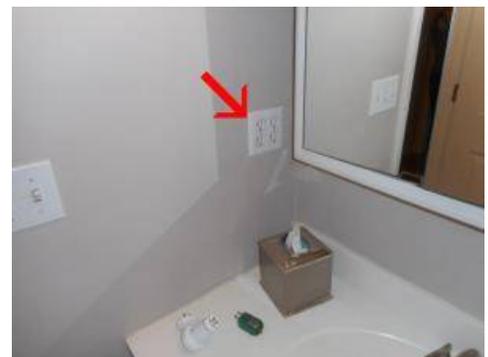
BATH LOCATION: Hall, Upstairs.
FIXTURES: Toilet, Sink, Bath tub with shower.
CONDITION OF SINK(S): Serviceable.
CONDITION OF TOILET: Serviceable.
TUB/SHOWER PLUMBING FIXTURES: Serviceable.
TUB/SHOWER AREAS: Tub and shower areas serviceable. Caulk and seal all tub and shower areas as a precaution.
FLOOR COVERING/CONDITION: Ceramic tile. Serviceable.
WALL/CEILING COVERING: Walls are, Drywall, Condition: Serviceable, Ceilings are, Drywall. Condition: Serviceable.
ELECTRIC Outlet not GFCI protected. This is a SAFETY CONCERN. Recommend replacing with a GFCI outlet by a licensed electrician.

Outlet not GFCI protected. This is a SAFETY CONCERN. Recommend replacing with a GFCI outlet by a licensed electrician.

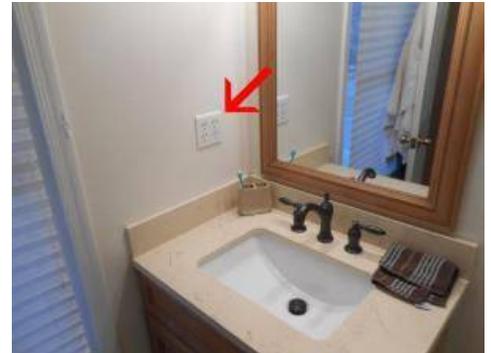
TUB/SHOWER AREAS: Enclosure appears serviceable.
FLOOR Ceramic tile. Serviceable.
COVERING/CONDITION:
WALL/CEILING COVERING: Walls are, Drywall, Condition: Serviceable, Ceilings are, Drywall. Condition: Serviceable.
ELECTRIC Outlet not GFCI protected. This is a SAFETY CONCERN. Recommend replacing with a GFCI outlet by a licensed electrician.

Outlet not GFCI protected. This is a SAFETY CONCERN. Recommend replacing with a GFCI outlet by a licensed electrician.

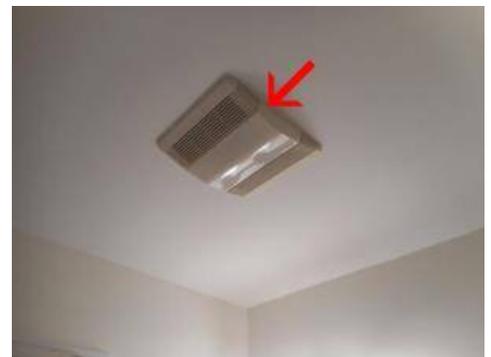
BATH VENTILATION: Exhaust fan makes unusual noises. Repairs or replacement needed.

Exhaust fan makes unusual noises. Repairs or replacement needed.

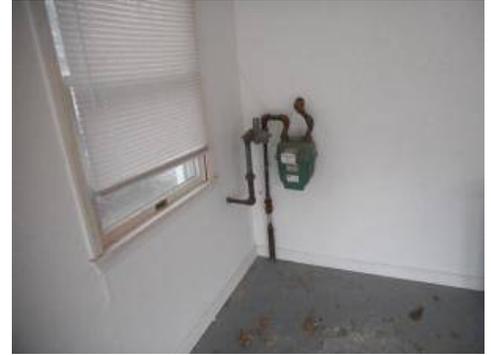
FUEL SUPPLY SYSTEM: Natural gas. Meter located in the garage.

GAS SUPPLY LINES: The gas piping in the house is predominantly steel (black pipe). CSST (corrugated stainless steel tubing) was noted in some areas.

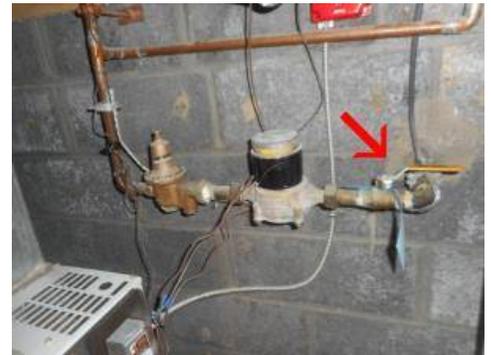
MAIN SHUTOFF LOCATION: The main interior water shutoff valve is located in the basement, Front wall. Recommend the installation of another shutoff valve on the house side of the meter.

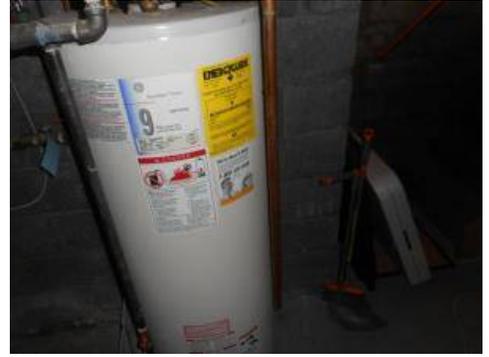
APPROXIMATE AGE: 12 years old, Unit has reached/exceeded it's normal lifespan. Anticipate replacement in the near future. Normal lifespan for a water heater is approximately 10-12 years.

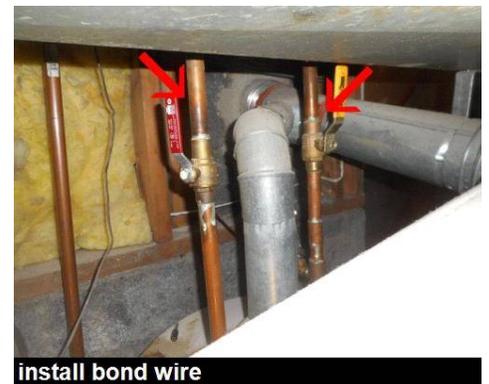
VISUAL CONDITION/OPERATION: The unit is operational, but the installation does not meet all of the modern recommended safety guidelines. See below for details. Electrical bonding/jumper wire not installed. Consider installing to continue ground through water tank.

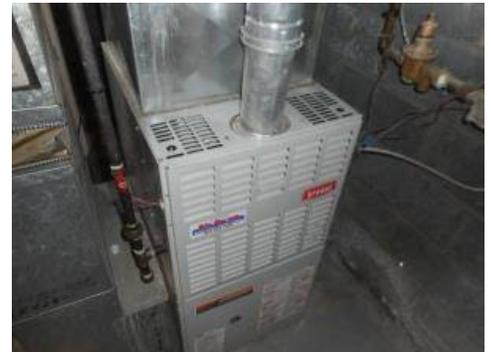
HEATING AREA: Whole house.
LOCATION OF UNIT: Basement.
BRAND: Bryant.
SYSTEM TYPE: Induced draft hot air furnace.
NET CAPACITY/OUTPUT (approx.): 90 thousand btu's.
APPROXIMATE ENERGY EFFICIENCY: 80% This is a mid-efficiency unit.
ENERGY SOURCE AND NOTES: Natural Gas.
APPROXIMATE AGE IN YEARS: 15 years old.
NORMAL LIFE OF HEATING UNIT: Gas-Fired Hot Air.....18-20 years.
VISUAL CONDITION/OPERATION: Serviceable. The heater was operated by turning up the thermostat, and then turned back to its original setting.

BURNERS: Serviceable.
COMBUSTION AIR/FIRE RATING: Serviceable.
AIR PLENUM: Serviceable.
VENTING: Metal to a masonry chimney.
HEAT DISTRIBUTION TYPE: Ducts to registers.
HEAT/AC DUCTS: Ducts used for: Heat and Air Conditioning, Type Viewed: Sheet metal. Evaluating the cleanliness of the insides of the ducts is beyond the scope of this inspection. consider having the ducts cleaned by a professional cleaning and sanitizing company.
HEAT DISTRIBUTION CONDITION: General condition of the heat distribution system appears to be serviceable. The home inspector is not required to determine the adequacy of the heat supply or the distribution balance and does not operate automatic safety controls. A laser non contact thermometer is used to determine the approximate temperature of the heat/air conditioning distribution units in rooms.
THERMOSTAT(S): Serviceable- Heating unit responded to the thermostatic/switch controls . One thermostat is

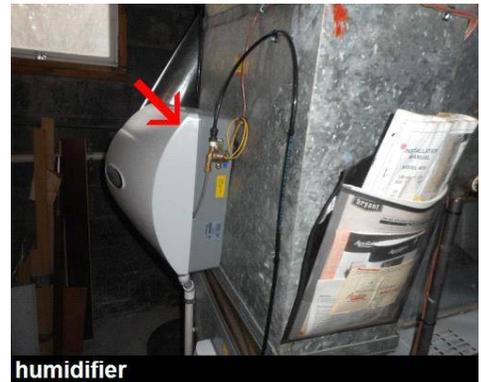
noted. This indicates only one zone heat.
A humidifier is installed, but was not tested.
Humidifiers require seasonal maintenance to work properly. Replaceable filter noted for this unit.
Regular replacement needed.

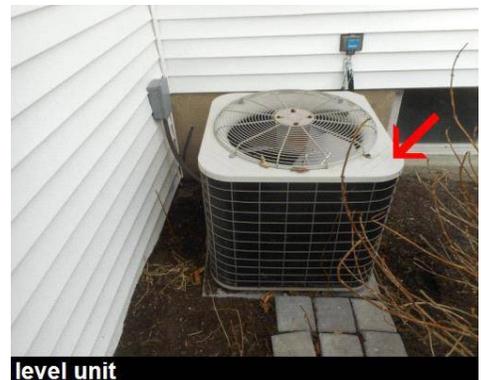
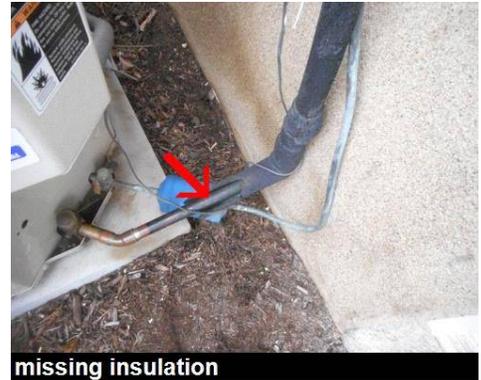
level unit

CONDENSER UNIT: *Needs Attention-* The compressor unit is not on a level pad. It is recommended that the unit be re-leveled to help prolong the units lifespan. Part of the insulation is missing near the exterior condenser unit. Recommend correction for energy efficiency.

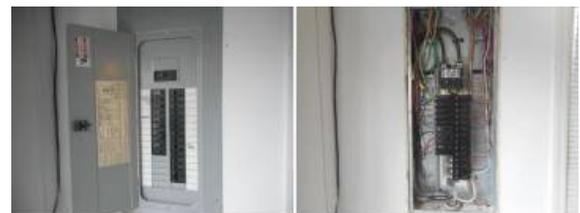
OVERLOAD PROTECTION: Circuit breakers.
SERVICE AMPERAGE/VOLTAGE: 200 Amps.-120/240 volts.
SERVICE: TYPE MATERIAL: Aluminum.
SERVICE PANEL LOCATION: Garage.
SERVICE PANEL CONDITIONS: General condition is serviceable.

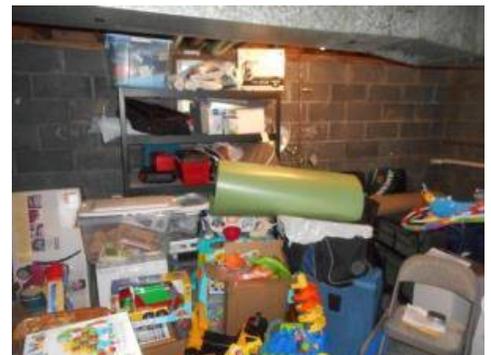
ACCESSIBILITY: Basement is unfinished. Basement is partially inaccessible due to large amount of clutter on floor and along walls. Consider a re inspection during the final walk through when the basement is empty.

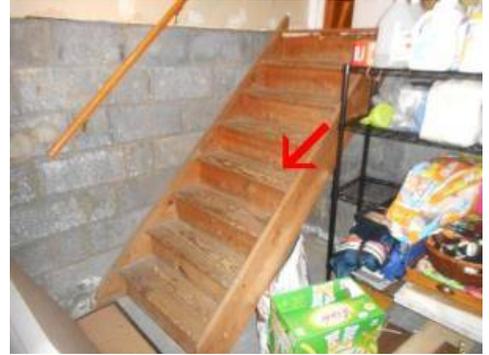
Needs Attention- Open side of stairway has no handrail or balusters. Consider installing for safety.

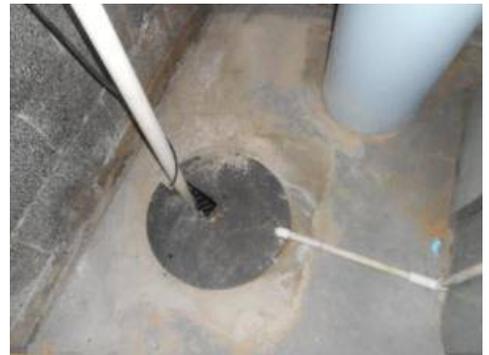
Sump pump is serviceable. The pump operated normally when manually tripped. Recommend purchasing another sump pump as a backup for emergencies. In addition, recommend having emergency battery or generator backup if a power failure occurs.
