Crowcombe Court Crowcombe Somerset

AN ARCHAEOLOGICAL COMMUNITY EXCAVATION

February 2023

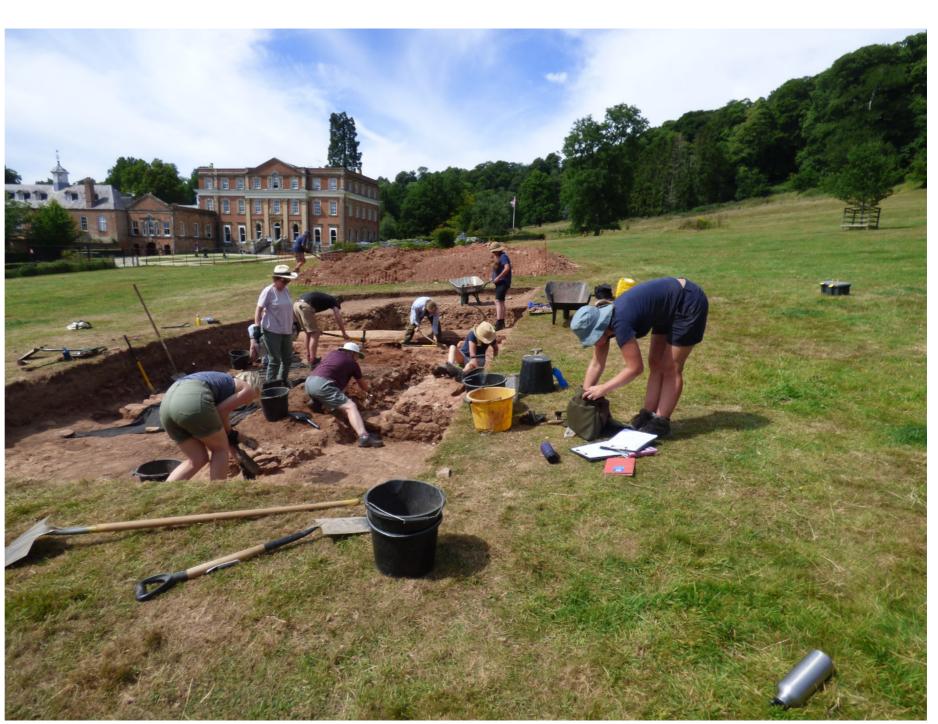
Figure 1. Excavation of Trench 1 in progress

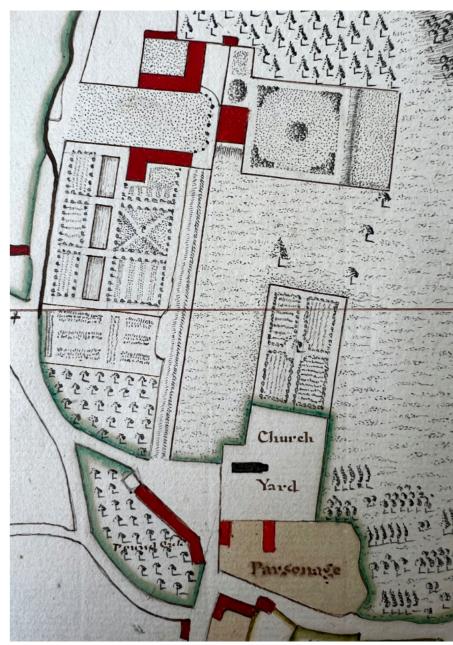
Figure 3. Extract from a plan of demesne land in Crowcombe, 1767 showing John Carew's garden

Details relating to Crowcombe manor house itself during the medieval period are scant with the earliest references only available from the late 13th century. Dovecotes and a fishpond are mentioned in the mid-14th century but nothing further (Riley 2006: 102; Baggs et al 1985: 54-64). Sir John Carew was granted the right to make a warren and park at Crowcombe during the reign of James I (1603-1625) and laid out a court and garden in 1676. The garden is depicted on an estate plan of 1767 and shows a substantial rectangular garden neatly attached to the north wall of the churchyard and encompassing a simple co-axial arrangement of four parterres divided by paths leading to a central circular area with a feature, possibly a tree, as its focal point (Figure 3).

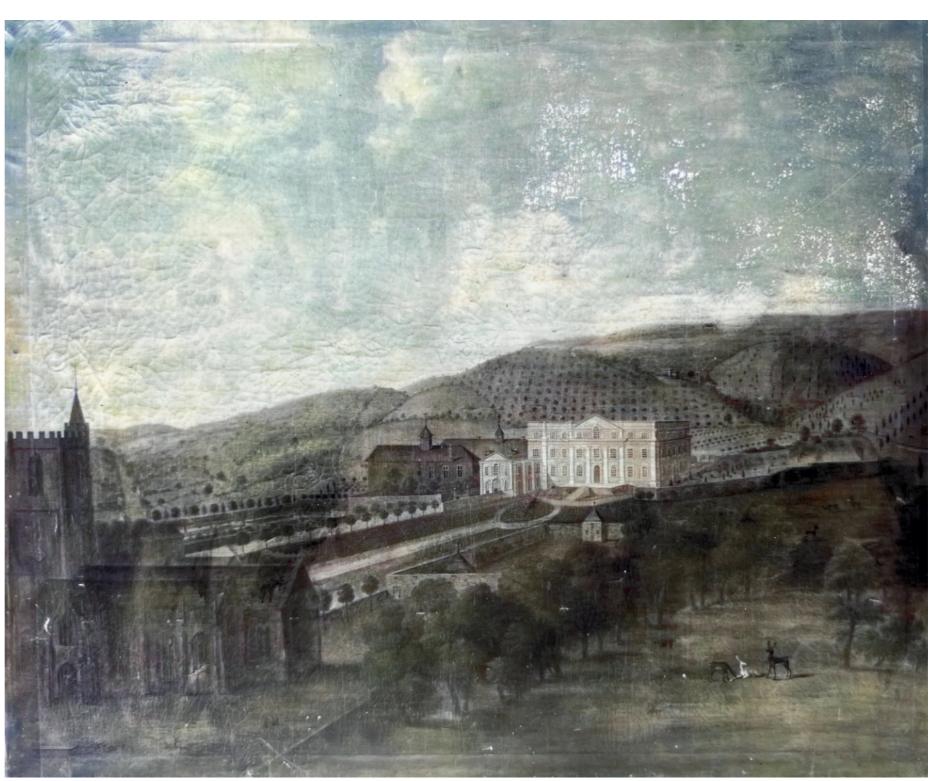
Figure 4. Colourised painting of Crowcombe Court, c. 1740 showing walled garden with pavilions in the foreground

A painting of Crowcombe Court dating to around 1740 (Figure 4), most likely commissioned to commemorate the completion of the new manor, includes the garden which is shown as being surrounded by a high stone wall incorporating pavilions centrally positioned along the northern and southern walls. A doorway is shown through the wall leading directly into the churchyard at the south-western corner with an opposing door in the far north-western corner. There are no sign of the parterres or paths within the garden although the inside of the western wall appears to have shrubs or trees growing up against it. The pavilions are shown to project out from the wall at either end with a central door flanked by windows on either side and a single window above. The roof forms an apex with a cupola.

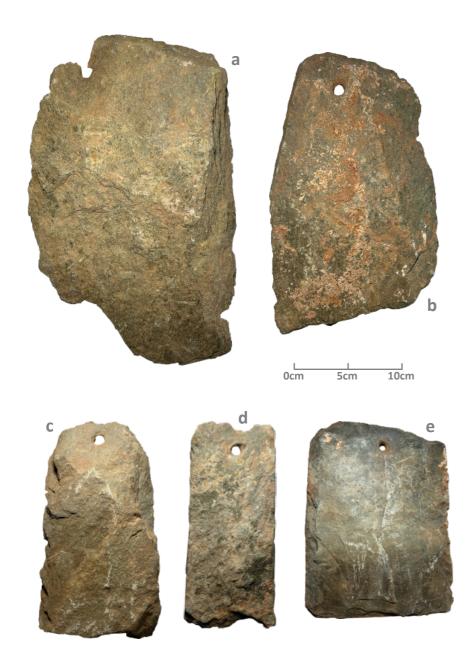
- a. Unstratified stone slate with broken single peg hole (medieval)
- b. Unstratified stone slate with single peg hole (medieval)
- c. Smaller, upper course stone slate with single peg hole (medieval)
- d. Modified stone slate with single peg hole (medieval)
- e. Post-medieval riven slate possibly used on pavilion roof

A large quantity of roof slate were retrieved during the excavation but only the best examples were selected for retention. Slates were noted in contexts 1006, 1011, 1013, 1015, 1014 and 1023. The exemplars were collected from three contexts (1014, 1021 and 1024) and a number of unstratified specimens were also retained for assessment. The details are provided in Table 5 with examples illustrated in Figure 41.

Examples of thinner riven slates were also observed across the Site with context 1021 producing the best and only complete example from a sealed deposit (Figure 41, e). This measured 14cm wide by 18cm long but only 0.50cm thick but again with a single peg/nail hole. Other slate fragments were similarly riven and thin but more regular in appearance and with two nail holes.

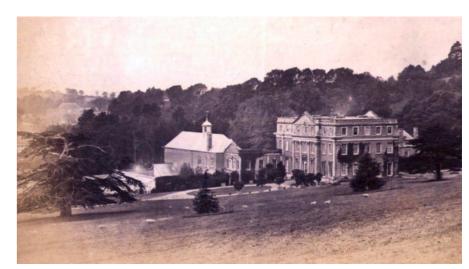
Figure 43. Crowcombe Court, c. 1860 with young and established cedars and associated fencing (after Riley)

The surveys have also led to confirmation of the former gardens on the eastern side of Crowcombe Court although the plan and painting only partially correlate A number of circular parchmarks/earthworks appear to represent tree boles, left as scars from a few scattered cedars that can be seen in Victorian and early 20th century photographs, some with a ring of animal fencing, as part of the parkland setting (Figure 43). One, in particular appears to be a signature planting at the corner of the formal garden closer to the house. Incidentally, this appears to form part of an extension of the Court garden which was not depicted in the painting. Away from these, the network of drainage channels on the higher ground, in particular, is plain to see. These probably take different forms depending on their age although the excavation showed that a number of these, at least, are Victorian. While neither the brick drain in Trench I and the smaller drain in test pit 6 were excavated beyond their exposure, recent remedial work in early 2022 encountered one of the Victorian drains just north of Trench I and showed this to have had a slate floor and clear of debris despite no longer functioning (Bellamy, pers. comm.)
