# ***First Look Home Inspections, LLC***

2698 Bigblock Dr. , North Myrtle Beach, SC 29582

Date of Inspection: 4/30/2020 Time: 9:30 am

Age of Home: 2003 Size: 3800 Sq. Ft.

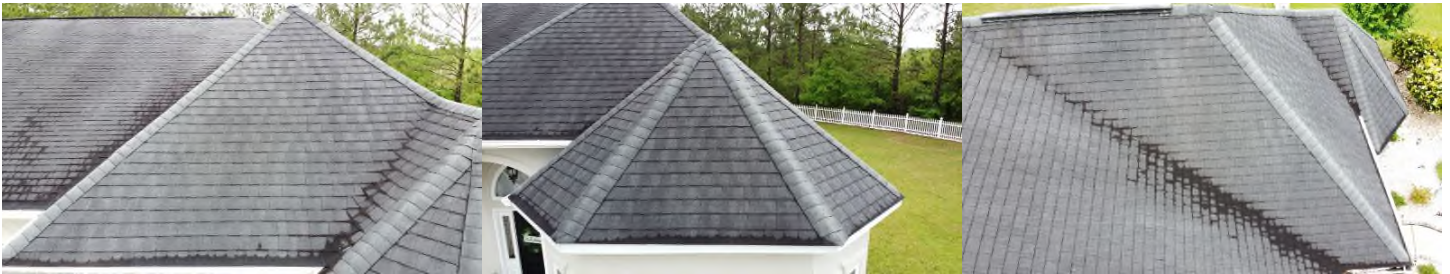
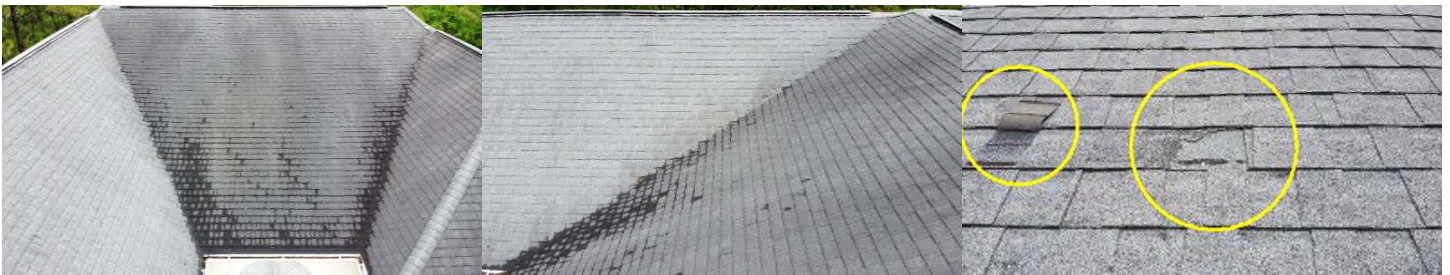
Roof over garage

- Some shingles damaged.

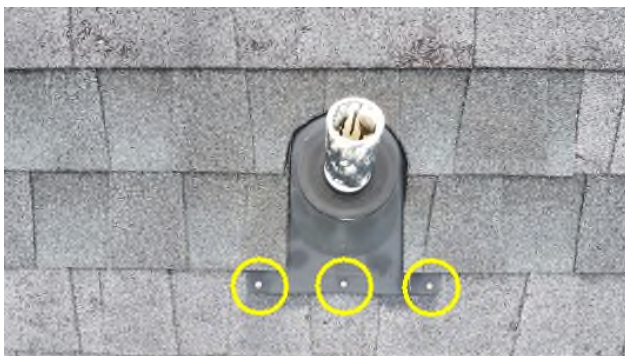
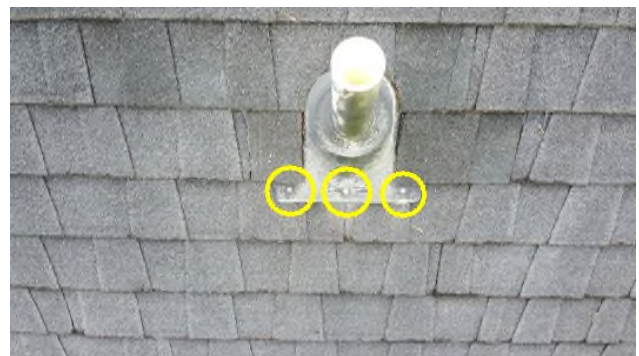
- Exposed nails on the roof vents. Recommend sealing all fastener heads.

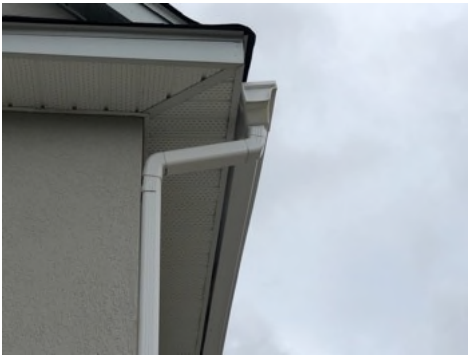
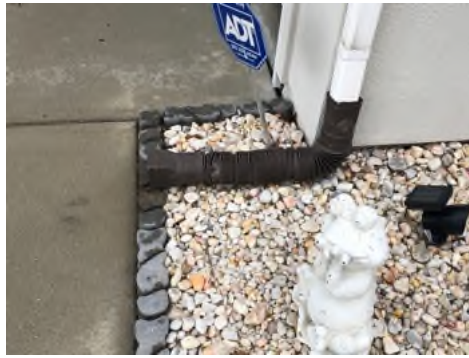
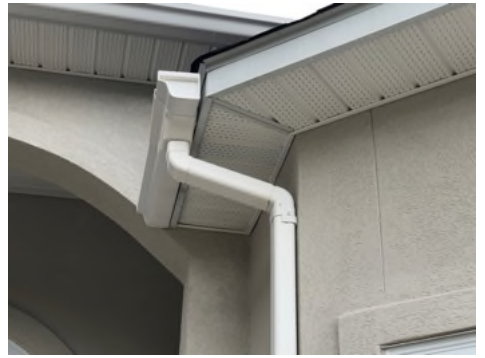
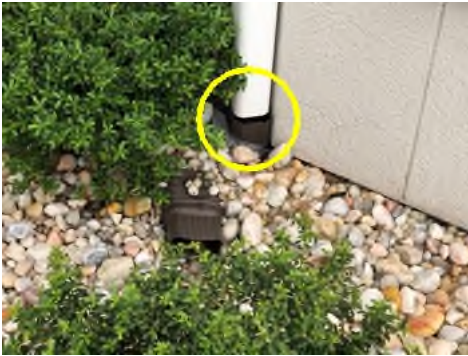
Front of house

- Make sure all downspouts are connected and routed to discharge away from the homes foundation.
- Partial gutters - Full installation recommended to keep water away from structure.
- Maintenance Tip: Keep gutters cleared of debris to prevent downspouts from being clogged causing overflow at gutters, ensure that all downspouts have extensions/splash blocks to carry water away from the foundation.
- One section of the gutter and one downspout needs to be reconnected.

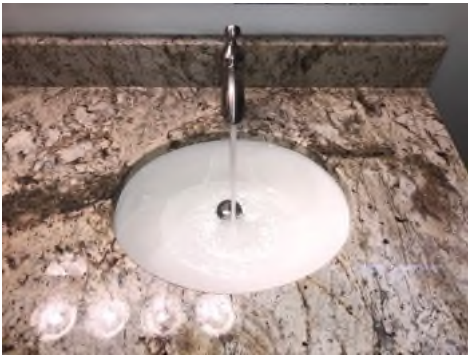
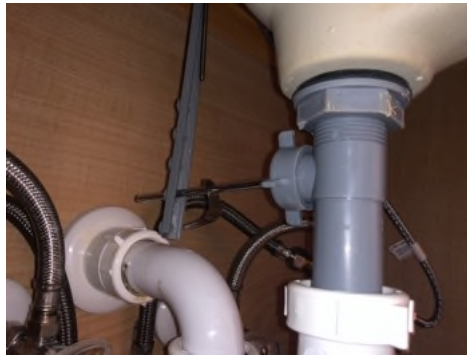
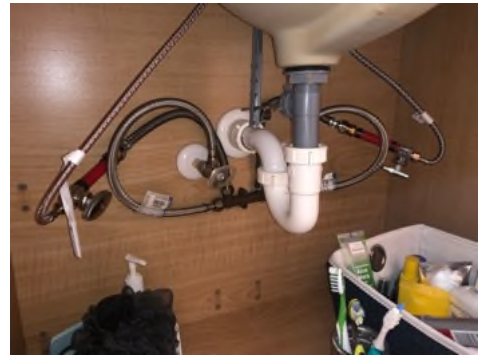
Left sink, master bath

- Operated normally with no leaks observed at the time of inspection.
- Drain stopper is missing/inoperable in the master bath left side sink.

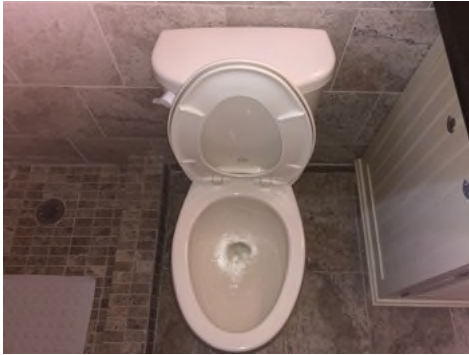
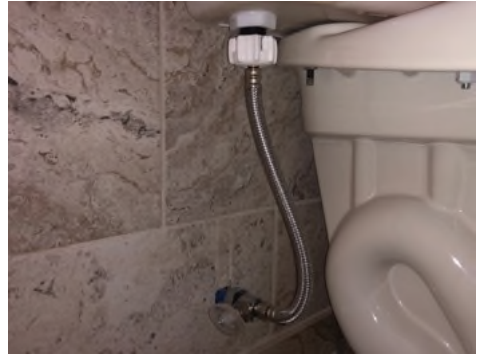
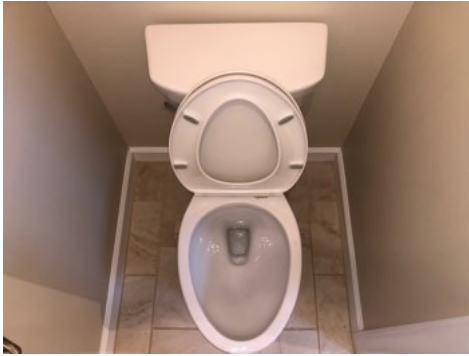
- Operated when tested. No deficiencies or leaks noted.
- Toilet noted as loose in the 1st floor guest bathroom and may need tightening or re-anchoring.

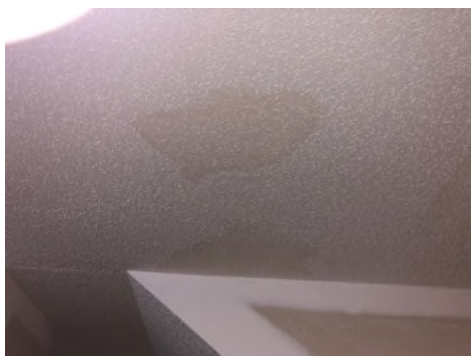
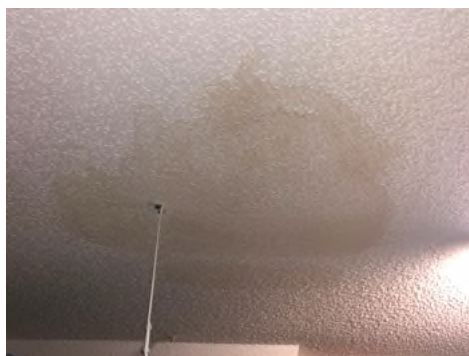
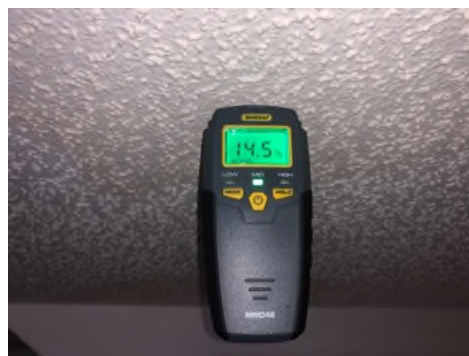
- No concerns noted with the ceilings at the time of the inspection
- Stains noted on the ceiling in the garage. They tested dry at the time of the inspection.

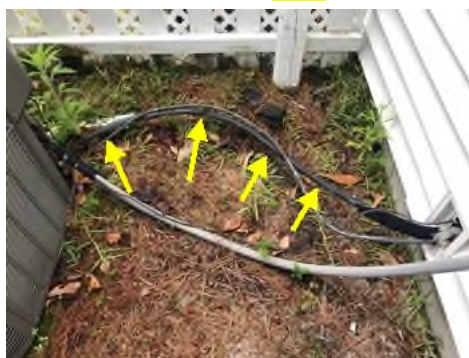
- No defects observed at the time of inspection.
- Missing insulation at the Lennox A/C unit.

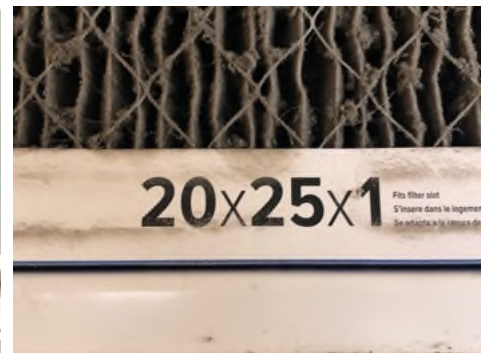
- Filter installed at the time of inspection.
- Unable to access the filter in the master bedroom due to owners personal belongings being in the way.
- Furnace filter dirty. Needs replacement.
- MAINTENANCE: The air filter(s) should be inspected at least monthly and cleaned or replaced as required.
