Maintenance

Prepared on behalf of Example Lettings Ltd

123 Preview Street
Sample City
London
AB1 2CD

1. PREVIOUS ALARM CONDITION			
Ref	Name	Location	Condition
1.1

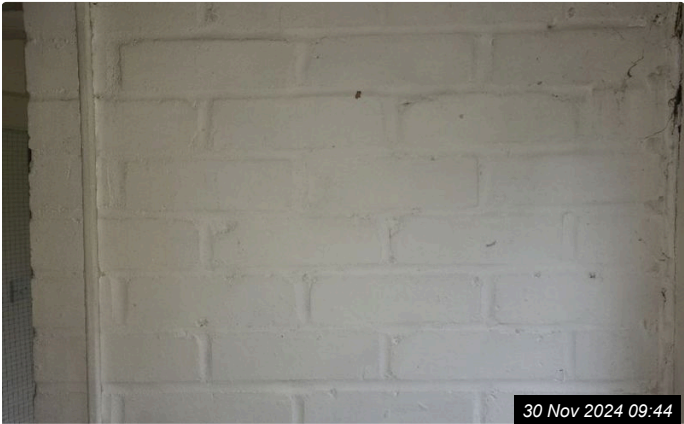
Carbon Monoxide alarm	None fitted	Not previously fitted
<div><div>

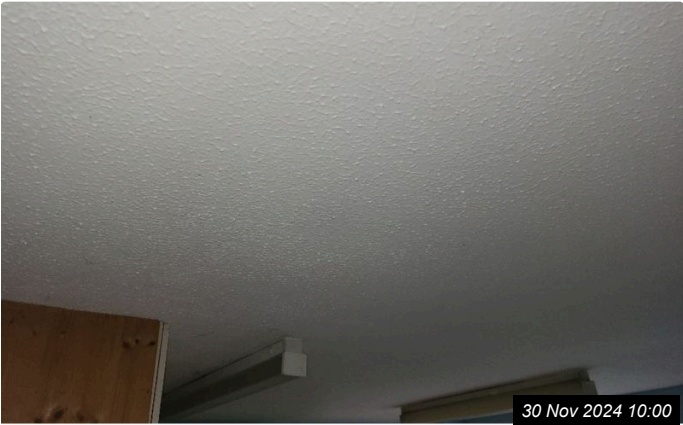
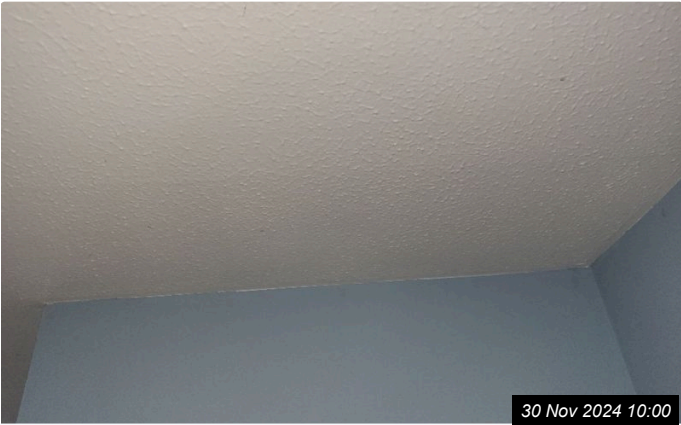
Heat Alarm	None fitted	Not previously fitted

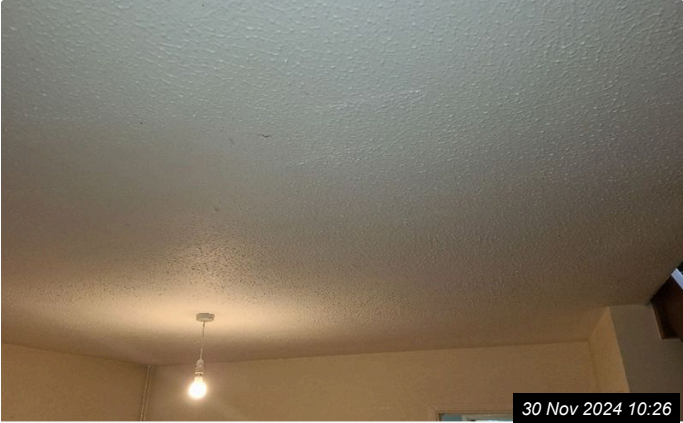
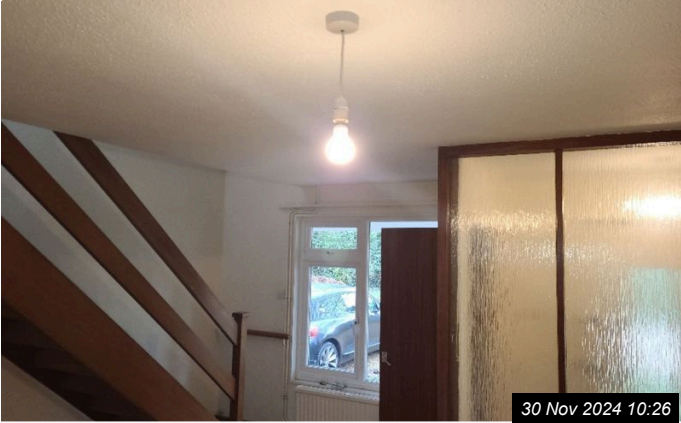
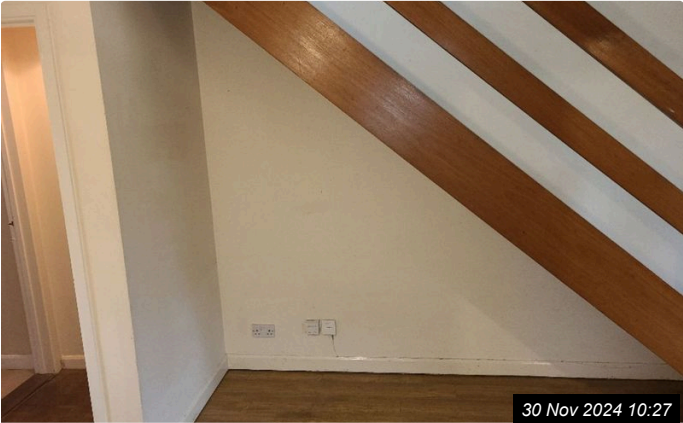
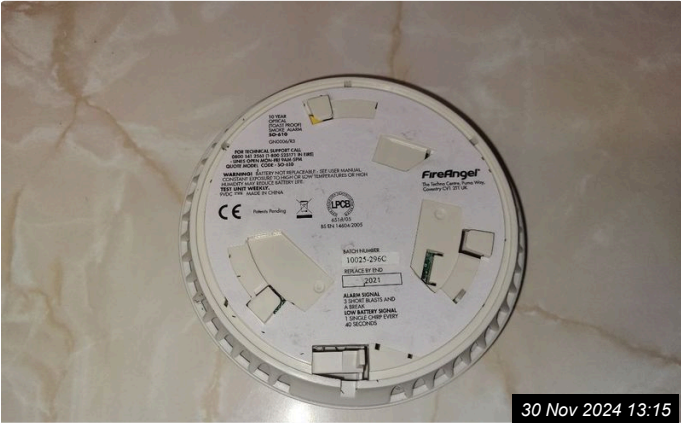
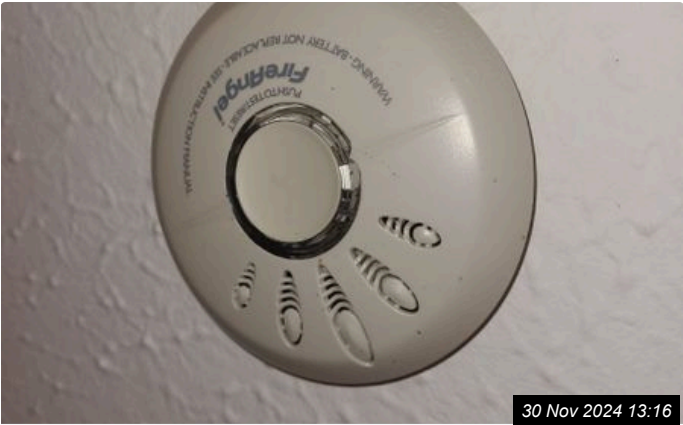
Smoke alarm	Not fitted in recommended room Previously fitted in reception 2	Not previously fitted in recommended room Previous alarm out of date; Ceiling in Reception room 2 retains baseplate for Fireangel optical smoke alarm, additional new alarm can be fitted direct to this plate however this is not required for compliance purposes, ; Retained fittings are compatible with newer alarms: Model example: FA6615-R
<div><div>

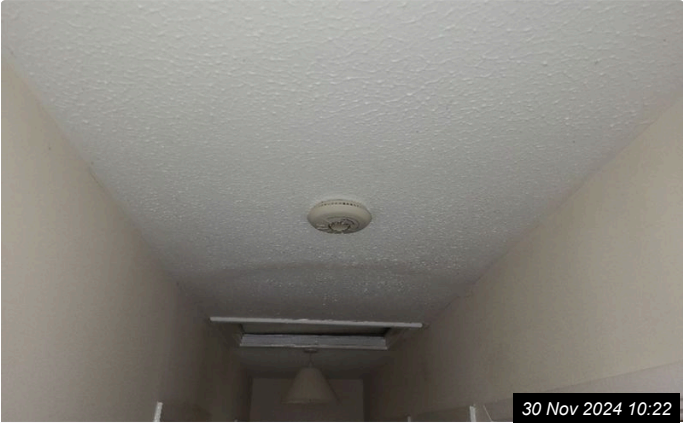
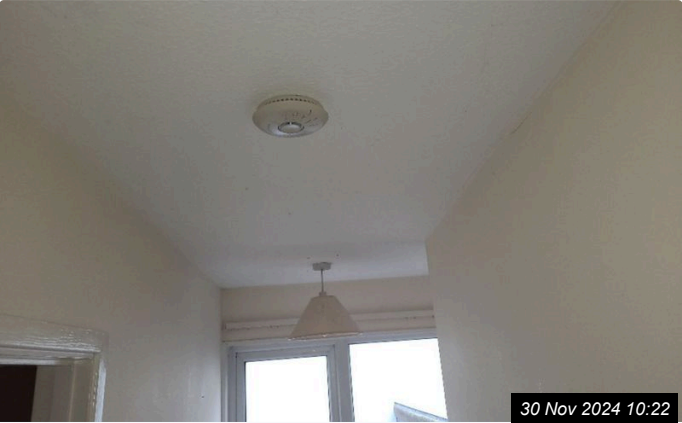
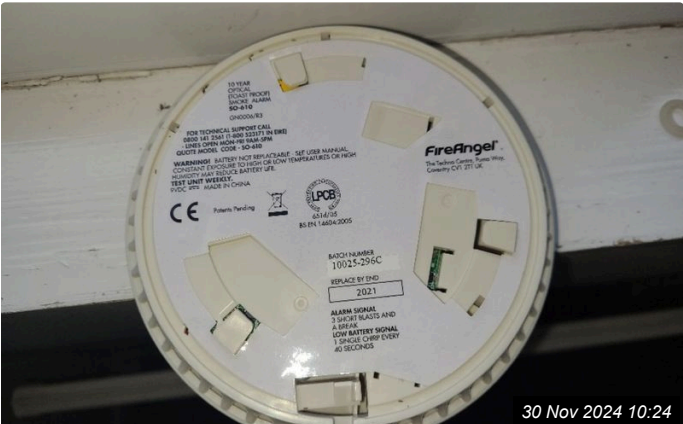
Smoke alarm	First floor Landing Ceiling	Out of date
<div>

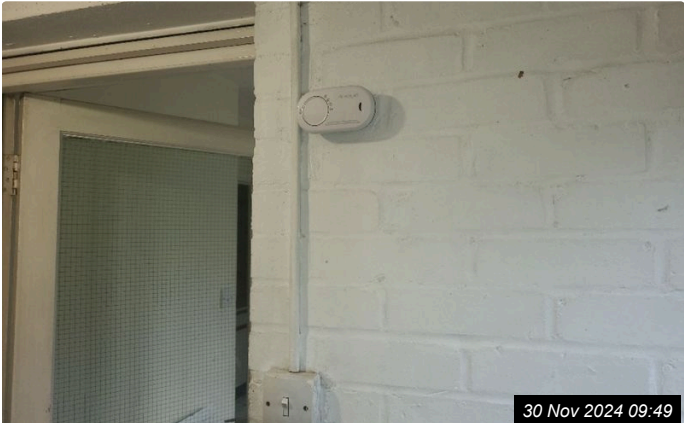
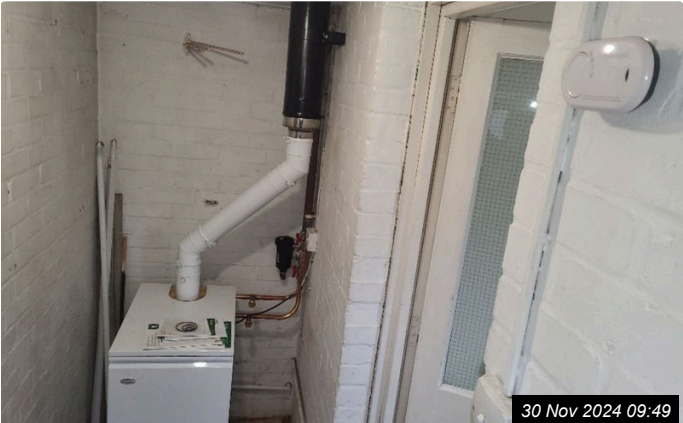
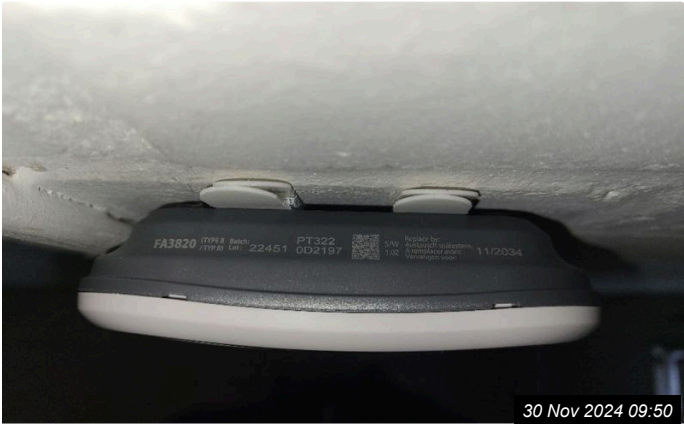
Carbon Monoxide Alarm	Ground floor Rear lobby Near wall Right side of entry from utility	01-11-2034	<p>Alarm tested for power only, audible alarm noted</p> <p>Note: Due to constraints with room height and requirements for tenants to be able to test alarm without access to ladder, alarm has been placed on wall at highest possible height, approximately 1.5m away from boiler.</p> <p>This does sit below top of door heights however no other suitable placement without other compromise on fireangel installation guidelines.</p>
<div><div>

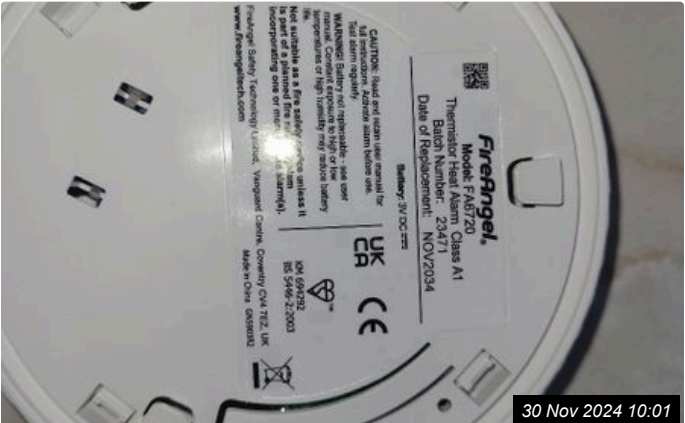
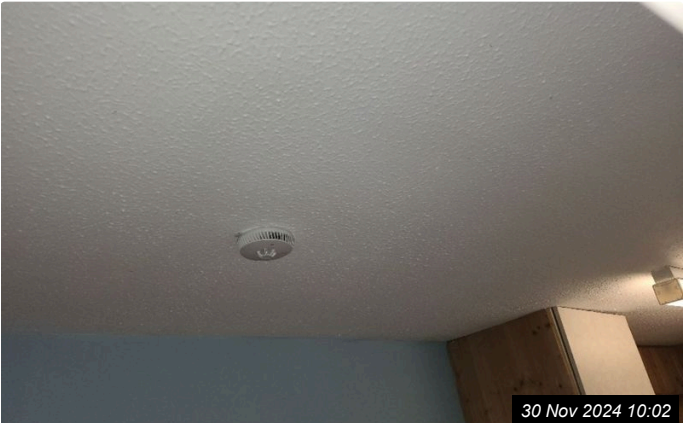
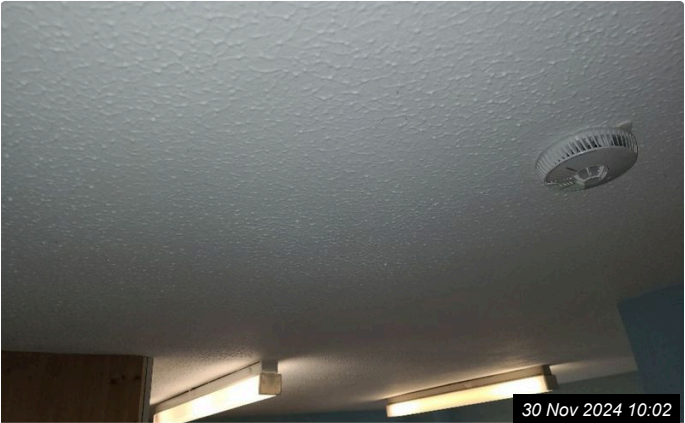
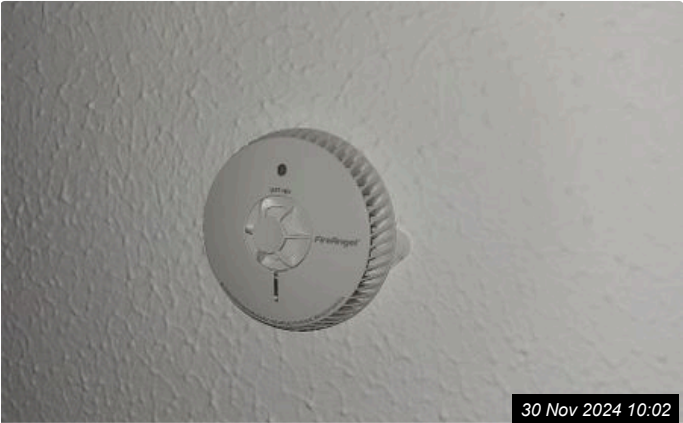
Heat Alarm	Ground floor Kitchen Ceiling between Reception room 1 and Utility	01-11-2034	Alarm tested for power only, audible alarm noted

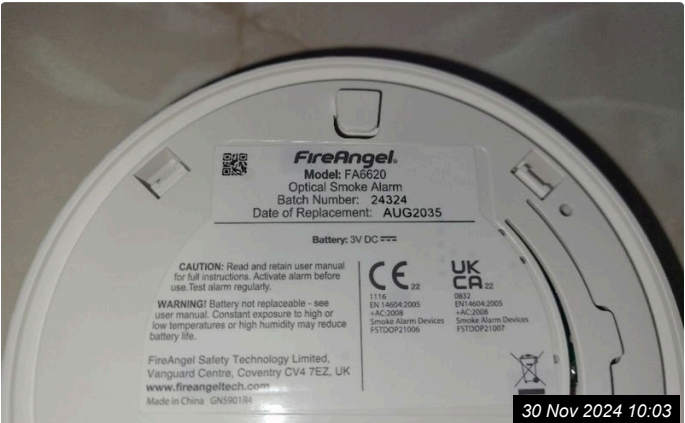
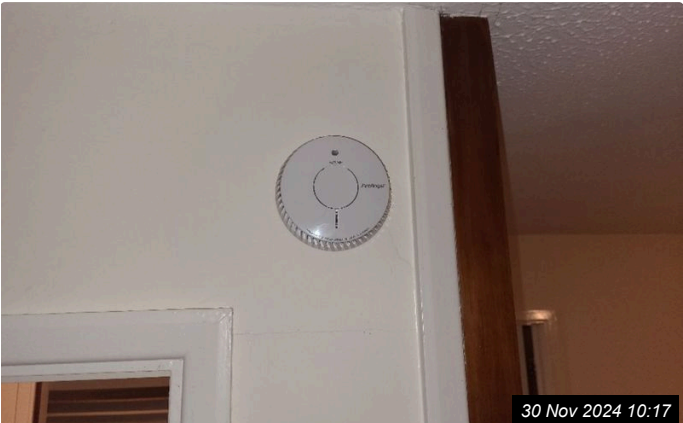
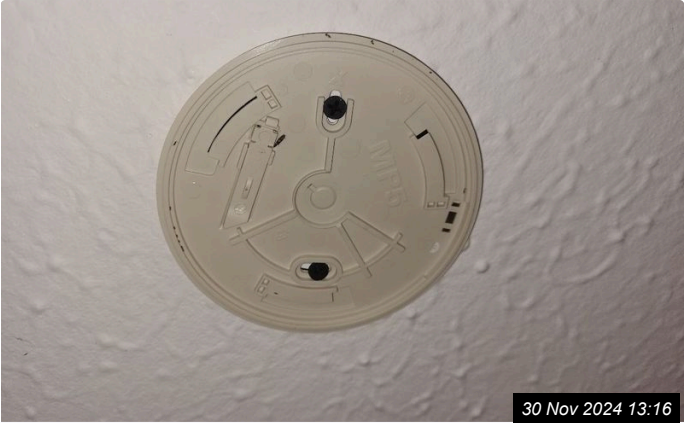
<div>30 Nov 2024 10:02</div>
		Ref # 2.2		Ref # 2.2
2.3	Smoke alarm	Ground floor Reception room 1 Wall to immediate left of entry	01-08-2035	Alarm tested for power only, audible alarm noted Placement as fitting guidelines: Approximately 5m from heat alarm, Within central area to home (open staircase opposite) 15cm from ceiling and above door and window height Within reach of most adults for testing without ladder or step.

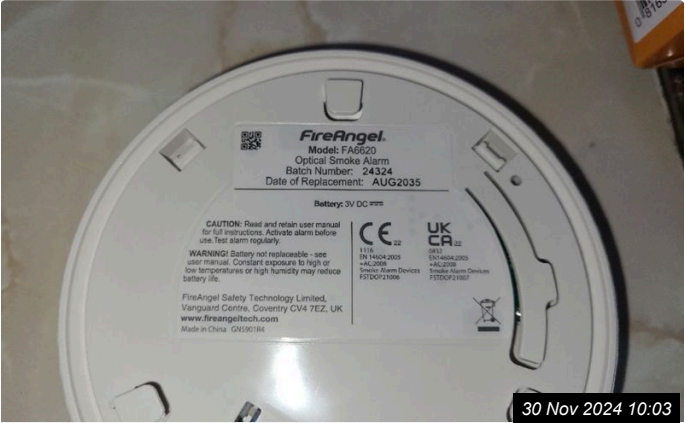
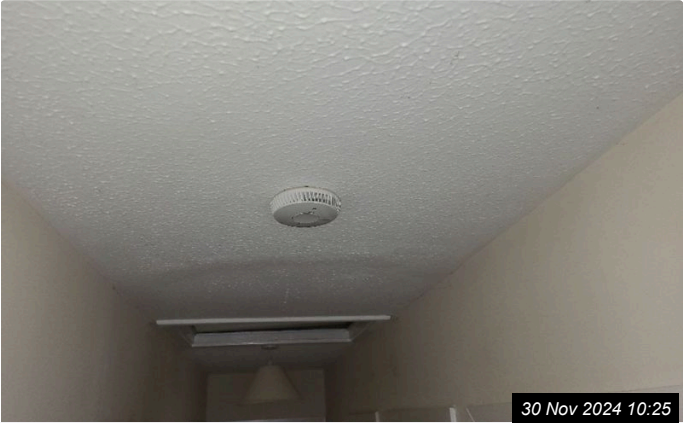
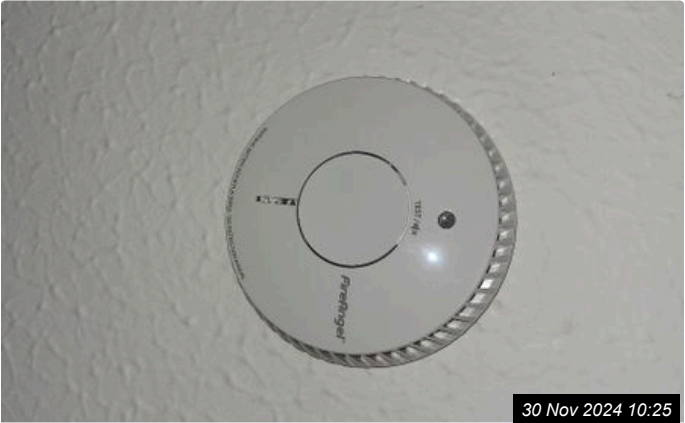
Smoke alarm	<p>Landing</p> <p>Ceiling</p> <p>Direct replacement for existing Within compliant location Some tenants may not be able to reach ceiling without step or ladder but can be pressed with a pole/stick if necessary for testing</p>	01-08-2035	Alarm tested for power only, audible alarm noted.
<div><div>
