## Property Inspection Report

1234 Very Nice Home, Fresno, CA 93722  
Inspection prepared for: Best Client  
Real Estate Agent: -

Date of Inspection: 8/20/2019 Time: 9:00 AM  
Age of Home: 1992 Size: 2958  
Weather: Clear

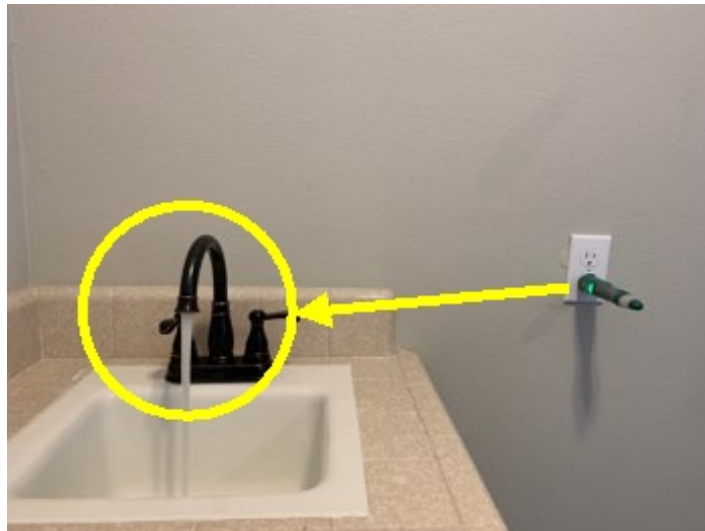
### 2. Bar

Observations: No Ground Fault Interrupter (GFI) protection was provided for this areas electrical outlets located within 6 feet of a plumbing fixture. Although this may not have been required at the time the home was built, The Inspector recommends installation of ground fault circuit **GFI** protection as a safety precaution.

Page 4 Item: 2	Bar	No Ground Fault Interrupter (GFI) protection was provided for this areas electrical outlets located within 6 feet of a plumbing fixture. Although this may not have been required at the time the home was built, The Inspector recommends installation of ground fault circuit GFI protection as a safety precaution.
Dining Room

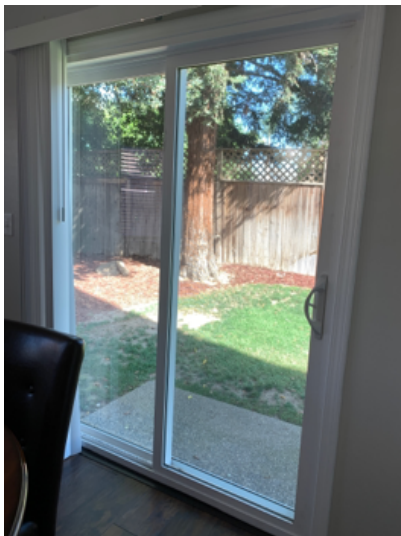
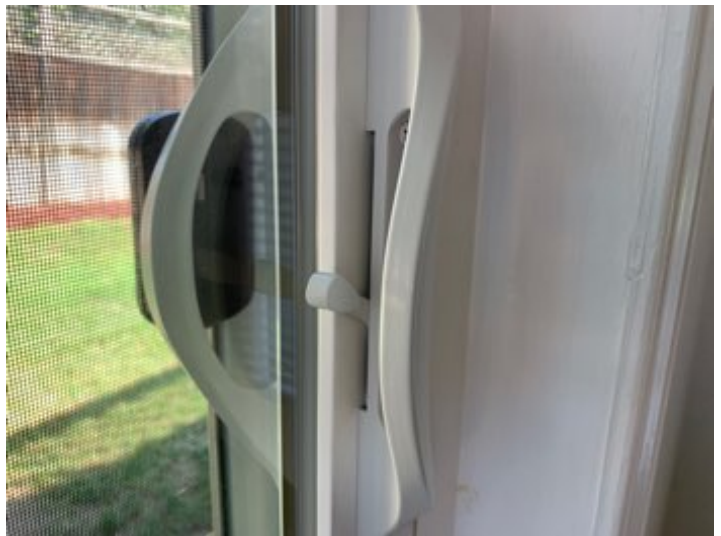
## 2. Sliding Doors

- Lock did not fully engage. We suggest further investigation and repairs as needed.

Page 5 Item: 2	Sliding Doors	• Lock did not fully engage. We suggest further investigation and repairs as needed.
Kitchen

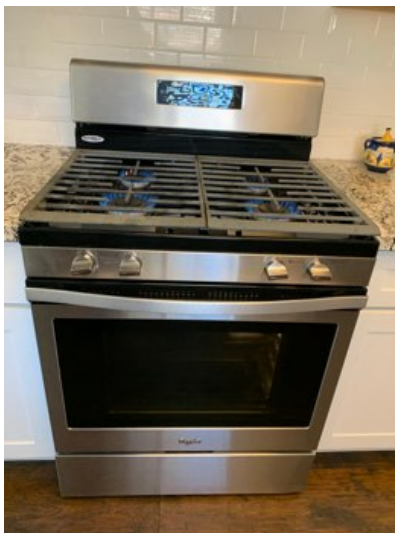
## 2. Cook Top, Range and Oven Condition

- Anti-tip bracket installation is missing from range. See manual or label inside oven door for information.

All free-standing, slide-in ranges installation should include an anti-tip device which is essential in the safe operation of the range. It provides protection when excess force or weight is applied to an open oven door.

Brackets are carried by home building centers.

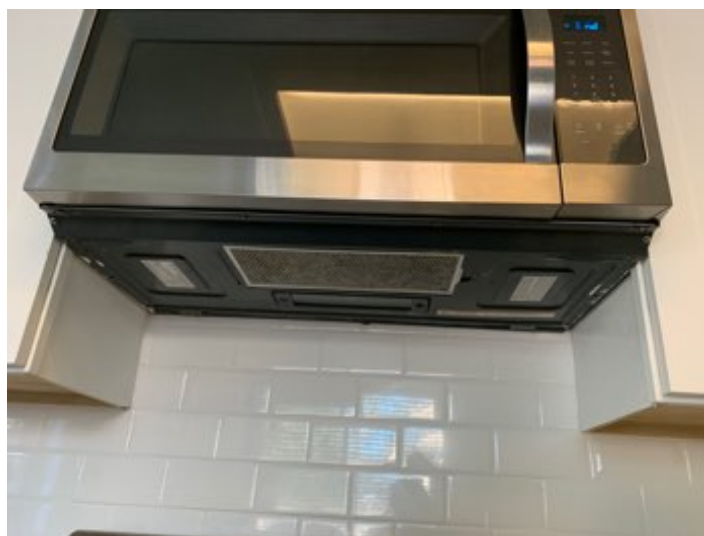
### 4. Exhaust Vent Condition

- Range hood lights were inoperable at the time of the inspection. The bulb may be burned out, or there may be a problem with the switch, wiring or light fixture. If after replacing the bulb the light fixture still does not respond, the Inspector recommends correction by a qualified electrician.

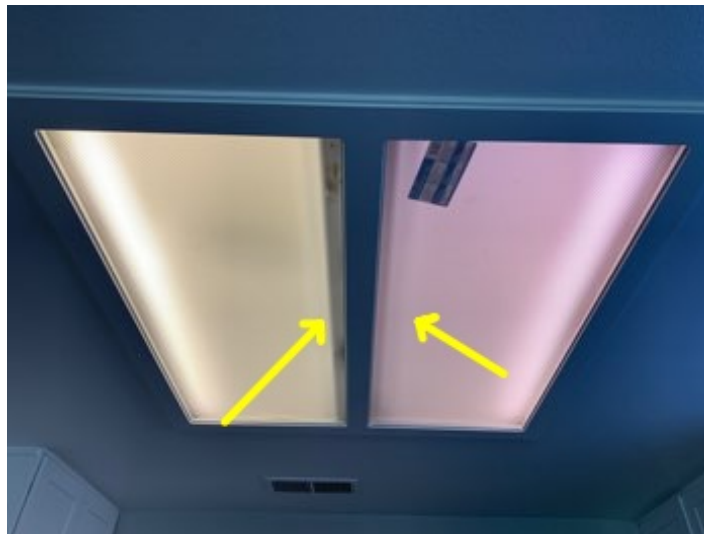
## 6. Light Fixture Condition

- Several ceiling lights did not operate at time of inspection . The bulb may need to be replaced or there may be a problem with the switch, wiring or light fixture. If after the bulb is replaced this light still fails to respond to the switch, this condition may represent a potential fire hazard and the Inspector recommends that an evaluation and any necessary repairs be performed by a qualified electrician.

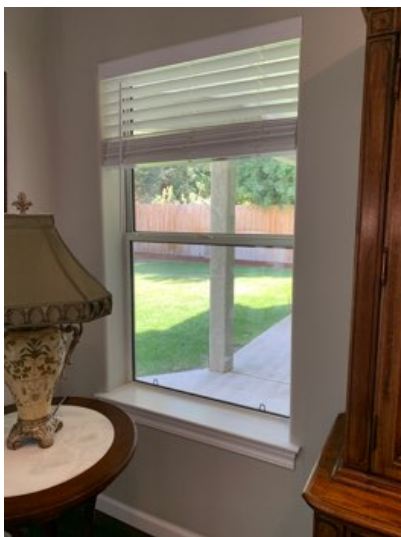
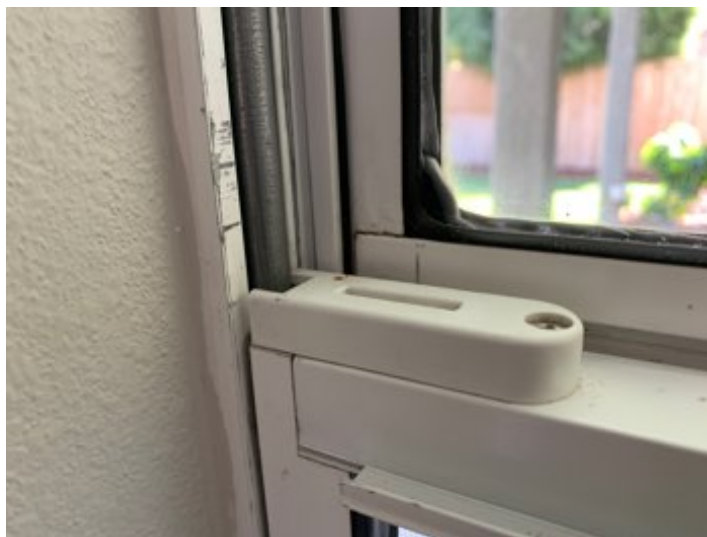
## 2. Window Condition

- Several latches that release window to open to clean were broken allowing it to lean into room. We suggest further investigation and repairs as needed.

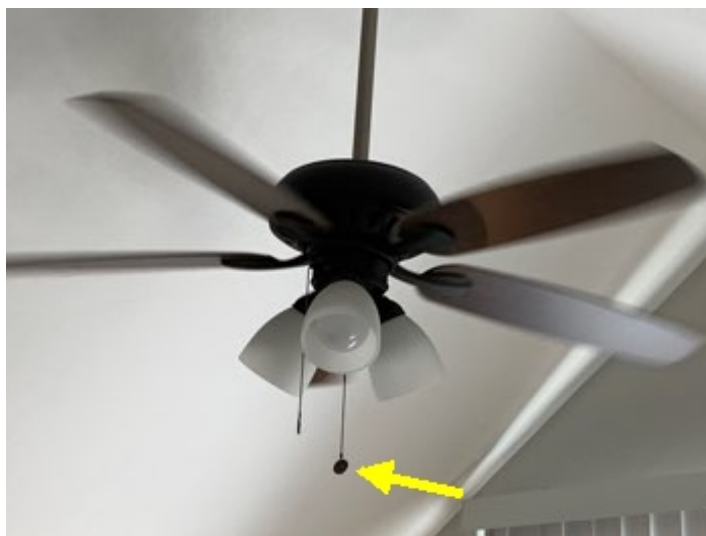
## 3. Ceiling Fan Condition

- The lights in a ceiling fan were not operated as the controls were out of reach.

We could not reach the chain.

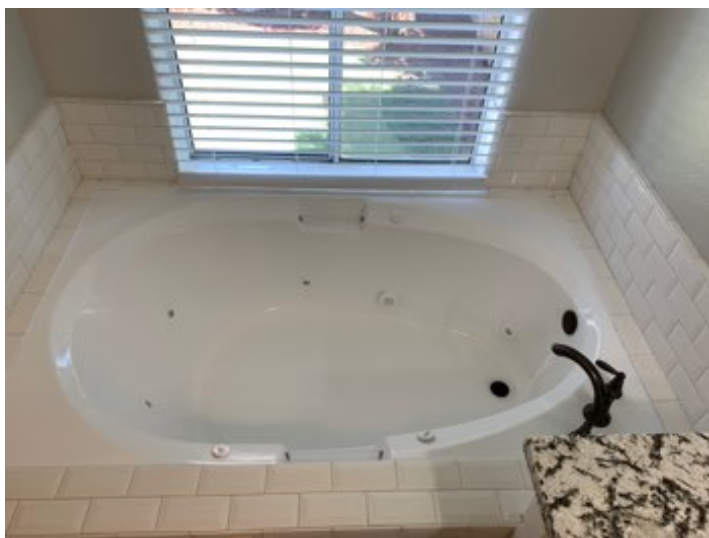
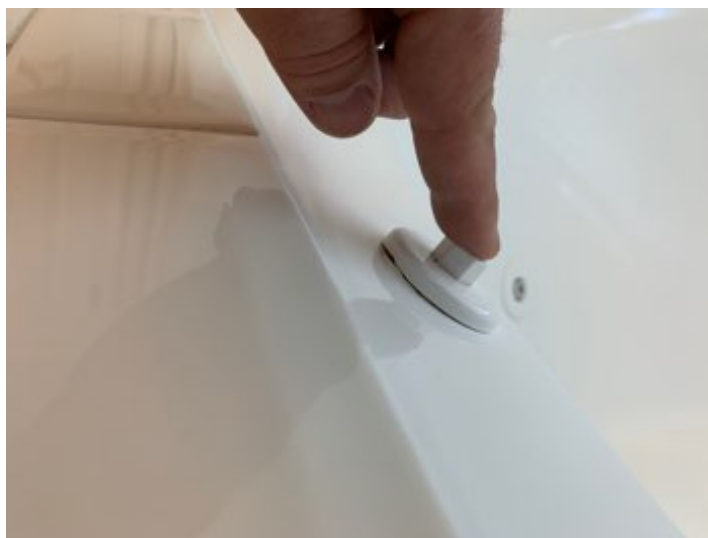
## 3. Tub Condition

- Jets in the whirlpool tub did not respond to the controls. The Inspector recommends correction by a qualified plumber.

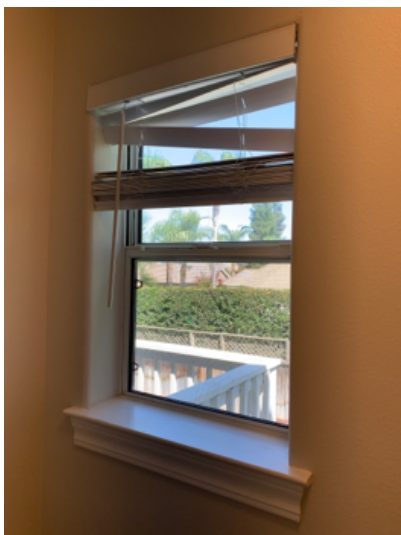
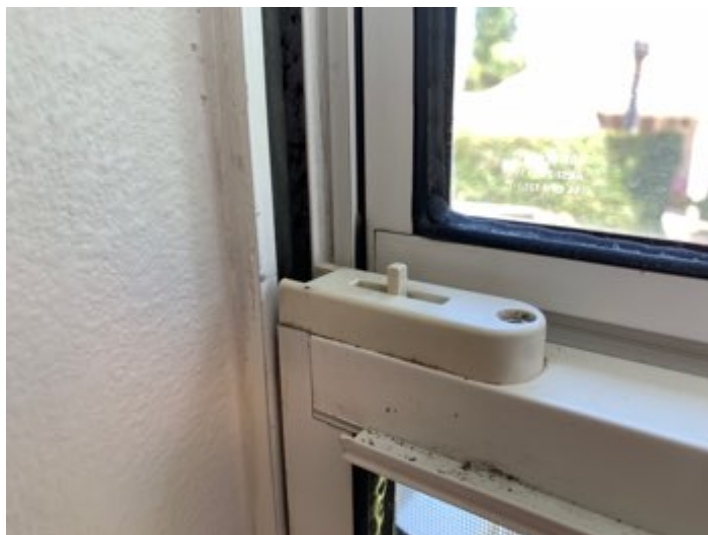
## 4. Window Condition

- Several latches that release window to open to clean were broken allowing it to lean into room. We suggest further investigation and repairs as needed.

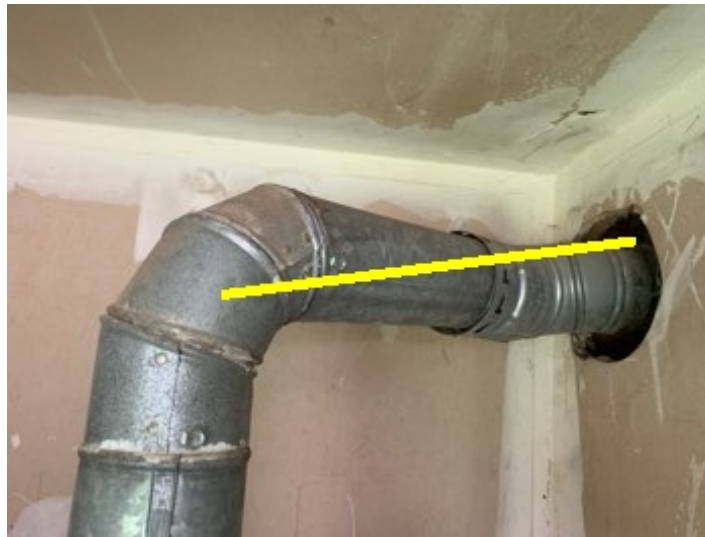
- The gas-fired water heater exhaust flue vent pipe had a negative or inadequate slope which should be corrected. Exhaust flue should slope upwards a minimum of 1/4 inch per foot.

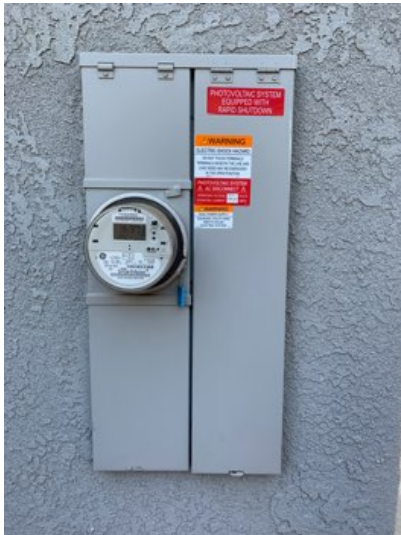
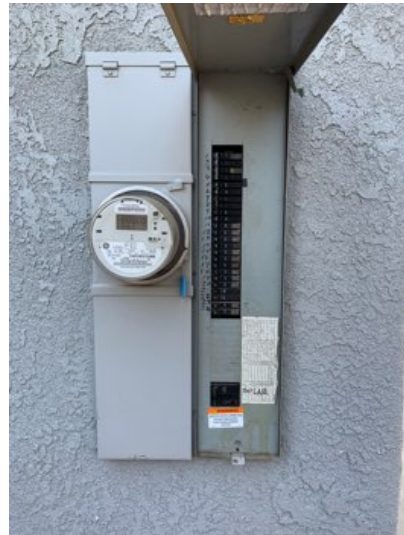
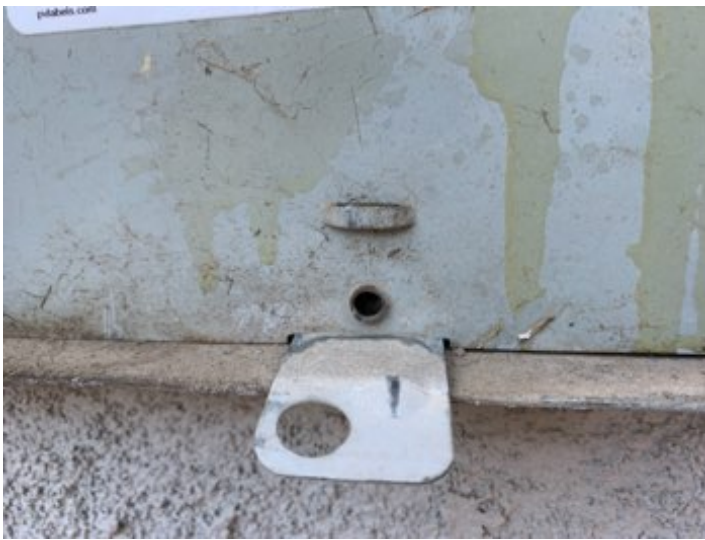
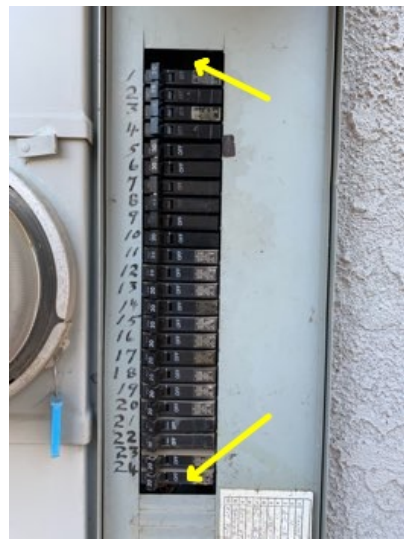
## 1. Electrical Panel Condition

• Plastic cover covering where circuit breakers were was missing in the dead front cover of the main electrical service panel has a open tab which may allow a person to come into contact with energized electrical components with little restriction. This potential shock/electrocution hazard should be corrected by a qualified electrician.

• The dead front cover of the main electrical service panel was missing several screws and was not held securely closed. The Inspector recommends correction by a qualified electrician.

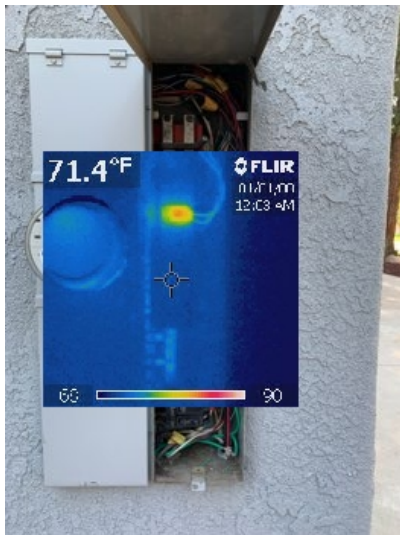
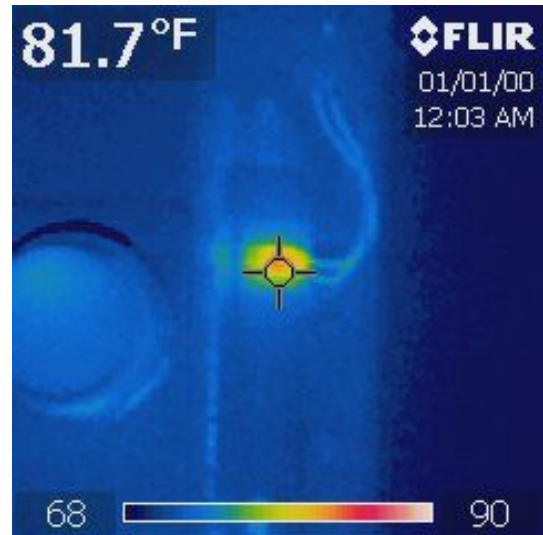
## 2. Breakers

- Circuit breakers in the main electrical service panel appeared to be in serviceable condition.
- Breakers were tested with infrared gun. No unusual hot spots seen with infrared camera at time of inspection.

A/C breaker OK under load.

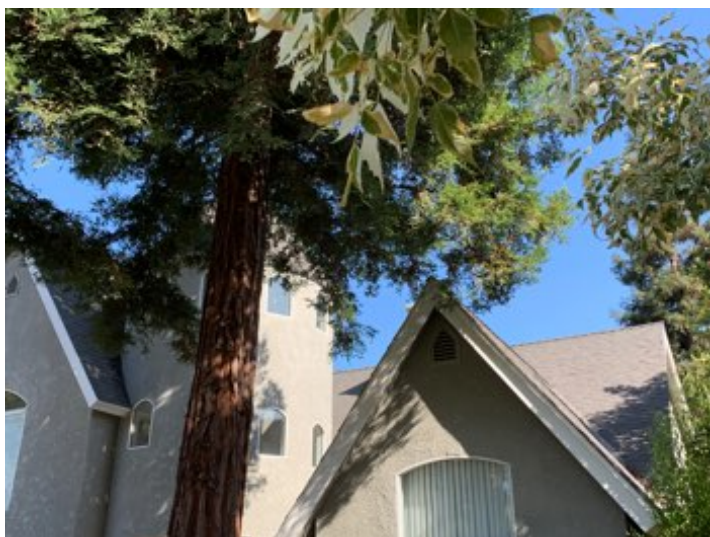
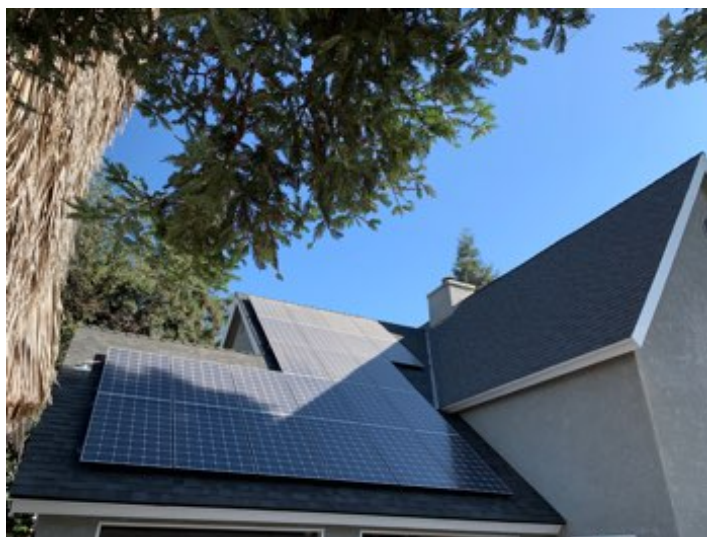
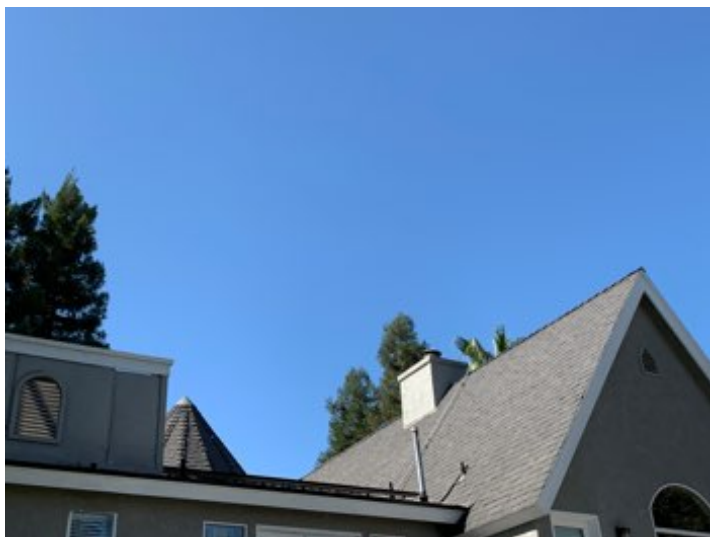
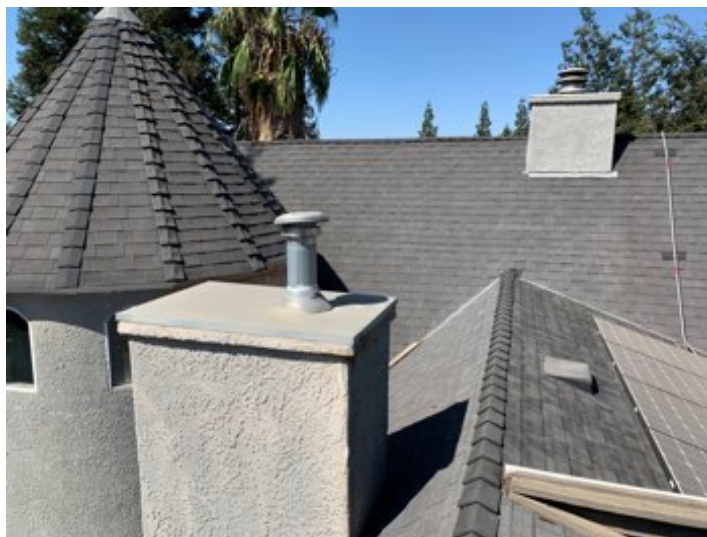
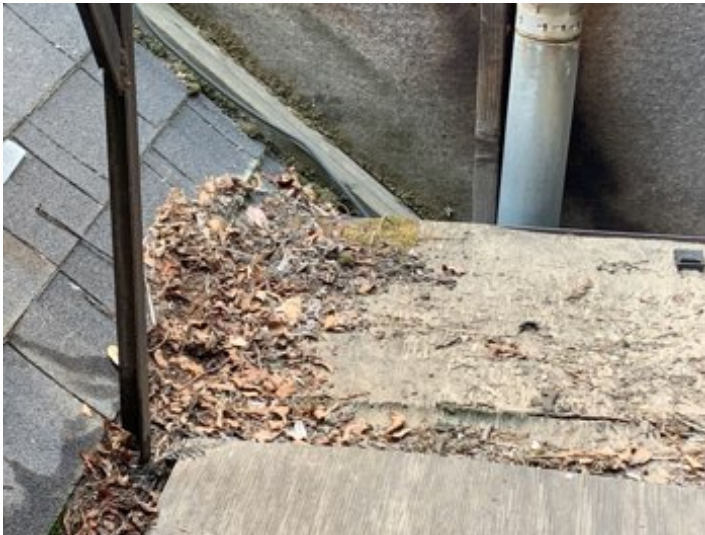
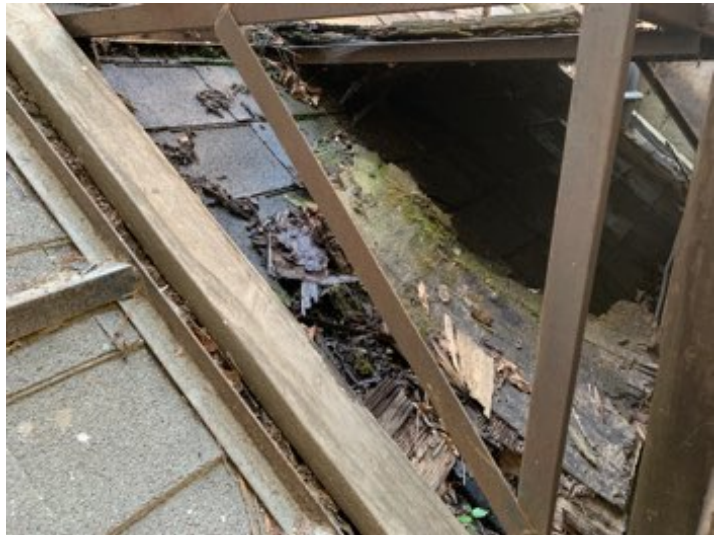
## 1. Roof Condition

- Asphalt composition shingles covering the roof of this home appeared to be in serviceable condition at the time of the inspection.
- Debris accumulated on the East and West roofs at the time of the inspection may damage roof covering materials by retaining moisture. Clearing the roof of debris should be included in annual maintenance.

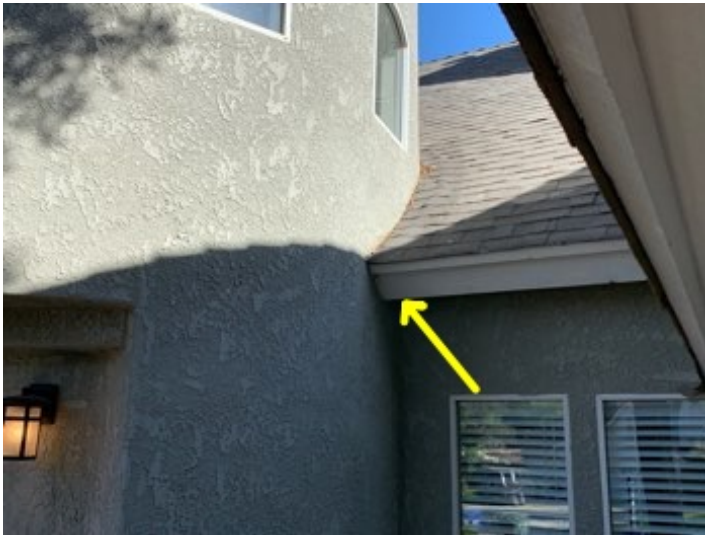
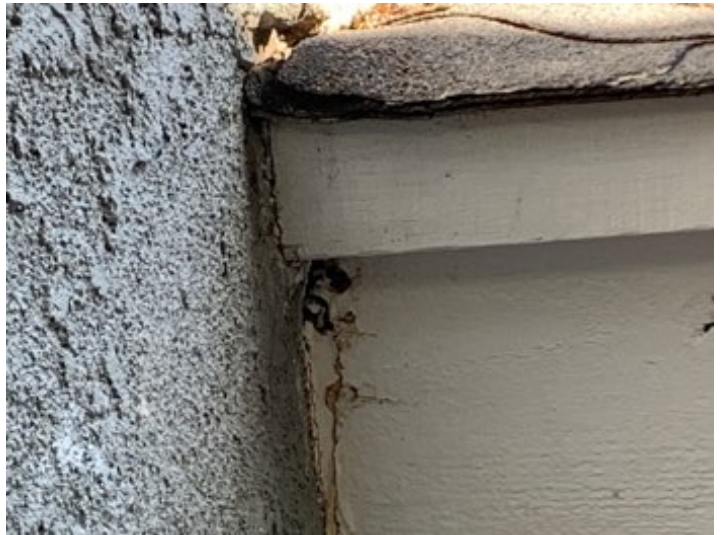
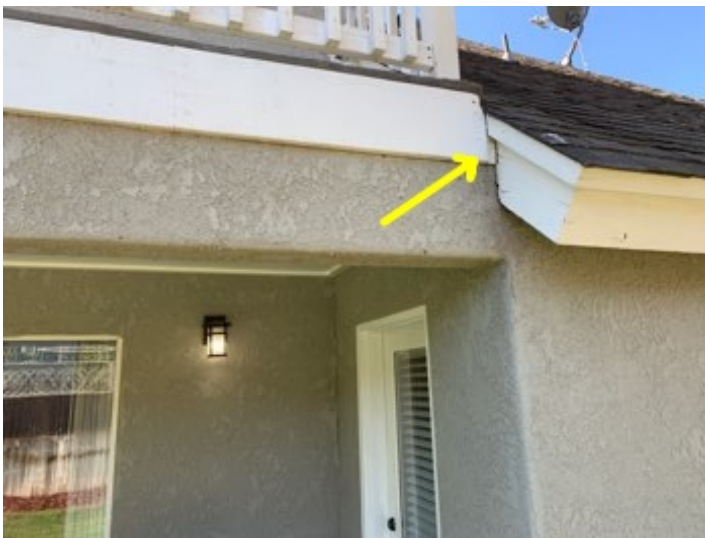
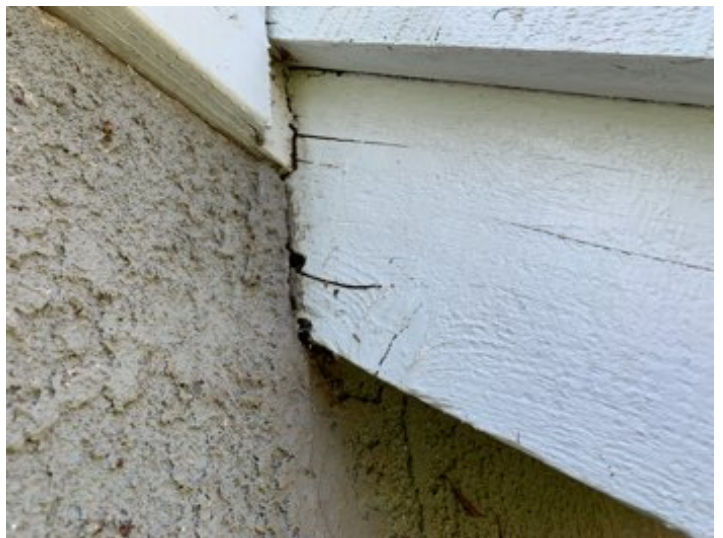
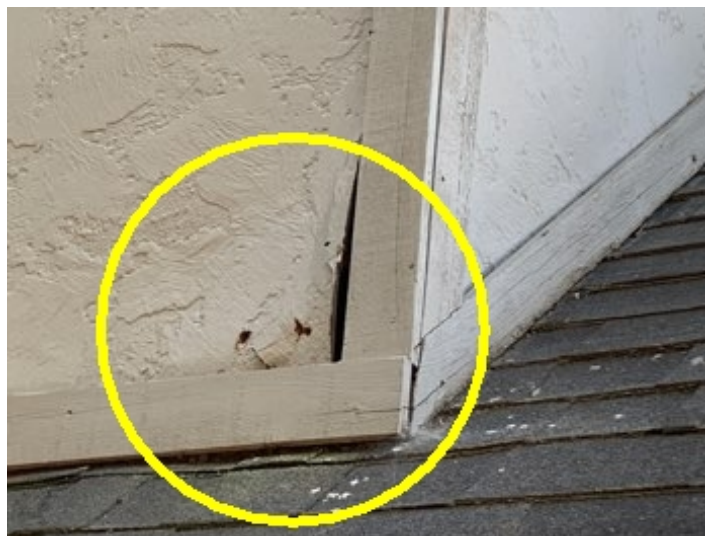
## 2. Fascia and Trim Condition

- Fascia at the following locations around the home had moisture damage visible.

- Fake wall on West side.

Please suggest further investigation and repairs as needed.

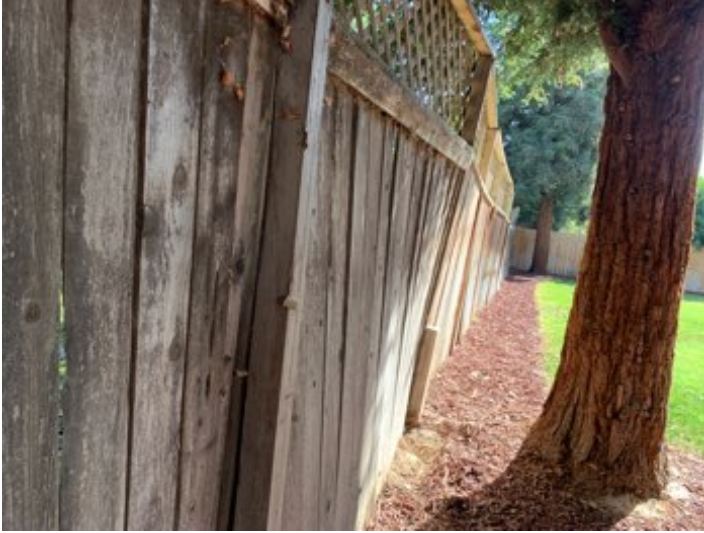
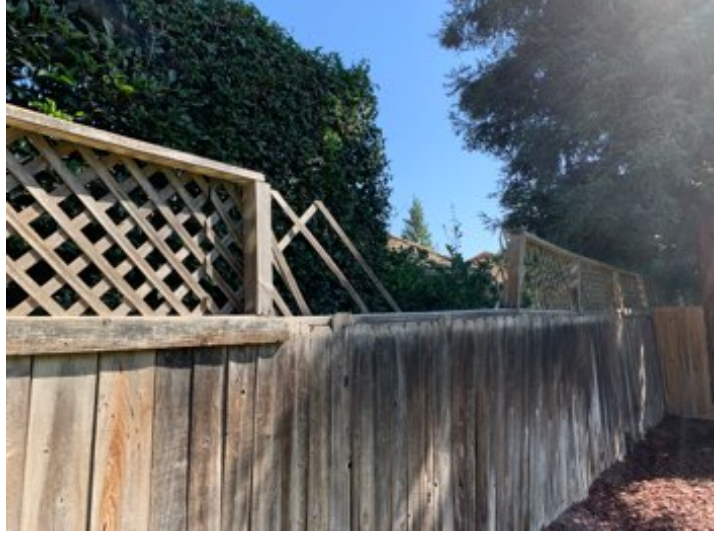
## 1. Fence Condition

- Some wood posts on the North fence line examined during the inspection were loose and needed maintenance or replacement.
- Wood boards forming the fence barrier on North side were damaged and in need of repair.

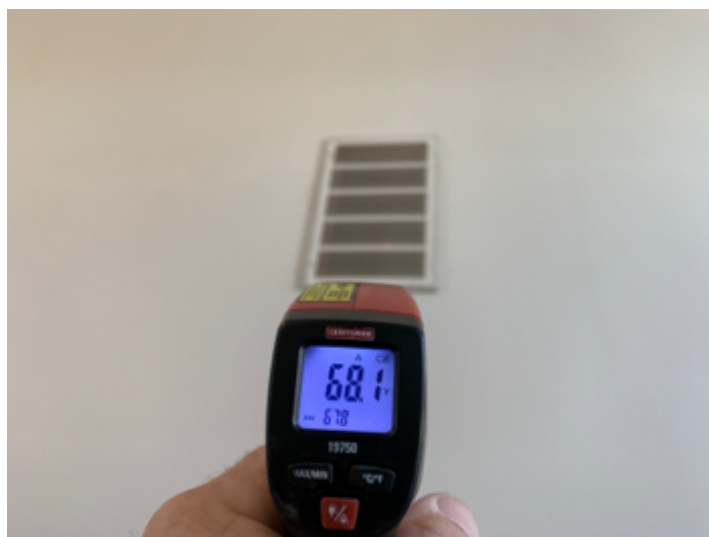
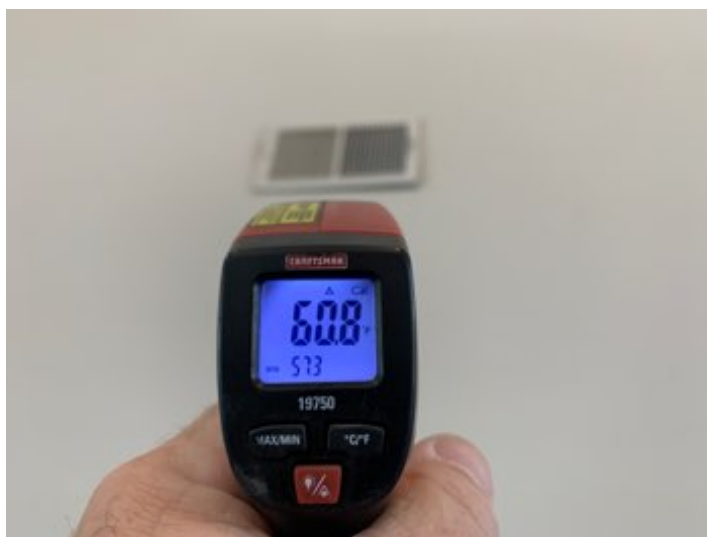
- The General Home Inspection does not include confirming even temperature distribution by the cooling system.
- Air temperature measured at supply and return registers had a difference of less than the minimum of 10 degrees Fahrenheit.  
We suggest washing the condenser coils outside. If the temperature does not return to normal conditions, we recommend service by a qualified HVAC technician.

Page 29 Item: 1	Air Temperatures and Gradient	<ul style="list-style-type: none"> <li>• Air temperature measured at supply and return registers had a difference of less than the minimum of 10 degrees Fahrenheit.</li> </ul> <p>We suggest washing the condenser coils outside. If the temperature does not return to normal conditions, we recommend service by a qualified HVAC technician.</p>

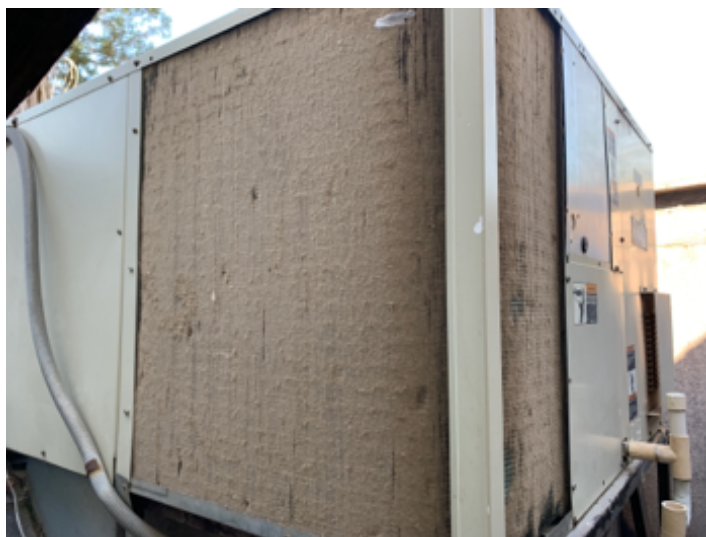
## 2. A/C Evaporator Coils

- Air flow to the air conditioner condenser coils was restricted by dirt and/or debris on the exterior which may limit their ability to dissipate heat. The coils and cabinet should be cleaned in order to maintain cooling system efficiency and avoid problems from overheating of the compressor.

We suggest that the unit is serviced by a qualified **A/C** technician.

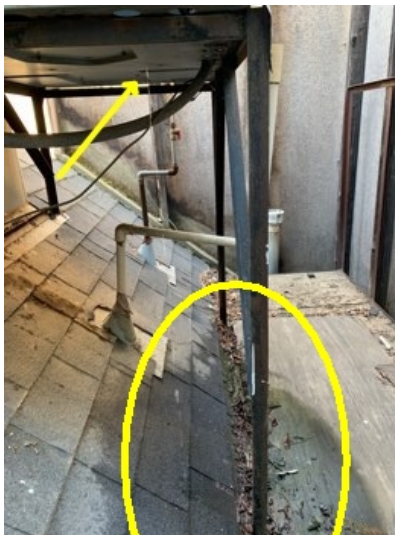
#### 4. Condensate Drain Condition

- The evaporator coil appeared to be leaking at the time of the inspection. This condition is an indication that the condensate drain is blocked. The Inspector recommends service by a qualified HVAC technician.

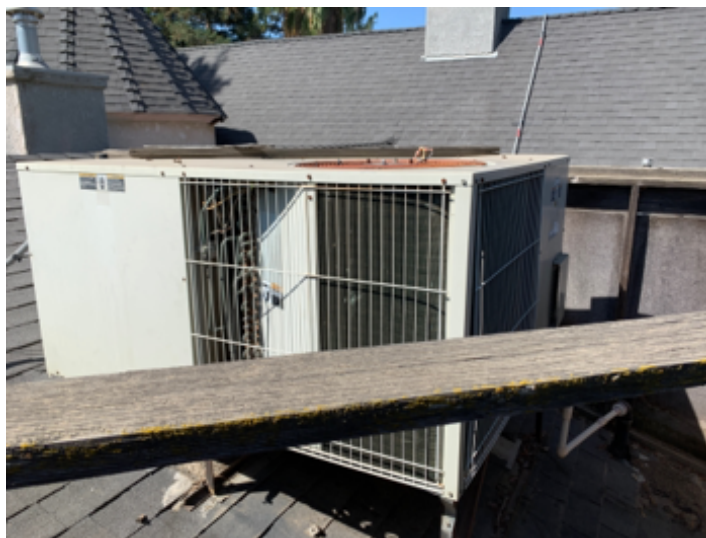
## 2. A/C Cabinet Location

- The air-conditioner compressor housing was located on the roof of the home to the southeast side.

Due to being on the second story, we could not walk up to unit the roof and fully inspect.
