# Uniform Mitigation Verification Inspection Form

| Inspection Date: 7/31/2023 | | |
| Address: 3131 S. Ocean Drive (clubhouse) | | Home Phone: |

3131 S. Ocean Drive (clubhouse)

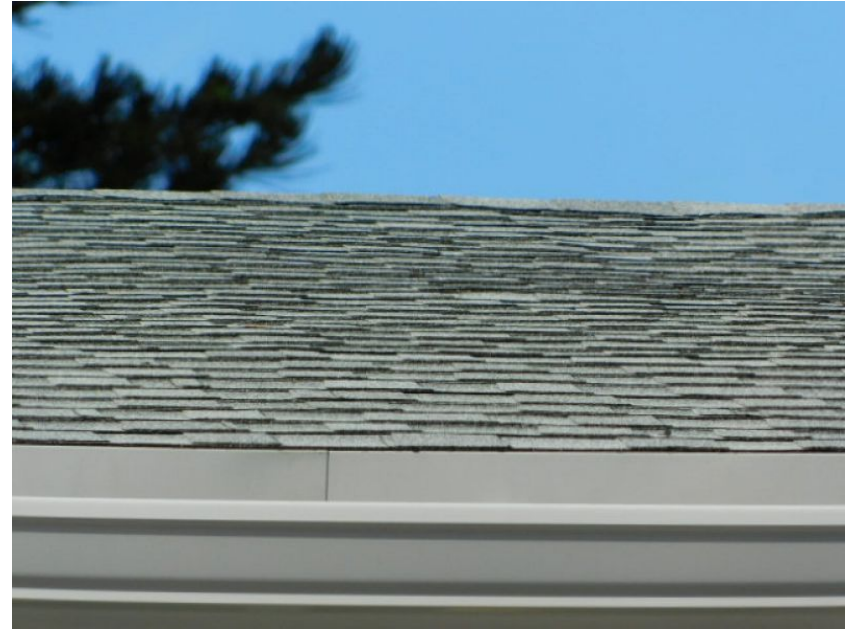
| 2.1 Roof Covering Type: | Permit Application Date | FBC or MDC Product Approval # | Year of Original Installation or Replacement | No Information Provided for Compliance |
|---|---|---|---|---|
| <input checked="" type="checkbox"/> 1. Asphalt/Fiberglass Shingle | 04 / 11 / 2023 | Prmt#: 2301801 | | <input type="checkbox"/> |

Architectural/Dimensional Shingle Roof Covering

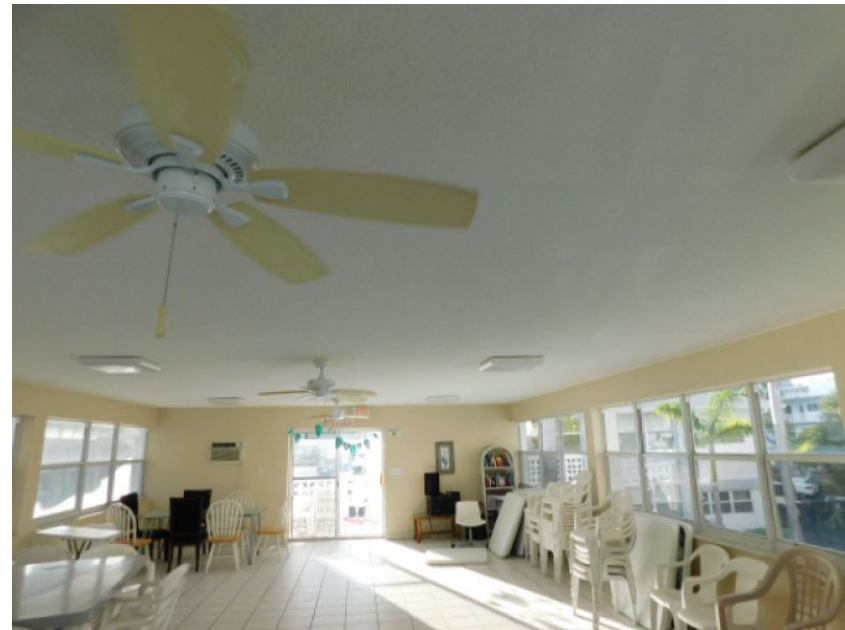
- ☐ D. Reinforced Concrete Roof Deck.
- ☐ E. Other: \_\_\_\_\_
- ☐ F. Unknown or unidentified.
- ☒ G. No attic access.

- ☐ E. Structural      Anchor bolts structurally connected or reinforced concrete roof.
- ☐ F. Other: \_\_\_\_\_
- ☐ G. Unknown or unidentified
- ☒ H. No attic access

No Attic Access

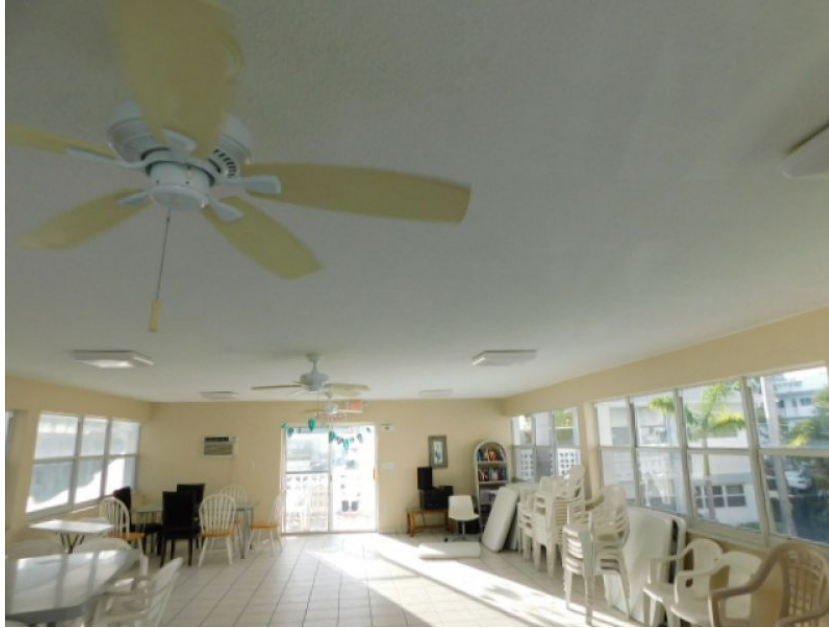
Attachment Unknown due to No Attic Access

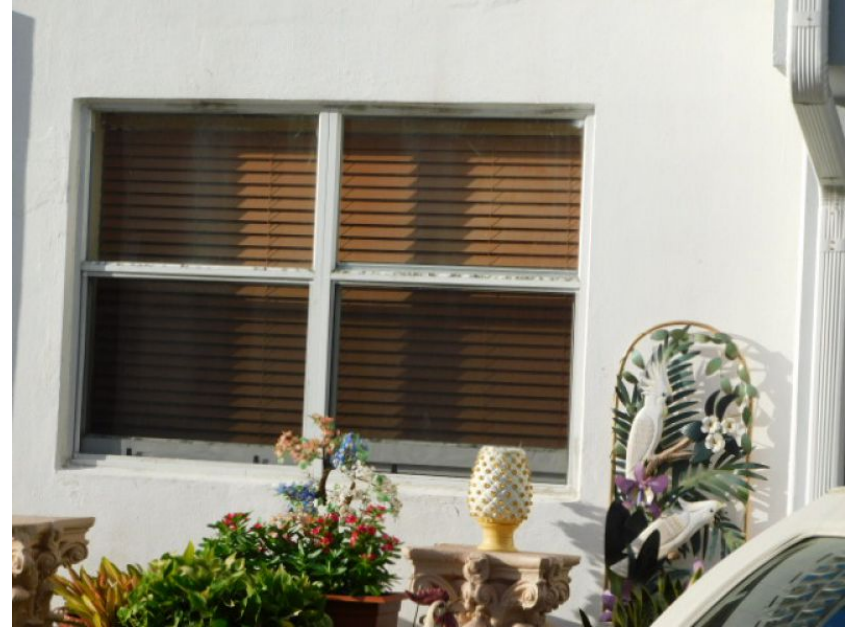
| Opening Protection Level Chart<br>Place an "X" in each row to identify all forms of protection in use for each opening type. Check only one answer below (A thru X), based on the weakest form of protection (lowest row) for any of the Glazed openings and indicate the weakest form of protection (lowest row) for Non-Glazed openings. | | Glazed Openings | | | | Non-Glazed Openings | |
|---|---|---|---|---|---|---|---|
| X | No Windborne Debris Protection | X | | | | X | |

Unprotected Window

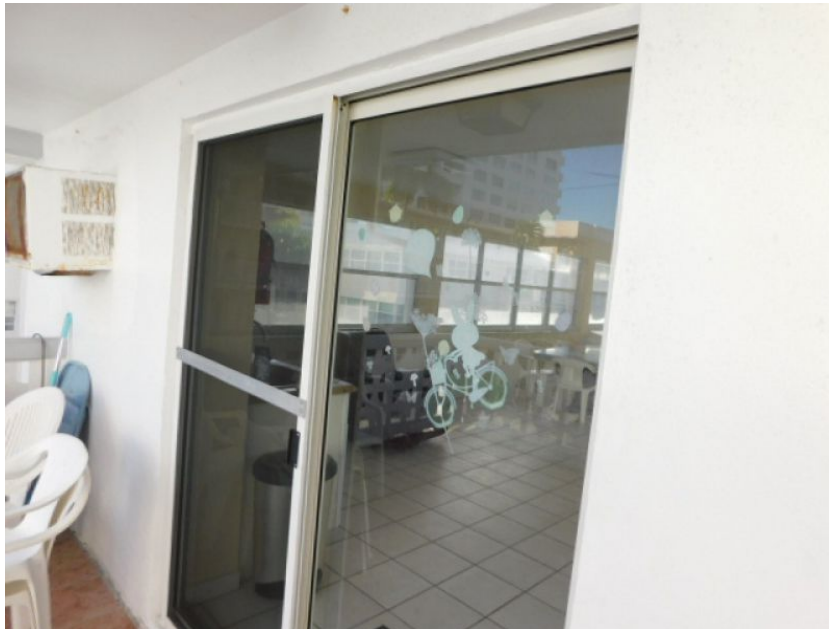
Unprotected Glazed Entry Door

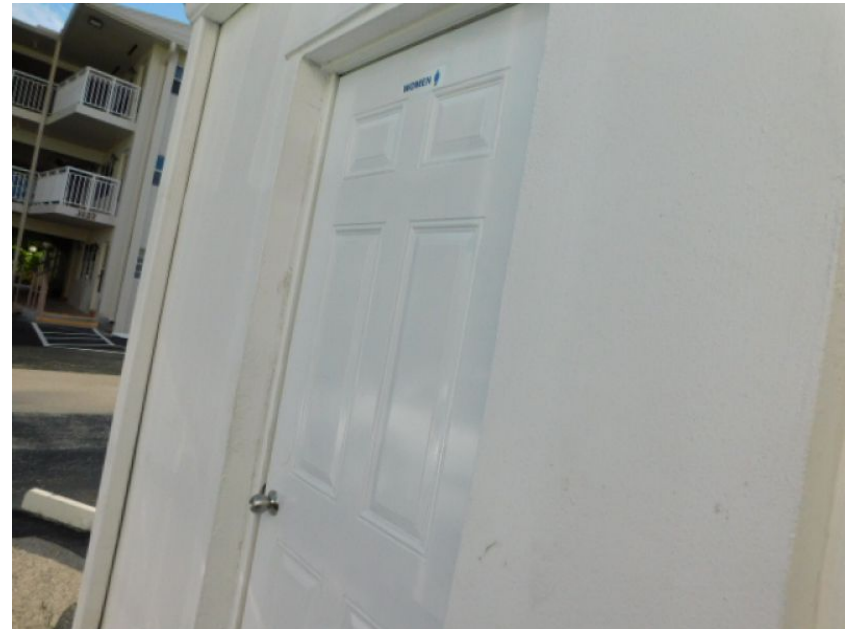
Unprotected Solid Entry Door
