Case Study: Stonehenge Visitor Centre and A344 Reinstatement

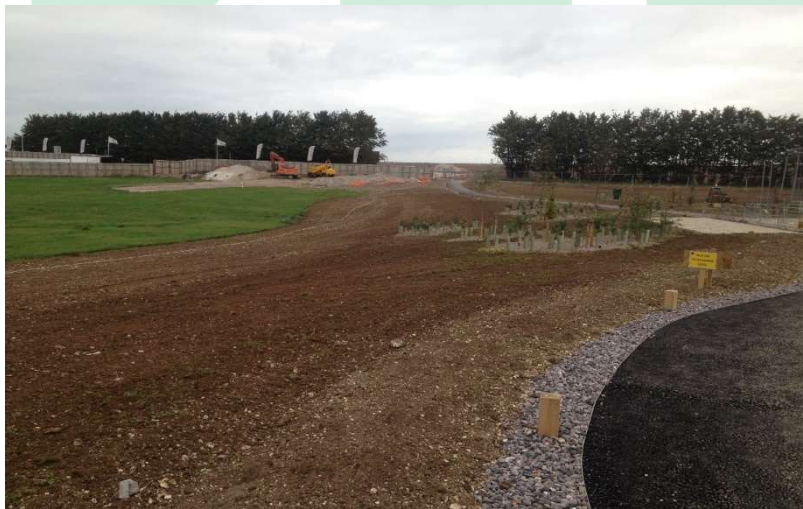
April 2013 - Cultivation around the new visitor's centre starts.

Using our tractor mounted Harley power rake, all the proposed seeding areas were prepared and raked down to a fine tilth ready for seeding. The stone was then removed by digger and dumper so the final seeding works could be carried out.

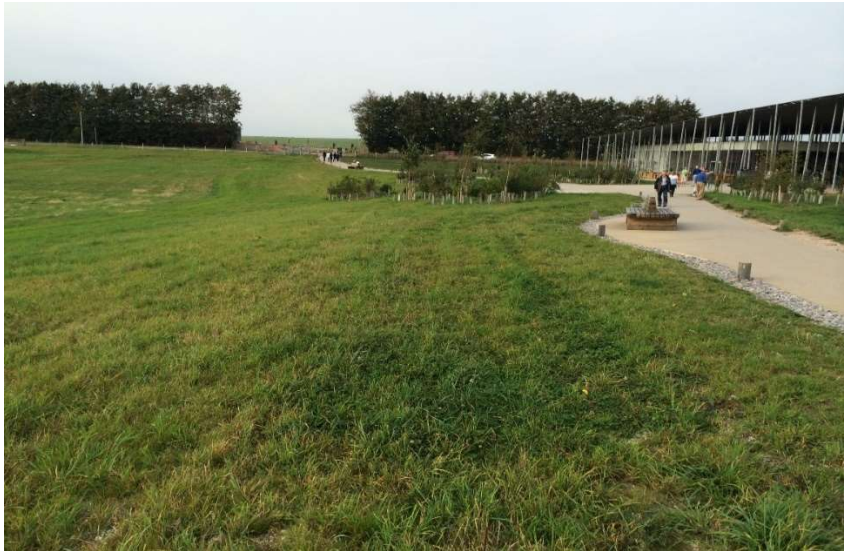
September 2014 – the landscaping looking well established and maintained.

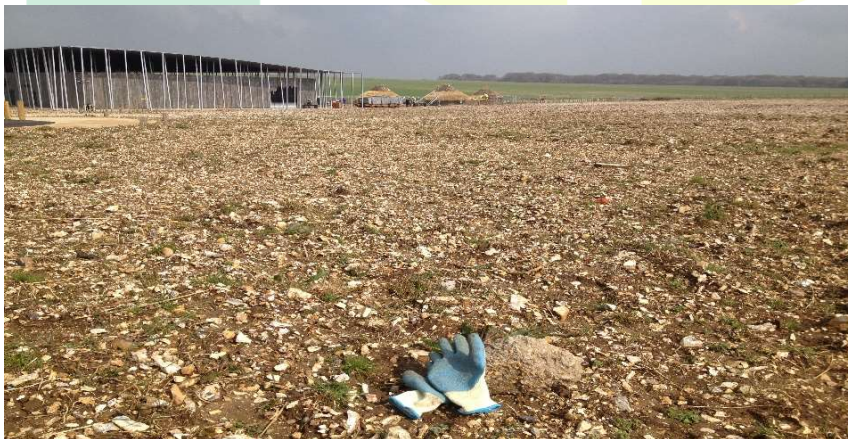
March 2014 areas around the new visitors centre prior to stone clearance and seeding.

Firstly, in late 2012, Hydroseeding was carried out around the new car park. In Spring 2013 cultivation, soil prep and seeding works began around the new visitor centre. The scope of preparation work had to be amended due to a high content of flint found in the site won soil. Due to the high risk of stone ejection under future maintenance and compounded by the design of the building being constructed using a lot of plate glass, the stone had to be removed.

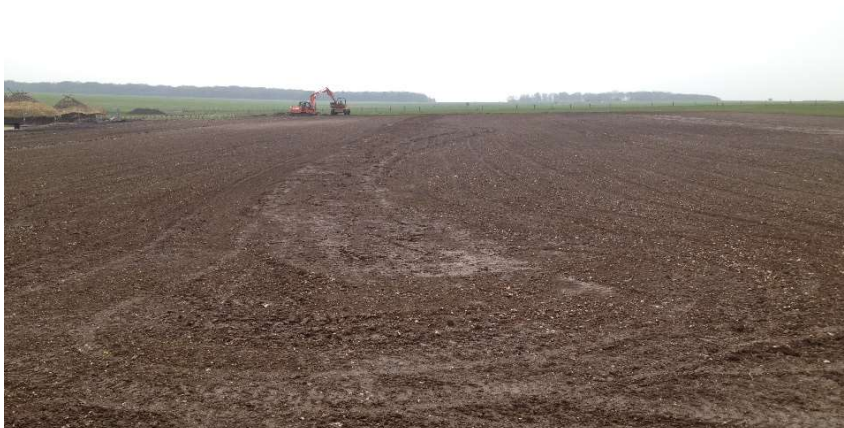
March 2014 stone clearance and removal completed.

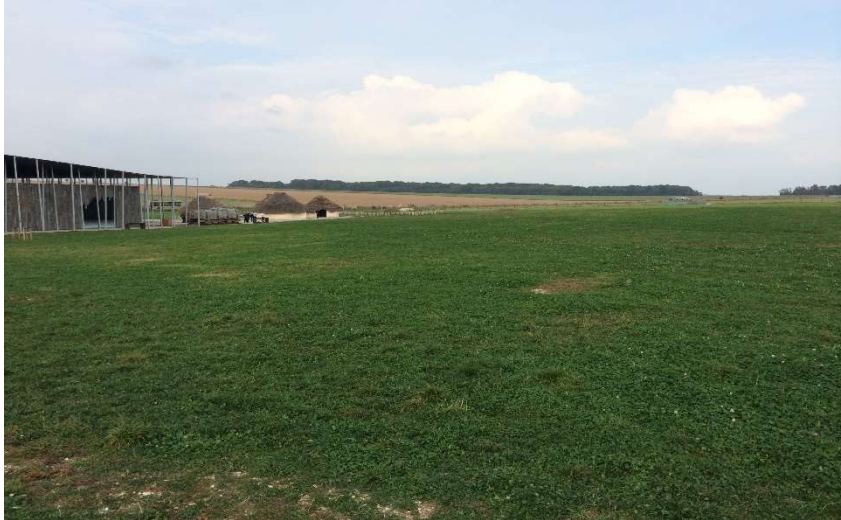
September 2014 the seeding well established.

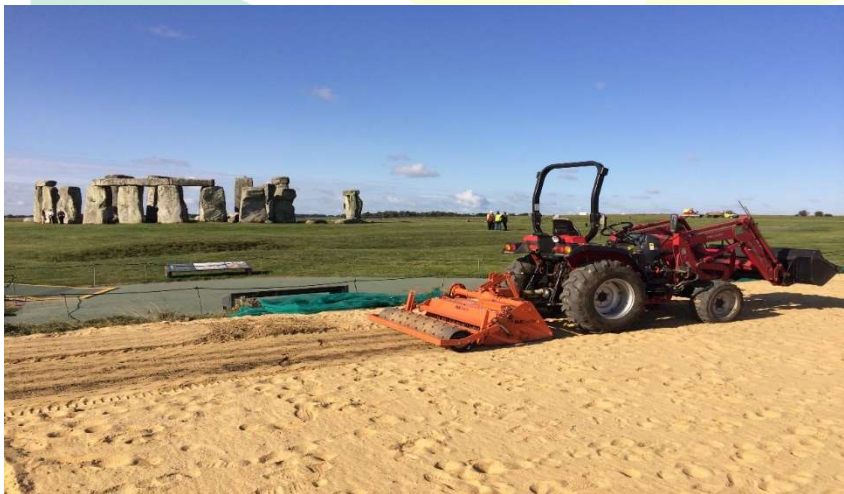
August 2013 - Mixing a thin layer of sand into the topsoil to improve drainage and soil quality using our stone burier as part of the A344 reinstatement work.

After the visitor centre was completed, the old A344 road that ran adjacent to the monument was then reinstated and seeded. A layer of sand was required to be incorporated with the topsoil to improve drainage prior to seeding. This was tackled with our stone burier and allowed us to quickly mix the top 100mm of sand and soil to make ready for seeding.

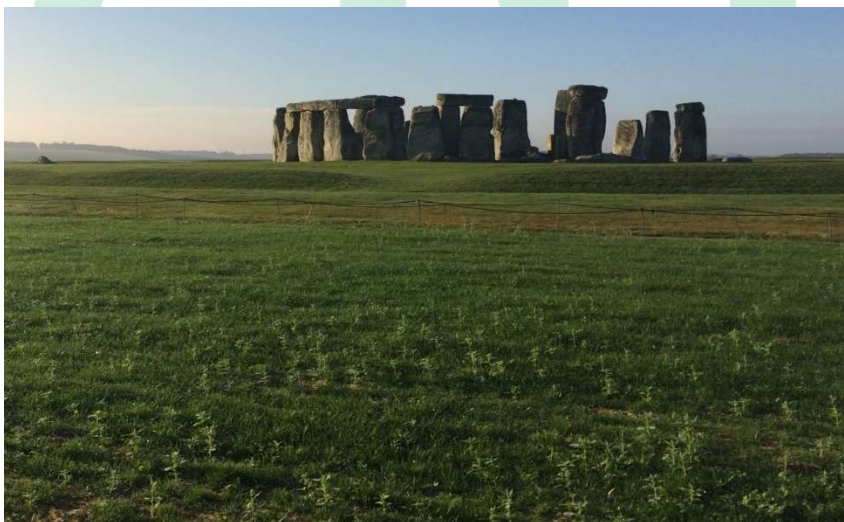
October 2013 - 3 months after seeding the old A344.
