JPR HOME INSPECTIONS LLC

RESIDENTIAL REPORT

1234 Main St. Franklin Wi 53132

05/14/2021 9:00AM

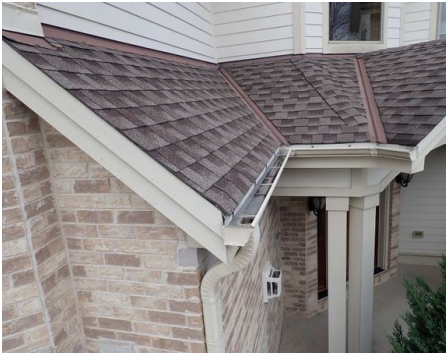
At the time of inspection the gutter and downspouts appeared to be functional. I recommend periodic cleaning to maintain open flow of water.

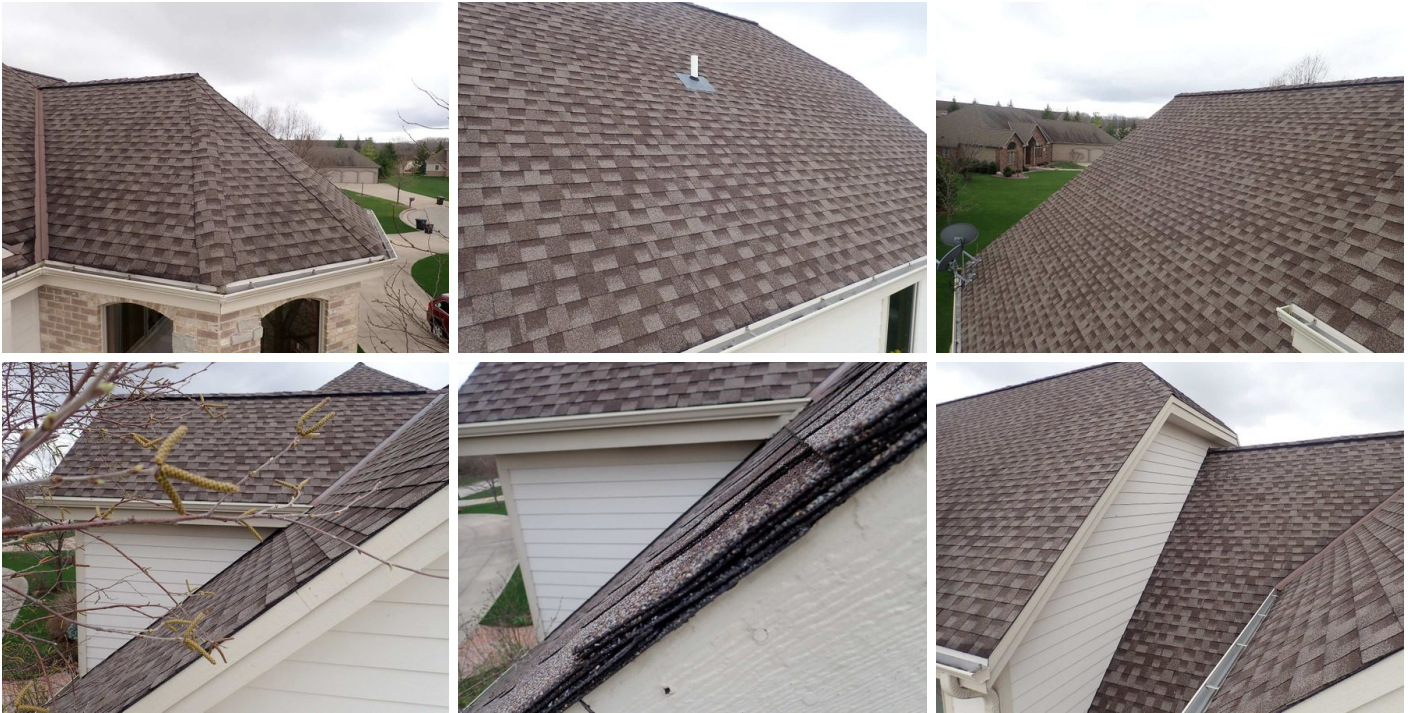
At the time of inspection the roof material seemed to be in good condition. I recommend monitoring for future damage and or leakage. Any defects will be listed separately in the report.

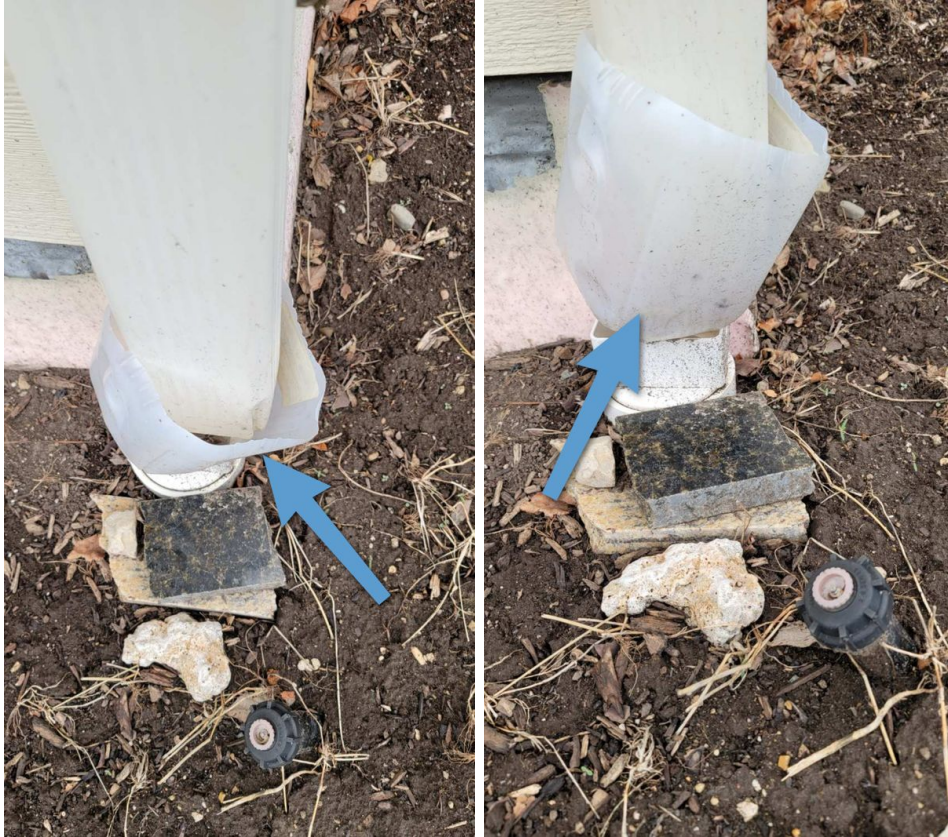
IMPROPERLY ALLINED WITH DRAIN

Gutter not properly aligned with ground drain. Recommend a lining drain tile with down gutter for proper drainage.

Contact a qualified professional.

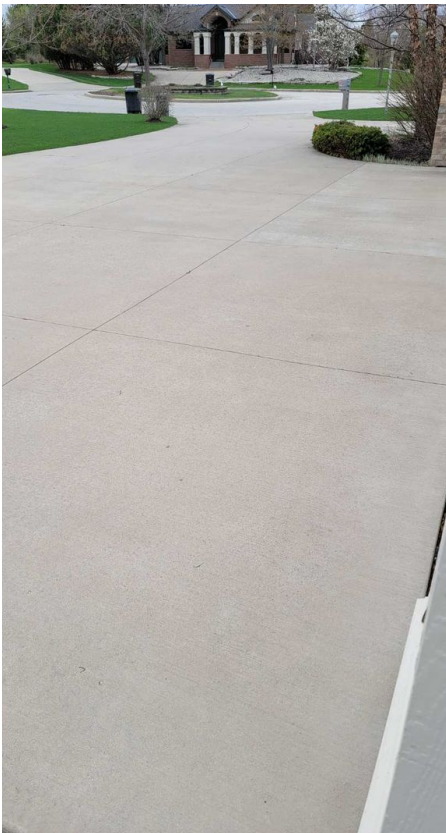
Driveways and walkways are inspected to determine their effect on the structure of the home. I will also report on any visual deficiencies that may be present such as cracking, displacement, etc. No deficiencies were observed at the time of inspection unless otherwise noted in this report.

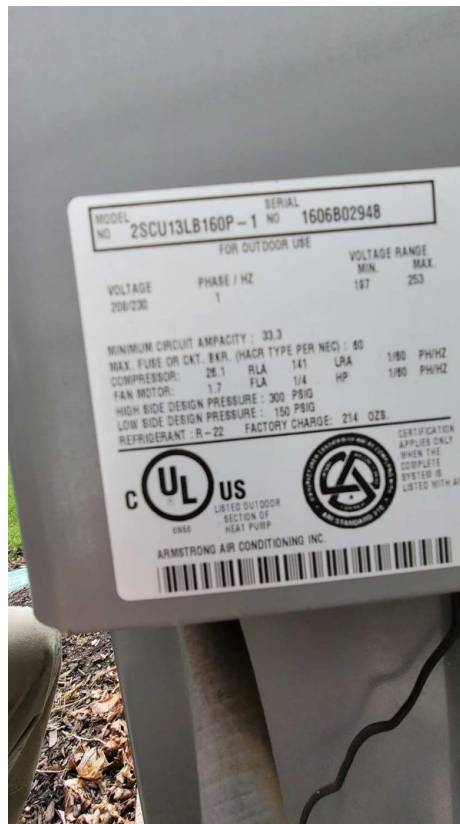
Cooling Equipment: Model Number
2SCU13LB160P-1

Cooling Equipment: Serial Number
1606B02948

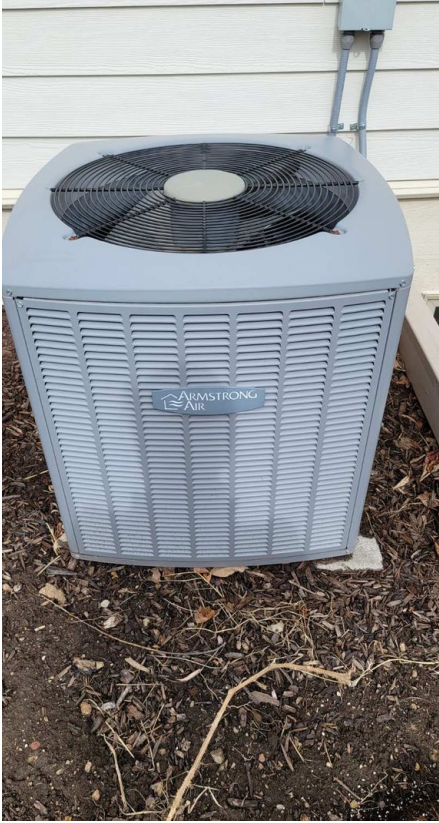
Cooling Equipment: A/C # 2 Brand Armstrong Air

Cooling Equipment: A/C Unit # 2 Model #. 4SCU14LE130P-1

Cooling Equipment: A/C # 2 Serial #. 1610A15939
Backyard

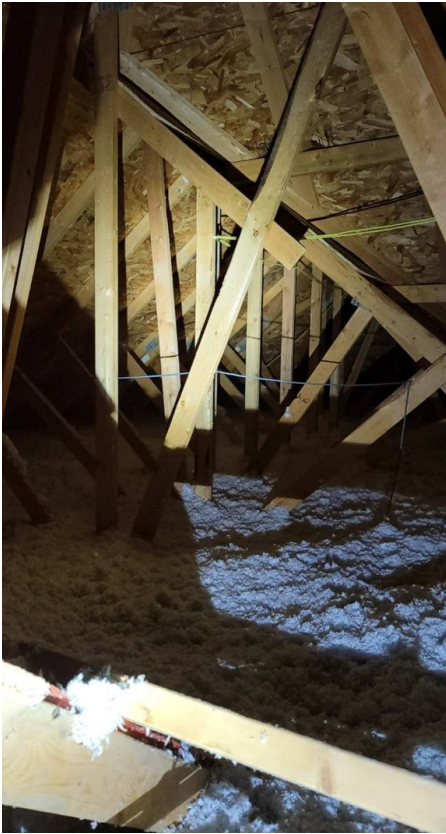
Loose-fill

At the time of inspection, the attic insulation appeared to be in good condition. Any defects will be listed separately in the report.

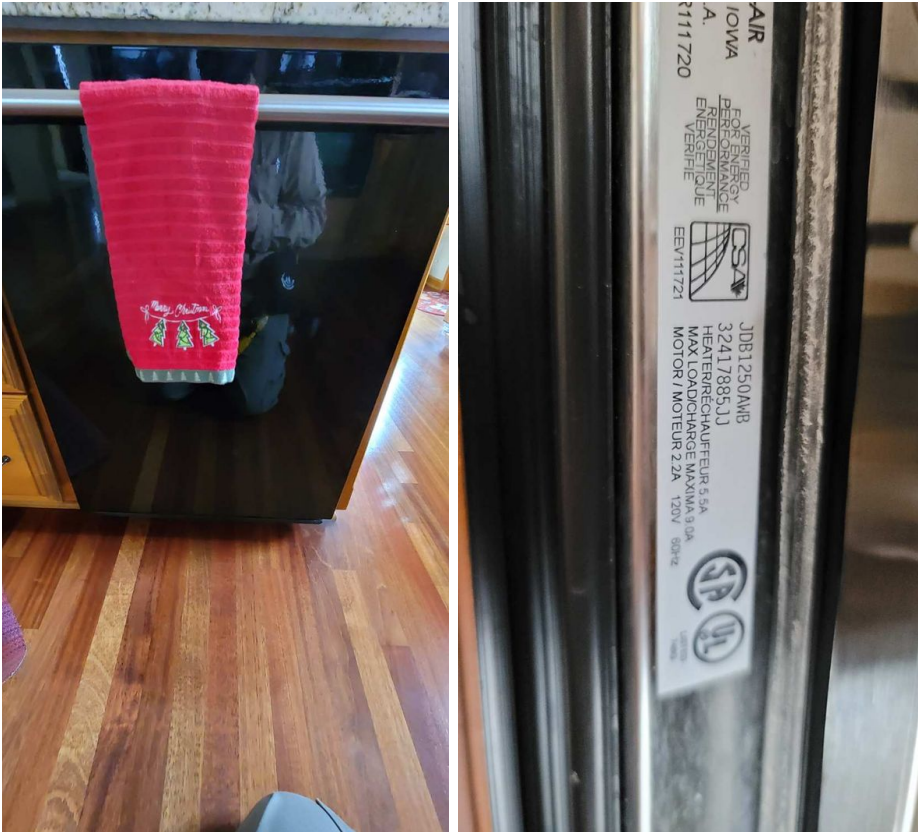
Dishwasher: Brand

Jenn-Air

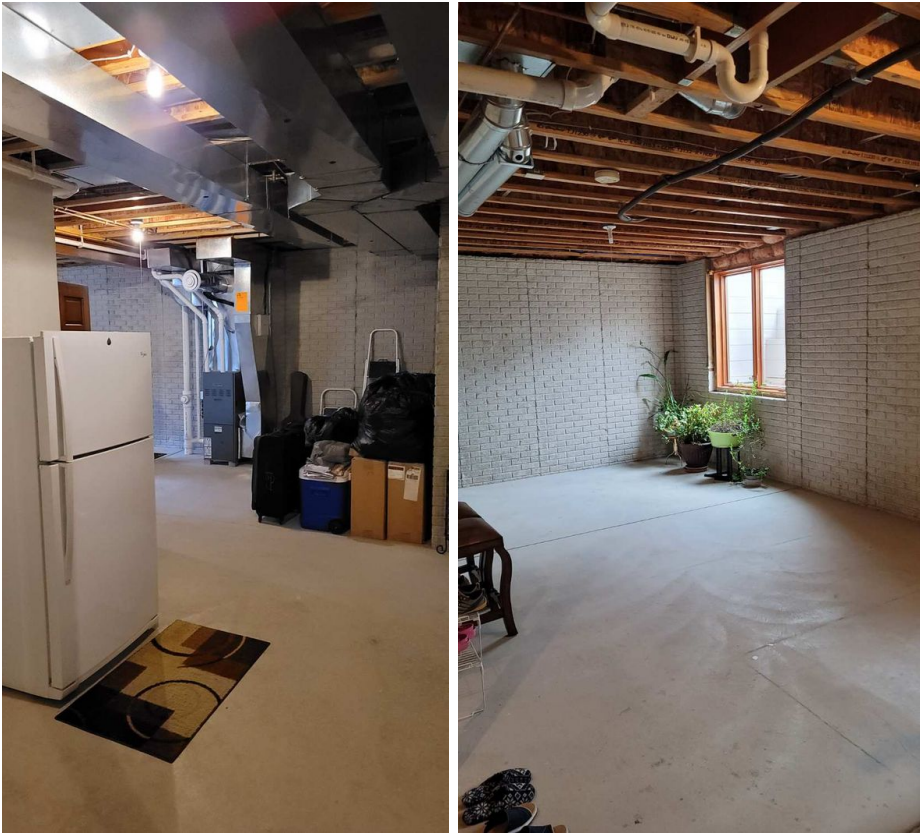
Foundation: Material

Poured concrete

At the time of inspection the foundation structure and material appeared to be in good condition. Any specific defects will be listed in the report.

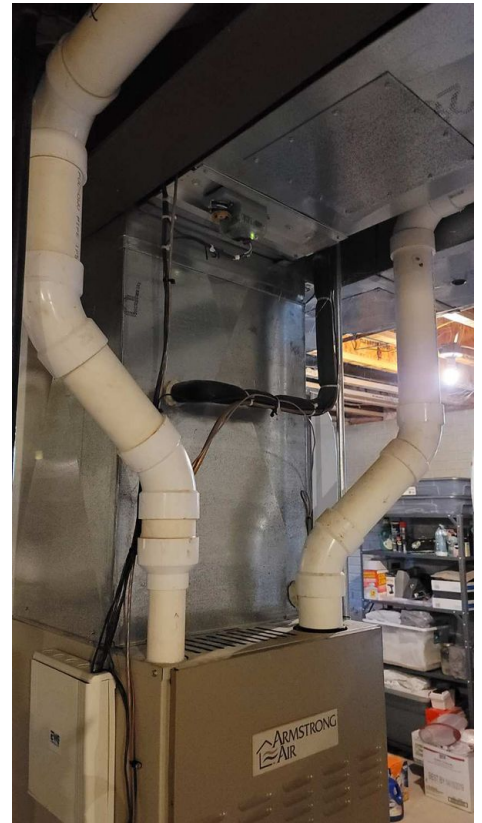
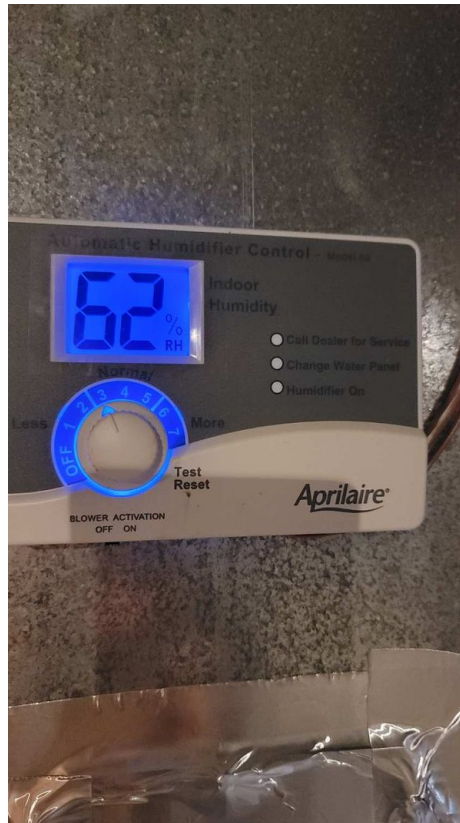
Fresh Air Intake: Fresh Air Intake
Present, plugged screen

Also termination next to sump in basement was also plugged. Recommend cleaning.

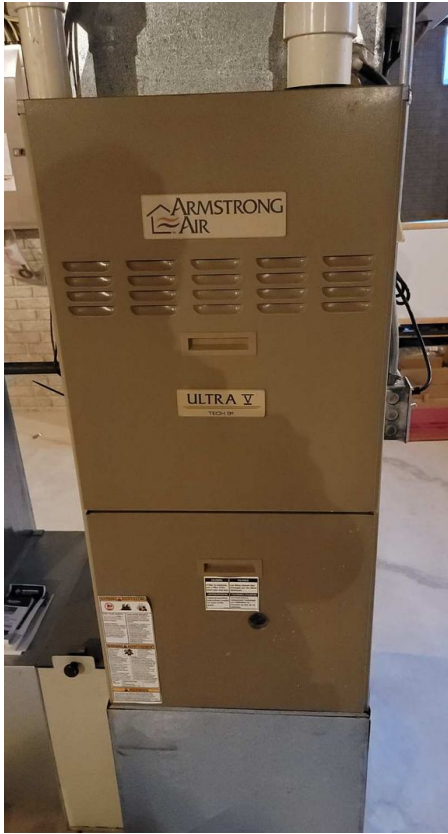
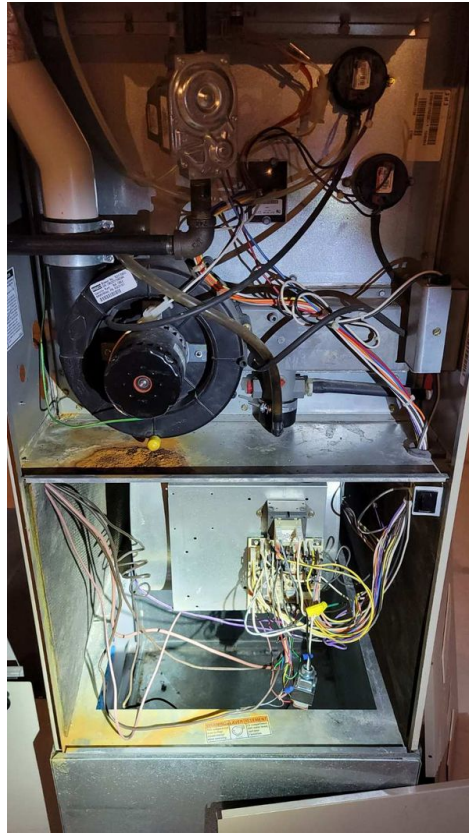
Armstrong

An annual maintenance agreement that covers parts and labor is recommended.

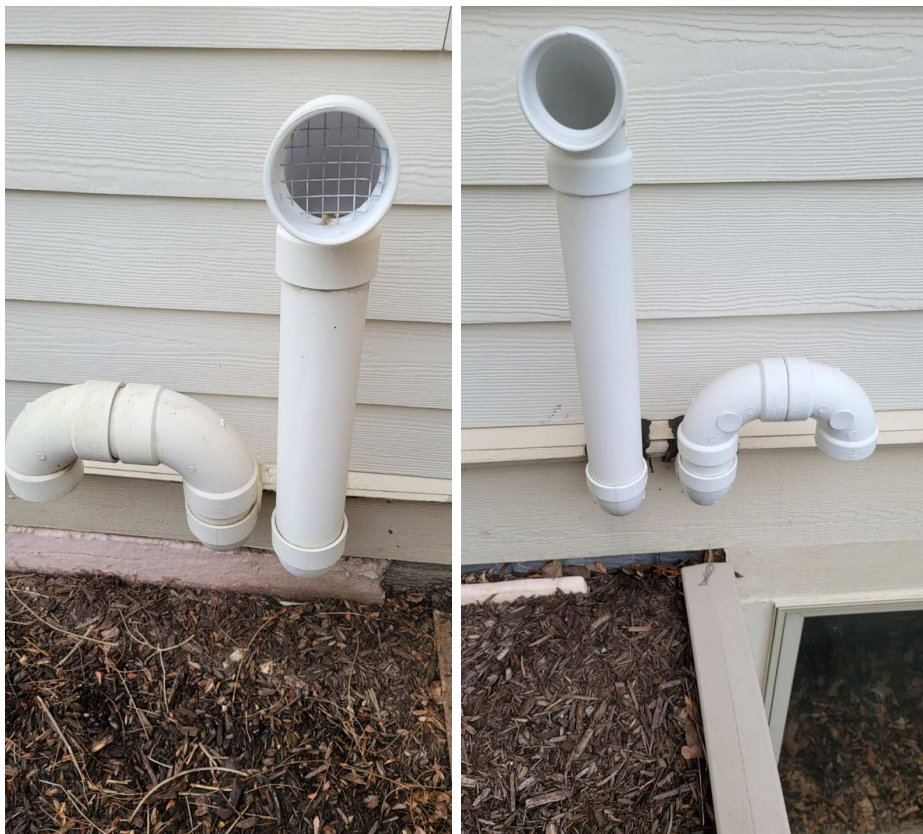
Air Filter: Filter Size

20x25x4

At the time of inspection the filter appeared to be in good condition. Any defects will be listed separately in the report.

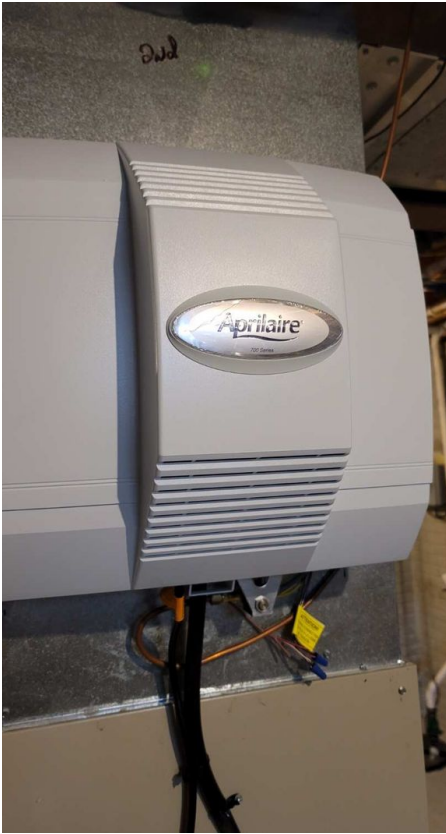
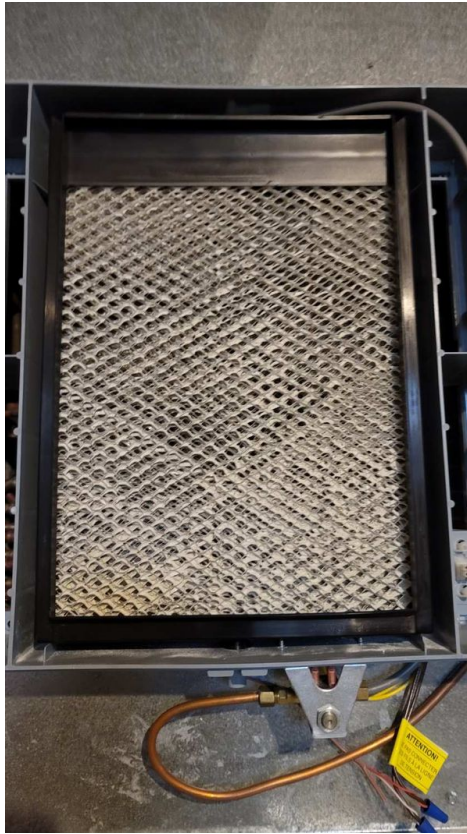
PAST LEAK/RUST

Inspector noticed rust spots in upper cabinet , Main furnace. ***There was no leaking at time of inspection.*** New buyer may want to check with owner for past records if this issue was corrected. It looks like original leak may have come from the collector box.

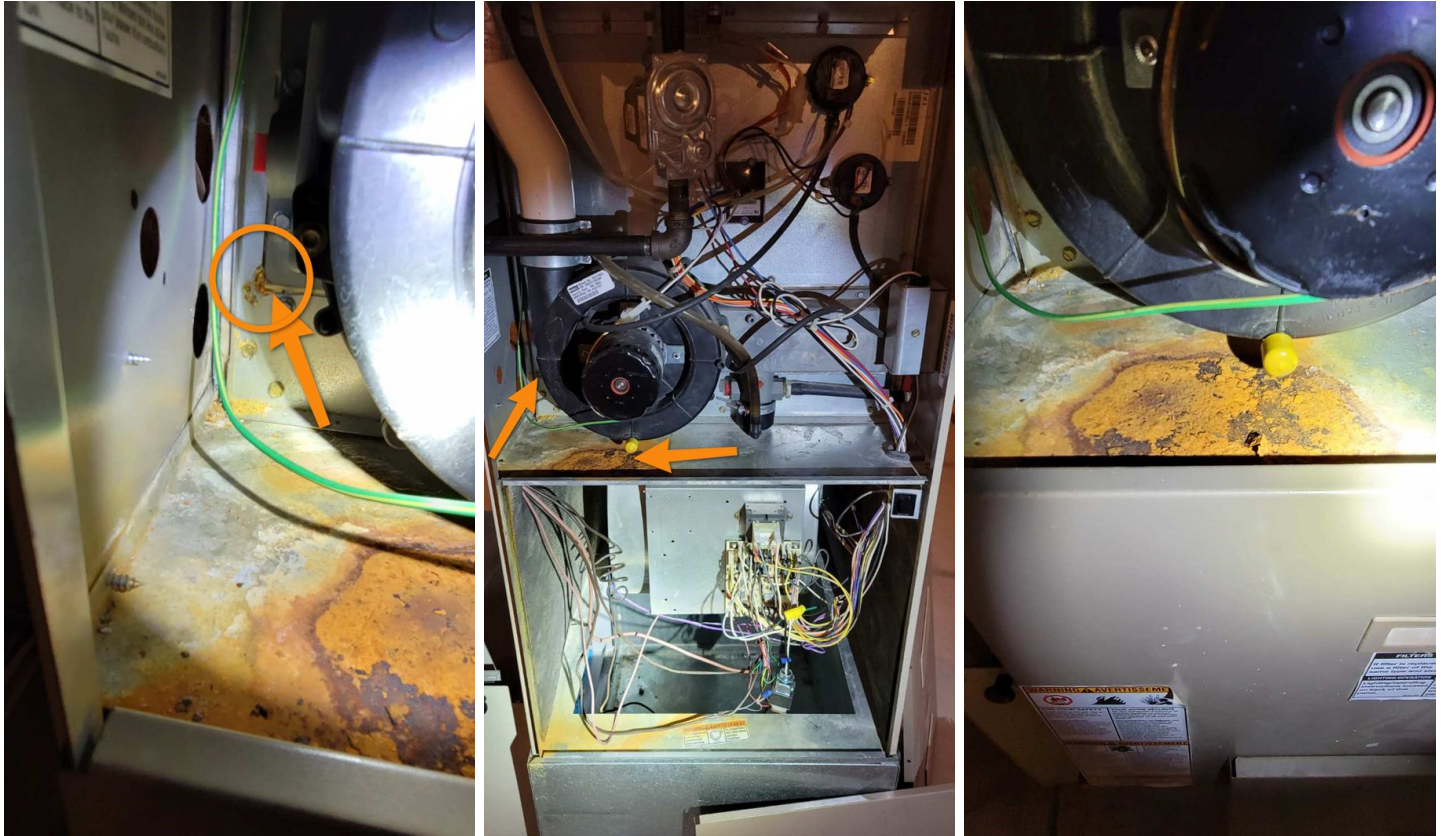
Past leak

Contact a qualified professional.

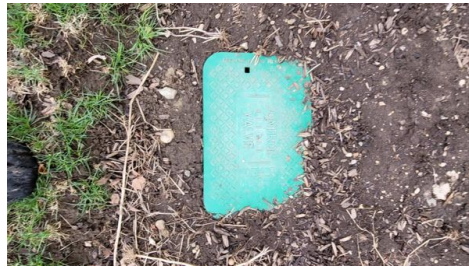
Ground Valves

Professional Sprinkler System Installation: Irrigation Backflow Preventer

It is recommended that the new buyers get the system inspected by a qualified irrigation contractor .

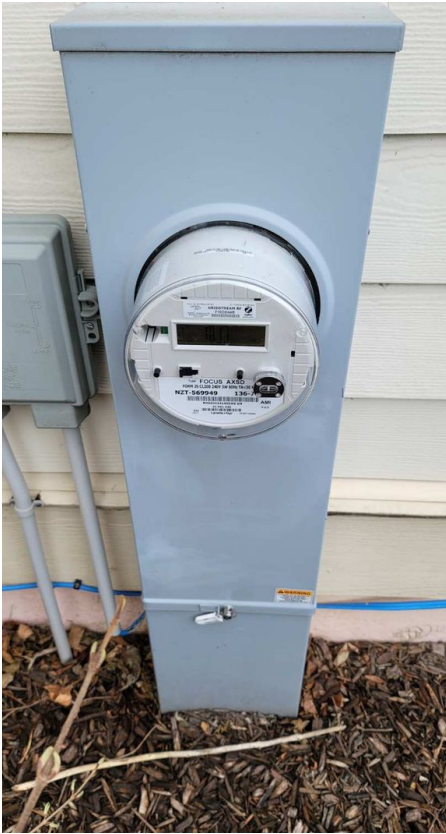
Main & Subpanels, Service & Grounding, Main Overcurrent Device: Panel Capacity
200 AMP

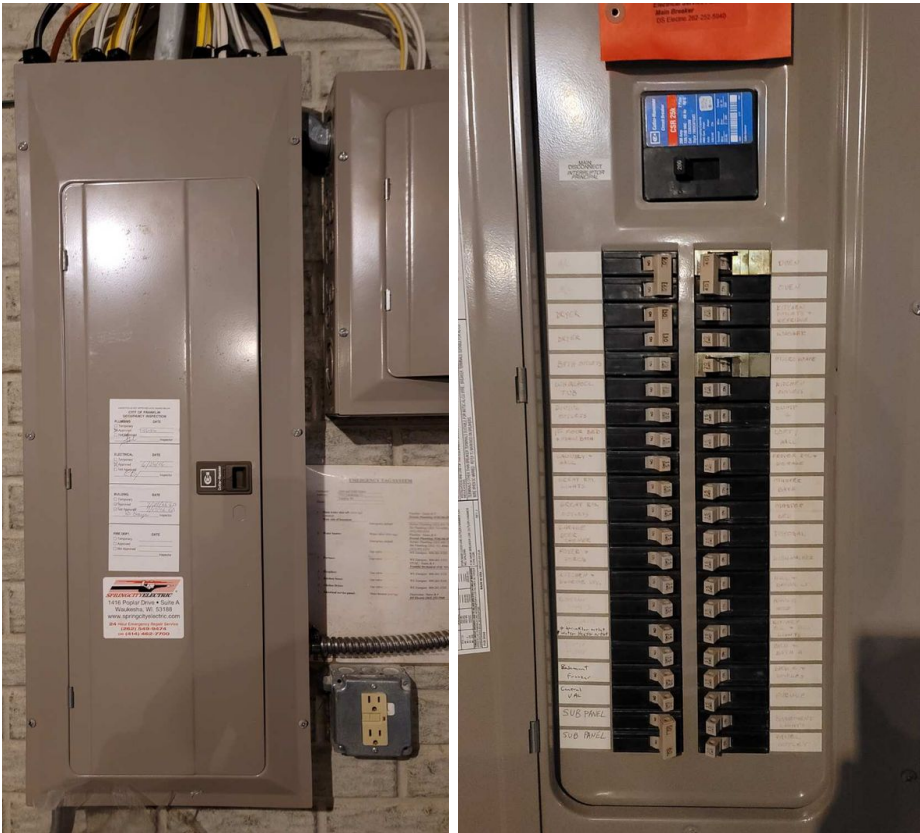
Main & Subpanels, Service & Grounding, Main Overcurrent Device: Panel Manufacturer
Cutler Hammer

Dead-front covers are removed for inspection of the wiring unless otherwise noted in this report.
