LEVEL 2 REPLACEMENT RESERVE REPORT FY 2023 CRESTWOOD VILLAGE

REPLACEMENT RESERVE REPORT

CRESTWOOD VILLAGE

FREDERICK, MARYLAND
June 22, 2022
Revised September 20, 2022

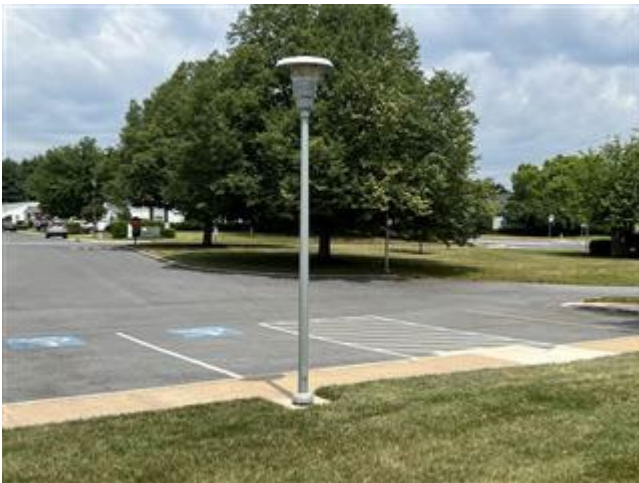
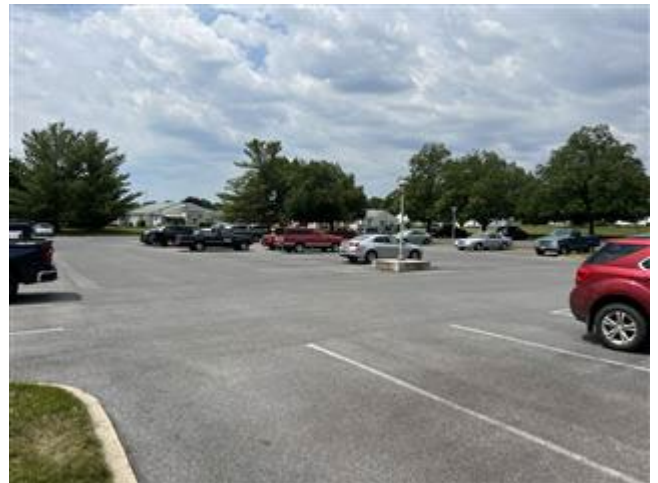
Asphalt Pavement. The Association is responsible for the roadways and parking areas within the community. In general, the Association's asphalt pavements are fair to good condition.

The Association maintains the asphalt pavement as indicated in the inventory. The RELs are based on the latest mill and overlay dates as provided by management.

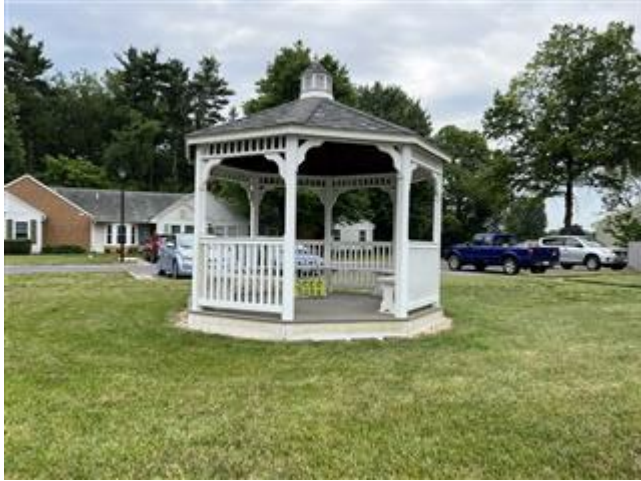
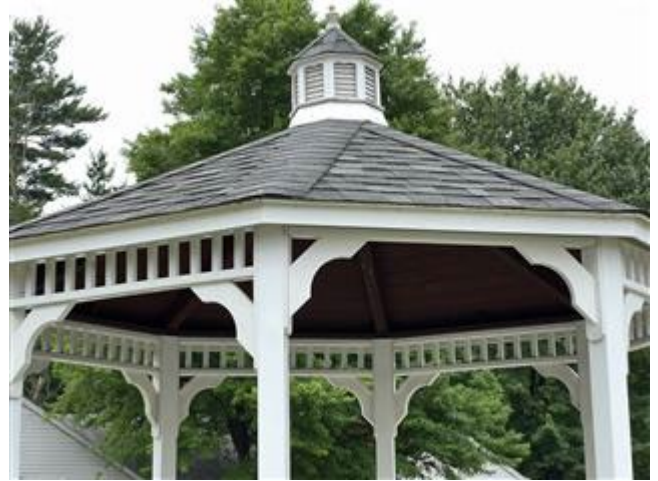
Gazebos. The Association has three gazebos of wood construction. The gazebos are made of wood with asphalt shingle roofs. Their condition is consistent with their age, with the newest gazebo being at Box Elder Court.

The rate of deterioration of the wood components of the gazebos will vary with the level of maintenance performed on those components as well as the exposure of the gazebos to the elements. Gazebos of this type can be expected to have a service life of 40 years.

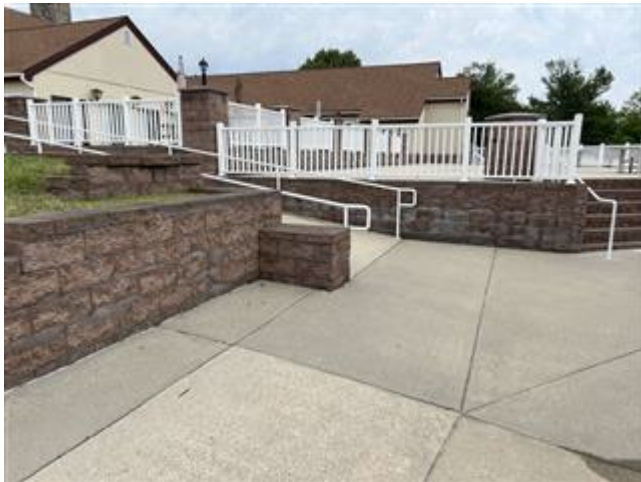
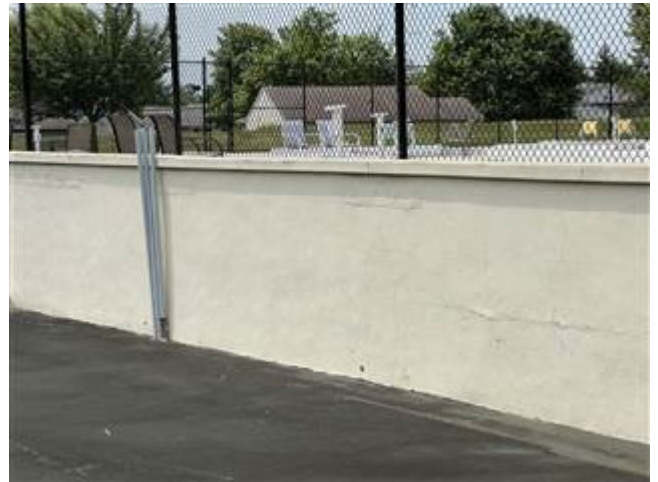
Retaining Walls. The Association maintains several masonry retaining walls. The retaining walls are generally good condition.

Retaining walls, in general, are designed to provide slope stabilization and soil retention by means of a structural system. Typically, walls that are three feet high or more require some level of design.

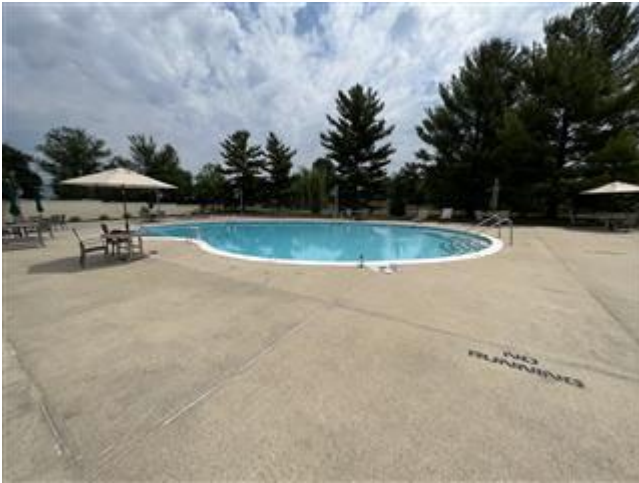
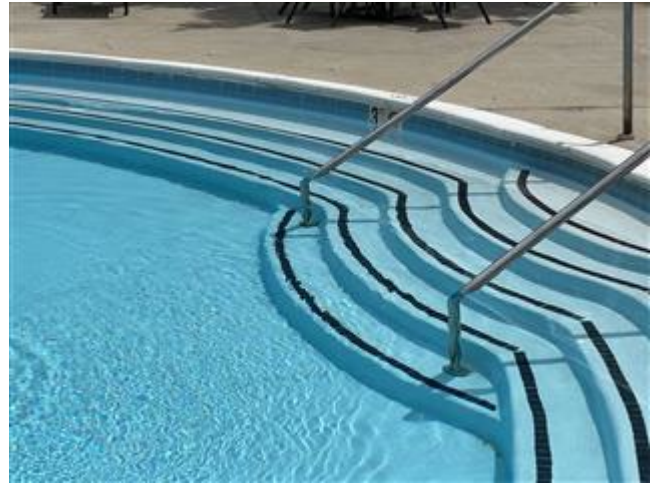
Swimming Pool. The community operates an outdoor pool of concrete construction. The pool and equipment is reported to be in good condition.

- Pool Shell. The shell for the swimming pool appears to be in good condition.
- Pool Deck. The pool has a concrete deck in fair condition with no observed tripping hazards.
- Whitecoat. The pool whitecoat is good condition. We have assumed service life of eight to ten years for the pool whitecoat.
- Waterline Tile. The waterline tile is good condition. We have assumed that the waterline tile will be replaced or restored when the pool is whitecoated.
- Coping. The pool is edged with pretest coping. The coping is in good condition.
- Pump and Filter System. The filter system is reported to be in good operating condition.
- Pool Fence. The swimming pool is enclosed by a chain-link fence that is in fair to good condition.

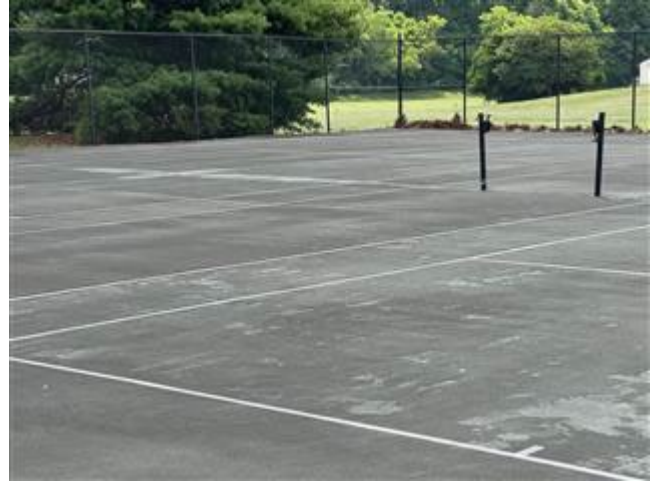
Tennis Courts. The community maintains the tennis courts. The overall condition of these courts in the process of being replaced.

- Asphalt Pavement (base layer). We have assumed a service life of 20 to 30 years for the asphalt base layer.
- Color Coat (surface layer). Annual cleaning is recommended to maintain the surface of the court. The base of a tennis court is subject to cracking and low spots known as “birdbaths” that can occur from weather and earth movement. A program to address cracks as they appear will help to prolong the useful life of the color coat. We have assumed a service life of five to ten years for the color coat.
- Net Posts. We have assumed that the new posts will be replaced when the asphalt pavement is replaced.

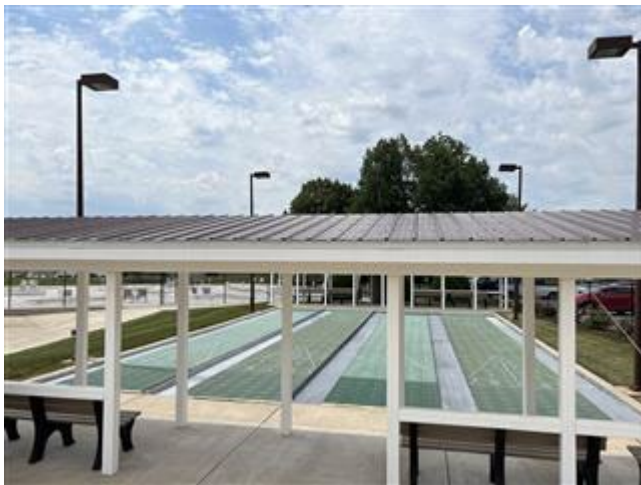
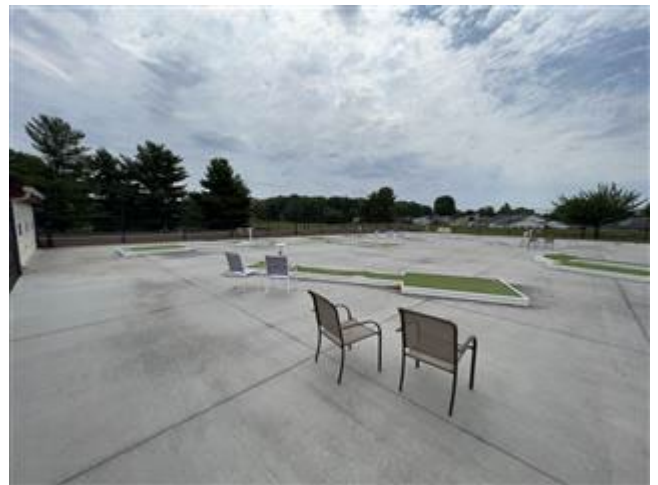
Other Courts. The community maintains Play miniature golf course with a concrete deck and several shuffleboard courts. These are in generally fair condition.

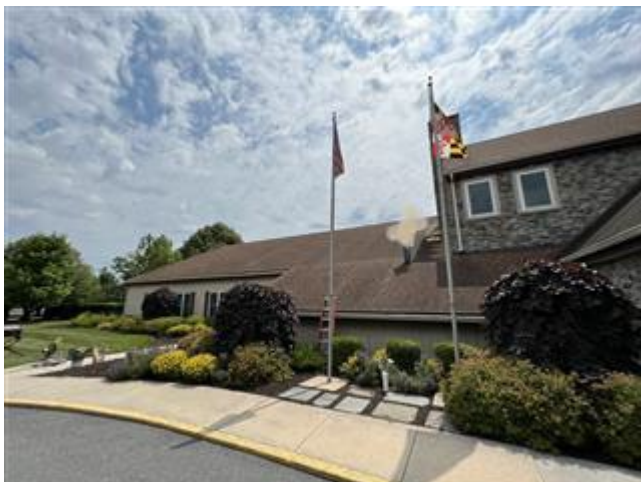
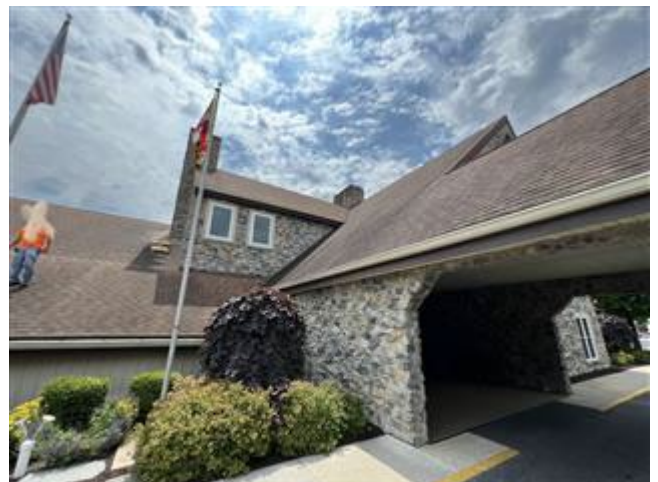
Building Roofing. The clubhouse building and pool maintenance building have asphalt shingle roofs which are in generally fair condition and in fact was having some minor repairs done at the time.

Asphalt shingle roofs can have a useful life of 20 to 50 years depending on the weight and quality of the shingle. Weathered, curled, and missing shingles are all indications that the shingles may be nearing the end of their useful life.

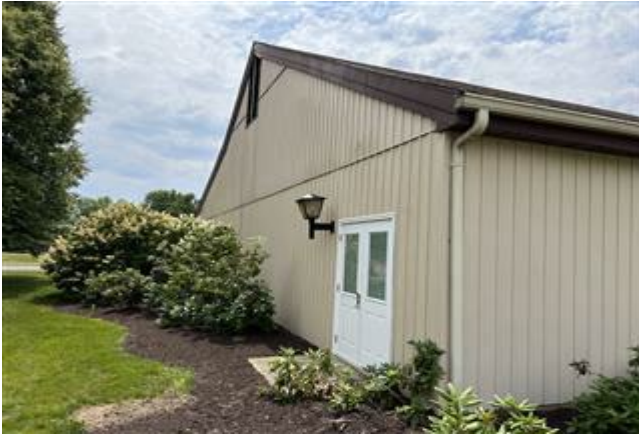
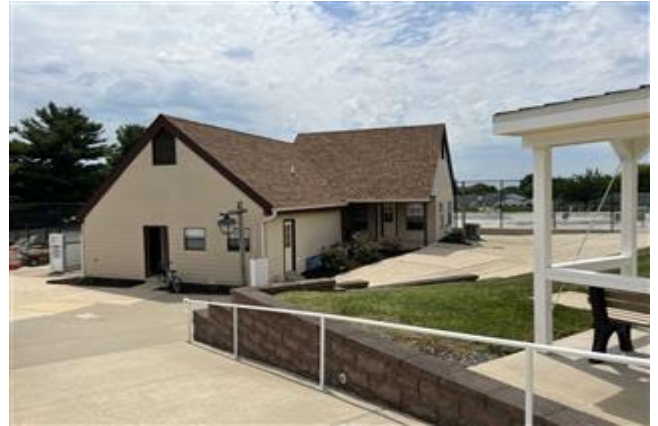
Siding and Trim. The clubhouse has a vertical aluminum siding and the pool maintenance building has horizontal vinyl siding. Both are in fair condition.

Vinyl/Aluminum Siding and Trim can have an extended useful life if not damaged by impact, heat, or other physical reasons. However, the coatings and finishes typically have a useful life and over time begin to weather, chalk, and show their age. For these reasons, we have modeled for the replacement of the siding and trim every 35 years.

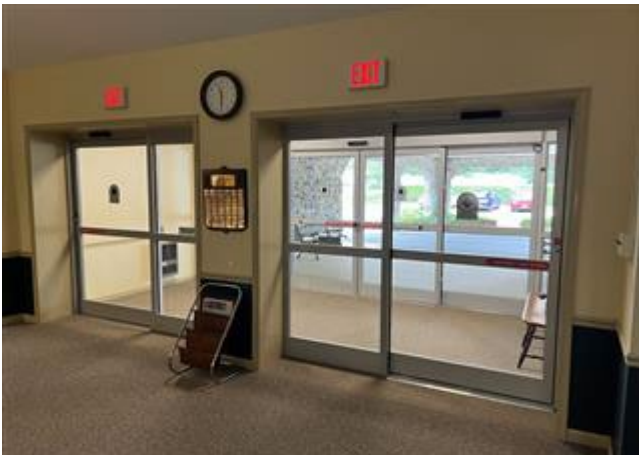
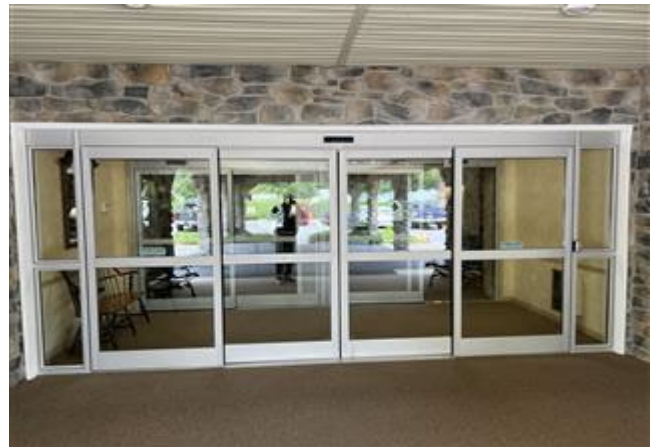
Windows and Doors. The Association is responsible for the windows and exterior doors of the clubhouse. The windows and doors are generally in good condition.

Window and door units play an integral part in a facility's overall comfort, efficiency, and energy use. The quality of the installed units and the care taken in their installation and maintenance are major factors in their effectiveness and useful life. These units can have a useful life of 20 to 35 years or more depending on their use and other factors mentioned above.

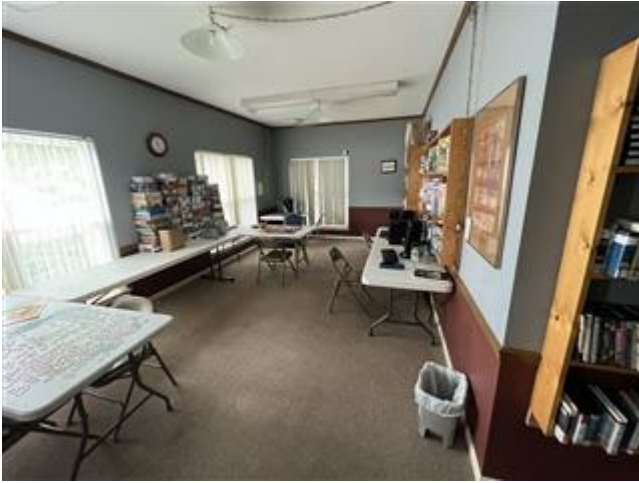
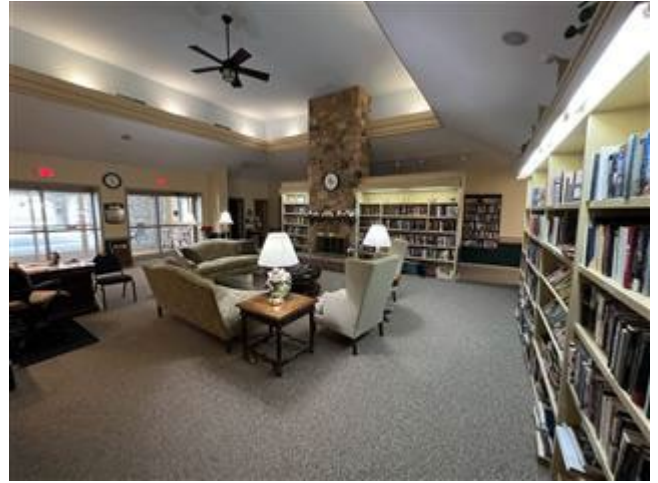
Carpet. The carpet in the building's private and common areas is in fair condition. The commercial carpet of this construction in this type of application has a typical service life of 7 to 10 years.

To extend the life of the carpet, it is important that the Association continues with a comprehensive maintenance program that includes regular vacuuming, spot and spill removal, interim cleaning of high traffic areas, and regularly scheduled cleanings. It is also recommended that all entrances be fitted with walk-off mats to trap soil.

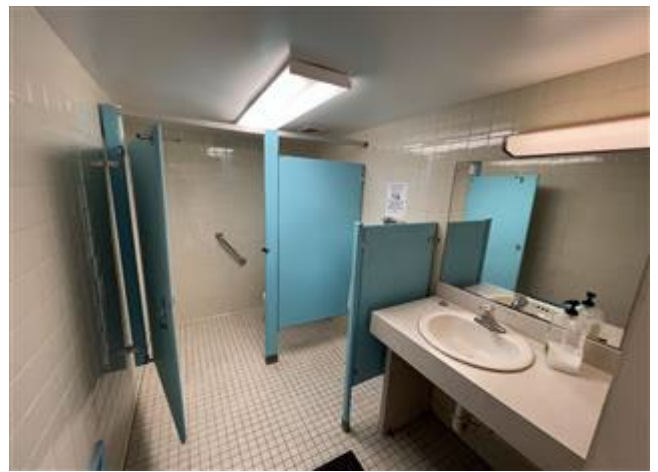
Vinyl Tile. The vinyl tile in the building's common areas is in fair to good condition. The commercial vinyl tile of this construction in this type of application has a typical service life of 25 years.

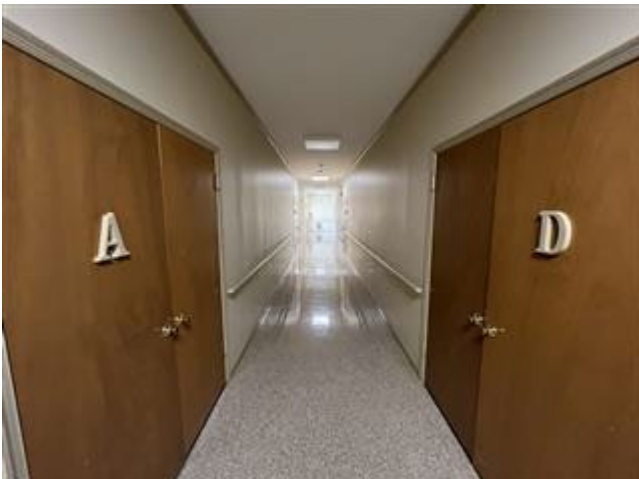
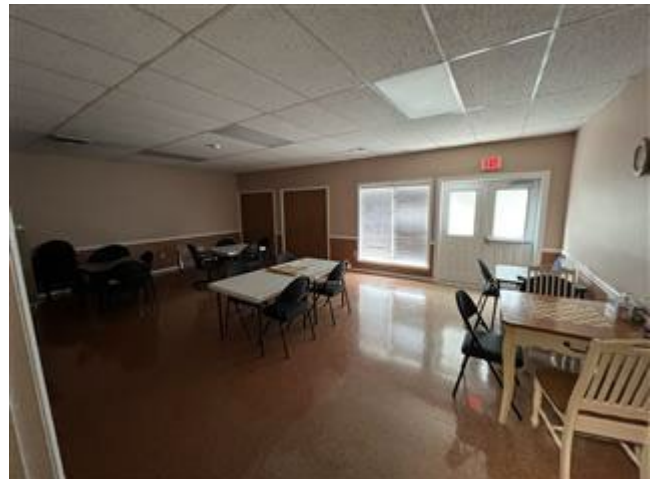
To extend the life of the vinyl tile, it is important that the Association continues with a comprehensive maintenance program that includes regular vacuuming, spot and spill removal, interim cleaning of high traffic areas, and regularly scheduled cleanings. It is also recommended that all entrances be fitted with walk-off mats to trap soil.

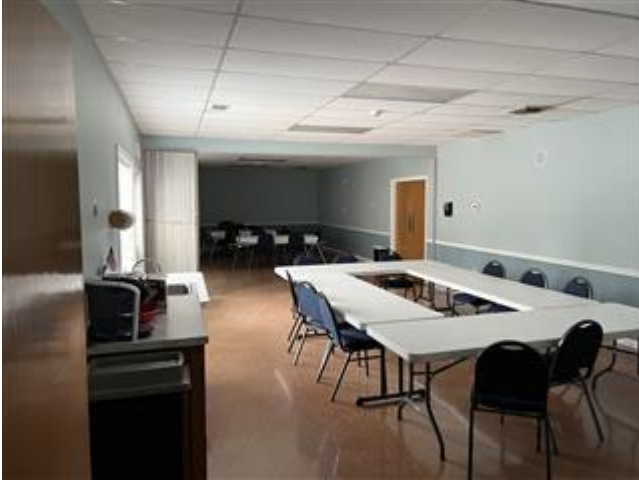
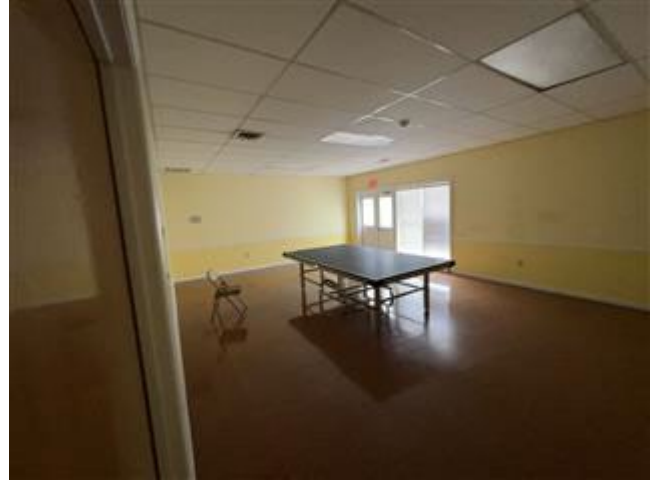
Ceiling Tile. The acoustical ceiling tile installed in some of the common areas is in fair to good condition. At some time, the tile will be discolored or it may be impossible to obtain matching replacement tile.

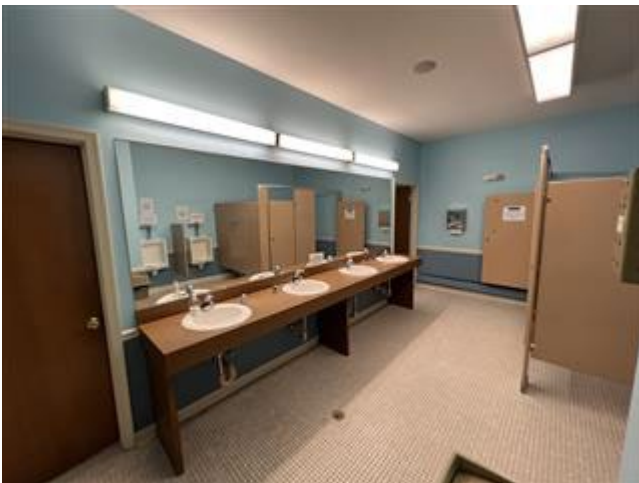
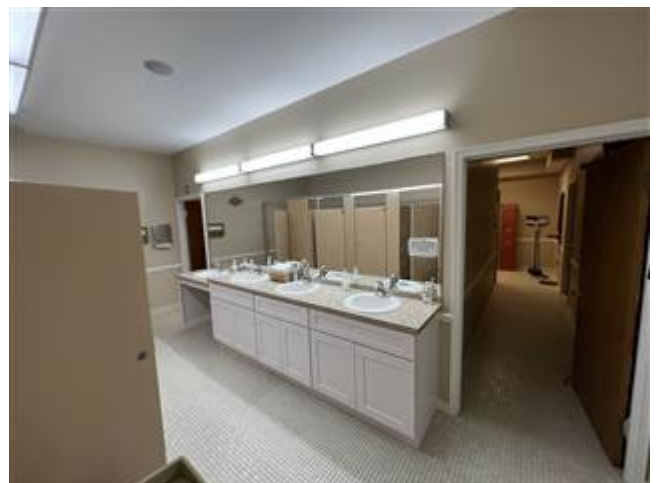
Locker and Restrooms. The locker and restrooms for the swimming pool, exercise facility, and clubhouse in general are located in the clubhouse. The overall condition of the locker and restrooms is fair.

- Ceramic Floor Tile. The ceramic tile in the locker rooms is in fair condition.
- Lockers. The locker rooms have half-height, steel lockers. All are in fair condition.
- Light Fixtures. Illumination is provided by ceiling-mounted and wall-mounted light fixtures. The fixtures are in working condition and provide adequate lighting. Fixtures of this type have a typical service life of 25 years.

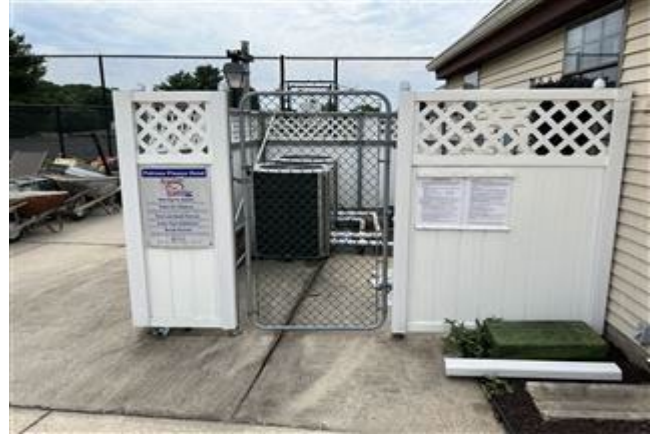
In addition, the Association maintains air handlers/furnaces throughout the facility, and these components can have a useful life of 20 to 40 years. With fan, motor, and coil replacements performed as needed, the casings of these systems can last significantly longer.

As is the case with most equipment, to achieve a maximum useful economic life, proper maintenance is essential. In some cases, proper and proactive maintenance can greatly extend the useful life of these components.

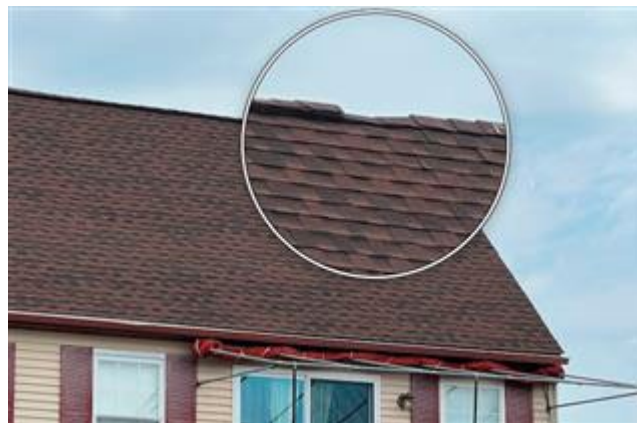
Building Roofing. The buildings have asphalt shingle roofs which are in fair condition.

Asphalt shingle roofs can have a useful life of 20 to 50 years depending on the weight and quality of the shingle. Weathered, curled, and missing shingles are all indications that the shingles may be nearing the end of their useful life.

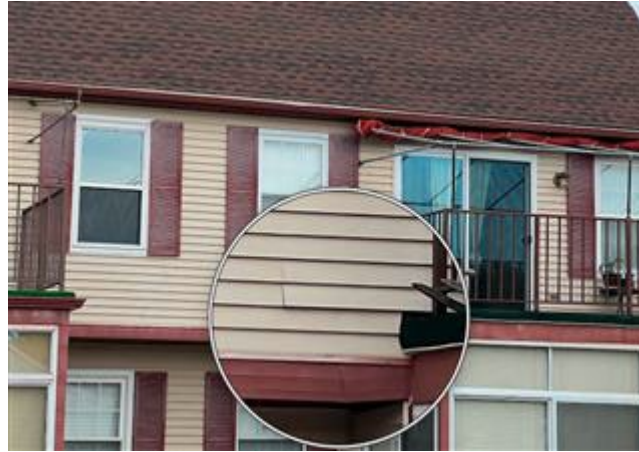
Siding and Trim. The buildings have vinyl siding and trim which is in fair condition.

Vinyl/Aluminum Siding and Trim can have an extended useful life if not damaged by impact, heat, or other physical reasons. However, the coatings and finishes typically have a useful life and over time begin to weather, chalk, and show their age. For these reasons, we have modeled for the replacement of the siding and trim every 40 years.

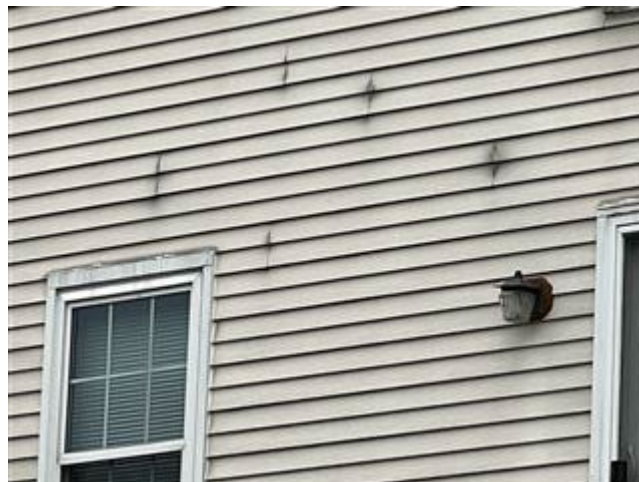
Siding and Trim. The exterior of the building is clad with vinyl siding which is in marginal condition.

Vinyl/Aluminum Siding and Trim can have an extended useful life if not damaged by impact, heat, or other physical reasons. However, the coatings and finishes typically have a useful life and over time begin to weather, chalk, and show their age. For these reasons, we have modeled for the replacement of the siding and trim every 35 years.
