ISLAND INSPECTIONS- LLC

ISLAND INSPECTIONS LLC

Buyer Name

08/18/2019 9:00AM

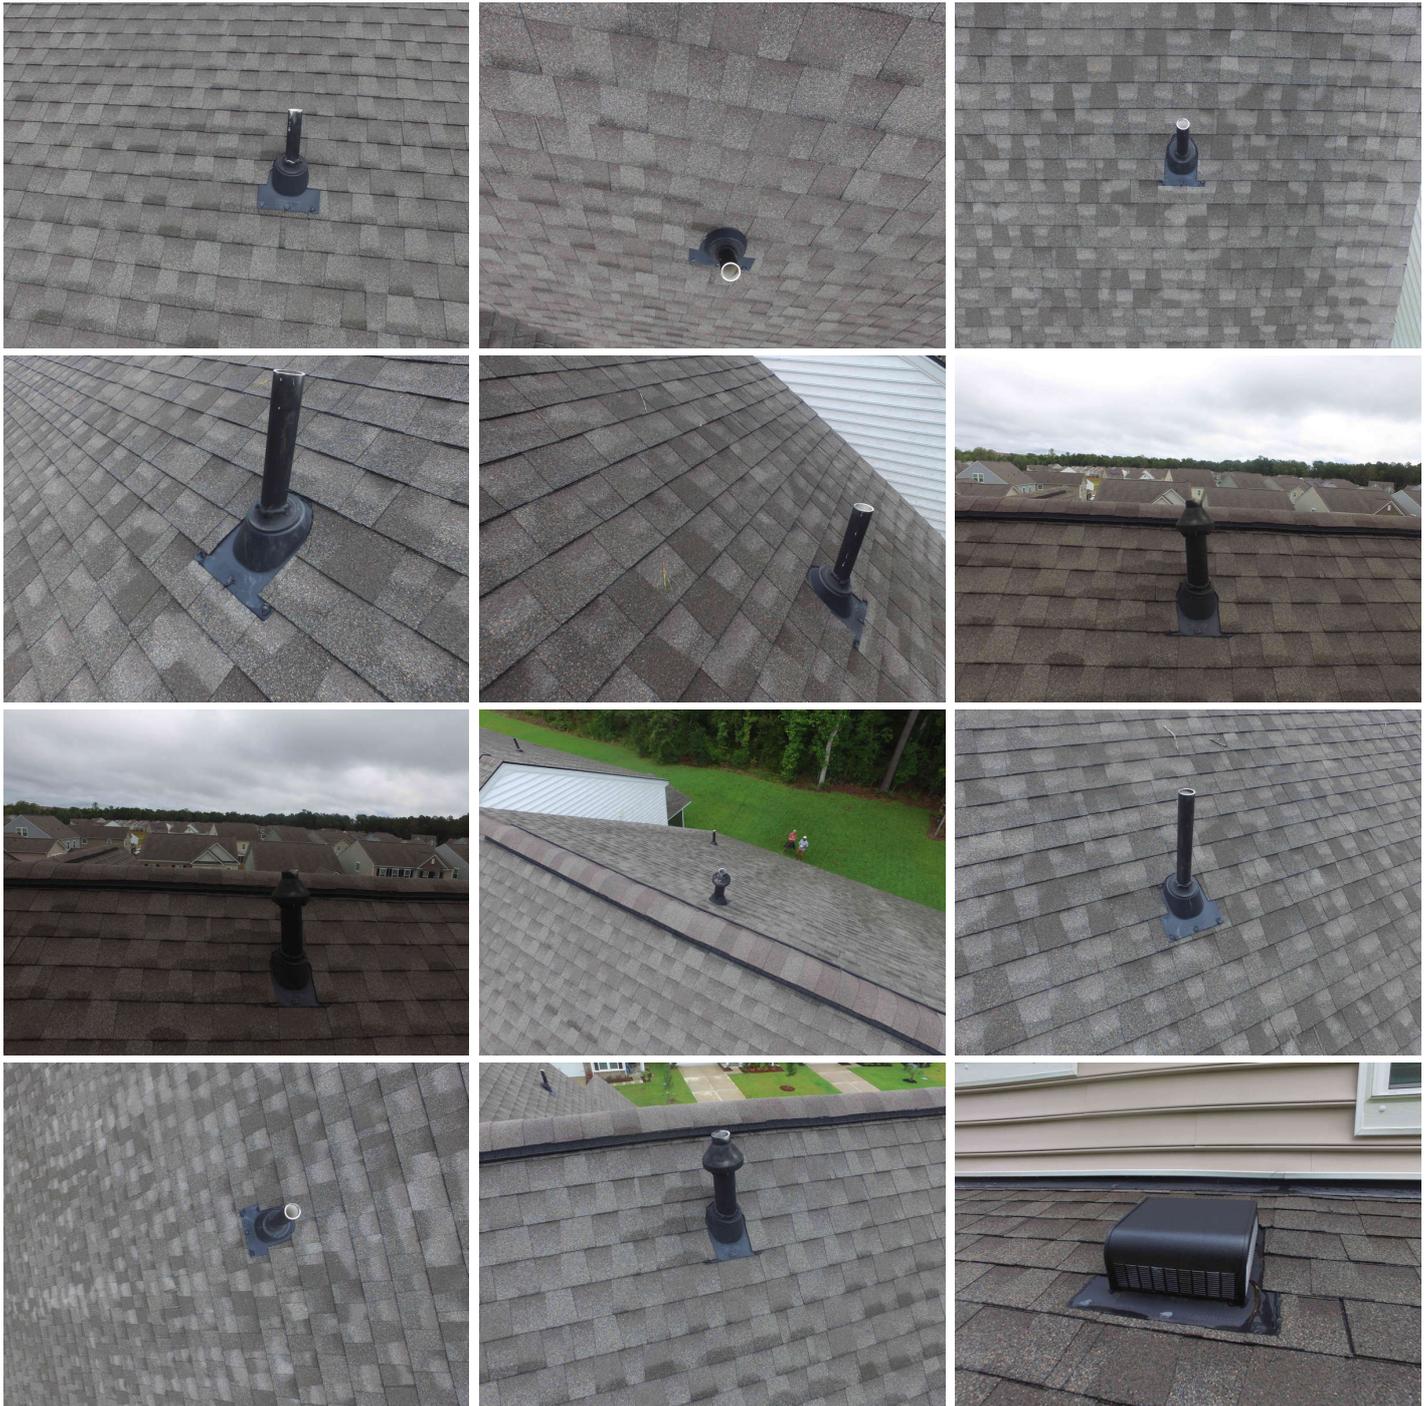
Plastic

The vent stack boots were inspected and no signs of defects were observed, unless otherwise noted in the report.

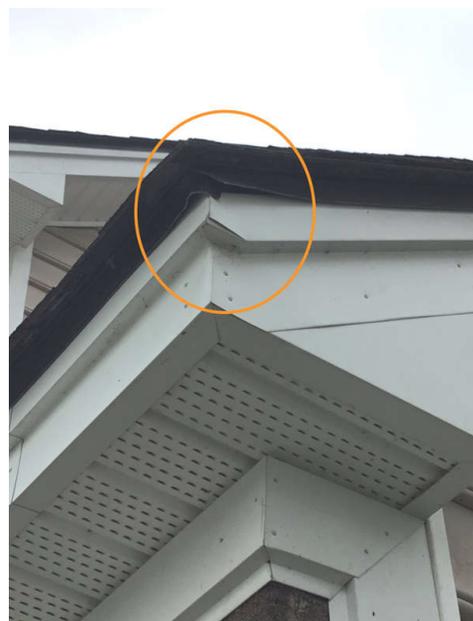
2.3.1 Roof - Flashings: Damaged
-

#### **DAMAGED**

Observed one or more areas of the drip flashing to show damage. Recommend having a qualified professional, handyman or DIY repair. Location observed: front right corner above garage.

Contact a qualified professional.

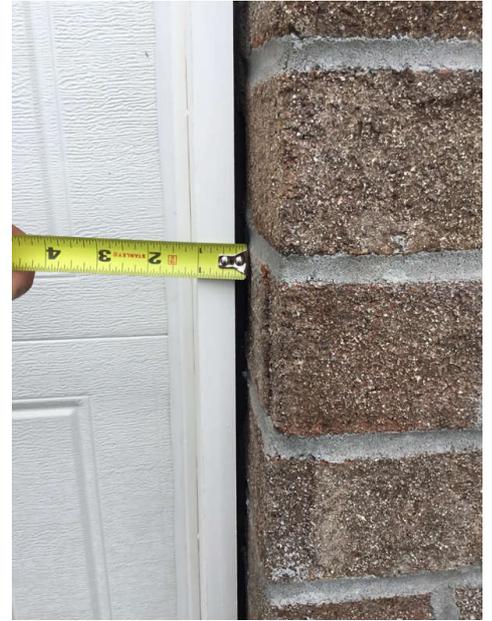
3.1.2 Siding, Flashing & Trim

**SETTLEMENT CRACKING**

Observed settlement cracking in one or more areas of wood trim. Double window, front of house.

Recommendation

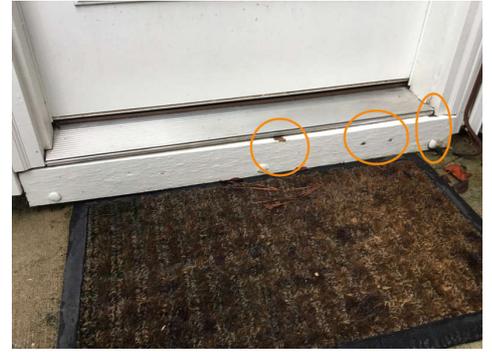
3.2.1 Exterior Doors

**PAINT/REFINISH  
NEEDED**

Door finish is worn. Recommend refinish and/or paint to maximize service life.

[Here is a DIY article](#) on refinishing a wood door.

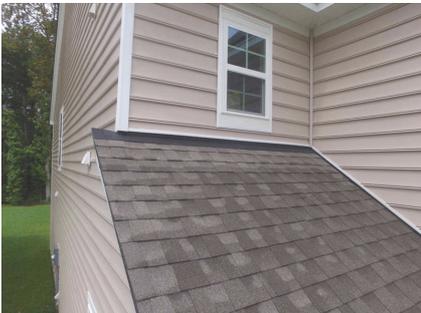
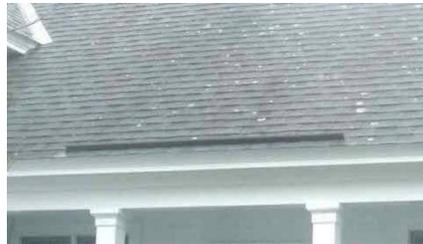
Observed the rain diverter above the front door to be missing. Recommend relaying the information to the builder for repair. This will help in diverting rain water away from the door entrance.

Contact a qualified professional.

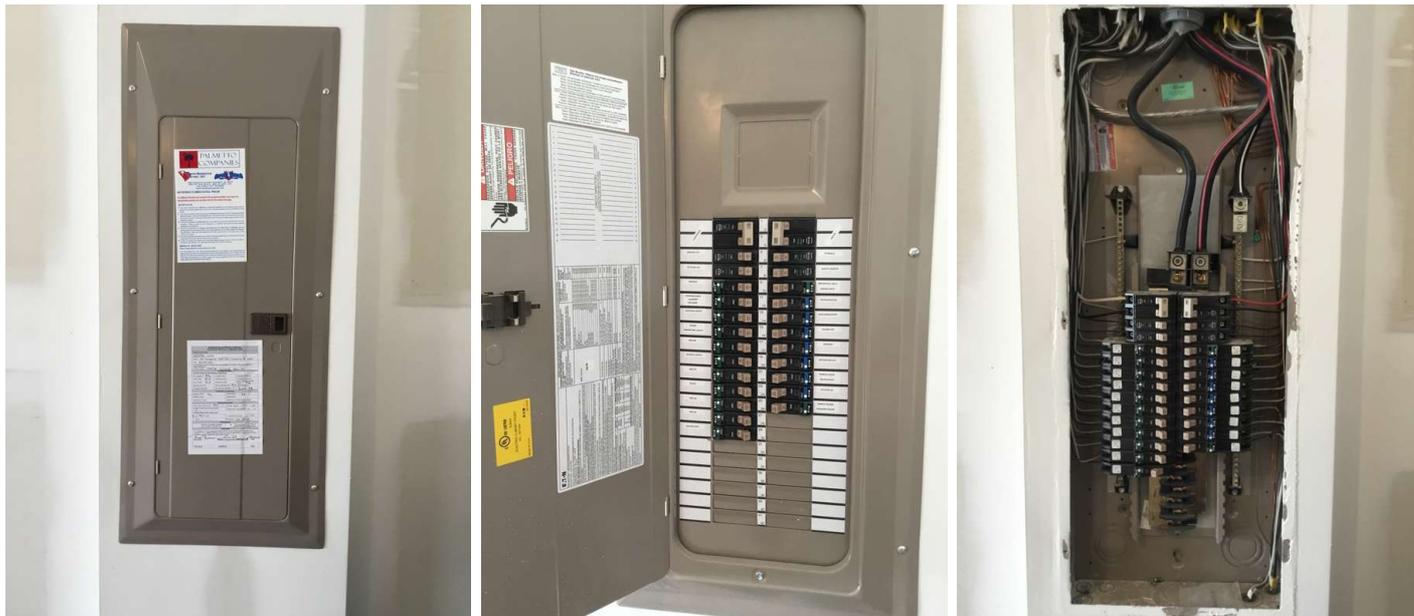
**Sub-Panel: Location**

Garage

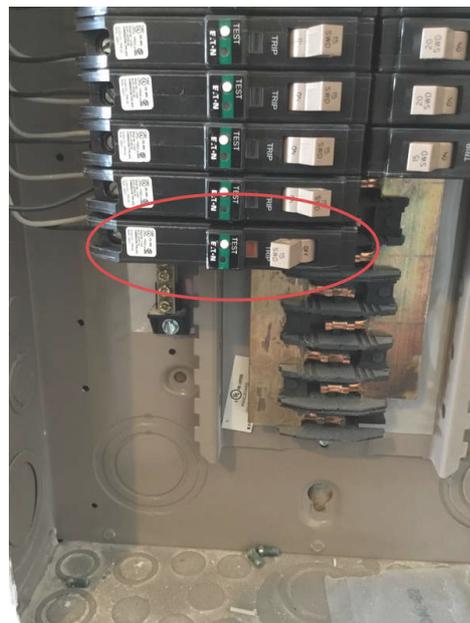
4.3.1 Electrical - Sub-Panel: AFCI/Defective
-

**AFCI/DEFECTIVE**

AFCI was tested by means of pressing the test button. An immediate spark was observed and the breaker tripped. The breaker was unable to be reset by turning the breaker off and then on. The breaker was also disconnected from the actual panel, with both the common and live wires disconnected to attempt to reset the breaker. The breaker was still unable to be reset. Recommend having a qualified professional (electrician) further evaluator and repair. The breaker in question goes to the master bedroom.

Contact a qualified professional.

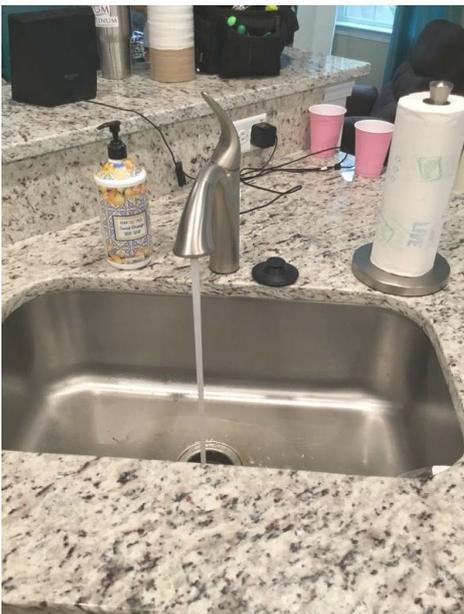
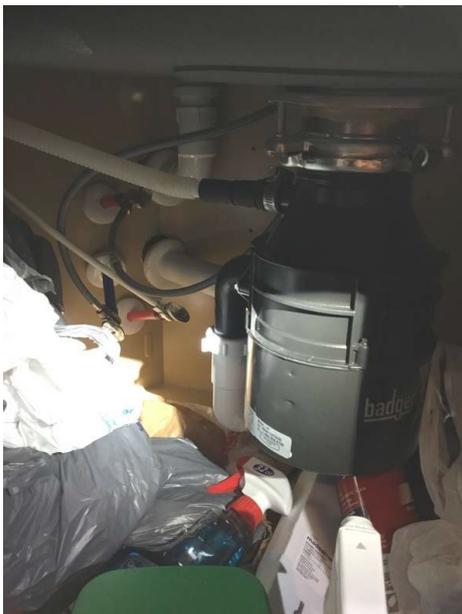
The sink worked as expected. No signs of leaks were observed around the faucet or plumbing.

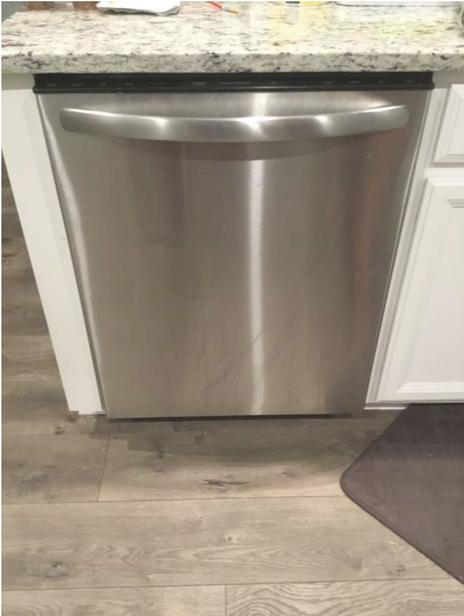
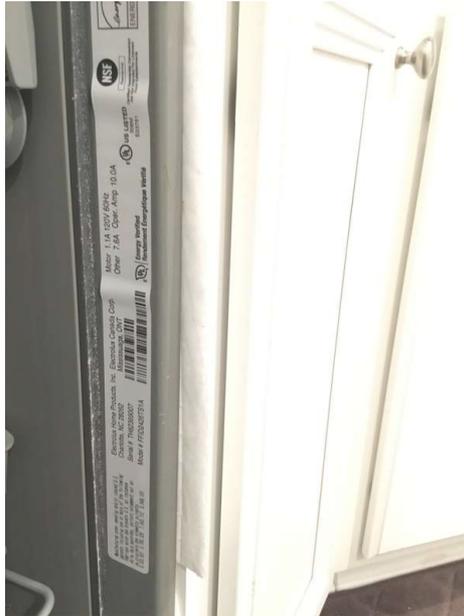
The dishwasher was operated with normal operating controls and ran through a cycle to inspect for leaks. No signs of leaks were observed below the dishwasher.

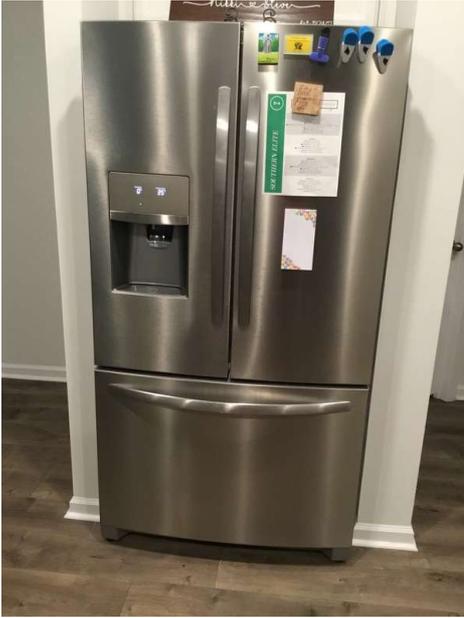
The refrigerator was working as expected.

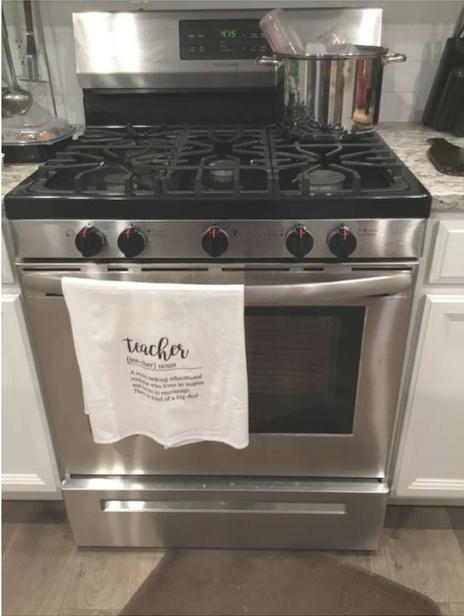
The cooktop & oven were operated utilizing normal operating controls. The unit worked as expected. No defects were observed unless otherwise noted in the report.

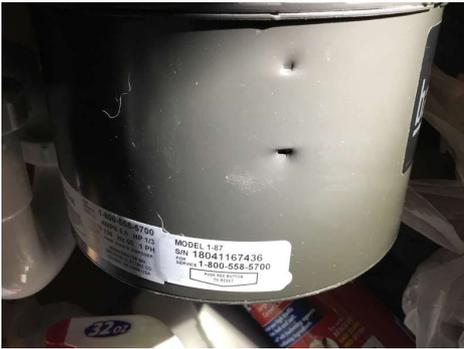
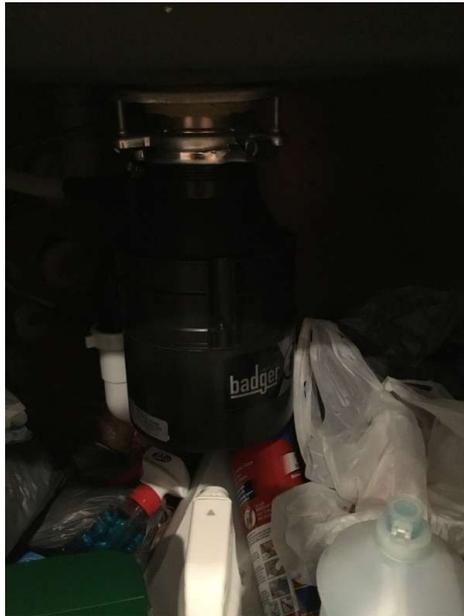
The disposal was tested utilizing normal operating controls. The disposal functioned as expected. The efficiency of how well the unit performs is beyond the scope.

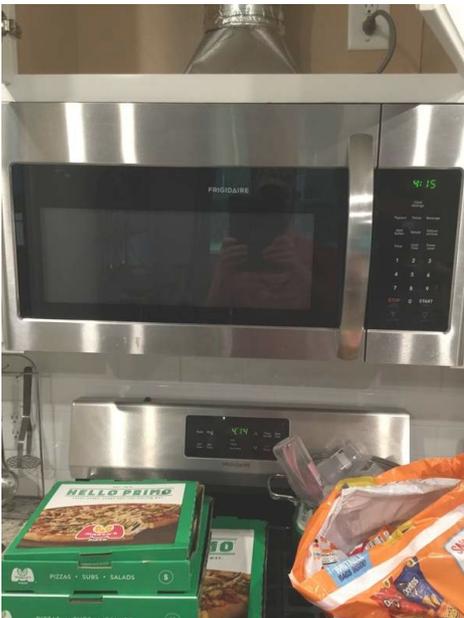
The microwave was tested utilizing normal operating controls. The microwave functioned as expected. The efficiency of how well the unit performs is beyond the scope.

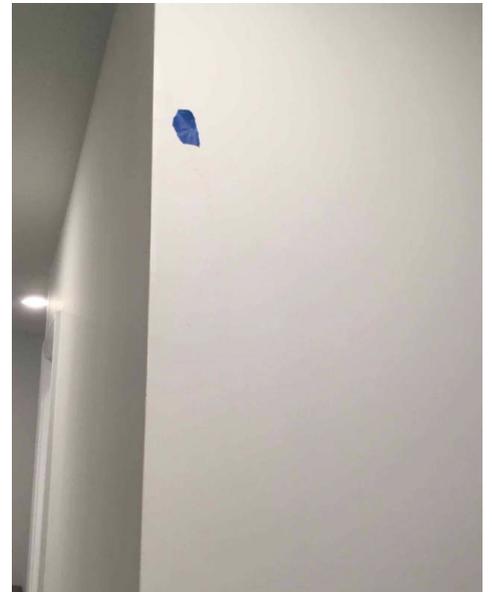
9.4.1 Interior - Walls: Sheetrock defects

**SHEETROCK  
DEFECTS**

Look for blue or green painters tape to show nail pops, rough areas, etc. these areas need to be brought forth to the builder for warranty information. **Not every nail pop or other defect pertaining to the walls or ceilings were photographed. Blue or Green painters tape was utilized to mark the defects in need of warranty repair.**

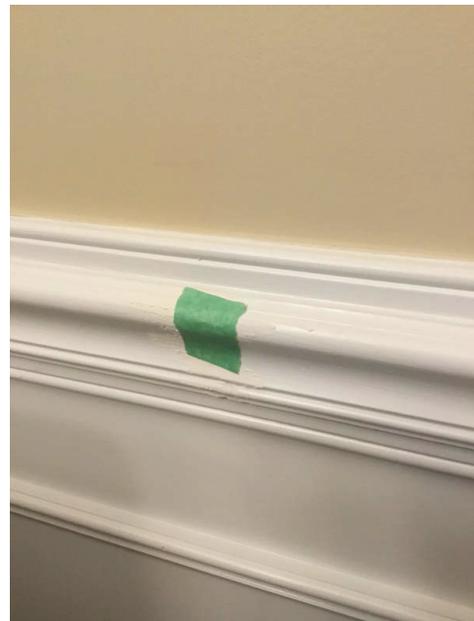
Observed chair moulding to show signs of uneven finish. Recommend sanding the chair moulding and painting.

Contact a qualified professional.

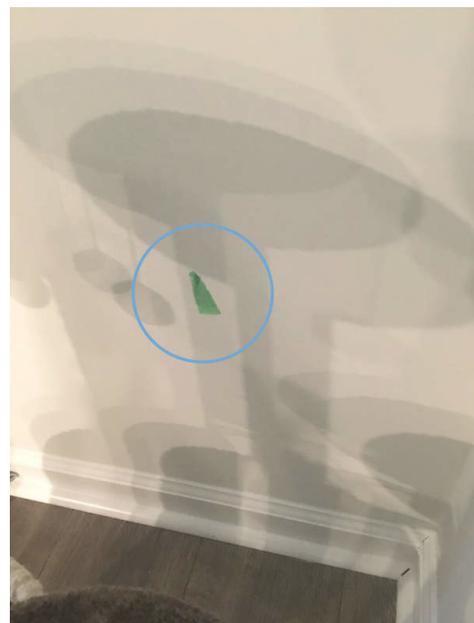
### NAIL POPS

Observed one or more areas to show signs of nail pops. Recommend tightening the screws/ nails and resealing with joint compound.

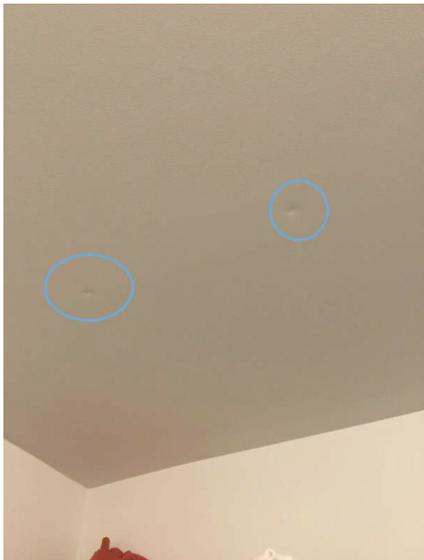
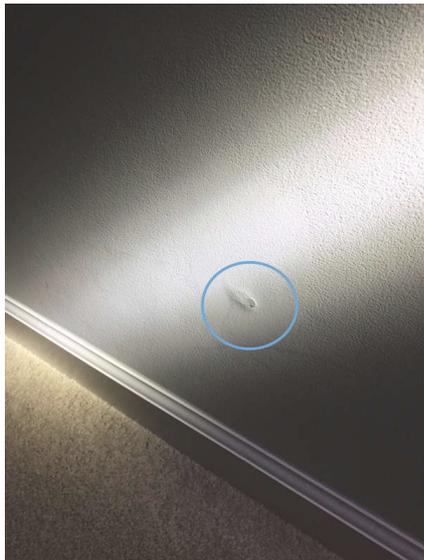
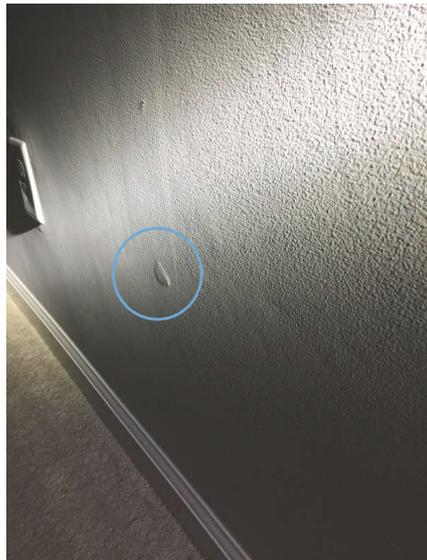
Observed one or more areas to show signs of nail pops. Recommend tightening the screws/ nails and resealing with joint compound.

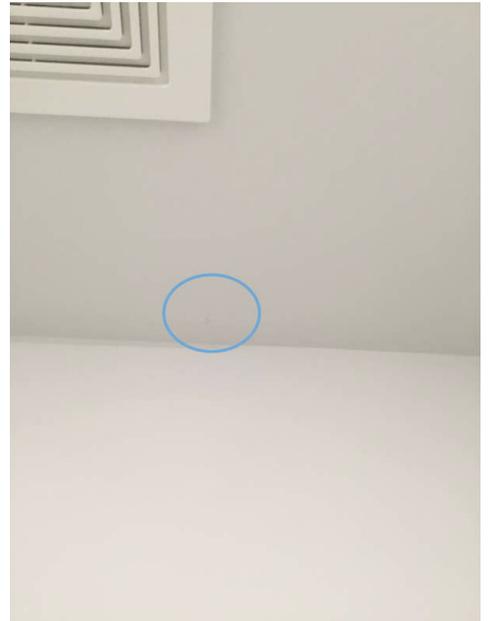
## 15.1.1 Bathroom #1

**NAIL POPS**

Observed one or more areas to show signs of nail pops. Recommend tightening the screws/ nails and resealing with joint compound.

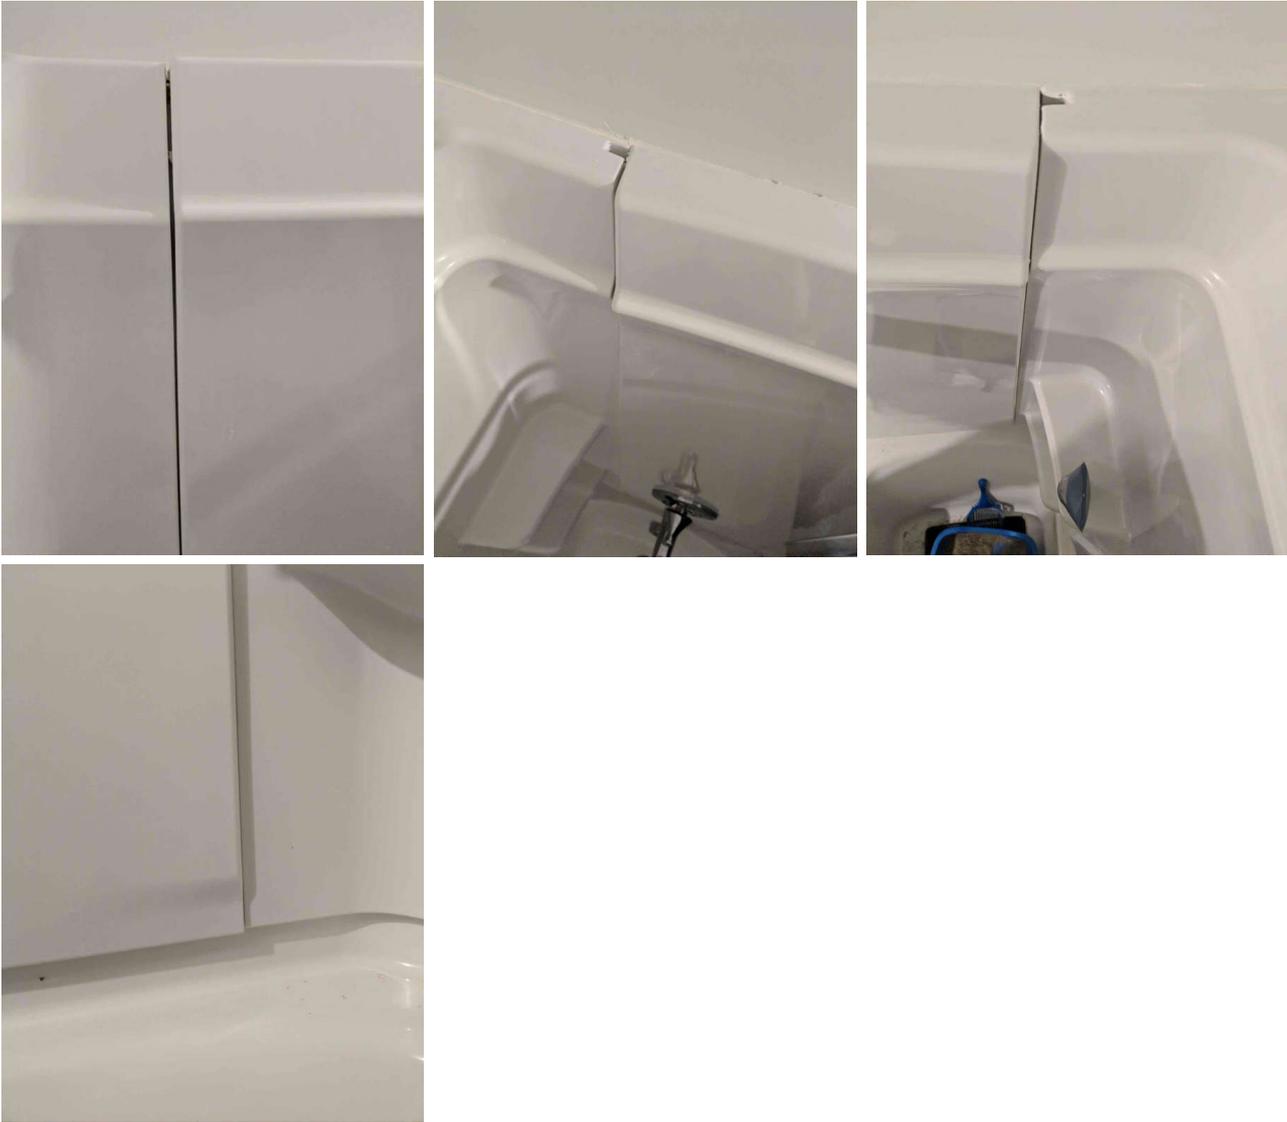
## 15.2.1 Bathroom #2

**SHOWER KIT**

The shower insert appeared to not be joined correctly and/ or sealed. Recommend relaying the area of concern to the builder.

Contact a qualified professional.

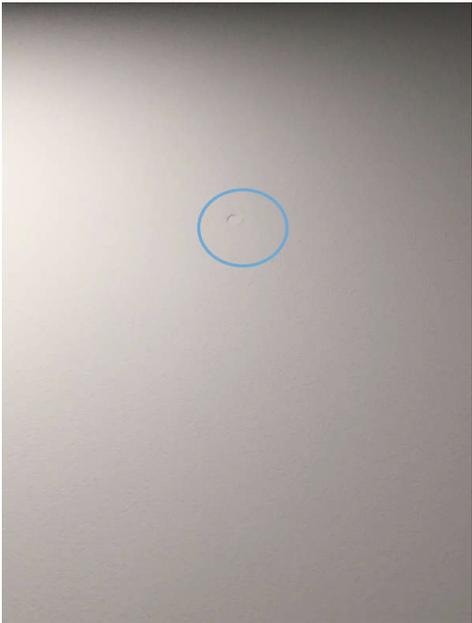
15.4.1 Bathroom #4

**NAIL POPS**

Observed one or more areas to show signs of nail pops. Recommend tightening the screws/ nails and resealing with joint compound.

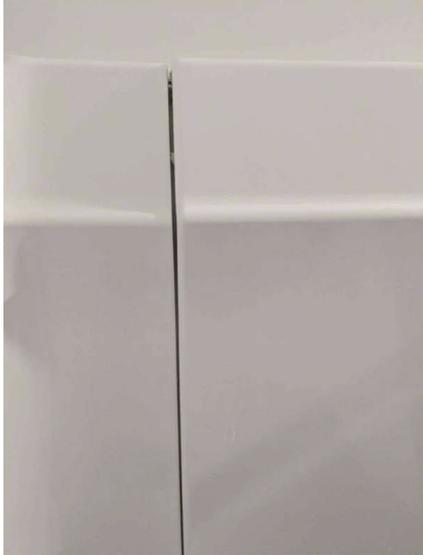
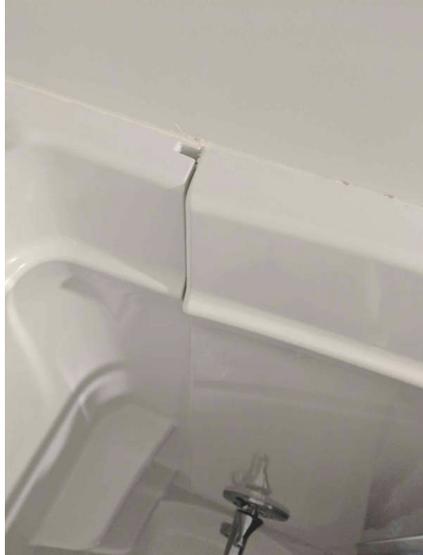
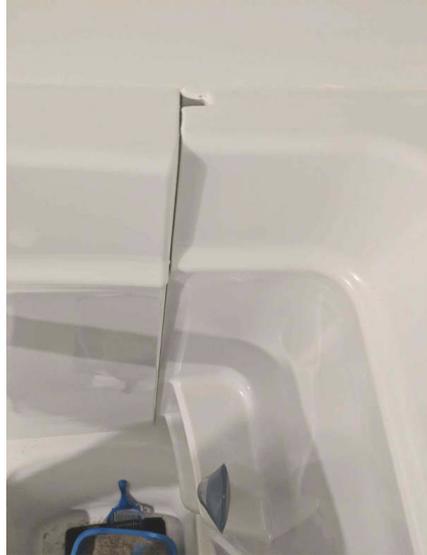
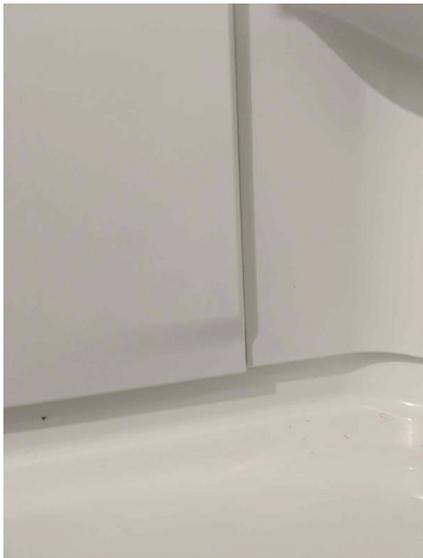
15.4.2 Bathroom #4

The shower insert appeared to not be joined correctly and/ or sealed. Recommend relaying the area to the builder.

Contact a qualified professional.

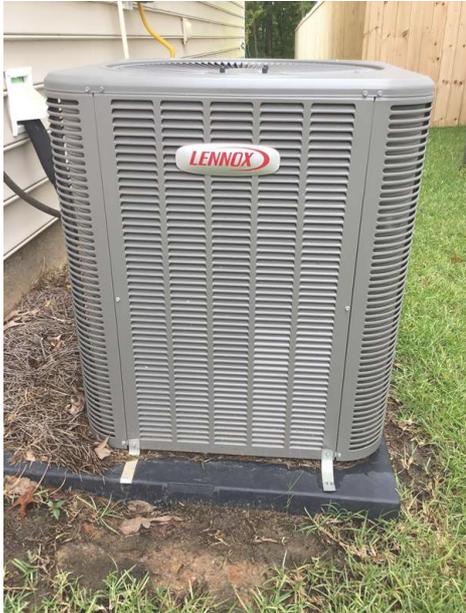
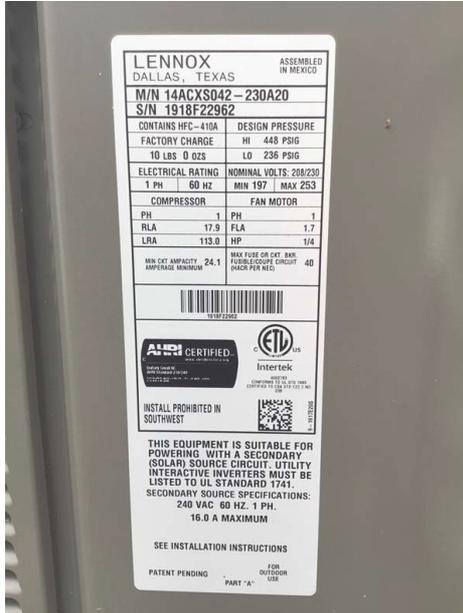
Lennox

The outside condensing unit worked as expected.

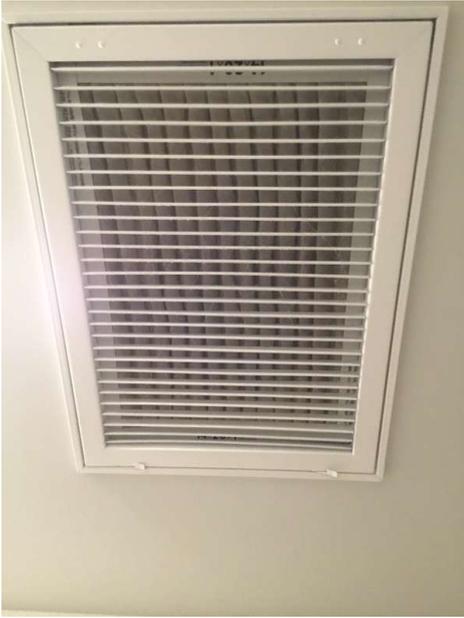
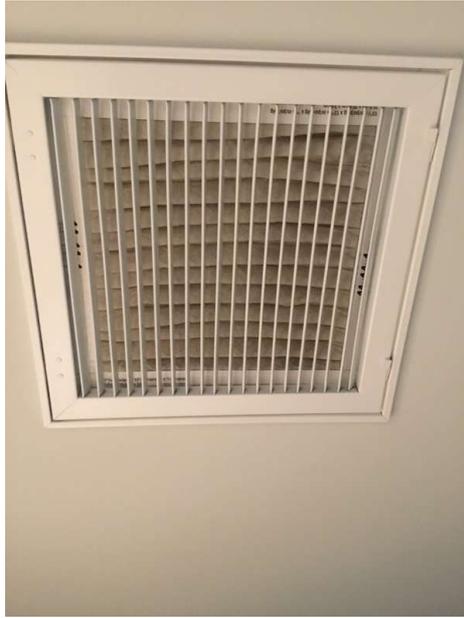
**Filter: Type**

Dirty, Disposable

Recommend replacing the filter/s/ every month, or per manufacturers cleaning recommendations.

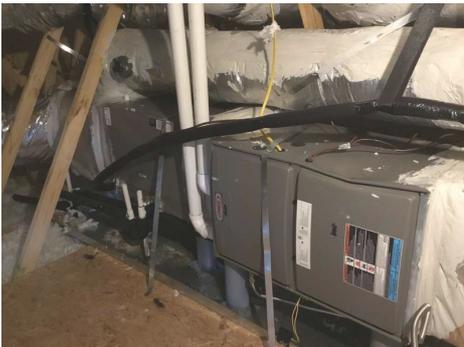
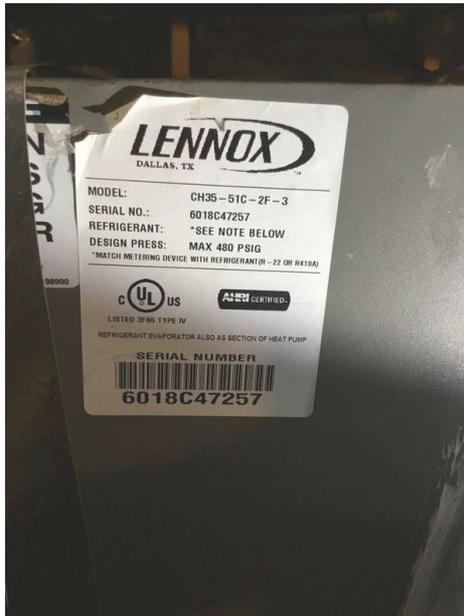
**Heating Equipment: Brand**

Lennox

The air handler worked as expected.

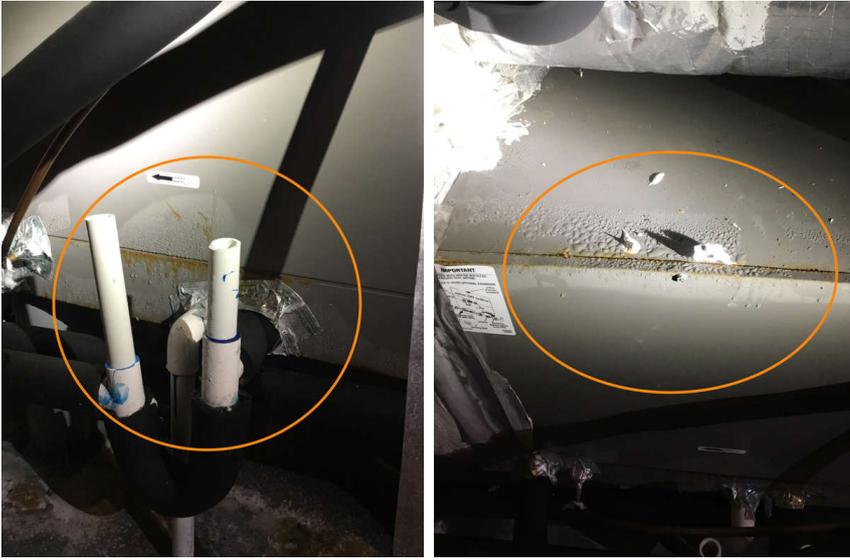
17.3.1 HVAC- Heating Ventilation and Cooling - Heating Equipment: Condensation/Rust
-

**CONDENSATION/RUST**

Observed condensation to the exterior portion of the air handler. Recommend having a qualified professional (HVAC technician) to conduct yearly maintenance.

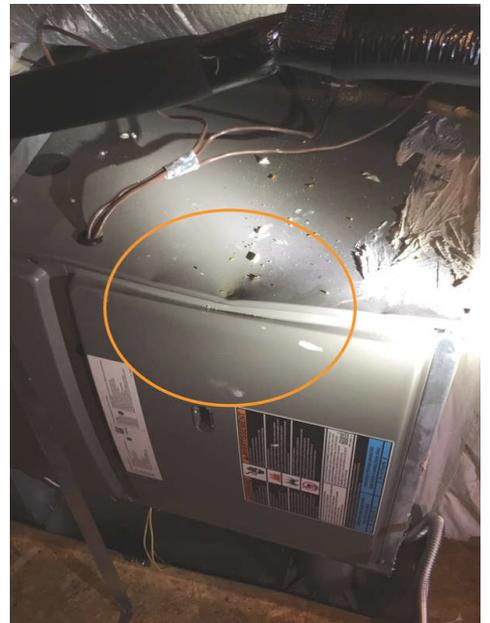
## 17.3.2 Heating Equipment

17.3.2 HVAC- Heating Ventilation and Cooling - Heating Equipment: Air handler damage

**AIR HANDLER  
DAMAGE**

Observed a large dent on top of air handler. Unknown when or how this damage occurred. Recommend having a qualified professional further evaluate.

Contact a qualified professional.

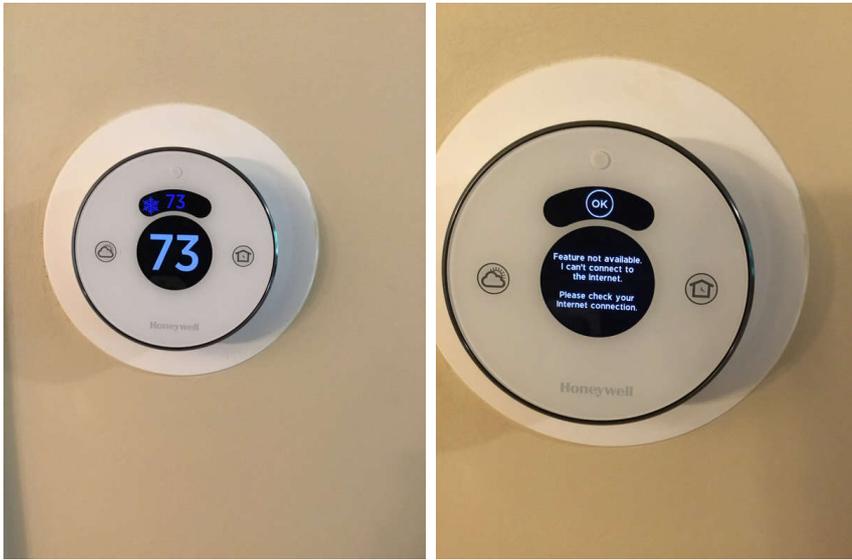
## 17.4.1 Thermostat

Observed the downstairs thermostat to show no -connectivity to the WiFi system. This issue is a known issue from the client. Recommend having the thermostat connectivity issue brought forth to the builder for warranty information.

Contact a qualified professional.

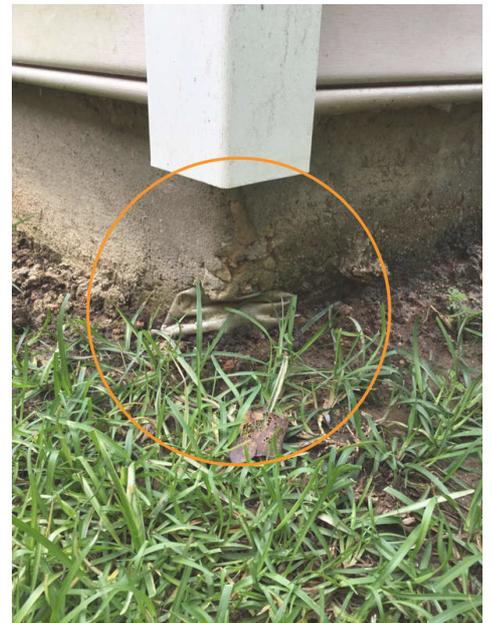
19.1.1 Foundation

19.1.1 Foundation, Crawlspace, Basement & Structure - Foundation: Moisture Barrier Visible

### MOISTURE BARRIER VISIBLE

Moisture barrier is visible where the foundation meets the ground. Recommend presenting the defect to the builder to inquire about repairs.

Contact a qualified professional.
