ISLAND INSPECTIONS- LLC

1234 Main St.
Pawleys Island, SC 29585

08/18/2019 9:00AM

1: INSPECTION DETAILS

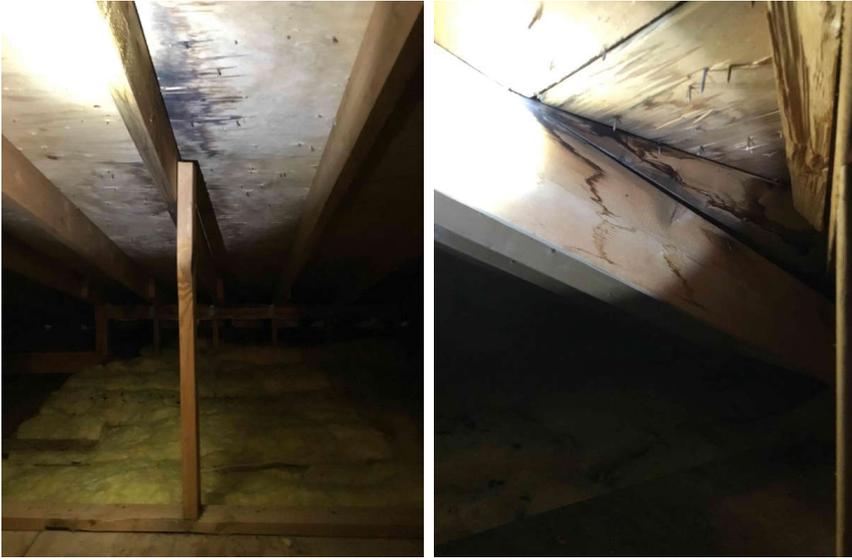
PRIOR ROOF STAINING

Observed prior moisture staining to the roof sheathing from within the attic. No signs of new or active moisture intrusion were observed.

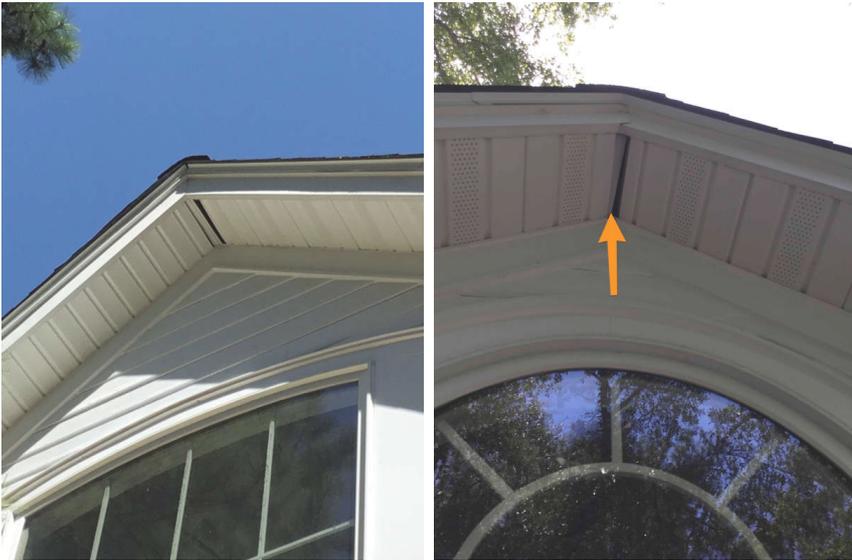
2.6.1 Eaves, Soffits & Fascia

SOFFIT DAMAGE

Observed one or more areas to show signs of loose/ damaged/ missing soffit. Recommend having a qualified professional, handyman or DIY to repair.

Contact a qualified professional.

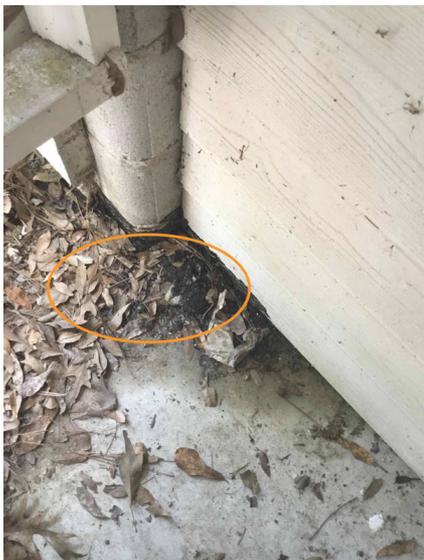
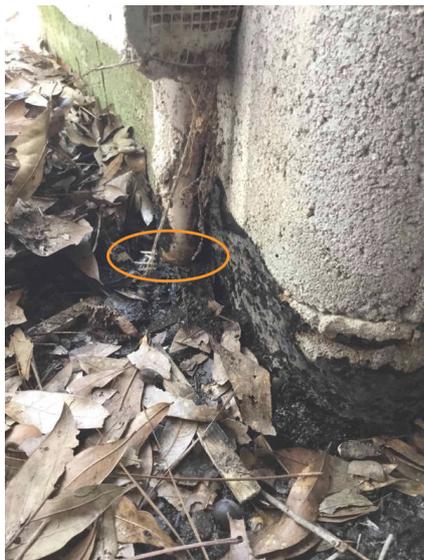
Siding showed signs of water intrusion. This could lead to further siding deterioration and/or mold. Recommend a qualified siding contractor evaluate and repair. The pictures below show the condensate line draining to the front left side of the property. Recommend diverting the condensate line further away from the exterior to prevent the moisture intrusion to the garage shop area.

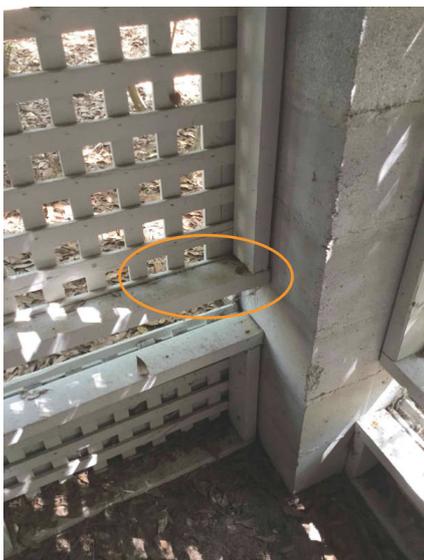
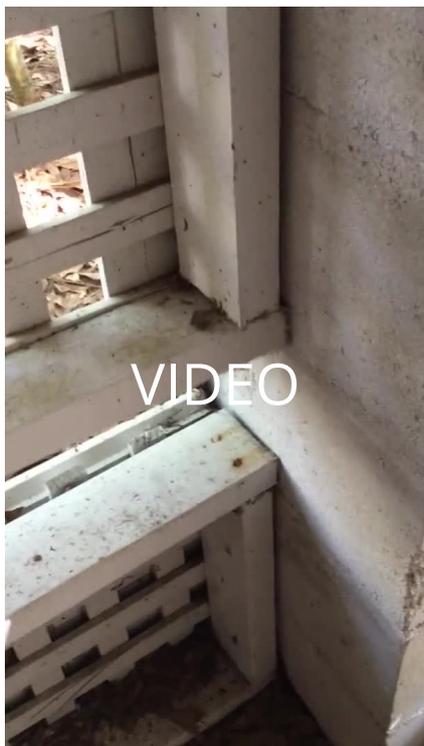
3.1.2 Siding, Flashing & Trim

DAMAGED/ LOOSE SIDING AND/OR TRIM

Observed one or more areas to show signs of damaged/ loose siding and/or trim. Recommend having a qualified professional repair. The areas in question are the lattice trim pieces to the front of the property.

Contact a qualified professional.

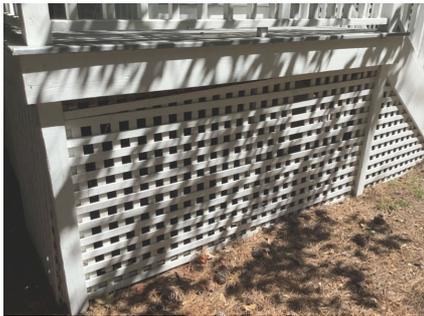
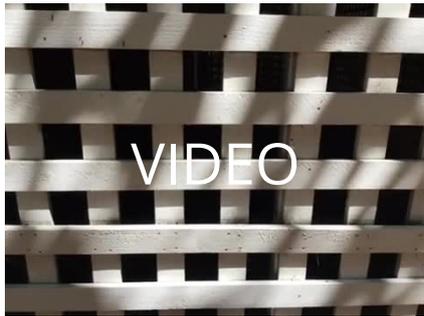
Observed one or more areas of lattice trim damage. Recommend handyman or DIY to repair.

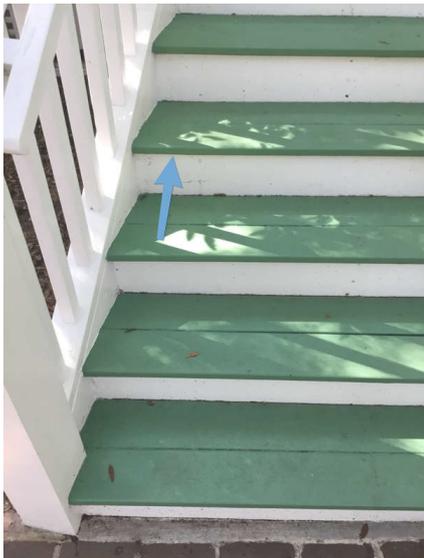
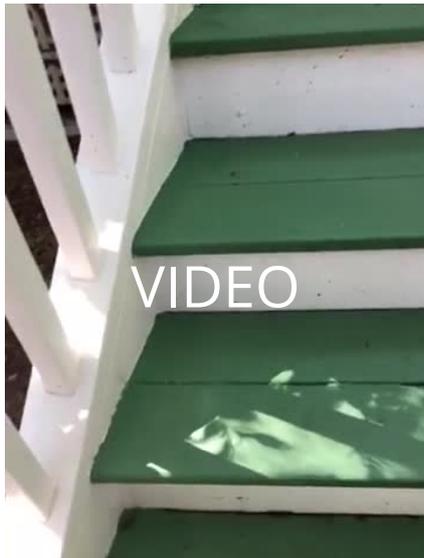
DECK STEPS- LOOSE BOARD/S/

Observed one or more areas to show loose boards. Recommend securing the boards.

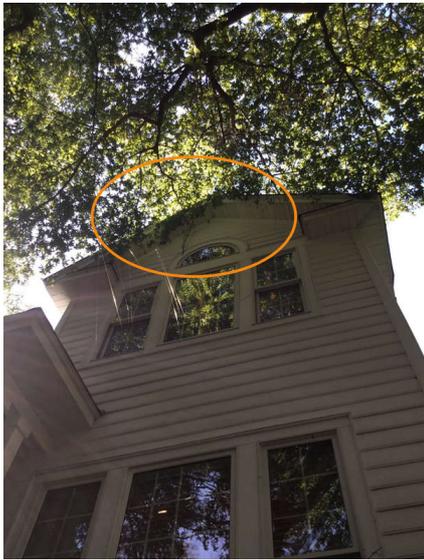
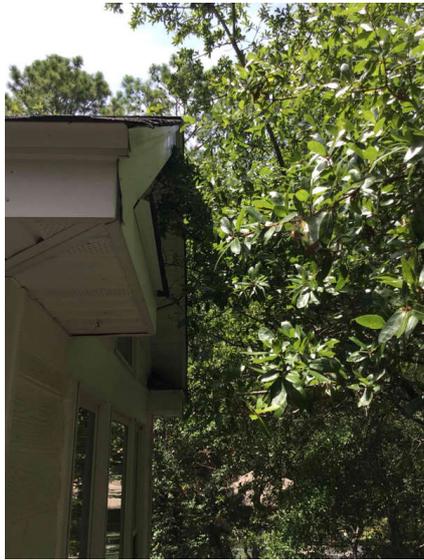
3.5.1 Vegetation, Grading, Drainage & Retaining Walls

TREE OVERHANG

Trees observed overhanging the roof. This can cause damage to the roof and prevent proper drainage. Recommend a qualified tree service trim to allow for proper drainage.

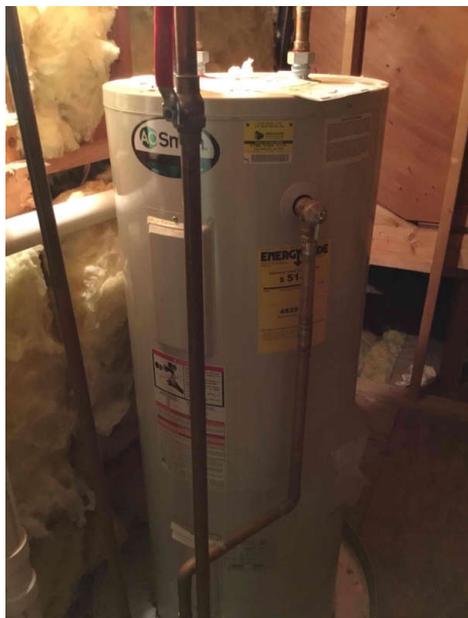
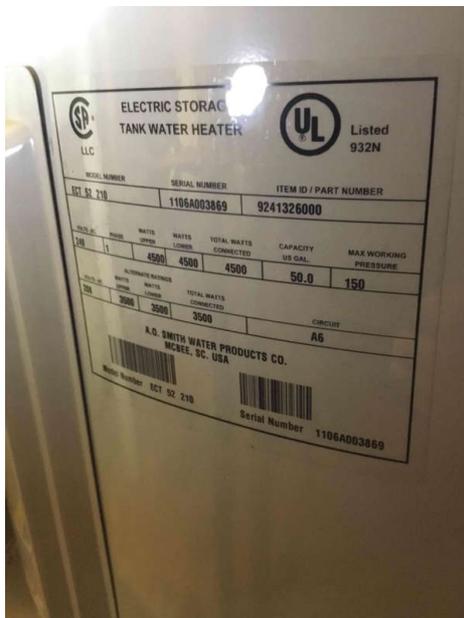
The water heater worked as expected. We recommend flushing & servicing your water heater tank annually for optimal performance. Water temperature should be set to at least 120 degrees F to kill microbes and no higher than 130 degrees F to prevent scalding.

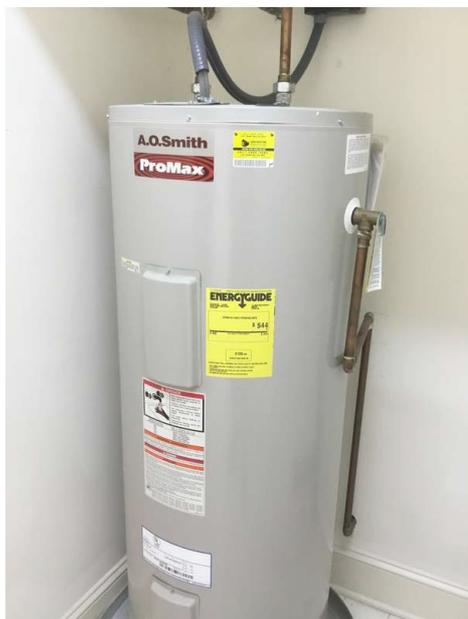
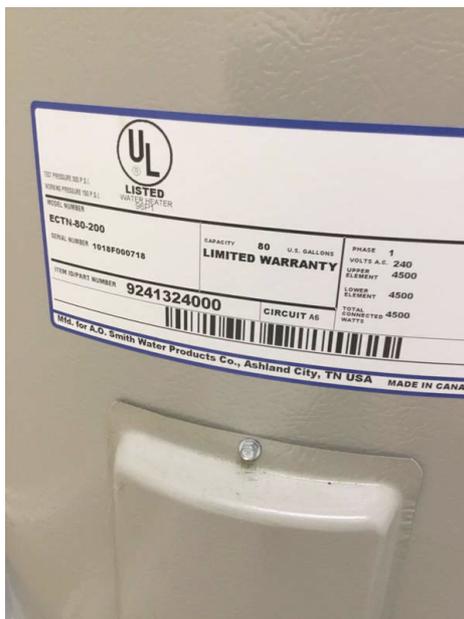
The water heater worked as expected. We recommend flushing & servicing your water heater tank annually for optimal performance. Water temperature should be set to at least 120 degrees F to kill microbes and no higher than 130 degrees F to prevent scalding.

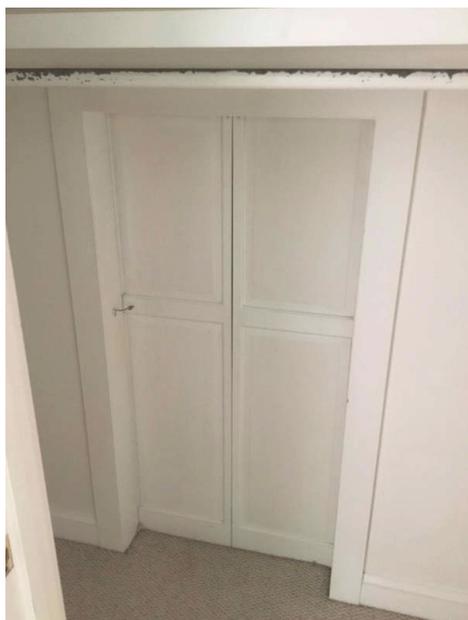
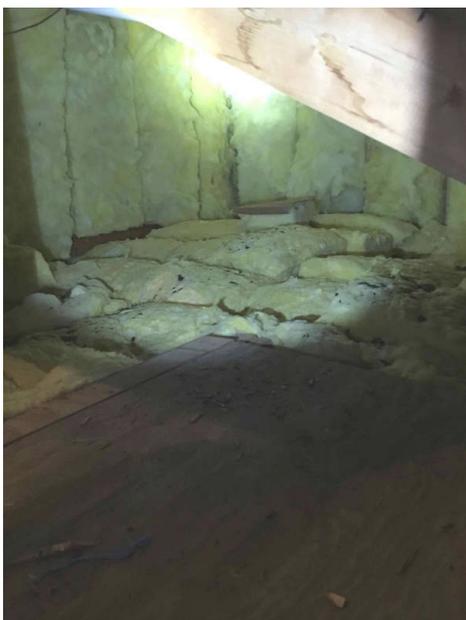
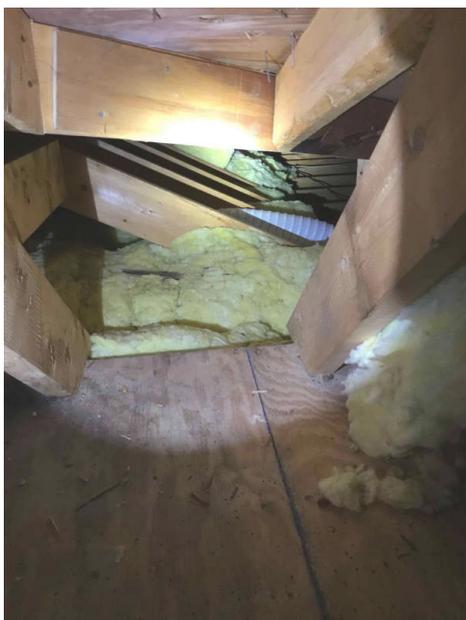
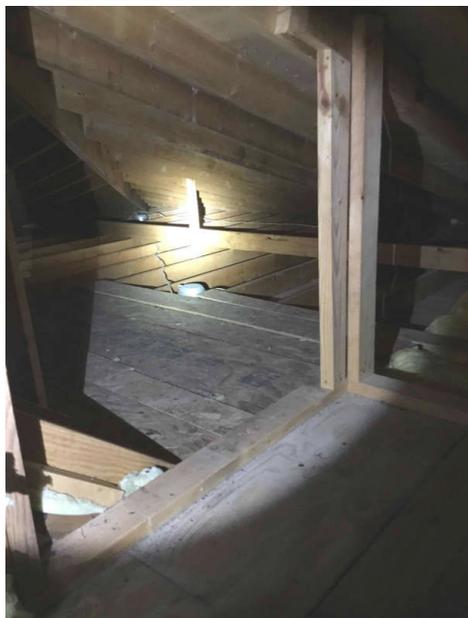
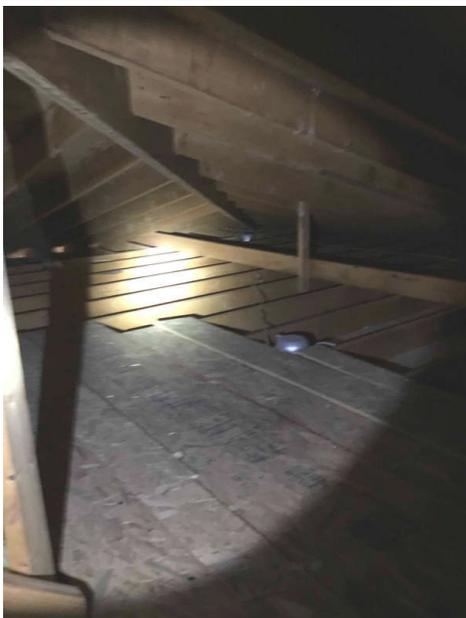
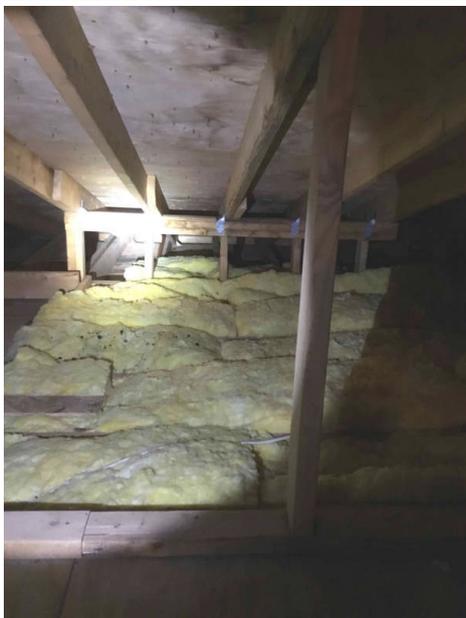
Attic Access/es/ Views: Attic Entry

Closet, Hallway, Pull-down stairs

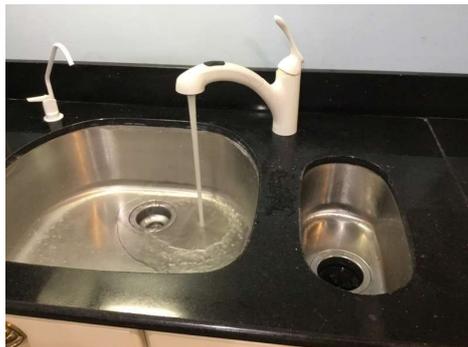
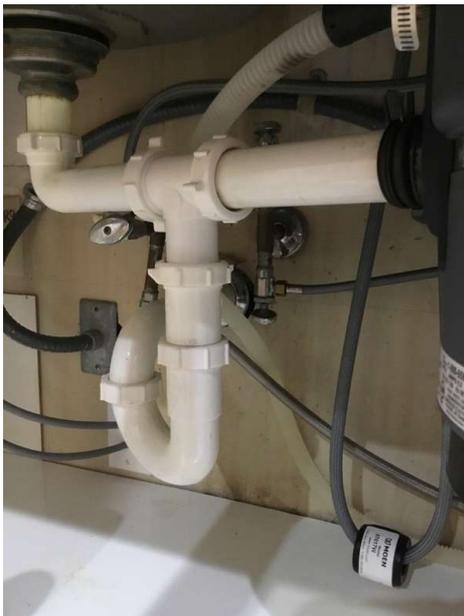
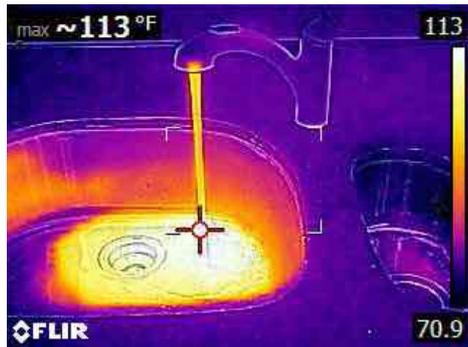
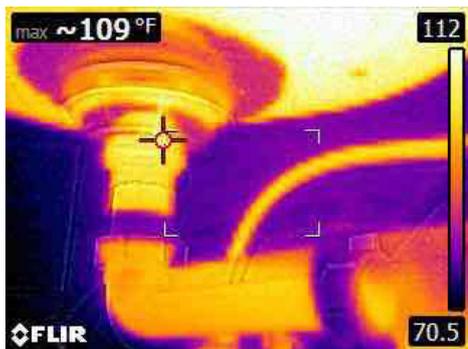
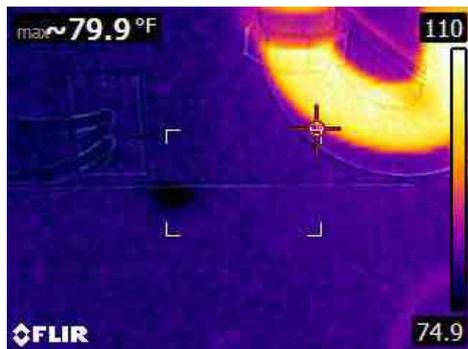
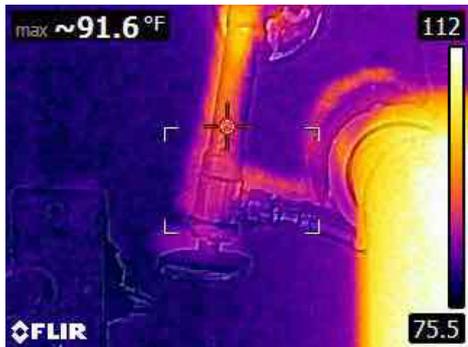
The sink worked as expected. No signs of leaks were observed around the faucet or plumbing. Thermal imaging revealed no concerning temperature variances.

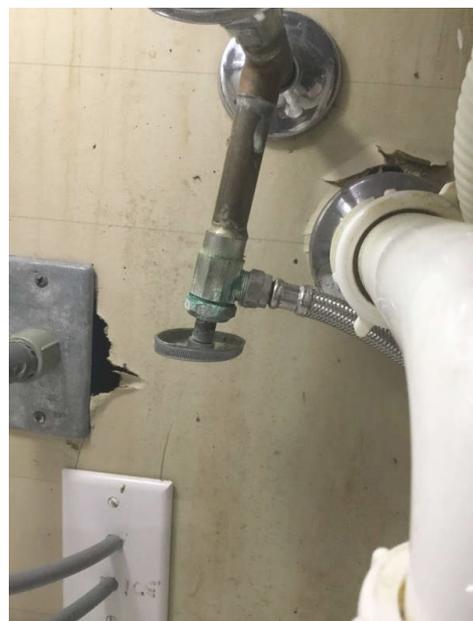
Observed the sink to have an active drip. Recommend having a qualified professional/ handyman/ DIY repair.

Contact a handyman or DIY project

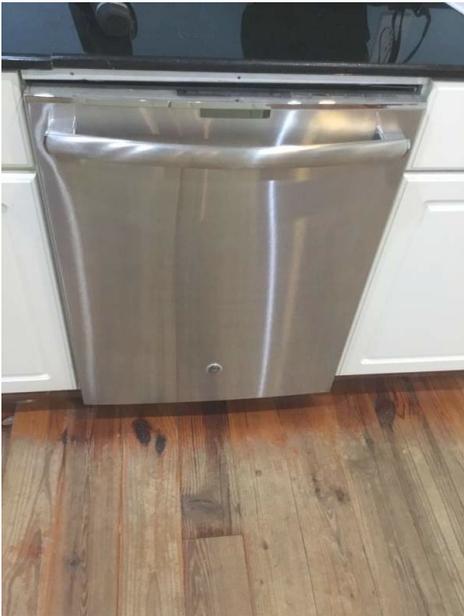
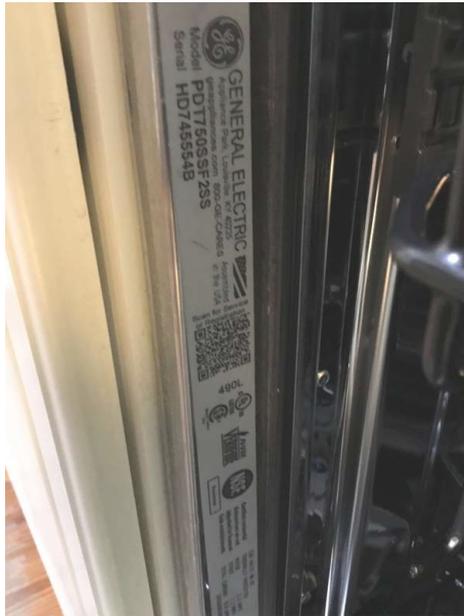
The dishwasher was operated with normal operating controls and ran through a cycle to inspect for leaks. No signs of leaks were observed below the dishwasher.

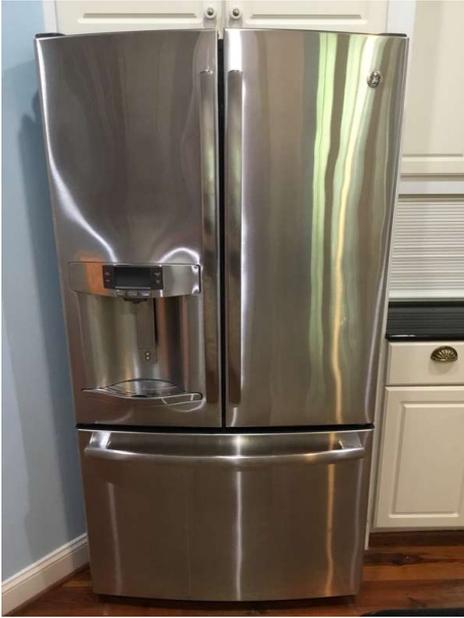
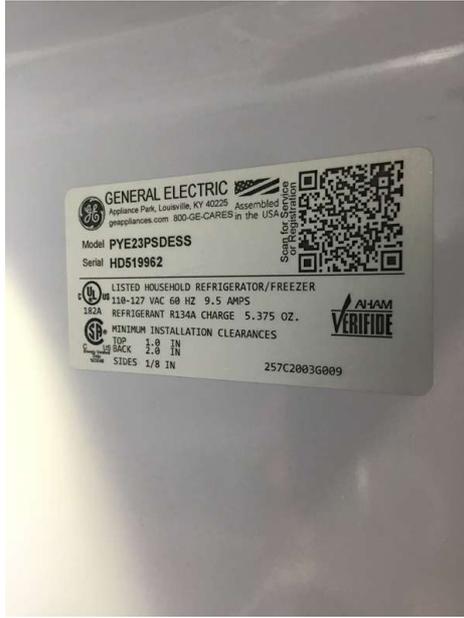
The refrigerator was working as expected. Unknown if its conditional with the house.

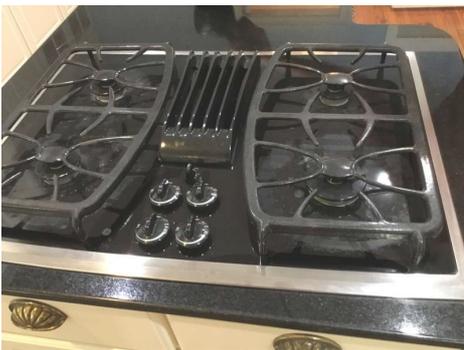
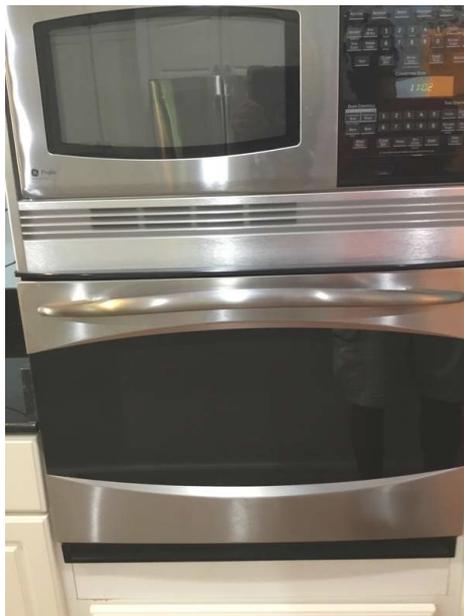
The cooktop & oven were operated utilizing normal operating controls. The unit worked as expected. No defects were observed unless otherwise noted in the report.

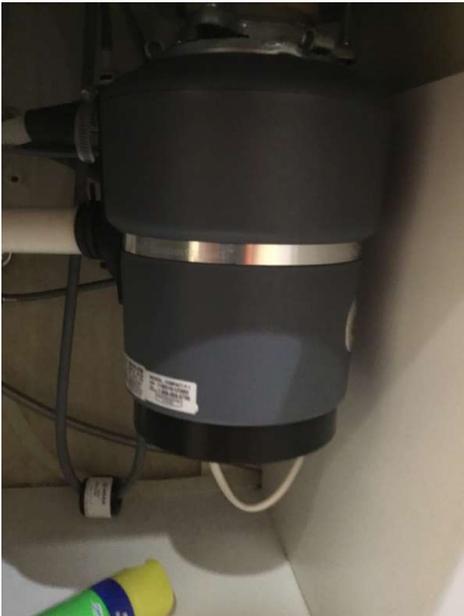
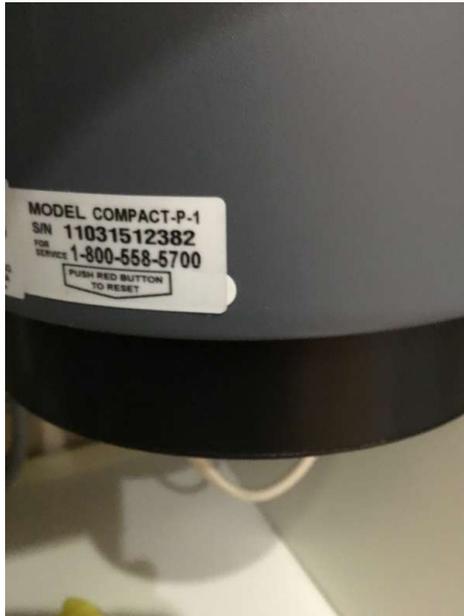
The disposal was tested utilizing normal operating controls. The disposal functioned as expected. The efficiency of how well the unit performs is beyond the scope.

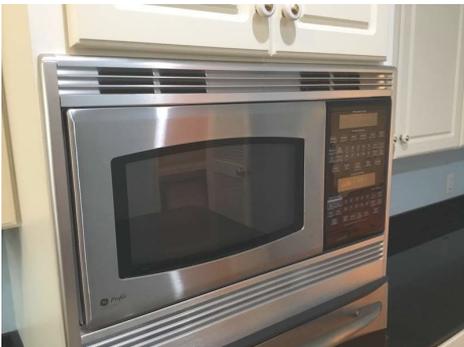
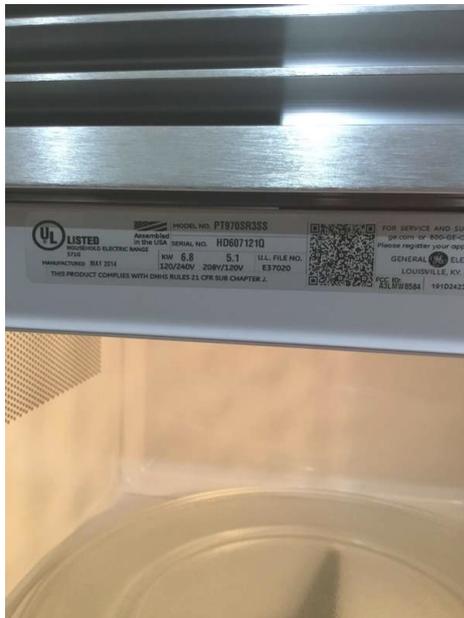
The microwave was tested utilizing normal operating controls. The microwave functioned as expected. The efficiency of how well the unit performs is beyond the scope.

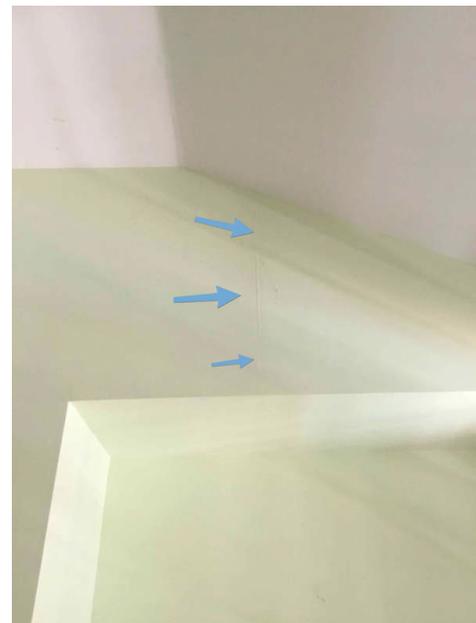
9.3.1 Walls

MINOR- CRACKING SHEETROCK JOINT

Observed one or more areas to show signs of Sheetrock joint damage. Recommend having a qualified professional repair.

Contact a qualified professional.

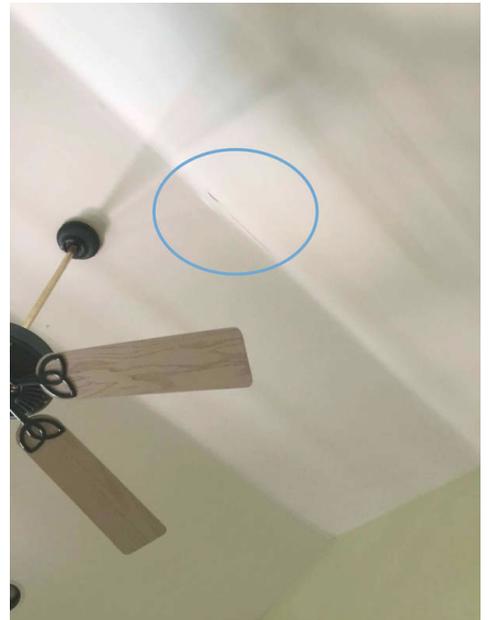
9.4.1 Ceilings

MINOR- JOINT DAMAGE

Observed peeling joint tape. Thermal imaging revealed no concerning temperature variances. Recommend having a qualified professional or handyman repair the joint tape.

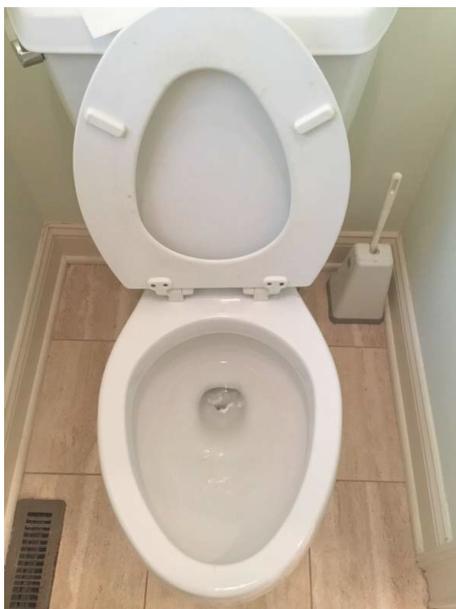
The vent fan worked as expected.

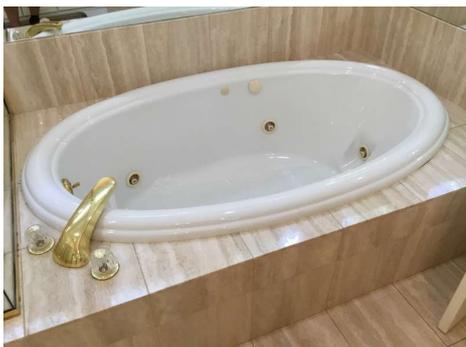
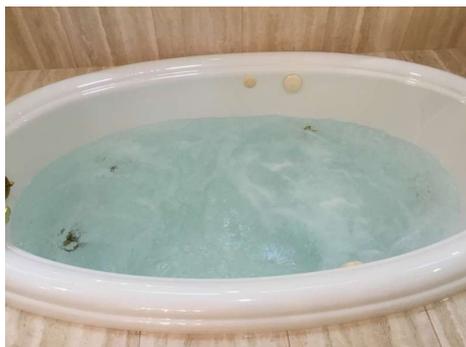
Bathroom #1: Bath tub & tub surrounding

Recirculating

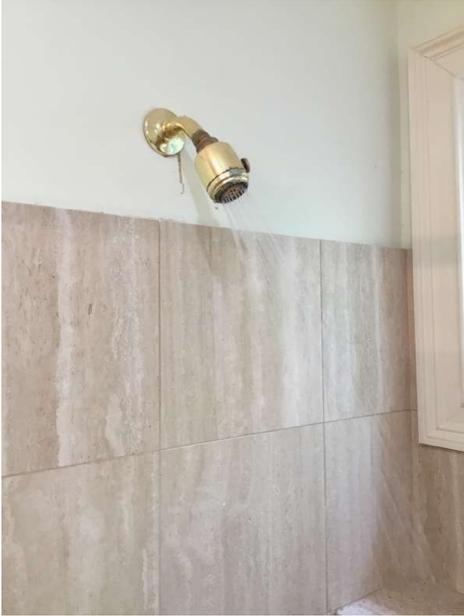
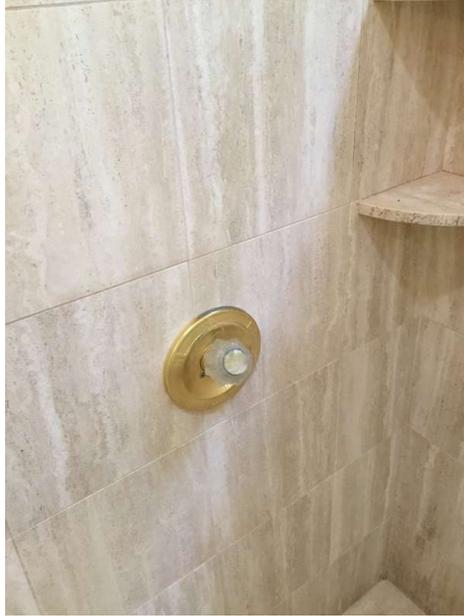
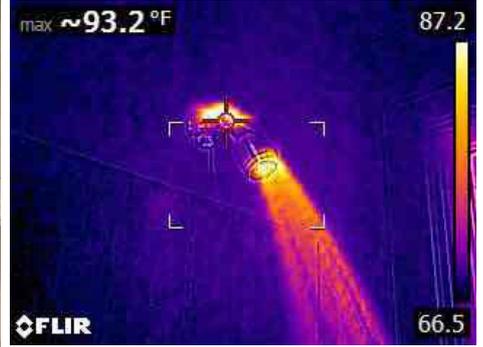
Bathroom #1: Shower

Tile, Stall

The shower was tested with normal operating controls. No signs of leaks were observed around the faucet and handle/s/. No reportable conditions were observed at the time of inspection unless otherwise noted in this report.

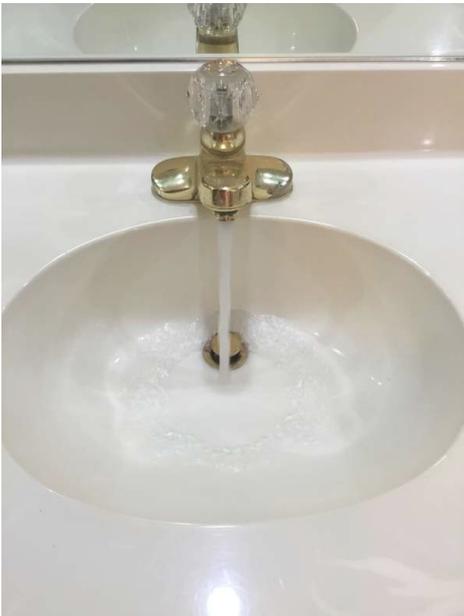
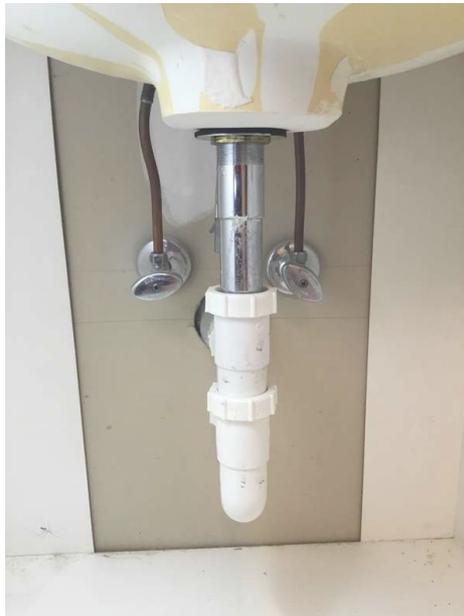
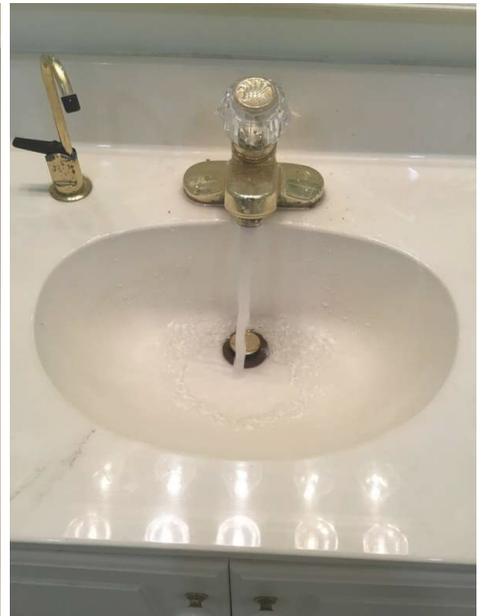
Bathroom #1: Sink(s)

Double Vanity

The sink worked as expected. No signs of leaks around plumbing connections. Thermal imaging revealed no concerning temperature variances.

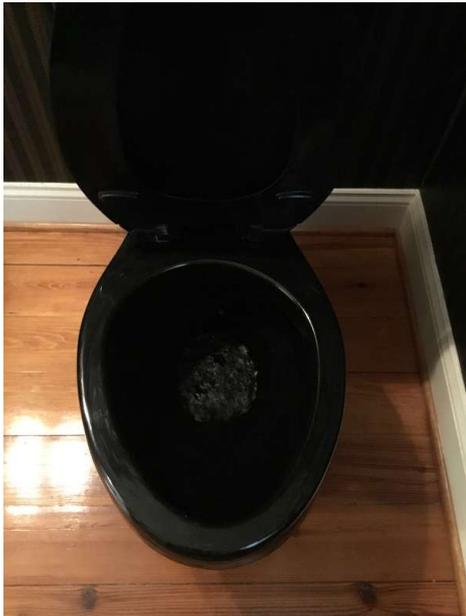
Bathroom #2: Toilet

Standard Tank

The toilet was flushed three times. The toilet was securely attached to the floor and no signs of leaks were observed. Thermal imaging revealed no concerning temperature variances.

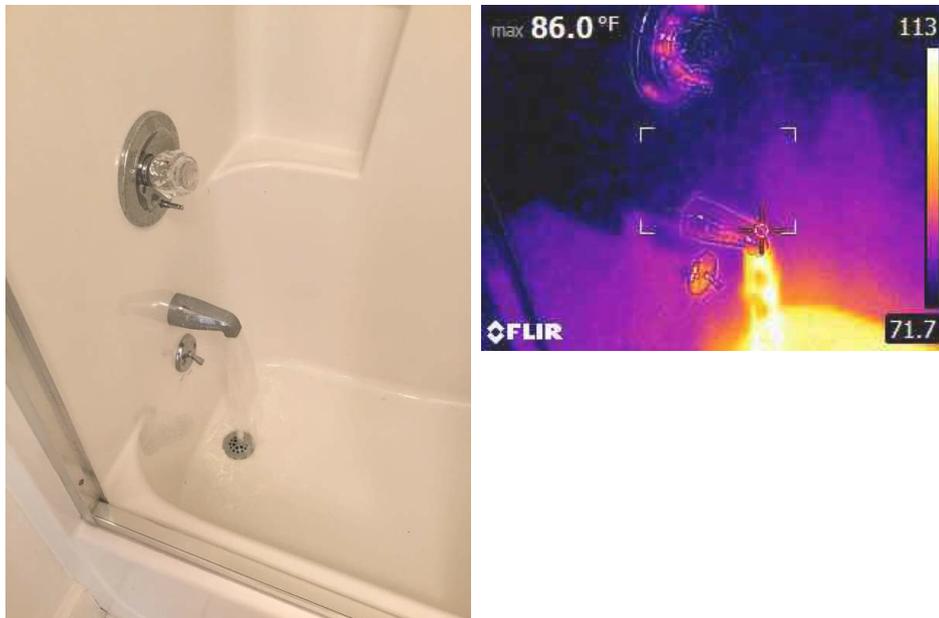
Recessed, Fiberglass

The bathtub was tested with normal operating controls. No signs of leaks were observed around the faucet and handle/s/. No reportable conditions were observed at the time of inspection unless otherwise noted in this report.

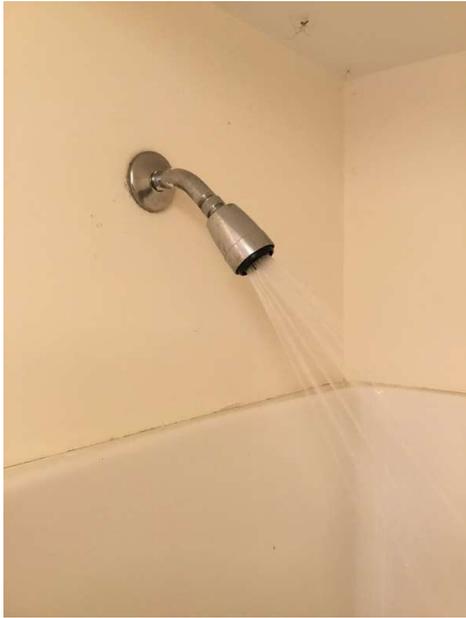
Bathroom #3: Shower

In Tub

The shower was tested with normal operating controls. No signs of leaks were observed around the faucet and handle/s/. No reportable conditions were observed at the time of inspection unless otherwise noted in this report.

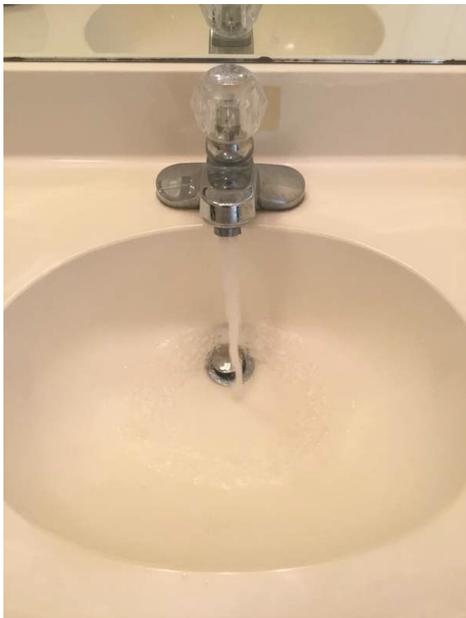
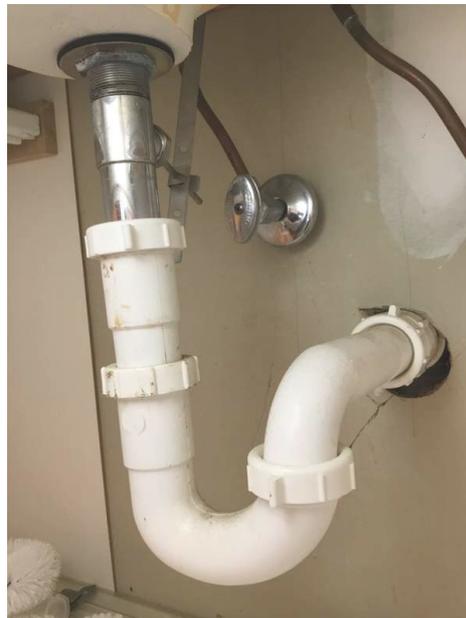
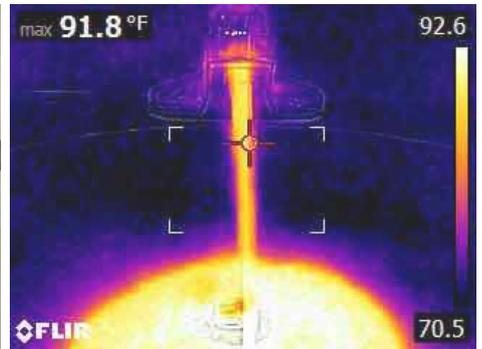
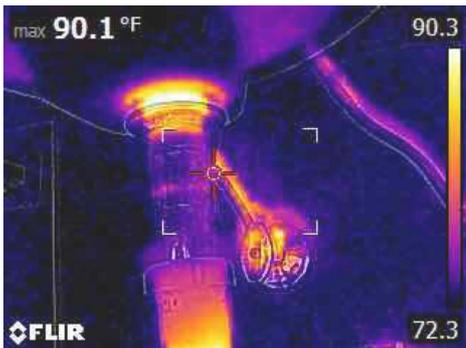
Bathroom #3: Sink(s)

Single Vanity

The faucet worked as expected. No signs of leaks were observed around the faucet or plumbing.

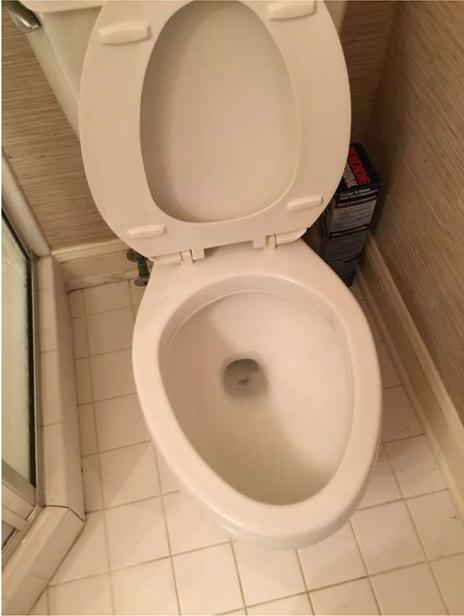
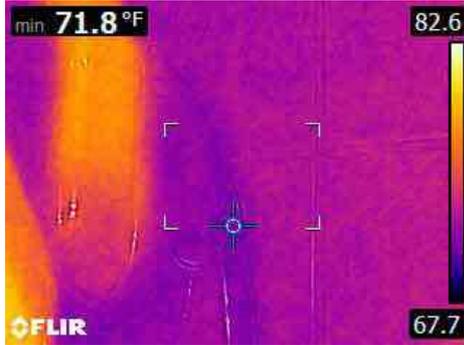
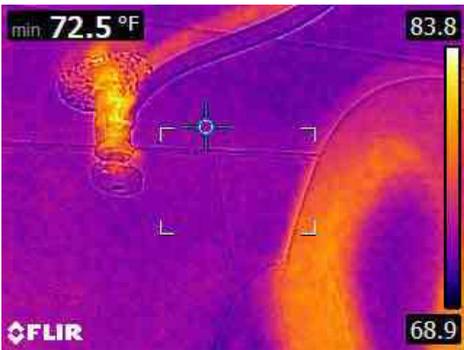
Bathroom #4: Toilet

Standard Tank

The toilet was flushed (3) times prior to utilizing thermal imaging. The toilet worked as expected. The toilet was securely attached to the floor. Thermal imaging revealed no concerning temperature variances.

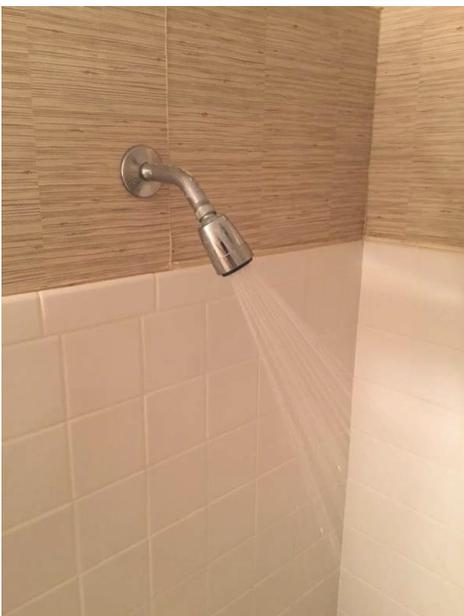
Bathroom #4: Shower

Stall, Tile

The shower was tested with normal operating controls. No signs of leaks were observed around the faucet and handle/s/. No reportable conditions were observed at the time of inspection unless otherwise noted in this report.

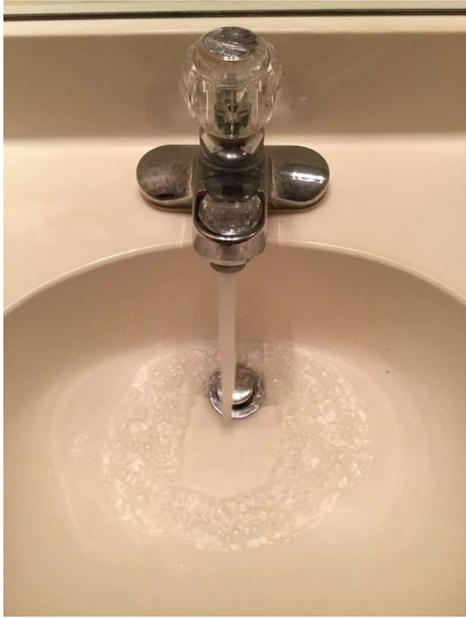
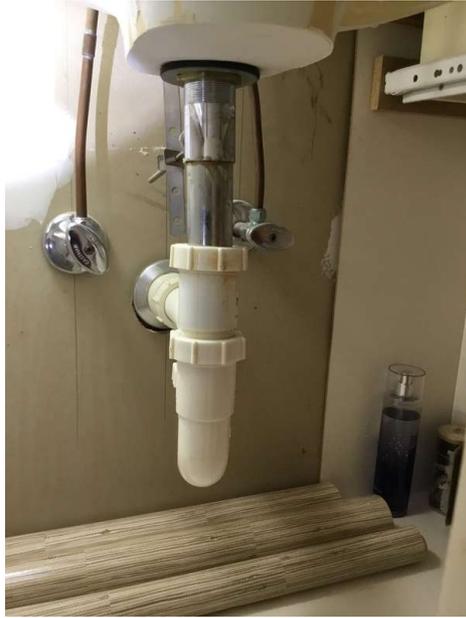
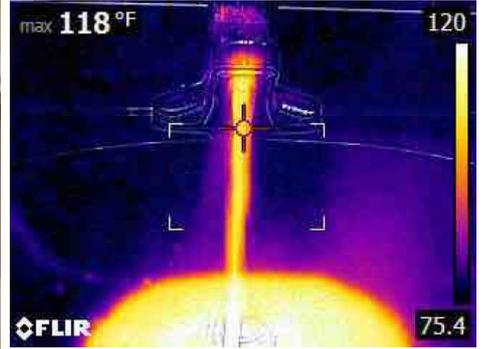
Bathroom #4: Sink(s)

Single Vanity

The faucet worked as expected. No signs of leaks were observed around the faucet or plumbing.

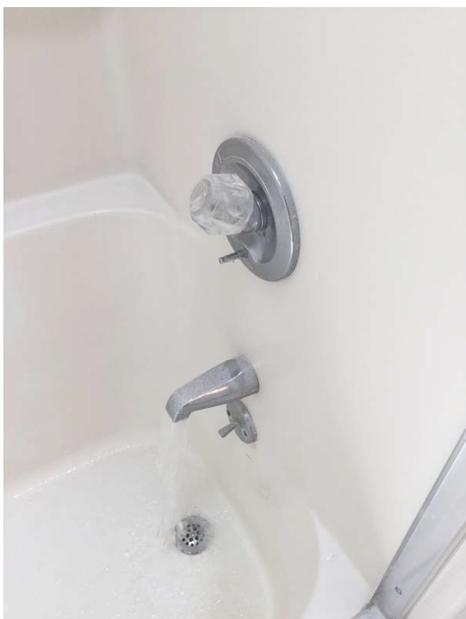
Bathroom #5: Bath tub & tub surrounding

Recessed

The bathtub was tested with normal operating controls. No signs of leaks were observed around the faucet and handle/s/. No reportable conditions were observed at the time of inspection unless otherwise noted in this report.

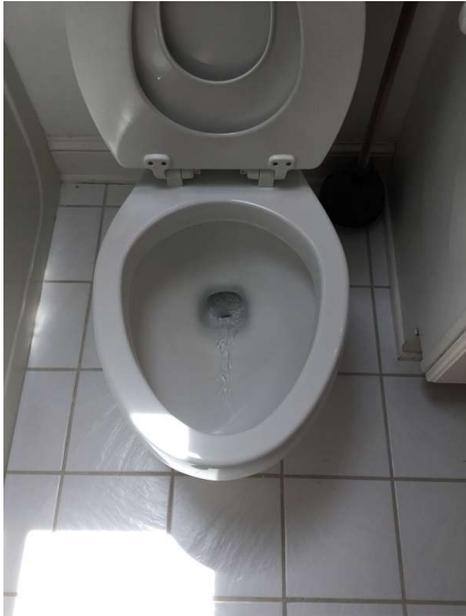
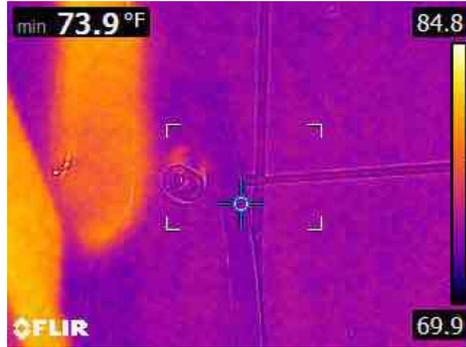
Bathroom #5: Toilet

Standard Tank

The toilet was flushed (3) times prior to utilizing thermal imaging. The toilet worked as expected. The toilet was securely attached to the floor. Thermal imaging revealed no concerning temperature variances.

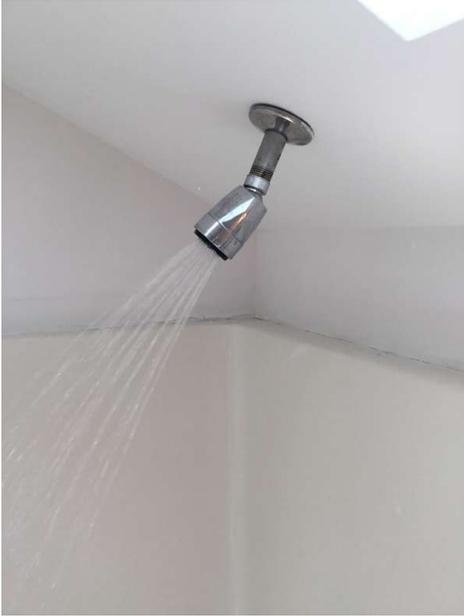
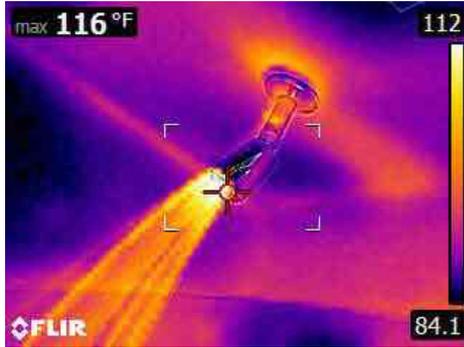
Bathroom #5: Shower

In Tub, Fiberglass

The shower was tested with normal operating controls. No signs of leaks were observed around the faucet and handle/s/. No reportable conditions were observed at the time of inspection unless otherwise noted in this report.

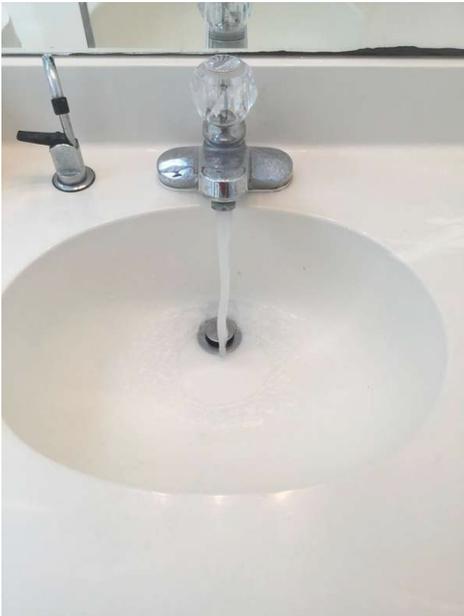
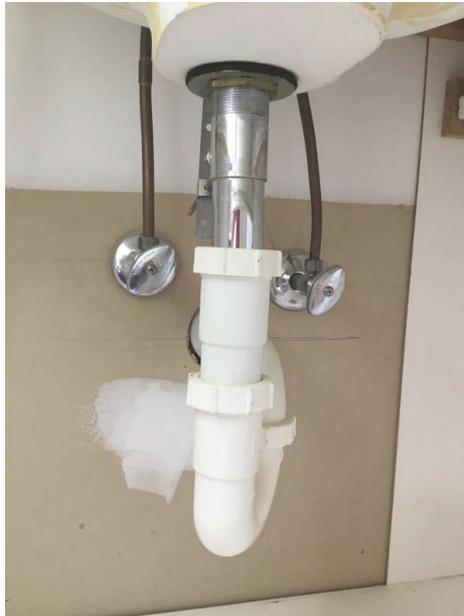
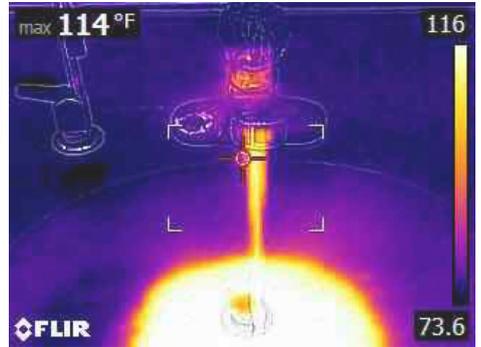
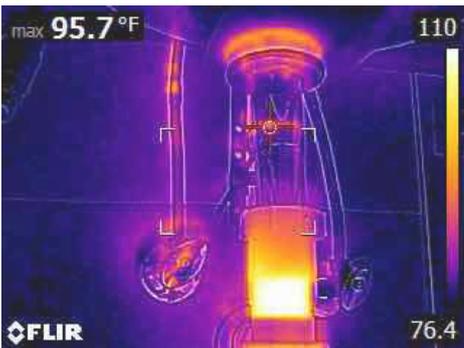
Bathroom #5: Sink(s)

Single Vanity

The faucet worked as expected. No signs of leaks were observed around the faucet or plumbing.

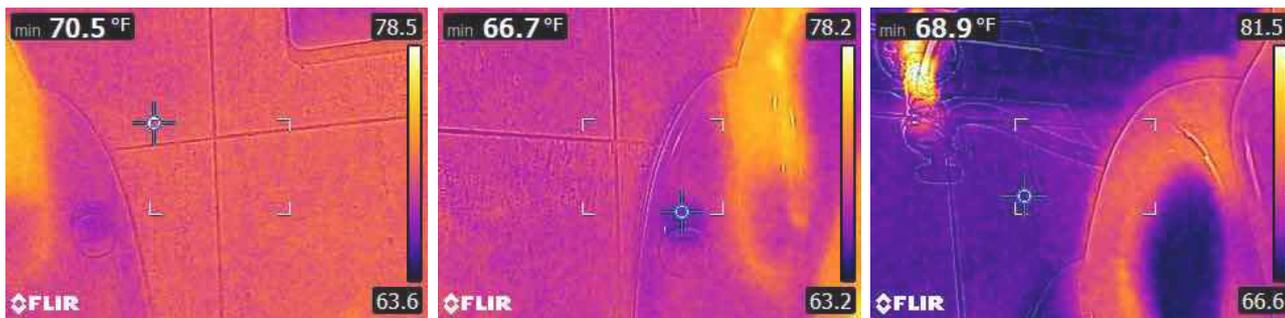
15.1.1 Bathroom #1

LOOSE

The toilet base was loose. Recommend tightening to prevent damage to the wax ring. The toilet was flushed (3) times prior to utilizing thermal imaging. Toilet functioned as expected. Thermal imaging revealed no concerning temperature variances around the base and water connections.

Contact a qualified professional.

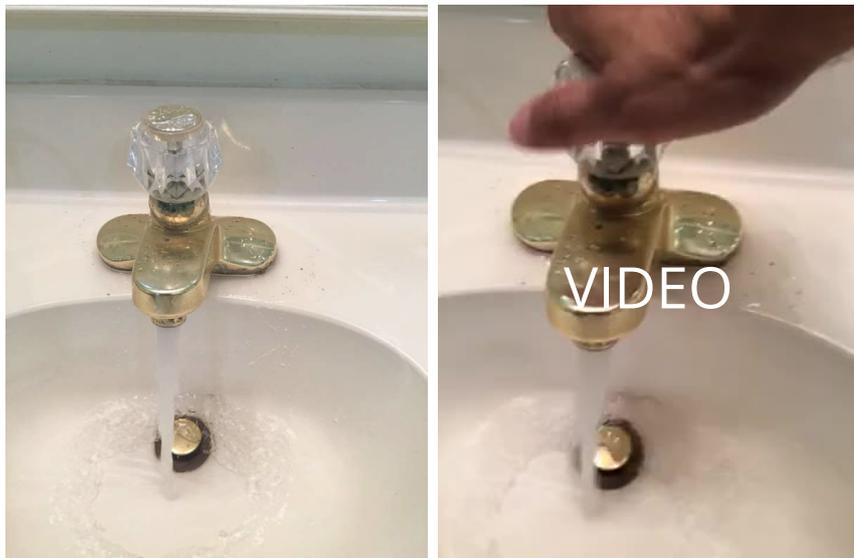
15.1.2 Bathroom #1

FAUCET- LEAK

Observed one or more faucets to leak. Recommend having a qualified professional repair.

Contact a qualified professional.

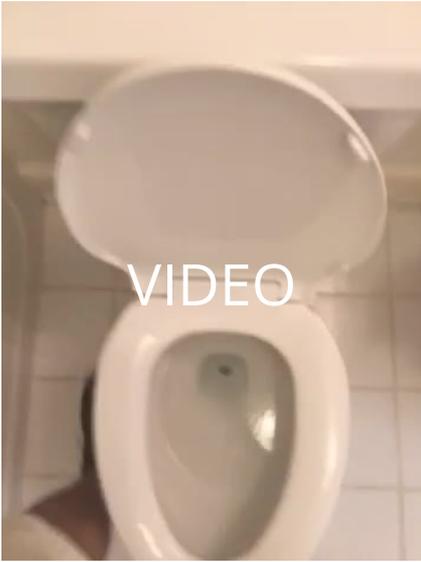
15.3.1 Bathroom #3

LOOSE

The toilet base was loose. Recommend tightening to prevent damage to the wax ring. The toilet was flushed (3) times prior to utilizing thermal imaging. Toilet functioned as expected. Thermal imaging revealed no concerning temperature variances or leaks around the base and water connections.

Contact a qualified professional.

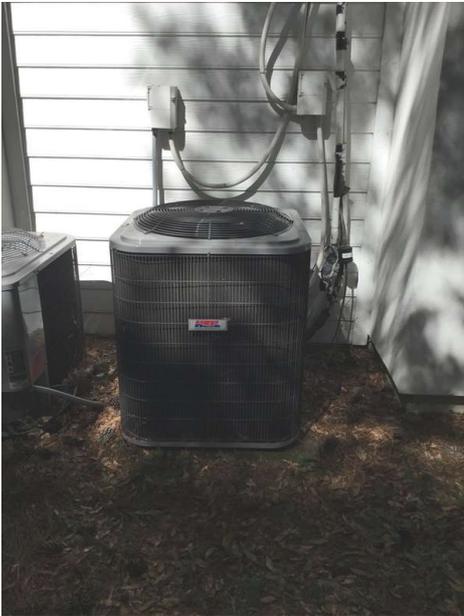
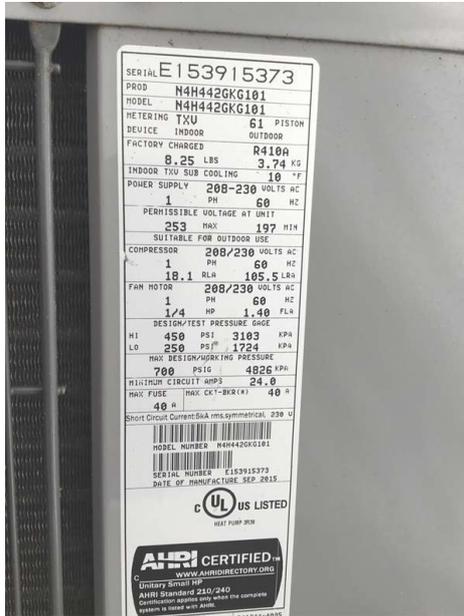
The outside condensing unit worked as expected.

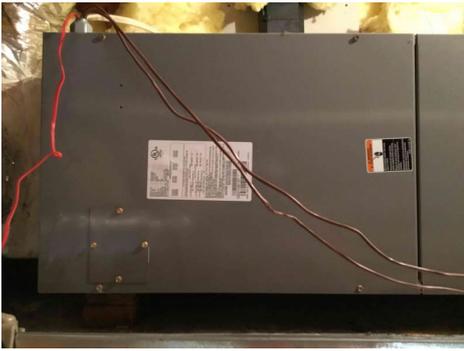
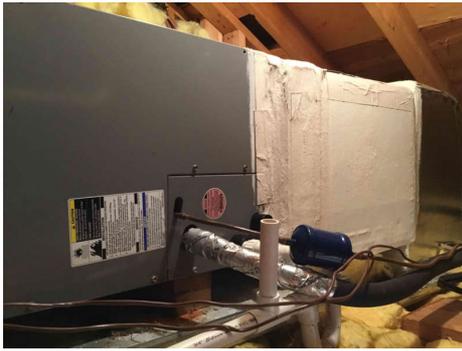
The air handler worked as expected.

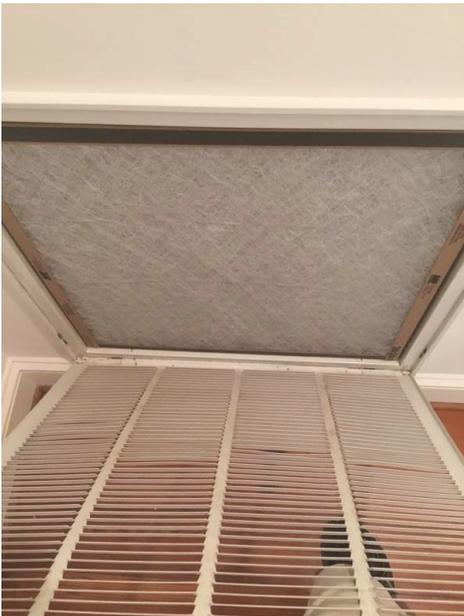
Disposable, Clean

Recommend replacing the filter/s/ every month, or per manufacturers cleaning recommendations.
