ISLAND INSPECTIONS- LLC

1234 Main St.
Pawleys Island, SC 29585

08/18/2019 9:00AM

1: INSPECTION DETAILS

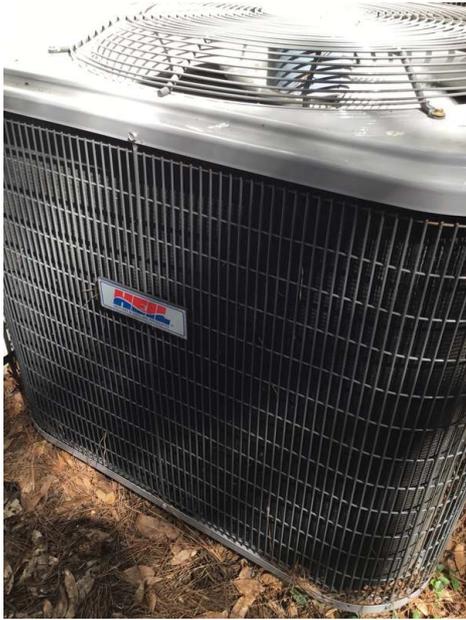
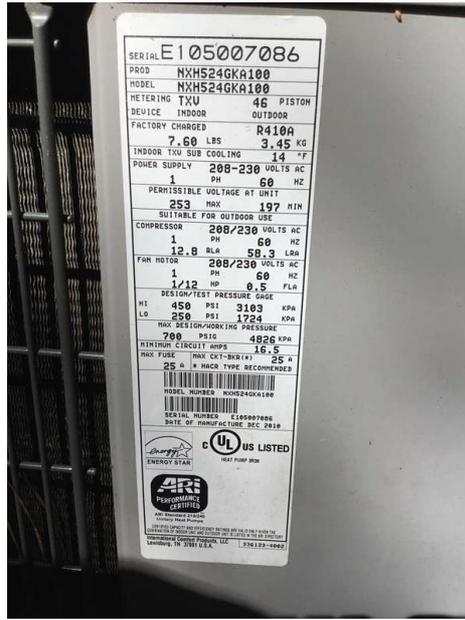
The outside condensing unit worked as expected.

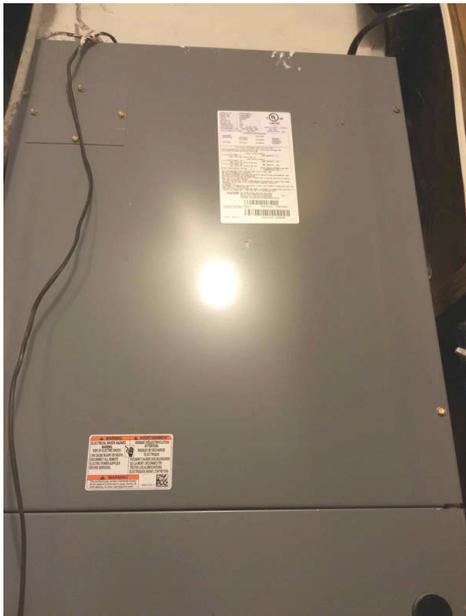
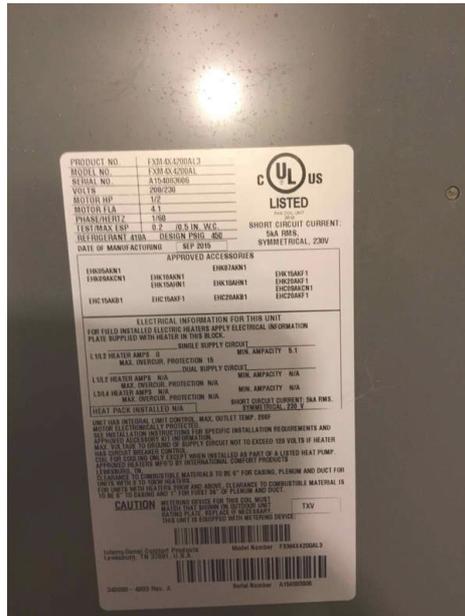
The air handler worked as expected.

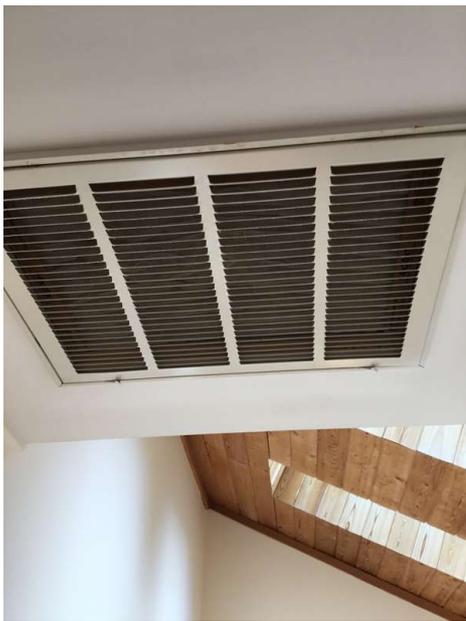
Dirty, Disposable

Recommend replacing the filter/s/ every month, or per manufacturers cleaning recommendations.

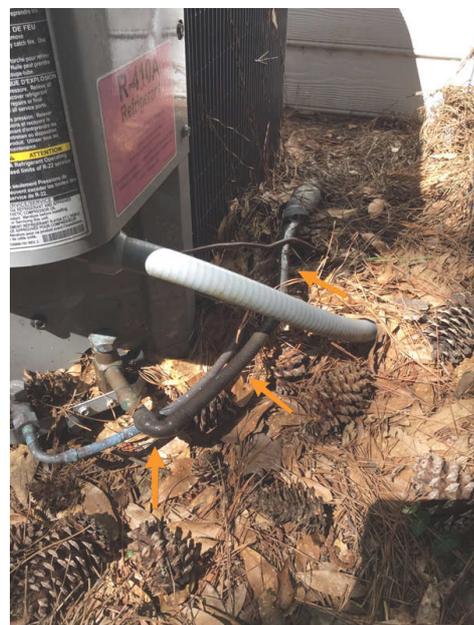
DAMAGED SUCTION LINE INSULATION

Observed the insulation to the suction line to show damage and missing part of the insulation. Recommend replacing the insulation.

Contact a handyman or DIY project

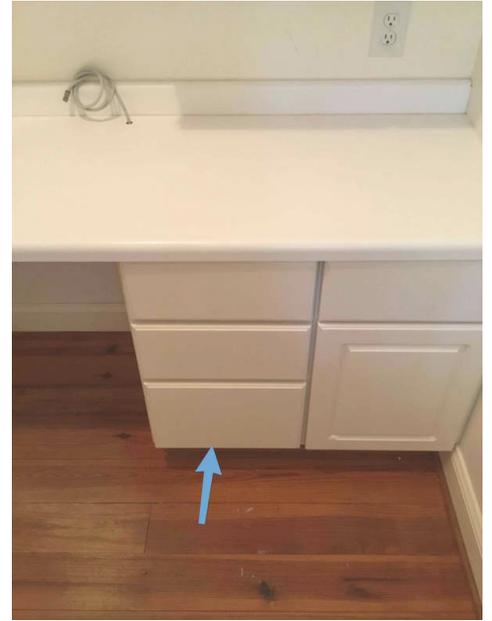
18.1.1 Cabinets

Observed one or more cabinet drawers to show signs of sticking. Recommend DIY, handyman to realign the drawer hinges.

Contact a qualified professional.

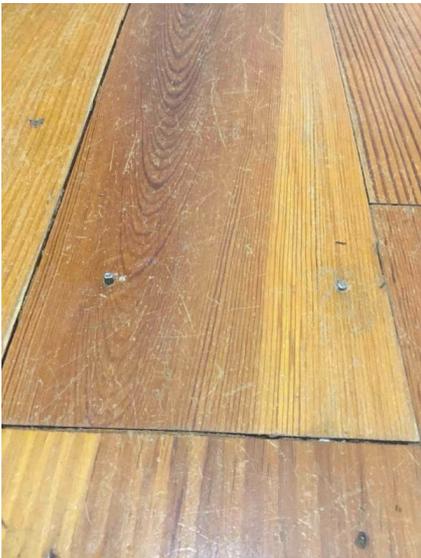
18.3.1 Flooring

MINOR- NAIL POPS

Observed one or more areas to show nails extending past the flooring. Recommend hammering the nails to prevent trip hazard and injury.

Recommended DIY Project
