*EURASIAN WATER MILFOIL MANAGEMENT PLAN
(2018-2020)*

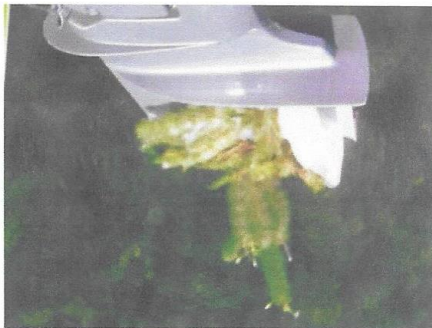
Each leaf of EWM has at least 12 thread-like segments.

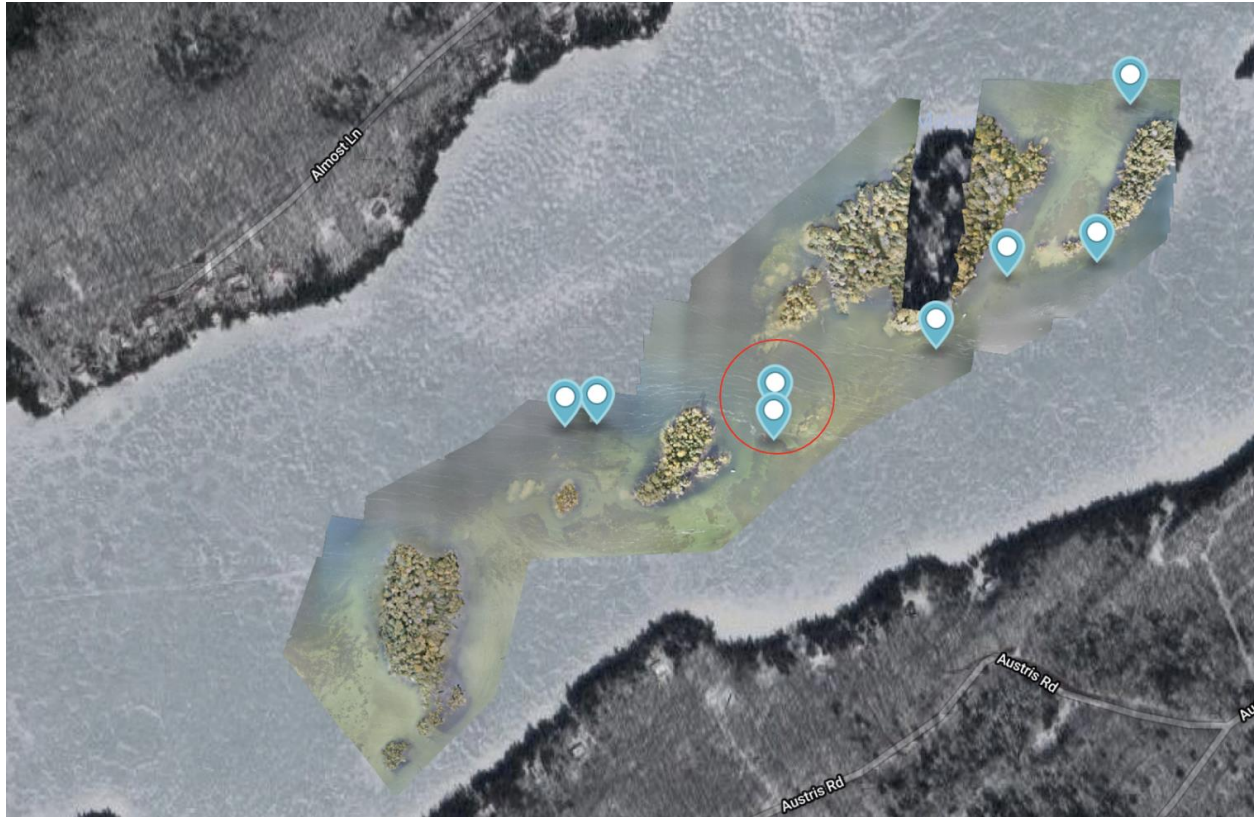
The image below, is the aerial imagery collected of the major patch surrounding the islands on Malcolm Lake. The major patch has an area of 573 m² with medium to low density areas. There are also two smaller dense patches in close vicinity to the major patch. For a more in-depth look at the other less prominent patches found on the island flight as well as the multiple other flights refer to [ArcGIS map](#).

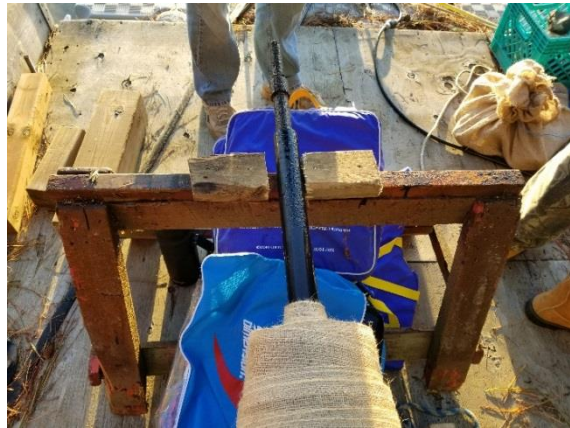
Apparatus made by Don M to dispense
burlap

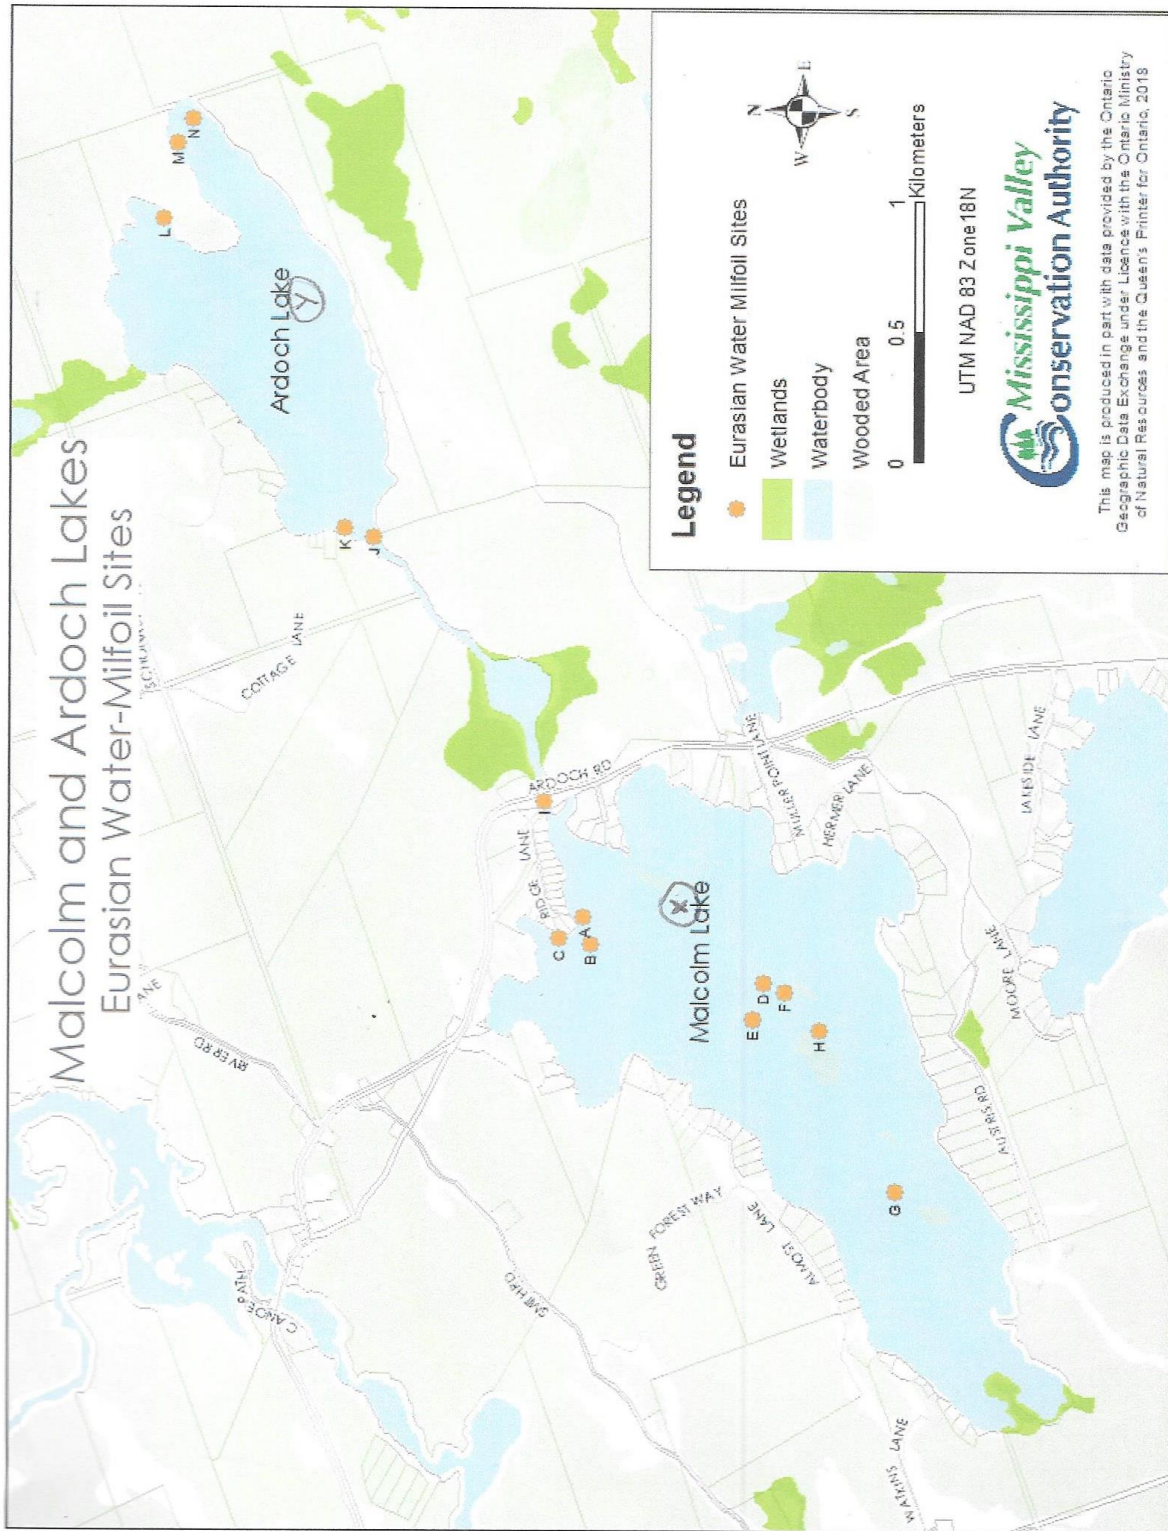
11.0 DISSOLVED OXYGEN TEST SITES (2019)

Dissolved Oxygen Test Sites on Malcolm Lake: B, X, F on Ardoch Lake: M, Y, J* pilot site
