Retrofitting Wind Turbine Monopiles with Cathodic Protection

By *Kathy Riggs Larsen* on 10/2/2017 12:29 PM

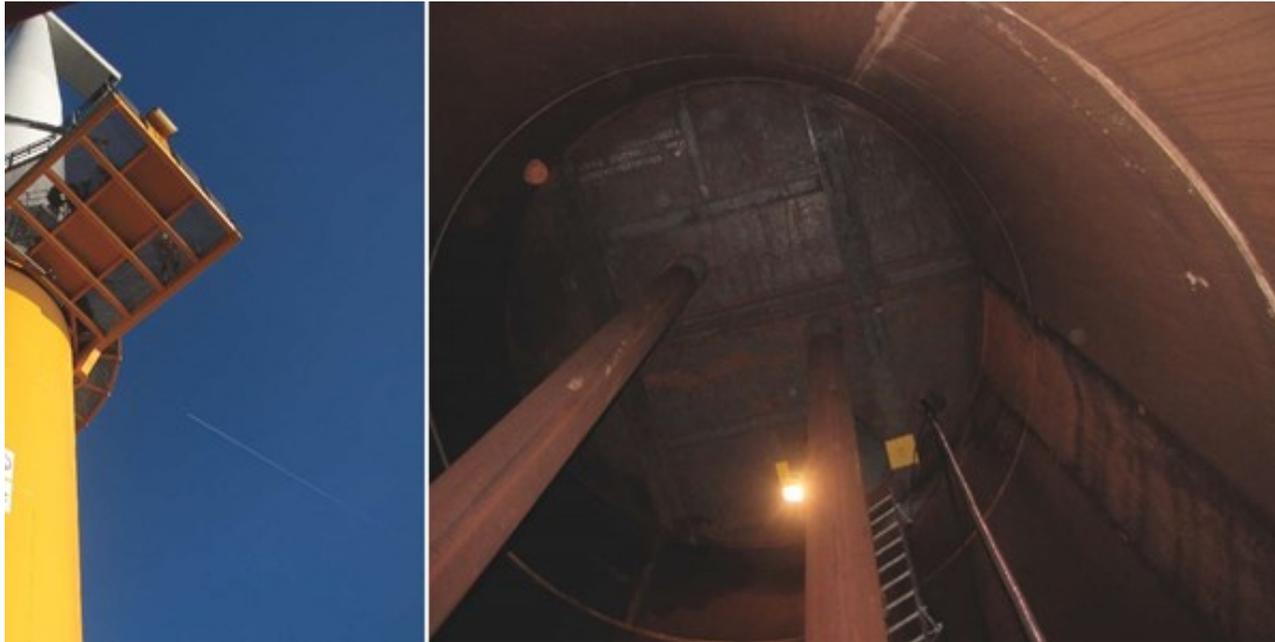
Left, the wind turbine monopile. Right, the sealed portion of the monopile below the lower platform. Photos courtesy of Alex Delwiche.

The transition piece, which supports steel components such as boat landings, ladders, and platforms required for accessing the wind turbine, is installed over the top of the monopile with an overlap of ~6 to 9 m. The annular space between the monopile and the transition piece is then filled with high-strength grout that cements the two pipes together. While in service, the transition piece will settle slightly from vibration of the turbine or broken bonds between the steel and the grout. The bottom end of the transition piece (called the lower platform) is sealed, and sits inside the top of the monopile. For a large number of designs, internal J-tubes are used to house the turbine's electrical connection cables. They enter the base of the monopile near the sea floor and run up the inside of the pile into the transition piece. Specially designed seals are used at the interface between the monopile wall and the J-tubes to create an airtight space within the monopile.

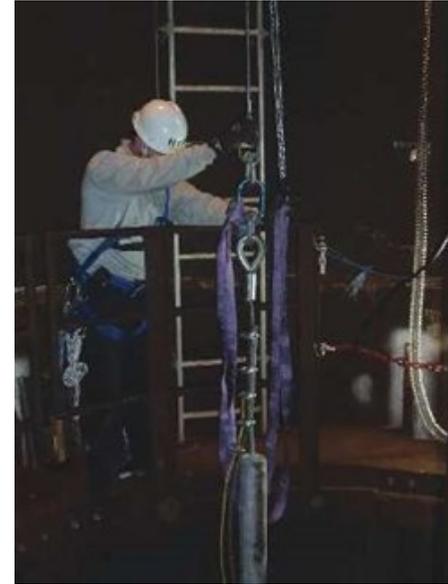
A trial anode string is lowered into the monopile's contained water. Photo courtesy of Alex Delwiche.

Since one aspect of the trial was to determine the total anode weight needed to meet the CP minimum protection requirement of -800 mV or more negative vs. a silver/silver chloride (Ag/AgCl) reference electrode, four anode strings comprised of six 55-lb (25-kg) aluminum alloy anodes cast on galvanized steel wire rope were installed. Although the CP designers expected that two anode strings would produce the necessary current for CP protection, the other pair of anode strings would be readily available during the trial if needed. For safety reasons, connections between the anode strings and structure were made in a junction box located above the sealed lower platform so the anode connections could be made without entering the airtight column. Initially, only two anode strings were connected to the structure.

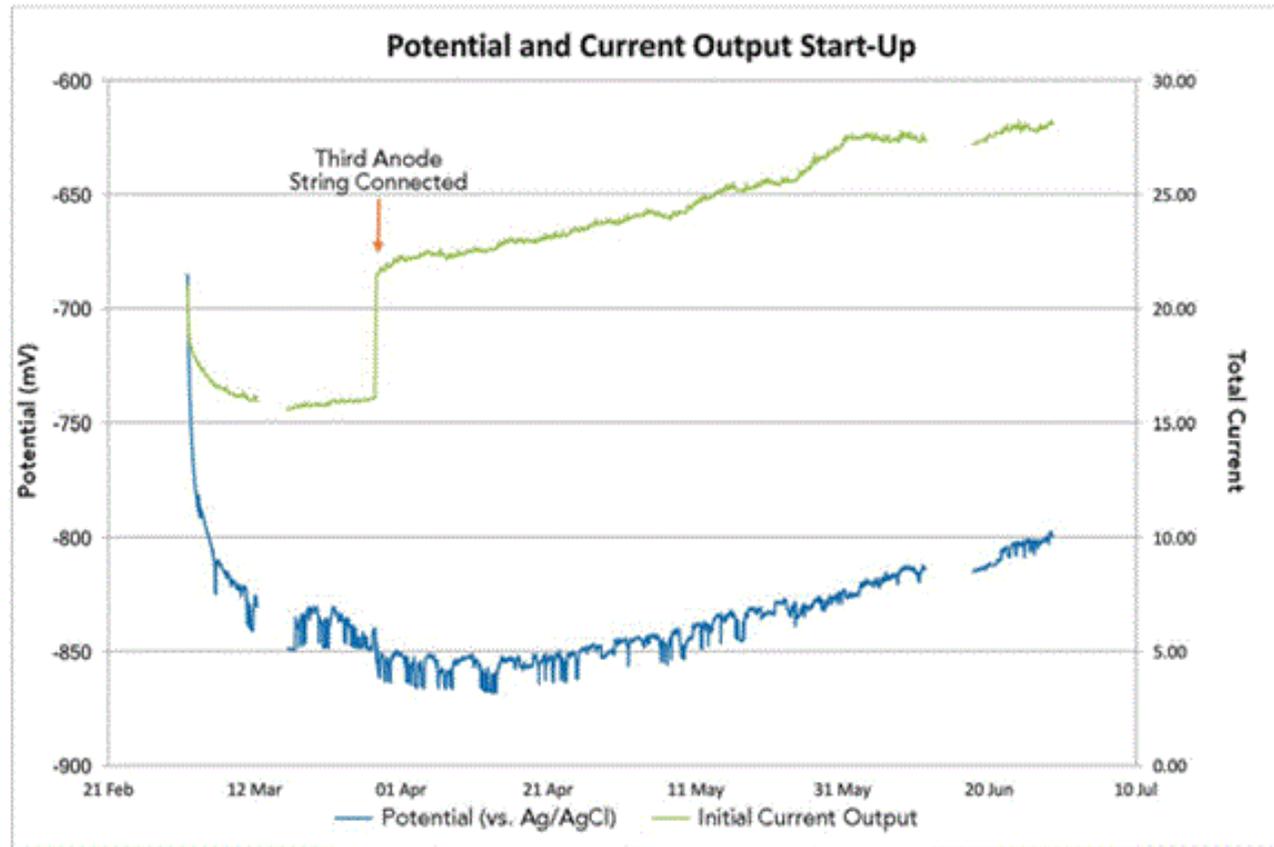
Potential and current output both started to increase about two weeks after CP start-up, which was surprising and a sign that there was a problem with the CP system. Image courtesy of Alex Delwiche.

After two weeks of operation, however, the structure unexpectedly started to depolarize and the structure-to-electrolyte potentials became less negative, which meant the structure was no longer adequately protected. The anode current output and CD also increased, which was unusual because the anode current output and CD were expected to show a time-dependent decrease as gradual structure polarization occurred. The ventilation system had been switched off so hydrogen levels could be monitored, and only insignificant changes in hydrogen were detected. At this stage, a risk of hydrogen build-up in the monopile, which could create a hazardous area within the monopile, was not a concern.

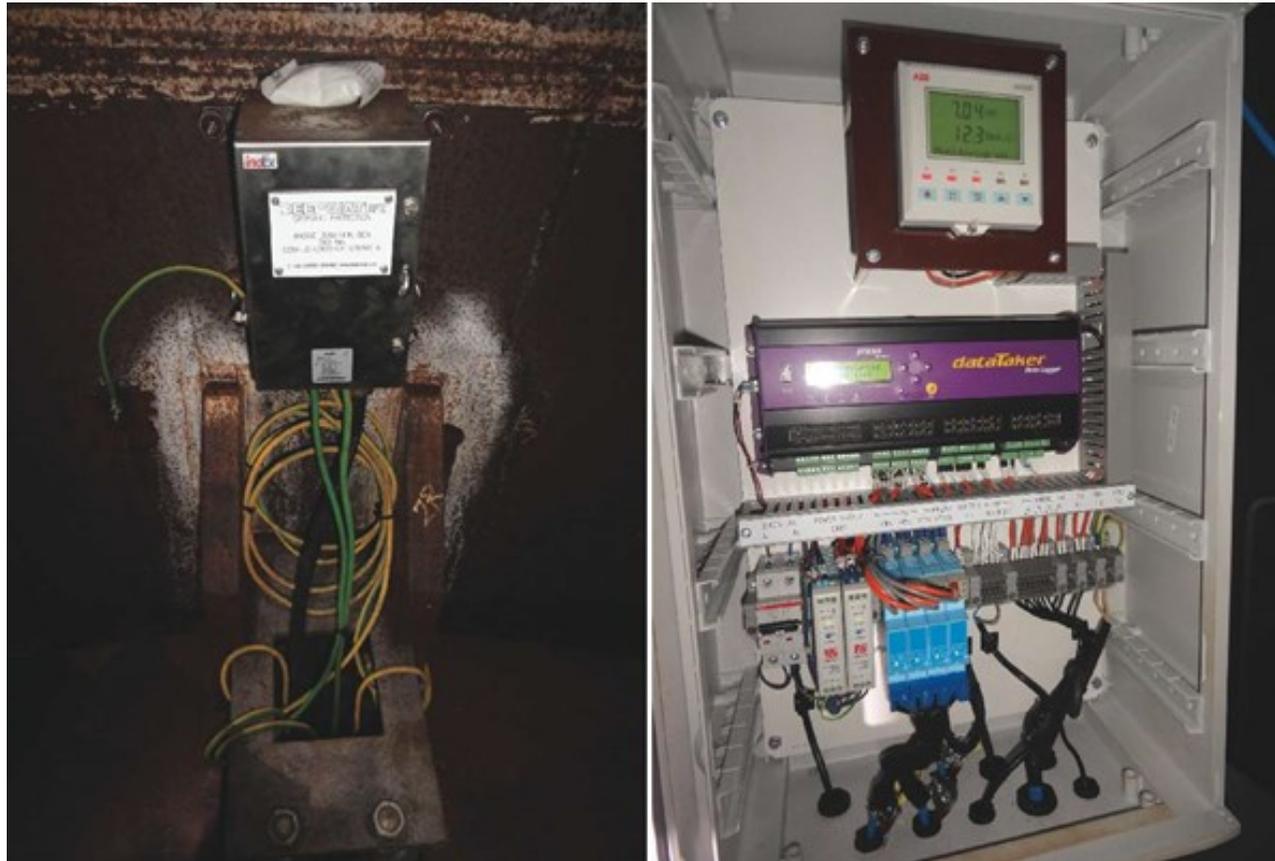
The junction box (left), installed above the lower platform, connects the anodes to the structure. Right, the monitoring system collects data from hydrogen sensors, a CD plate, pH probe, dissolved oxygen probe, and current input monitor to confirm the operation of a ventilation system. Photos courtesy of Alex Delwiche.

Six Ag/AgCl dual reference electrodes, located in two positions at three elevations in the monopile, monitored the structure-to-seawater potential. An additional reference electrode monitored an anode string. Hydrogen sensors and a 1- by 1-m steel plate to measure current density (CD) were installed at the top of the sealed monopile column. The monitoring system also included a pH probe, dissolved oxygen probe, remotely accessible datalogger, and current input monitor to confirm the operation of a ventilation system, which was switched off after a short time period to determine the presence of accumulated hydrogen, one of the major concerns with installing a CP system in an airtight environment.
