### Riviera Bay Civic Association Neighborhood Association Meeting

04/22/25

### Agenda

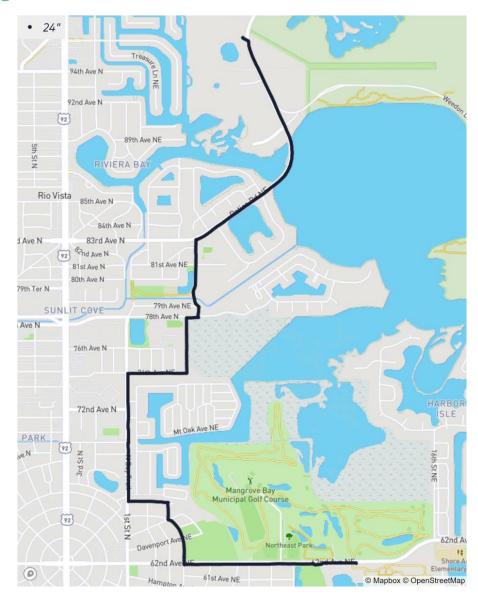
#### **Forcemain Condition Assessment**

This project involved physical condition assessment and analysis of the entire length of the forcemain from LS-63 to NEWRF

- The physical condition assessment has been completed by utilizing ultrasonic sensors that send and collect soundwaves to accurately measure the geometry and to detect anomalies in the pipe wall or pipe joints of the forcemain
- The forcemain was found to be structurally sound and no repairs are needed
- While no locations of concern were identified by the ultrasonic analysis, excavations at random sections are being performed to confirm the analysis performed by the ultrasonic analysis
- In the event that the visual inspection identifies needed repairs, these will be sequenced in Phase 3 of NEWRF Basin Capacity Improvements
- Note that the location of the break in the vicinity of the San Martin Bridge was due to construction debris which was dumped on the pipe

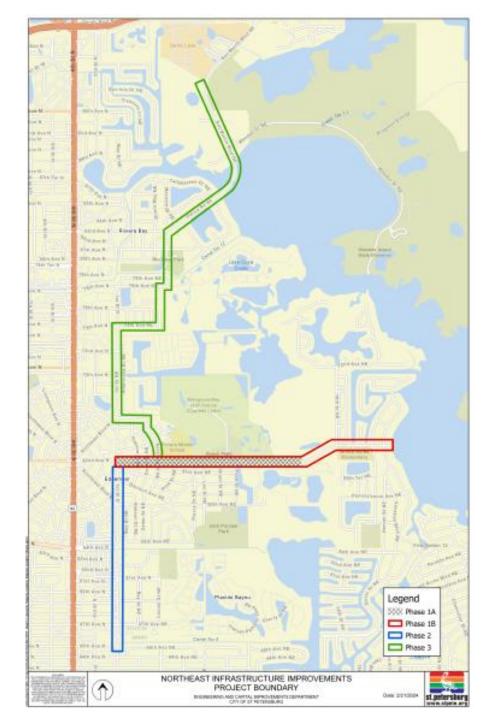
#### Program comprises 4 distinct elements:

- Phase 1A 62<sup>nd</sup> Avenue NE (Shown in black hatch)
  - Completed
- Phase 1B 62<sup>nd</sup> Avenue NE (Shown in red)
  - Currently in Design Phase
- Phase 2 1<sup>st</sup> St N (Shown in blue)
- Phase 3 Multiple locations (Shown in green)
  - Condition Assessment completed

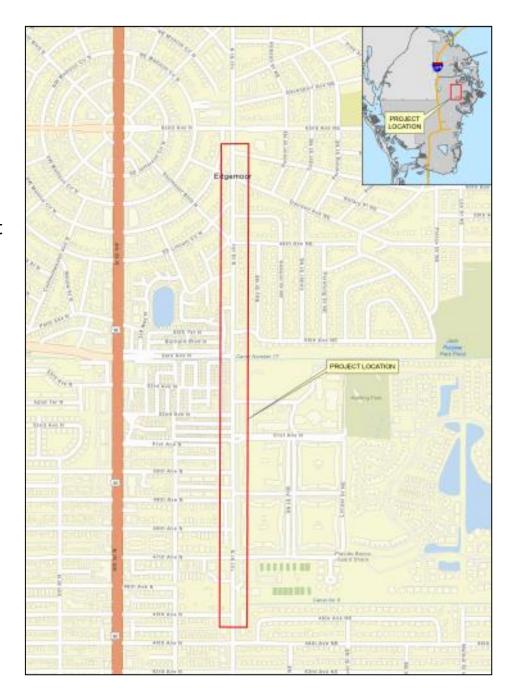
Phase  $2 - 1^{st}$  St N

- Construction of new force main from approximately 4580 1<sup>st</sup> Street
  N to connect to force main at 62<sup>nd</sup> Avenue N and 1<sup>st</sup> Street which
  was constructed as part of Phase 1B
- Construct new wet weather lift station at approximately 4580 1<sup>st</sup>
   Street N

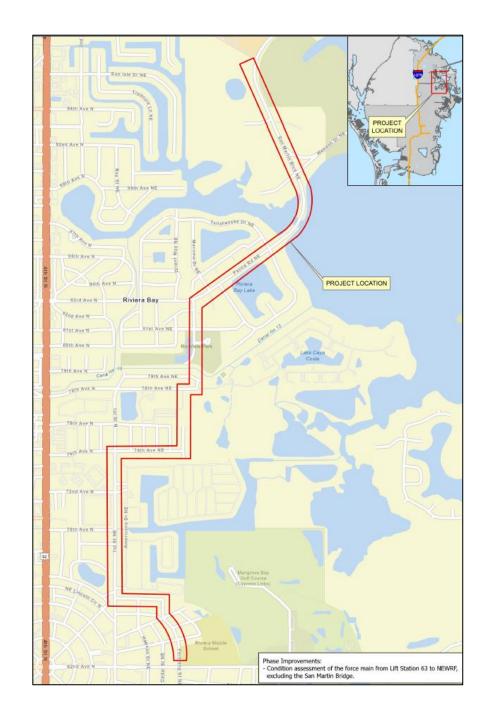
#### Phase 3 – Various locations

- Ultrasonic condition assessment was performed to identify any deficiencies to the pipe, joints, etc.
- Condition Assessment is complete
- While no initial locations were identified, field tests are being conducted to further refine the analysis
- Exception is the segment along the bridge which is being replaced due to the replacement of the San Martin bridge

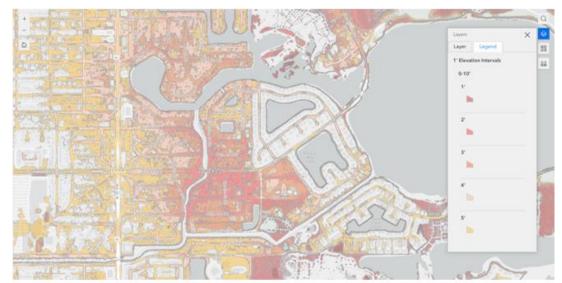
Figure 2 - Topography ranging from 1' to 5.99' NAVD

- This project is a Neighborhood-specific Vulnerability Assessment
- Review in a comprehensive model the existing conditions and flood conditions within the subject neighborhood and perform a vulnerability assessment
- This model will compile topographic data, the existing configuration of the stormwater system, canals and conduct analysis of impacts by simulating various scenarios, tidal level and rainfall which will result in projects/alternatives that provide measurable risk and flood reduction benefits across the neighborhood
- Proposed projects/alternatives will consider both rainfall and tidal-induced flooding
- The intent is to prioritize projects which mitigate structural and street flooding due to precipitation, storm surge, and high tide
- Note that this Project is being advanced ahead of the City's Vulnerability Assessment and is currently underway

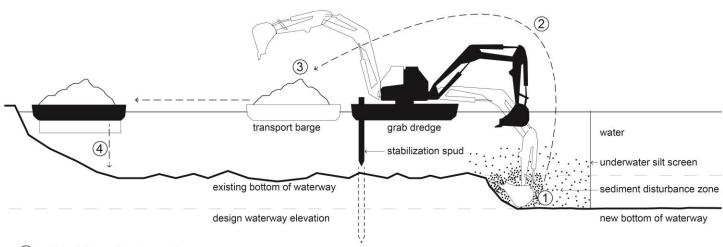
### **Mechanical Dredge**

- 1 dislodging of in-situ sediment
- 2 raising of dredged material to the surface
- 3 horizontal transport
- 4 placement or further treatment

- Mechanical
  - Excavators with buckets dig and remove sediments either from the shoreline or by barge
- Hydraulic
  - Pipes and pumps use water pressure and suction to loosen and move sediments to shore
- Suction/Hand Dredging
  - Similar to hydraulic dredging but on a smaller scale
  - Time consuming

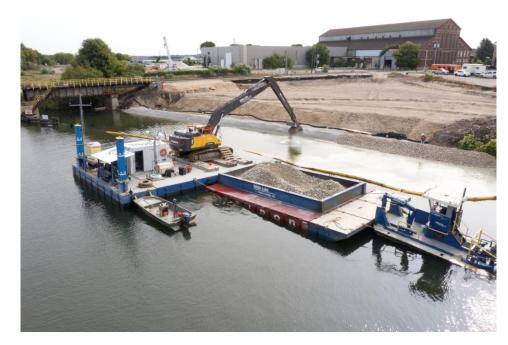
### **Hydraulic Dredge**

- 1 dislodging of in-situ sediment
- 2 raising of dredged material to the surface
- 3 horizontal transport
- 4 placement or further treatment
