## **Survey of Rodman Reservoir and middle-Ocklawaha River springs during spring 2008 draw-down conditions: FWC and FWS**

**Date of Survey:** February 26, 2008

**Purpose:** To evaluate known second and third magnitude springs, connected to the Ocklawaha River in areas exposed due to a draw-down, but generally submerged under dammed waters of the Rodman Reservoir, as possible thermal refuges for manatees in the event of the restoration of the Ocklawaha River to its natural banks.

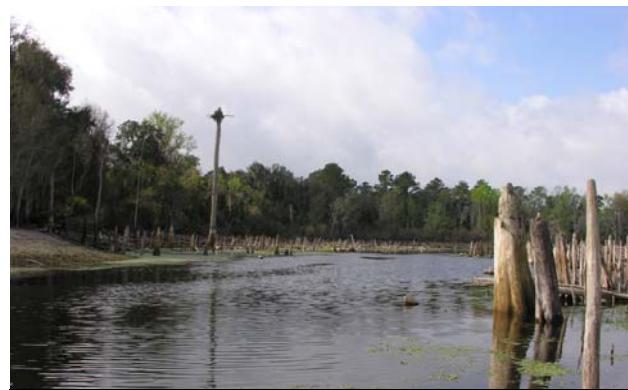
The Blue Spring pool is accessed from the north through an approximately 200 foot channel that averages 4 feet in depth, and which is about 10-15 feet in width. The channel winds its way from the historic Ocklawaha River channel to an open spring pool that is 30 feet from the shore, and which is surrounded by hardwood stumps (mostly cypress and sweet gum) cut about 4-5 feet above the sediment surface and left in place when the reservoir was filled. Another

Figure 2: Blue Spring (Marion) run approaching the main boil.

Manatees could access this spring pool through the northern run channel without the need for any modifications of the existing channel. It is likely that flows from the spring will remove accumulated organic sediments from the channel and spring pool bottom, as flow from the spring will contribute to currents down the run to the river. The pool provides a large volume of warm water that could hold an estimated 100 to 150 manatees comfortably during winter cold periods. Access to forage would be to areas of aquatic

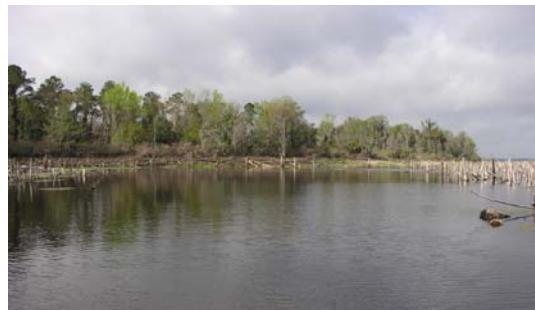
shallower channel, which flowed over a sediment sill, was observed to the west, but we could not access the spring from this channel due to the shallow nature of the water in the system (about 6 inches in depth). The spring pool is estimated to be 100 feet in diameter and ranges from 4 feet along the sides to 19 feet in maximum depth where the spring vent is located. Surface water temperatures in the pool were 71° F, whereas ambient water temperatures were 67° F. Aquatic vegetation observed throughout the run and spring pool included hydrilla (*Hydrilla verticillata*), coontail (*Ceratophyllum demersum*), southern naiad (*Najas guadalupensis*), duckweed (*Lemna spp.*) and water lettuce (*Pistia stratiotes*).

Figure 3: Blue Spring (Marion) spring pool.

vegetation along the river littoral zones if the system was restored. With full access provided, this system could be a primary warm water refuge, as previously defined by the Manatee Warm Water Task Force and Habitat Working Group.

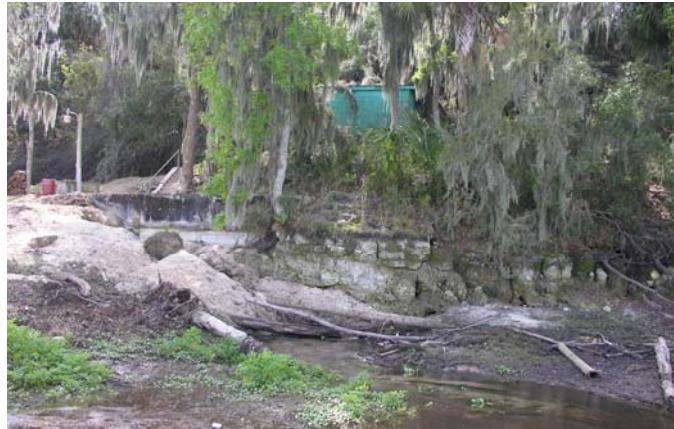
Alcorn Spring lies at the base of an old river bank bluff, where artesian spring water flows directly out of the base of the bluff and into a diffuse muddy flood plain. The spring was originally called Sim's Spring, but was developed by George Alcorn well before the 1970s (Abbott, 1971). Flow is limited, but artesian water is clear and warm (no temperatures were taken, but the water was determined to be similar in temperature to most artesian spring water, so estimated to be between

70-72°F). With the Rodman Reservoir at the low level we observed, the spring run is only a few feet long and extremely shallow (less than 6 inches). Spring waters flow out into organic sediments deposited during the period of submergence by lake waters. The spring is over an estimated 300 meters from the river bed through remnant river flood plain forest stumps. This spring system also has a vent exit into an open well casing with a visible pipe and pump system. When Rodman Reservoir water head pressure exceeds the force of flow from the spring water, this spring flows out of the open karst feature, and into the open casement.

Figure 4: Alcorn Spring. Note pump house on hill, and well basin center left in the photo.

For all purposes, this spring is inaccessible to manatees. An extensively modified channel system would have to be dredged and maintained to allow manatees to move from the river within its banks to the spring, and spring waters would need to be encased to provide adequate thermal refuge for a very limited volume of warm water. Survey staff estimated that this spring could not support more than 10 manatees if

properly maintained, and it is therefore considered inconsequential as a potential warm water refuge.

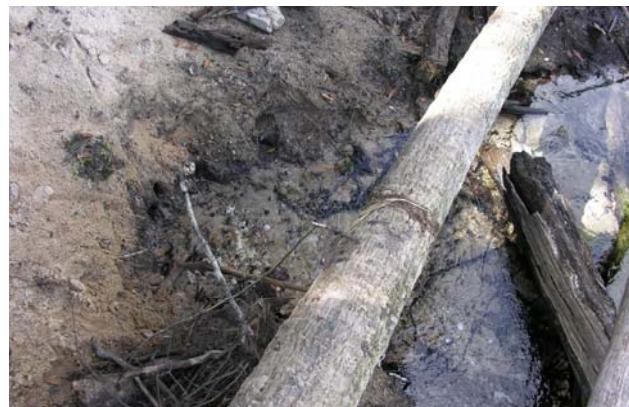
Figure 5: Alcorn Spring boil.

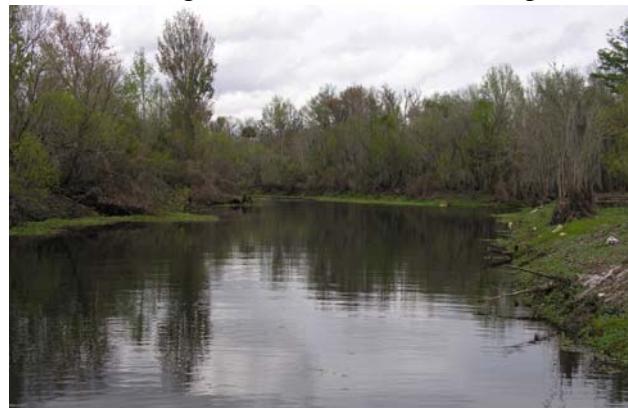
Hasty Greene spring lies on the south shoreline of the Ocklawaha River bank on the south side of a rise in the bank forming a peninsula between the spring run and the river. The run is wide, averages 4-6 feet deep, and is an estimated 60-70 feet long. The spring is recognized by clearer spring waters populated with large numbers of fish reaching a maximum depth of about 12 feet at what was presumed to be the spring boil. The spring boil basin is approximately 40 feet in diameter, and water temperature at the surface was recorded at 72°F. The basin is enclosed on all sides by a relatively high embankment that is not easily accessible from land. There is a clear spring run that veers to the south at the western extent of the spring boil basin, which may have multiple small springs contributing to the slow flow moving toward the spring boil.

Figure 6: Hasty Greene Spring viewed from west to east across the spring boil basin.

**Manatee thermal refuge assessment:** The somewhat isolated nature of this spring system, along with its deep spring run, and spring boil basin, make this a likely candidate spring system for use by manatees as a warm water refuge. Manatees could easily access the system from the main stem of the Ocklawaha River, and there is abundant submerged aquatic vegetation in the system. Although the flow is not as great as that found at Blue Spring (Marion County), the system could easily maintain 100 or more manatees during cold weather. With full access to the river afforded manatees, this spring system could also be a primary warm water refuge for manatees.

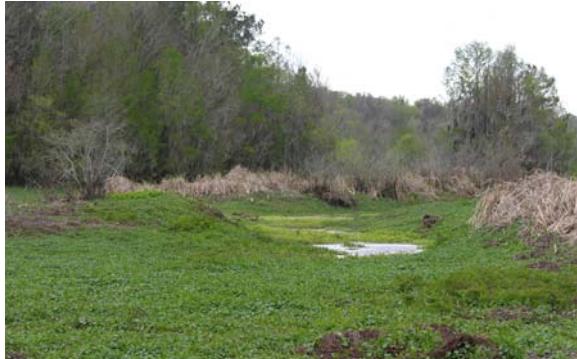
At least 1, but perhaps 3 small springs flow to a confluence approximately 100 feet west of the Big Rack Road boat ramp. With the river levels well within the banks during our survey, these springs were stranded on the bank network, with only small slowly flowing runs passing through organic rich hydrosoils. Pennywort (*Hydrocole sp.*) was observed growing over most of the exposed hydrosoils, with dense spatterdock (*Nuphar polysepala*) rhizomes partially buried in the muddy sediments. The springs were identified from a distance of about 40-60 feet, as they were inaccessible by foot across

the hydrosoils. A narrow channel runs from the river to the boat ramp exists, but is neither navigable by boat nor accessible to manatees.

Figure 7: One of the Big Rack Road Springs.

**Manatee thermal refuge assessment:** This system of springs is close to the river, but has a number of drawbacks relative to the potential provision of warm water for manatees. First, if water levels were elevated, the access channel from the river is narrow, and would be used by vessels launching at the Big Rack Road ramp. Access to the collective spring water would be directly by the area where vessels are launched, so disturbance could be a problem for warm water-seeking manatees. Second, the combined flow of these

springs appears to be but a trickle, and does not form a convergent area of warm water large enough to support appreciable numbers of manatees during cold weather. Extensive dredging would be required to provide channel access, and perhaps a pool of warm water sufficient to provide necessary refuge habitat for manatees. These characteristics dictate that this spring system would not provide sufficient warm water habitat for numbers of manatees without substantial and costly modifications.

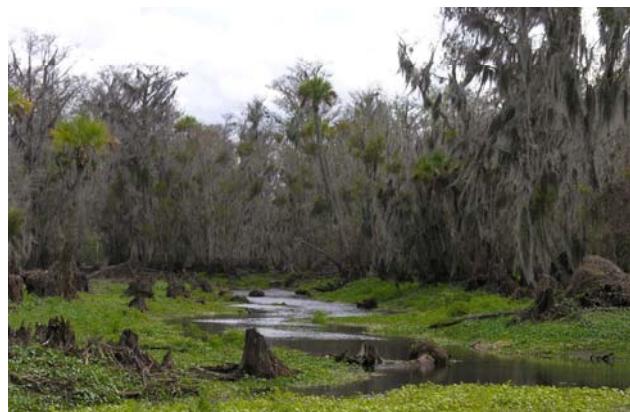
These are relatively large spring systems in a network along a spring run that was estimated to be 700 feet long that intersected directly with the main stem of the Ocklawaha River. The spring run was relatively shallow, about 20 feet wide, and blocked for boating access by numbers of logs, and floating vegetation. Water flow from the combined springs was observed down the run. Surface water temperature at the confluence of the run with the river was 74°F. Although the survey team could not access the main spring boil basins, at least one of the basins is 20 feet deep and 30 or more feet in diameter (Mickey Thomason and Dave Bowman, FDEP, pers. com.).

Figure 8: Run leading up to Cannon/Strange Springs boil basins.

Manatee thermal refuge assessment: The characteristics of this spring complex indicate that it could be a significant (possibly primary) warm water refuge for manatees if appropriate access was provided. This would require clearing of dead wood from the run, and possible minor sediment dredging to improve access directly from the river channel. The survey team did not see the main spring boil basin(s), but based on the input from other recent surveyors, the spring system could be comparable to Haste Green Springs (mentioned above), capable of sustaining 100 or more manatees during cold weather.
