# HOME INSPECTION REPORT

**Address Avenue  
Yankton SD 57078**

**November 4, 2019**

**COMPLETE • STRUCTURE • INSPECTIONS**

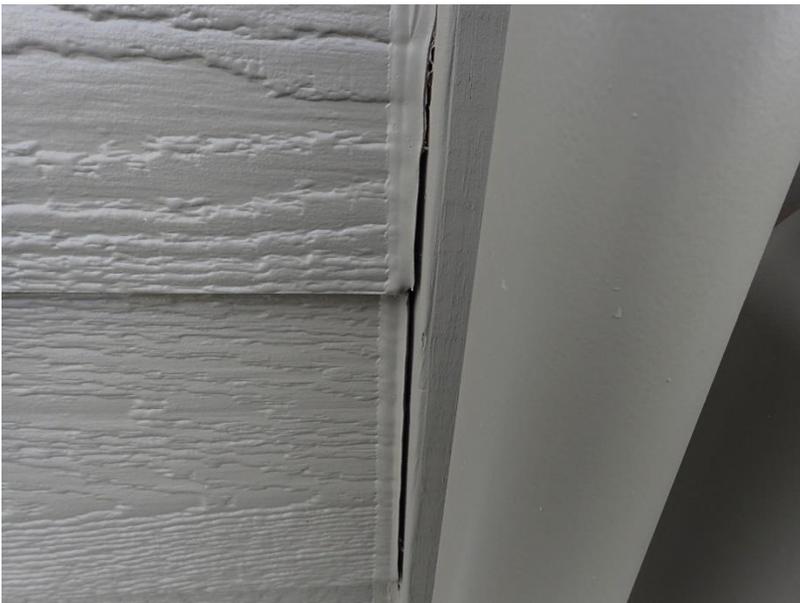
**Comments:** There is caulking at the main electrical service entrance that needs repair due to separation.

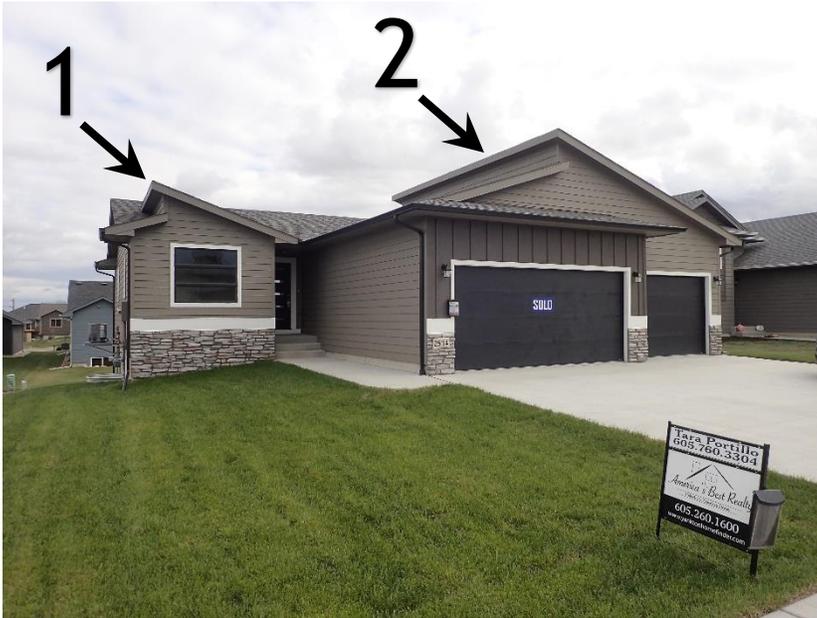
## ROOF TRIM INSTALLATION

There are two skillion style roof installations on this property which have been improperly trimmed at the apex of the roof line.

Apex 1 has a standard drip edge installed which is unacceptable for this type of installation.

Apex 2 has no trim at all installed.

Below are two acceptable methods of securing the asphalt roof covering and providing a weather tight seal for this type of roof. I recommend the builder install one of the applications below.

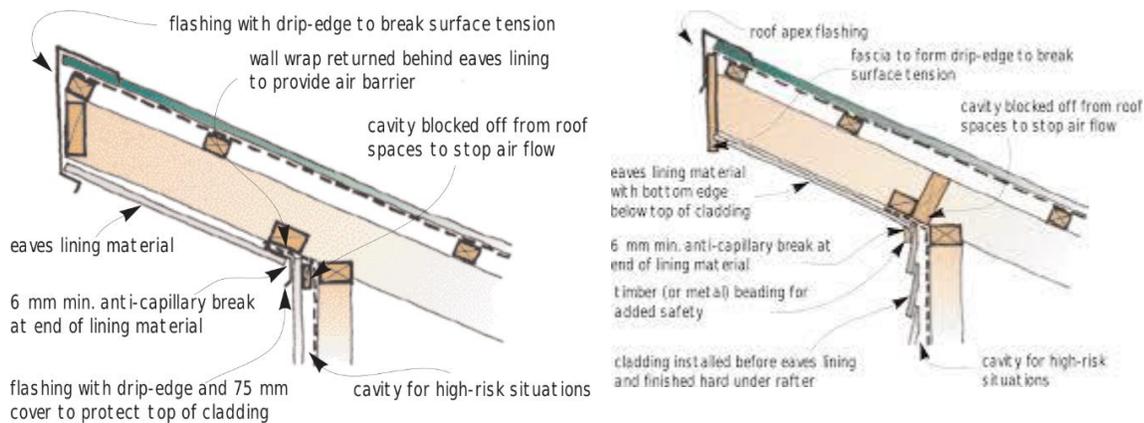
As pictured below, the trim must extend downhill on top of the shingles and be properly secured with self-sealing roofing nails or screws.
