# HOME INSPECTION REPORT

**Address Trail  
Yankton SD 57078**

October 22, 2019

**CSI, LLC  
1202 West Street  
Yankton, SD 57078  
605-760-0750  
tohara@iw.net**

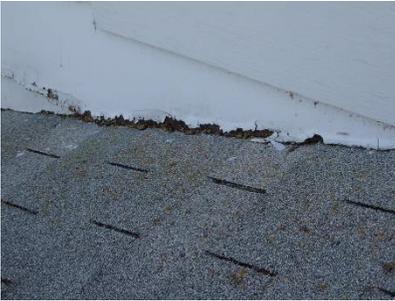
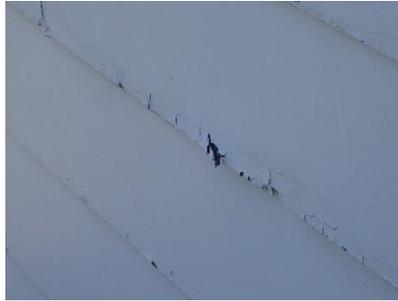
Deteriorated siding

1. The shingles are serviceable for an estimated 2 - 4 years. Much of the aggregate is missing and the shingles will need to be replaced soon.
2. There is significant deterioration of the siding and the siding should be replaced.

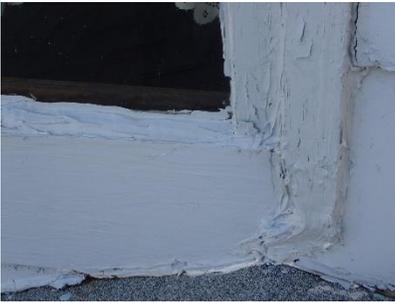
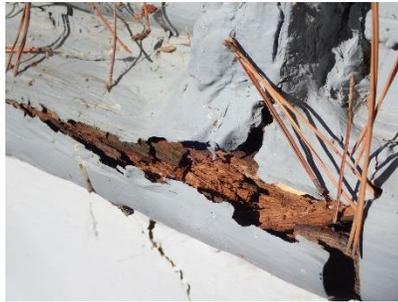
Rotted window frames. The photo on the left is the north window in the upstairs hallway. This window is covered with caulking to prevent leaking through the rotted areas.

3. Several of the windows have rotted trim and frames and should be replaced.
4. The trim and frame of the sliding door to the deck have rotted and the door frame and trim should be replaced.

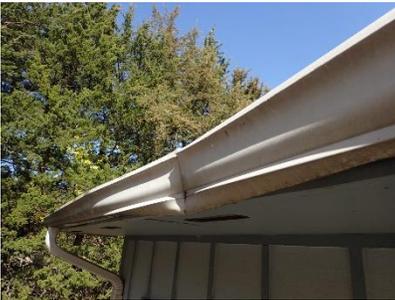
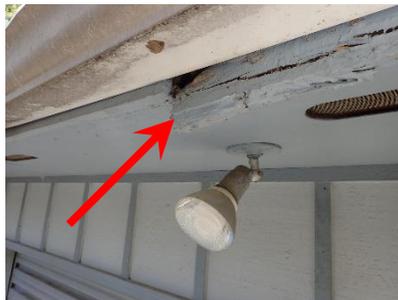
Damaged gutter and fascia above garage door.

7. There is excessive cracking of the driveway, sidewalks and patio.
8. There are rotted railings and posts on the deck that need to be replaced.
9. There is a damaged gutter on the front of the garage and most downspout extensions are missing.

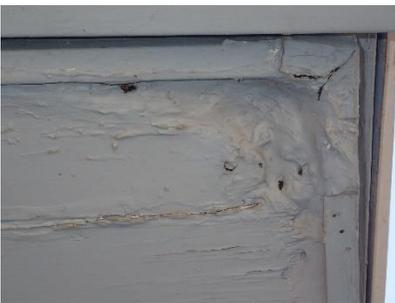
This is the underside of the soffit on the northeast corner of the structure. The soffit has been filled with caulking and the soffit and fascia are rotten.

5. There are isolated areas of wood rot and damage to the fascia and soffits that need repair.
6. The grading in front of the structure slopes to the foundation.

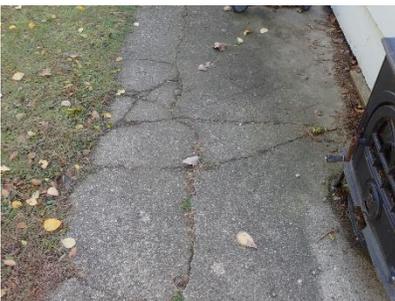
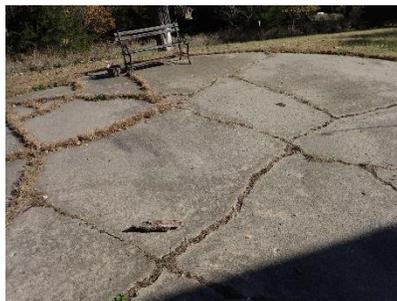
The sidewalks, patio and driveway have excessive cracking and there are areas of the patio that slope to the foundation.

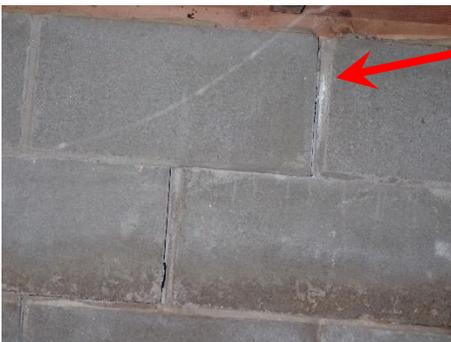
**Basement Comments:** The foundation has a significant step crack in the southeast corner that has daylight showing through. This crack should be repaired. There is also potential mold or mildew in the southeast corner of the crawlspace.

There is a significant step crack on the east wall of the crawlspace. The crack is large enough to see daylight in the areas above grade.

10. The foundation has a significant step crack in the southeast corner that has daylight showing through. This crack should be repaired.
11. There is also potential mold or mildew in the southeast corner of the crawlspace.

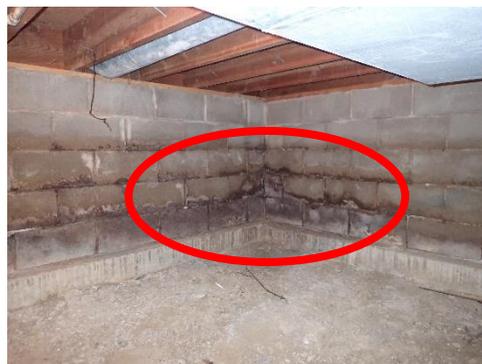
This is a photo of the southeast corner of the crawlspace. I recommend having the black material tested.

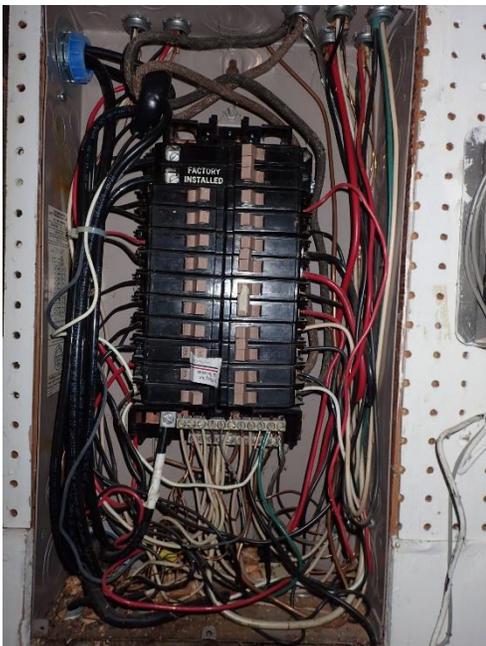
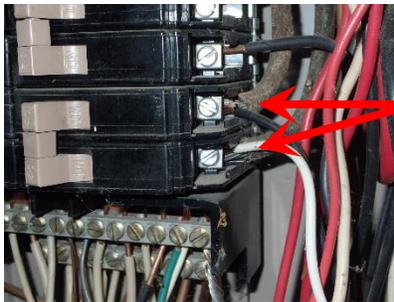
The white and black wires are rated for 20-amps and this is a 40-amp breaker. An electrician needs to repair this defect.

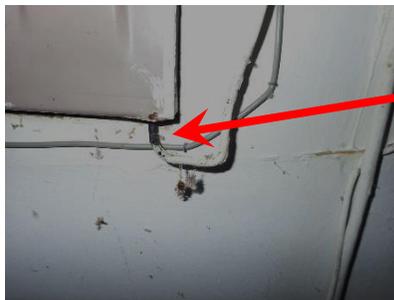
**Electrical Panel Comments:** There is a wire entering the electrical panel between the panel body and the cover. This is an unsafe situation and could cause the panel to be electrified.

This wire is entering the panel between the cover and the panel body. If the insulation becomes damaged the panel can become electrified and be a shock hazard.

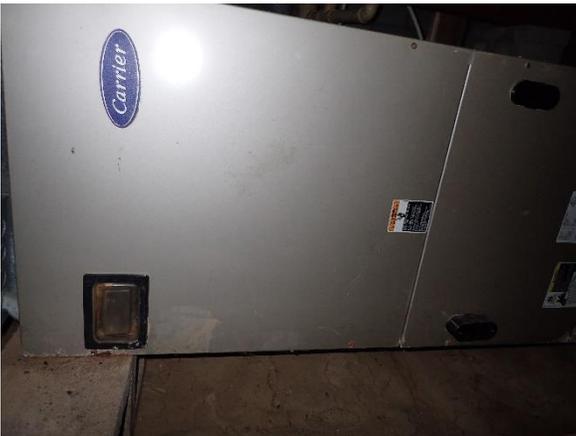
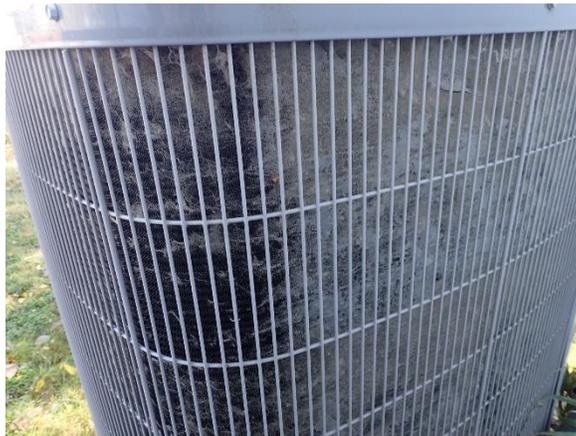
The coils on the heat pump need cleaning.

1. The coils on the air conditioner need to be cleaned.
2. The windows that can be saved need interior refinishing and exterior painting.

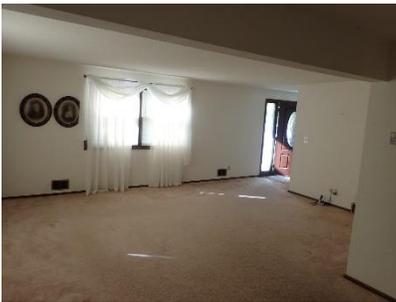
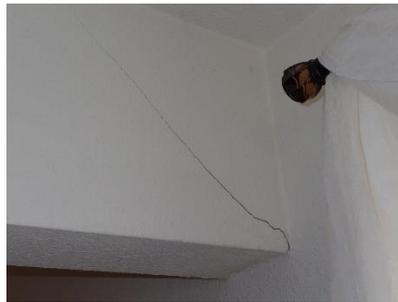
Significant settlement cracks were observed around the beam supporting the floor joists above.

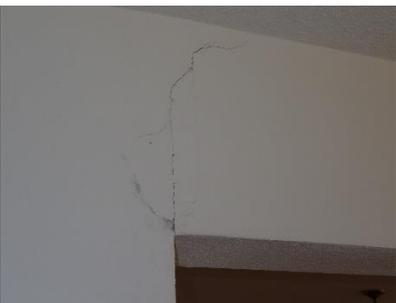
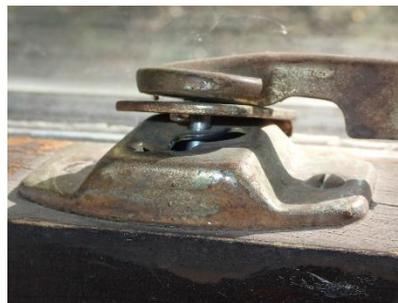
**Comments:** Most of the windows do not fully close and will not latch, several have rotted frames.

Several of the windows in these rooms had damaged latching hardware.

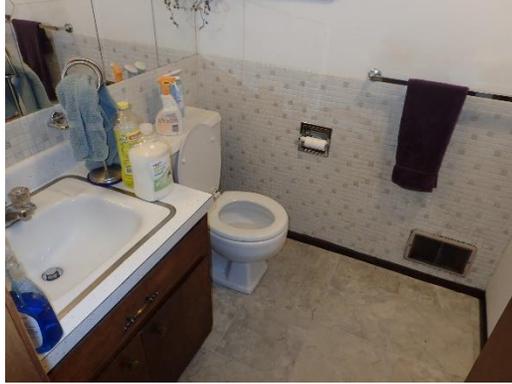
**Main Level ½ Bath**

Entry Door	Appears Serviceable	Appears Serviceable
Window(s)	N/A	Single pane
Operation		Appears Serviceable
Window Glass		Appears Serviceable
Window Screen		Appears Serviceable
Window Frame		Needs refinishing
Floor Covering	Vinyl	Carpet
Floor Condition	Appears Serviceable	Fair
Walls & Ceiling	Appears Serviceable	Appears Serviceable
Lighting	Appears serviceable	Appears serviceable
Outlets	Appears serviceable	Appears serviceable
Toilet	Appears serviceable	Appears serviceable
<b>Sink(s)</b>	Appears serviceable	Appears serviceable
Countertop	Appears serviceable	Appears serviceable
Cabinet	Appears serviceable	Finish is deteriorated
<b>Bathtub/shower</b>	N/A	Appears serviceable
Enclosure Type		Fiberglass
Faucet		Appears serviceable
Ventilation Fan	Appears serviceable	Appears serviceable

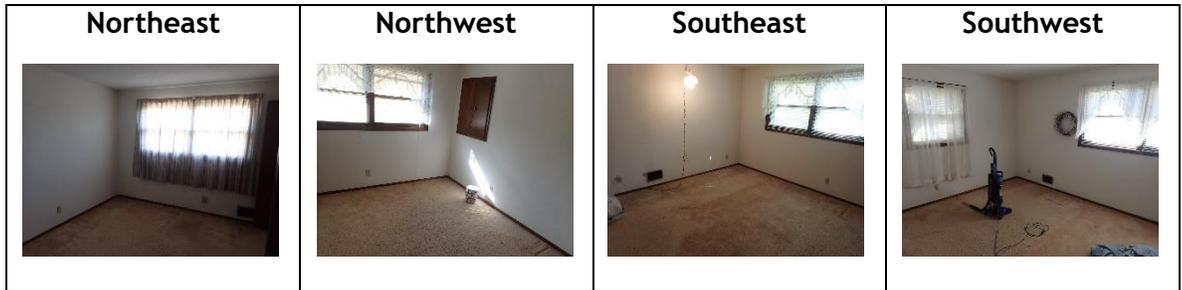
Entry Door	Won't latch properly	Appears Serviceable	Appears Serviceable	Appears Serviceable
Closet Door	Appears Serviceable	Appears Serviceable	Appears Serviceable	Appears Serviceable
Window(s)	Single pane	Single pane	Single pane	Single pane
Operation	Will not latch	Will not latch	Will not latch	Will not latch
Window Glass	Appears Serviceable	Appears Serviceable	Appears Serviceable	Appears Serviceable
Window Screen	Appears Serviceable	Appears Serviceable	Appears Serviceable	Appears Serviceable
Window Frame	Needs refinishing	Rotted	Needs refinishing	Rotted
Floor Covering	Carpet	Carpet	Carpet	Carpet
Floor Condition	Poor	Poor	Poor	Poor
Walls & Ceiling	Appears Serviceable	Appears Serviceable	Appears Serviceable	Appears Serviceable
Lighting	No light	No light	No light	No light
Outlets	Appears serviceable	Appears serviceable	Appears serviceable	Appears serviceable
Ceiling fan	N/A	N/A	N/A	N/A

**Bedroom Comments:** As pictured below some of the bedroom windows have rotted windowsills and exterior trim.

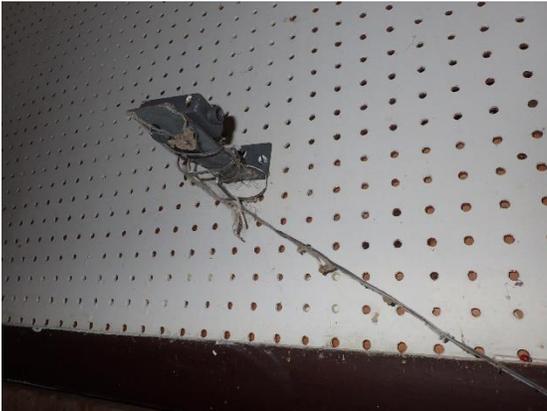
Bypassed photo electric opener

14. Most of the windows do not fully close and will not latch.
15. The door between the house and garage is not fire rated due to the window.
16. The garage vehicle door and opener need to be serviced. The door is out of adjustment and the electronic eyes have been bypassed. In addition, the pressure required to reverse the garage door is out of adjustment.

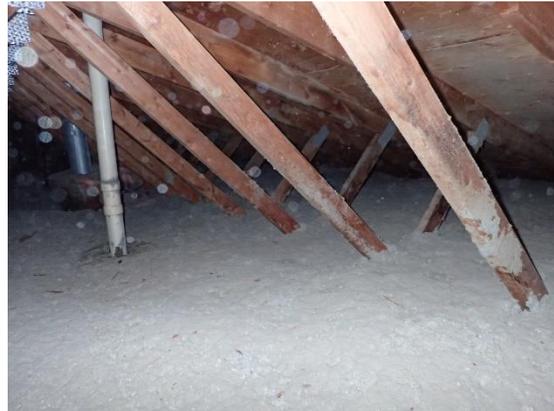
Attic Photo

**ATTIC**  N/A  Appears serviceable
