MEMORANDUM

PROJECT: 24159.000

REGARDING: Methane Assessment Workplan 1 – Lots No. 1 through 64
Mill Pond Crossing Development
1701 Chapel Drive
Philomath, Oregon 97370

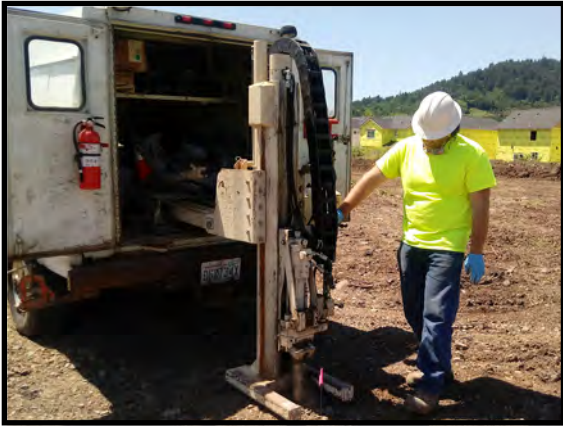
Looking southeast; advancing Soil Boring SG5 by direct push.

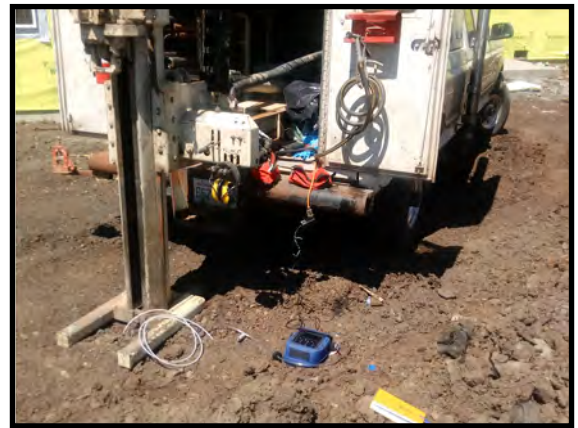
Collecting Landfill Gas reading through polyethylene tubing inserted into a sealed borehole.

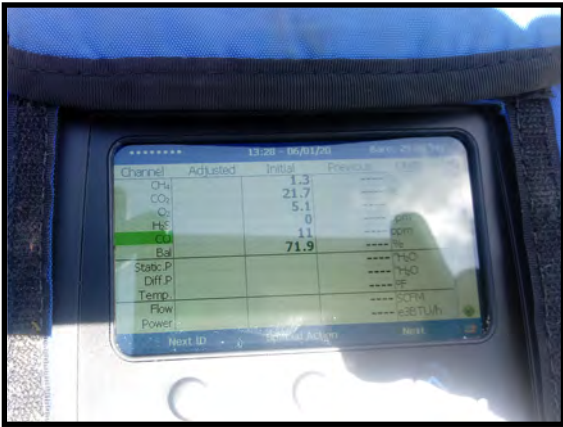
Landfill Gas reading; GEM 5000 instrument

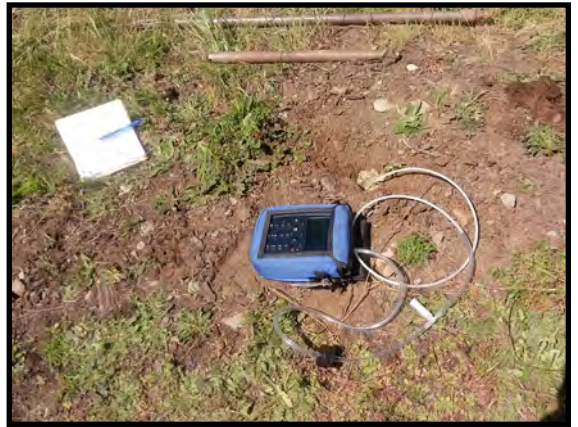
Performance of Landfill Gas survey through borehole sealed at surface.

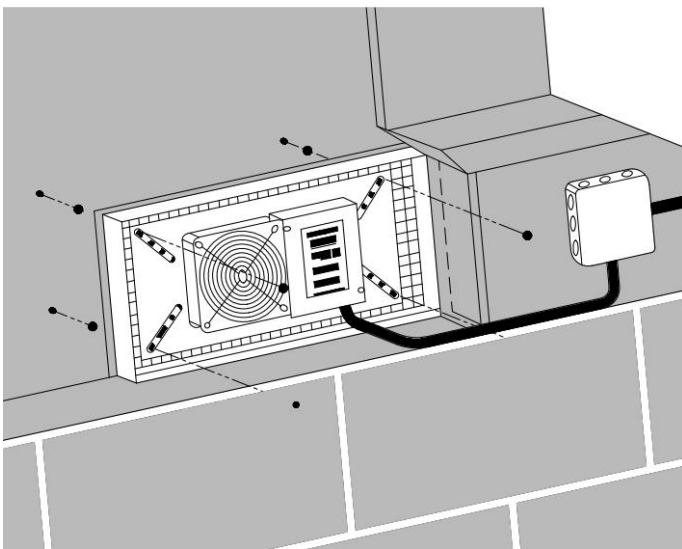
INSTALLING MODEL M1

1. Remove the existing doors / covers on ventilation openings around the perimeter of the crawl space.
2. Position the Crawl Space Ventilator over the ventilation opening.
3. (a) If installing on foundation block or brick, mark location of mounting holes in the four corners of the metal panel plate and drill 5/16" holes with masonry drill bit. Insert wall anchors into openings and secure Crawl Space Ventilator to the wall with four screws. (b) If installing on a wood wall, rim joist or mesh panel on crawl space vent openings, secure your ventilator with screws, washers and nuts in the four corners of the ventilator metal panel plate.

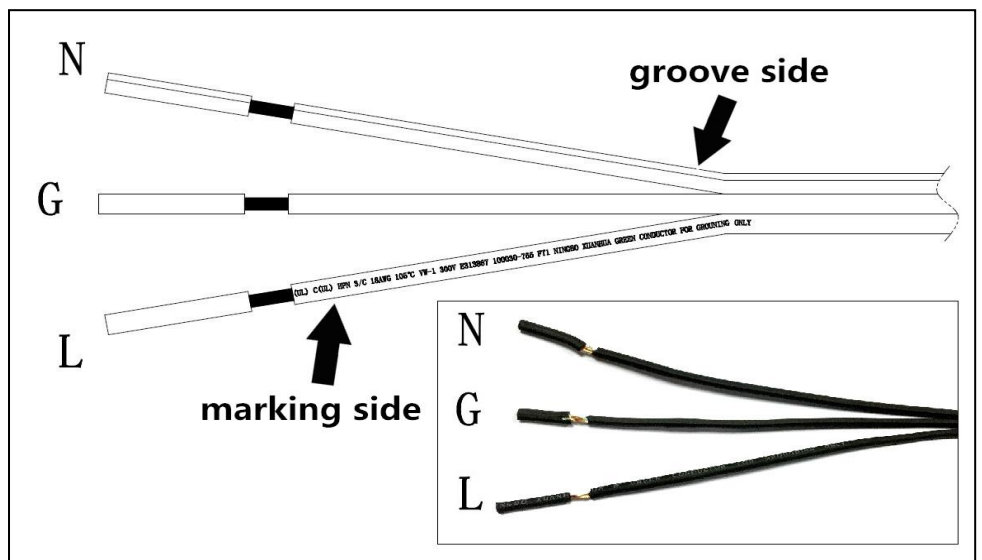
Identify the wires:
 (N) Neutral wire
 (G) Grounding / Earth wire
 (L) Live wire

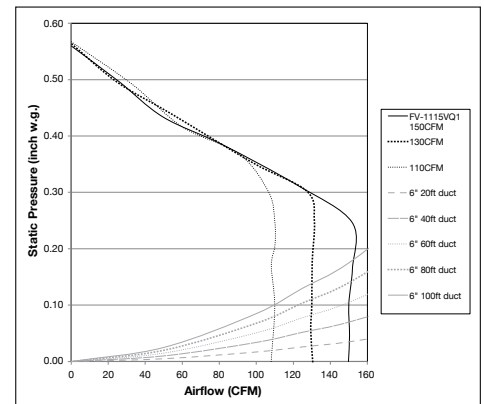
Performance Curve 6" Duct

Specifications: WhisperCeiling DC FV-1115VQ1		6"		6"		6"	
Ventilation Fan Characteristics (HVI Certified Data)	Static Pressure in inches w.g.	0.1	0.25	0.1	0.25	0.1	0.25
	Air Volume (CFM)	150	152	130	131	110	110
	Noise (sones)	<0.3	0.7	<0.3	0.5	<0.3	<0.3
	Power Consumption (watts)	11.8	20.2	9.0	15.7	6.8	12.1
	Energy Efficiency (CFM/Watt)	12.9	7.6	14.7	8.5	16.4	9.2
	Speed (RPM)	698	925	671	918	636	900
	Current (amps)	0.19	0.31	0.16	0.25	0.12	0.20
	MAX. Current (amps)	0.31					
	Power Rating (V/Hz)	120/60					
	ENERGY STAR rated	Yes

0.25=Installed Performance
