## YOUR INSPECTION REPORT

1588 Smart Place  
The Villages, FL 34762

05/11/2026

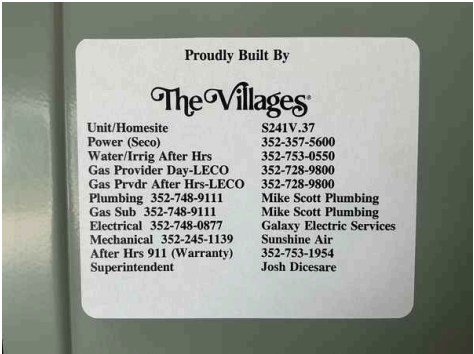
#### STICKER INFORMATION

Picture of Builder sticker on electrical panelbox for Warranty. This sticker tells you the Builder, all main Sub-contractors and lot number. The Villages Warranty Department has asked this to be in the report so as to assist them with Sub-contractor information, etc. This is not a defect or an issue to be repaired or replaced.

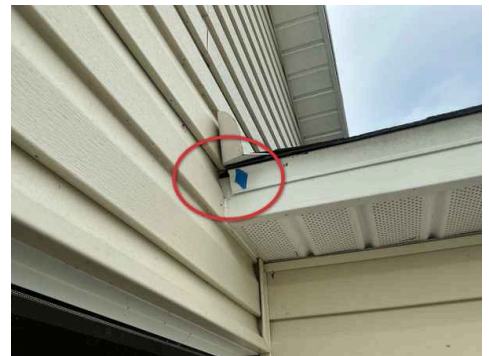
Front of House

#### **FLASHING TOO SHORT**

The drip edge over the small garage door area was found cut too short. This leaves a gap between the fascia and the roof sheathing. The roof sheathing can be seen. This could allow possible pest and moisture intrusion. Suggest a qualified contractor properly seal this gap.

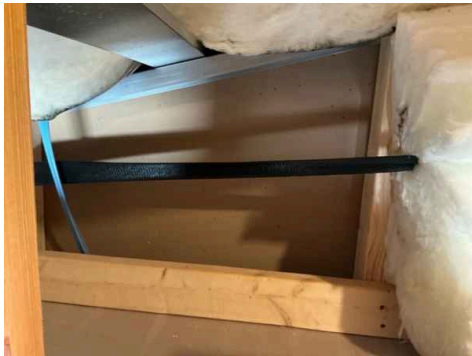
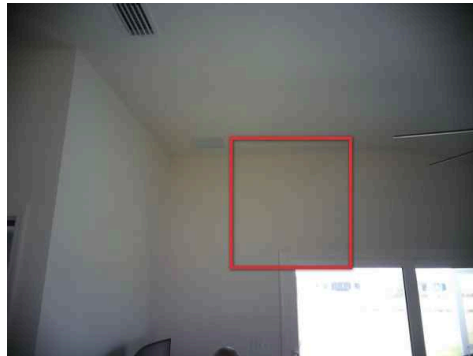
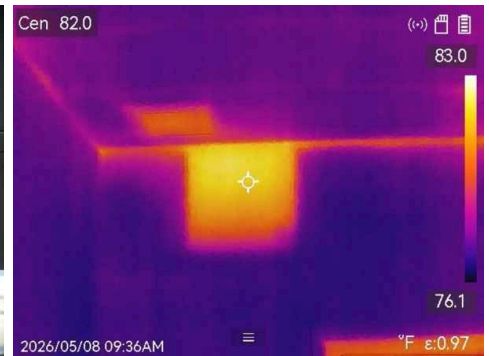
**MISSING BATTS**

Batt(s) of insulation were found displaced in the attic. This insulation needs to be installed properly, as insulation should always be installed between conditioned and unconditioned space. Leaving this as is risks energy loss and possible condensation and mold issues. See photos for locations of missing batt(s).

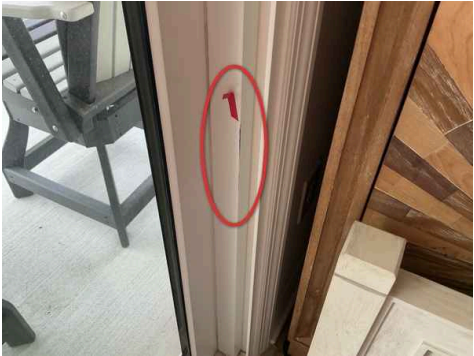
Large Sliding Glass Door

#### MISSING FINISH

The finish on the large sliding glass door was found chipped off. This was marked out by the builder, but never repaired. Suggest you qualify contractor properly repair this finished

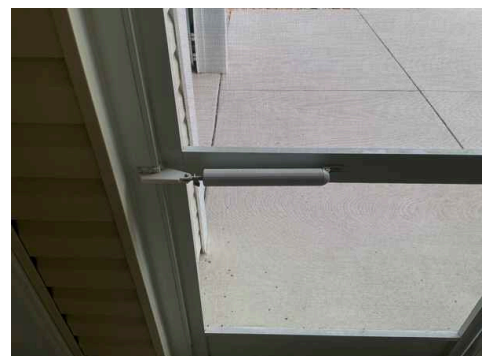
Front Porch

**DOOR CLOSER "SLAM"**

The door closer for the screened in lanai did not work properly. The screen door would "slam" despite any adjustments made on the closer. This closer needs to be replaced.

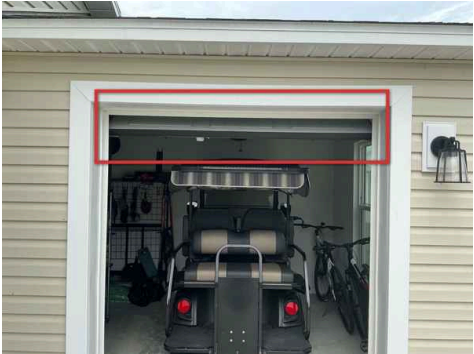
Small Garage Door

**GARAGE DOOR TOO LOW**

Small garage door was found to not open far enough when compared to the large garage door. Suggested qualified contractor properly adjusted this door to open further.

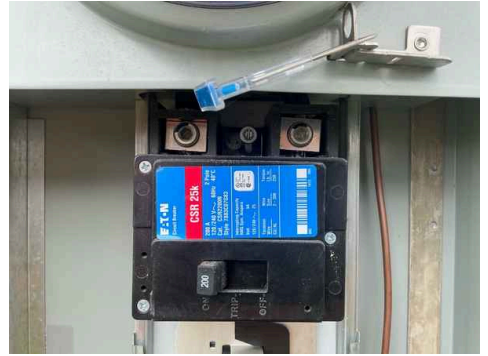
**LUG PROTECTORS**

The main service lugs in the main panelbox were found missing the proper covers to protect the lugs. The protectors are only required at the main breaker/disconnect. The protectors are required by the 2020 National Electric Code 230.62(c), and these new codes have been adapted as of January 1, 2024. Although this is a new code of the NEC, these protectors would be required under the labeling and listing prior to the new code. Suggest a licensed electrical contractor properly install these lug protectors.

Note: NEC 230.62(c)

Barriers shall be placed in service equipment such that no uninsulated ungrounded service bus bar or service terminal is exposed to inadvertent contact by persons or maintenance equipment while servicing load terminations.

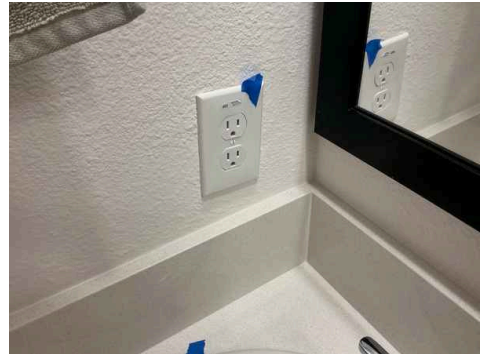
Master Bathroom

**LOOSE RECEPTACLE**

One or more loose receptacle(s) was found in the above location. Blue tape was placed here. Suggest repair by a licensed Electrician.

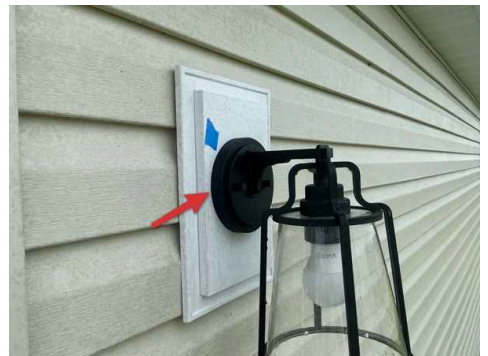
Right Side of House

**LIGHT FIXTURE GAPS**

Gaps were found along the backplate of the surface mounted lights by the side door. Suggest caulking these fixtures to minimize possible moisture and pest intrusion.

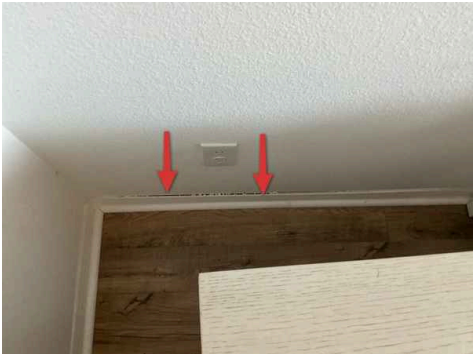
Master Bedroom

#### BASEBOARD TOO TIGHT

The baseboard in the master bedroom was found installed too tight. This causes the baseboard to bow and pop away from the wall. This is aesthetically unpleasing. Suggest qualified contractor properly repair this issue.

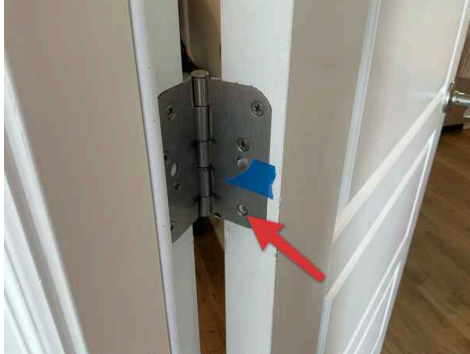
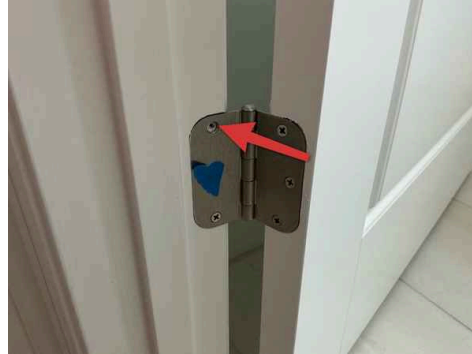
**HINGE SCREW MISSING**

One or more screws were found missing from the hinges on the door located below. This is aesthetically unpleasing. Blue tape was placed in this area. Suggest a qualified contractor properly install these missing screw

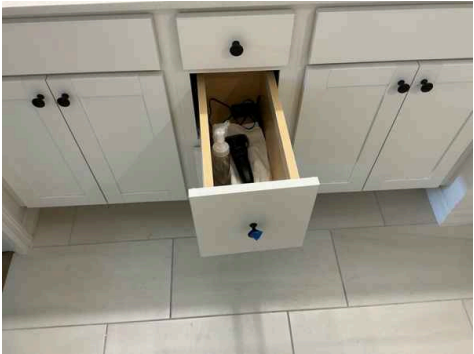
Master Bathroom

#### CROOKED DRAWER PULLING OUT

One or more of the drawers was found pulling out crooked. This is aesthetically unpleasing. Suggest a qualified contractor properly adjust or repair this issue.

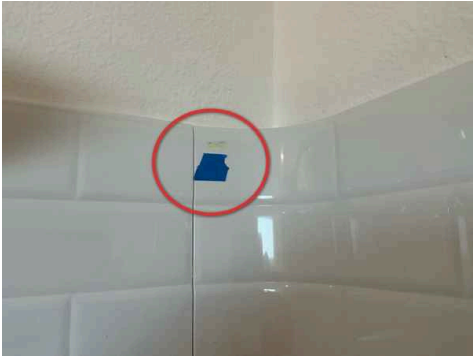
Guest Hallway Bathroom

#### YELLOW FINISH

An abnormal yellow mark/finish was found on the tub surround in the above location. This is aesthetically unpleasing. Suggest a qualified contractor properly remove this mark/finish.

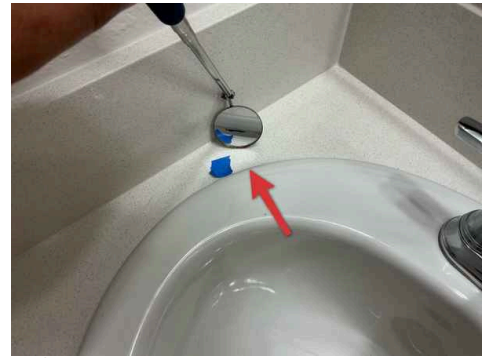
Left Sink

**SINK CAULK**

There were gaps found along the seam between the vanity countertop and the vanity sink(s). These gaps could allow water to get under the sink into the countertop substrate and the cabinet below and damage both the countertop and the cabinet. Suggest recaulking to prevent this potential damage.
