PROPERTY INSPECTION REPORT

Gregory Walker HI-4060
AAA Inspection Services, LLC

Date of Inspection: 8/9/2022

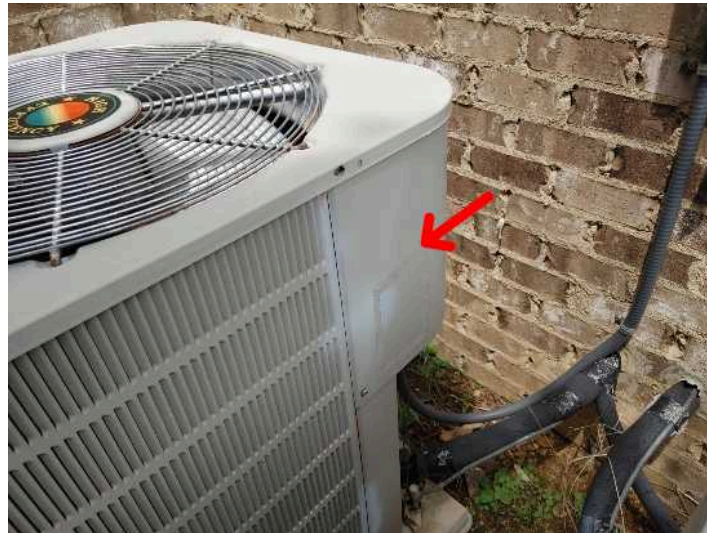
- Air cooled
- Heat pump
- Split System
- Location: Exterior side wall
- Brand Name: Frigidaire
- Model # Unknown data tag missing
- Serial # Unknown
- Approx. Age Unknown
- Energy source Electric
- Outside Disconnect Yes, Fuses/Breakers installed (amps)
- Level: Yes
- Condenser Fins Satisfactory
- Insulation: Yes
- Marginal

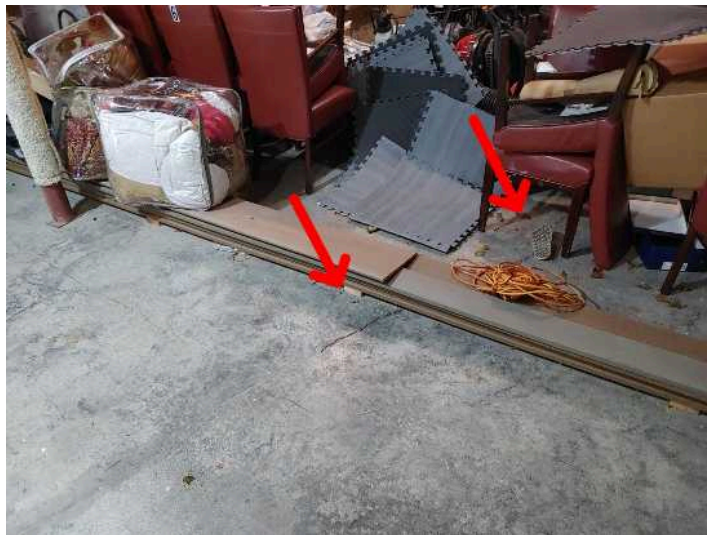
8. Floor

- Concrete
- Typical cracks
- Burners less than 18" above floor No
- Recommend sealing cracks on the basement garage floor

Page 16 Item: 8	Floor	• Recommend sealing cracks on the basement garage floor
-----------------	-------	---

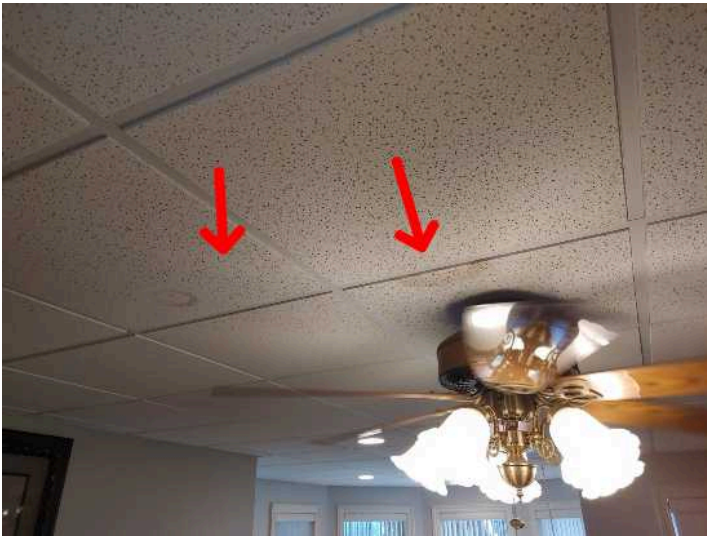
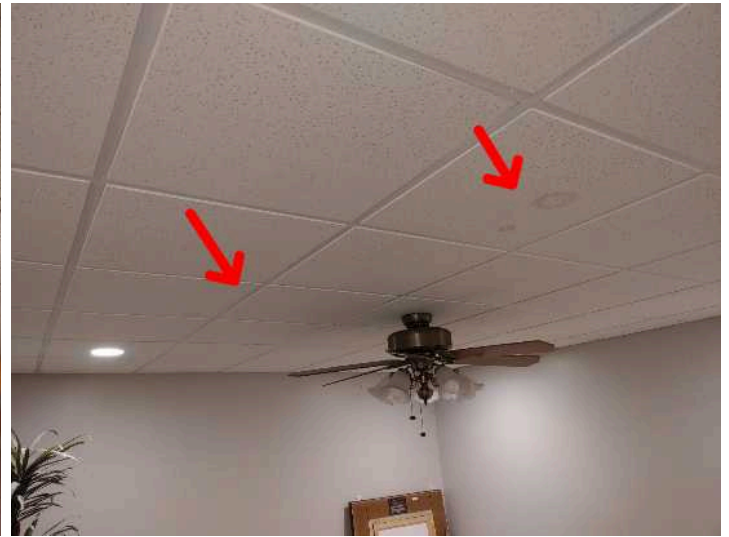
1. Den

- Basement
- Walls & Ceiling Marginal
- Moisture stains Yes
- Floor: Satisfactory
- Ceiling fan Satisfactory
- Electrical Switches Operable, Yes
- Electrical Receptacles Yes, Operable
- Electrical Open ground/Reverse polarity No
- Heating source present Yes
- Doors: Satisfactory
- Windows: Satisfactory
- Stains present on the ceiling tiles recommend replacing

Page 28 Item: 1	Den	• Stains present on the ceiling tiles recommend replacing
-----------------	-----	---
