## The Resurrection of a BG FS-520i Speaker

## The Repair Plan and Implementation;

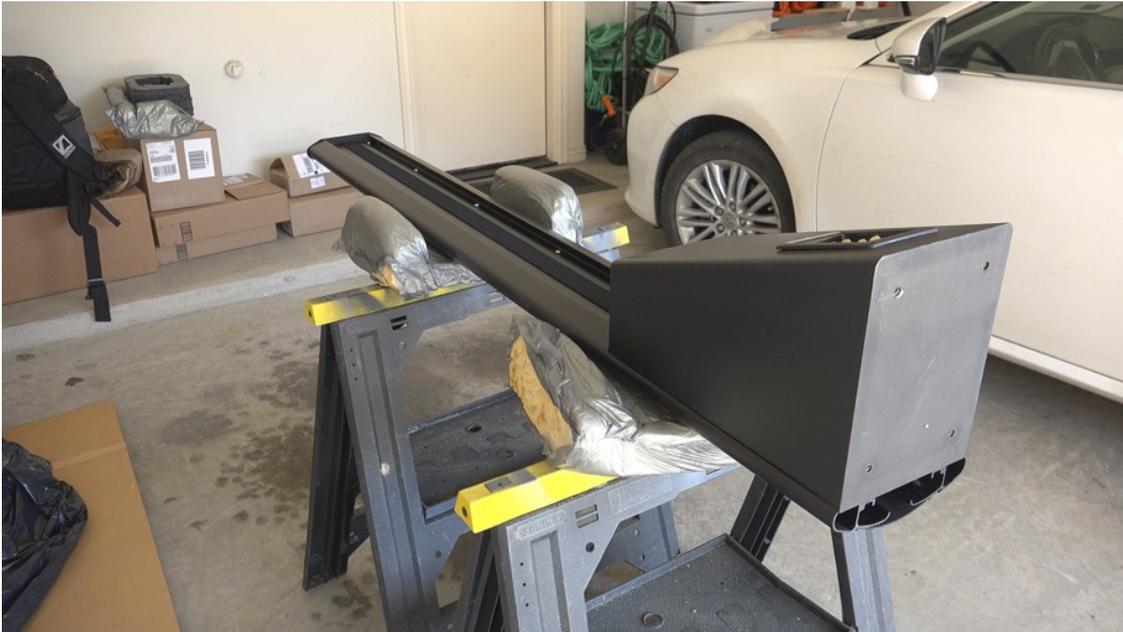
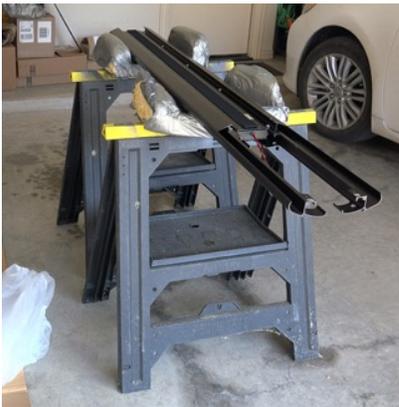
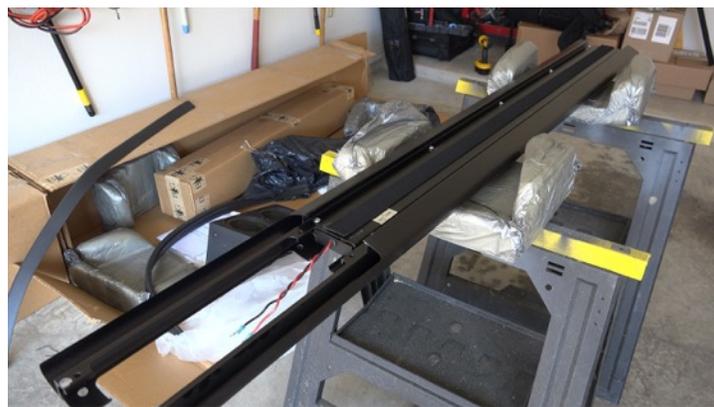
1. Dis-assemble the speaker to remove the ribbon module

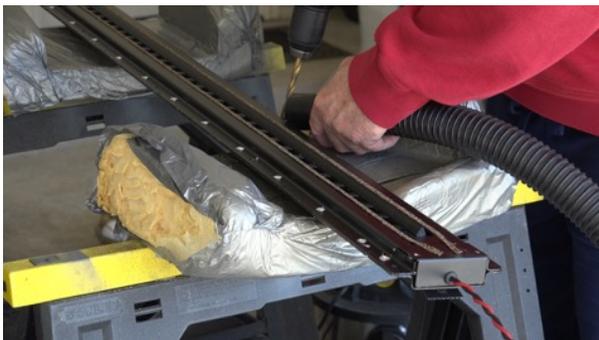
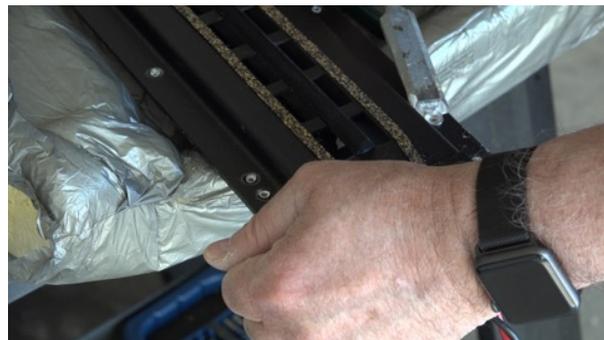
2. Once the ribbon module was completely removed from the frame I had to drill and remove all of the rivets that held the clamshell of the housing together.

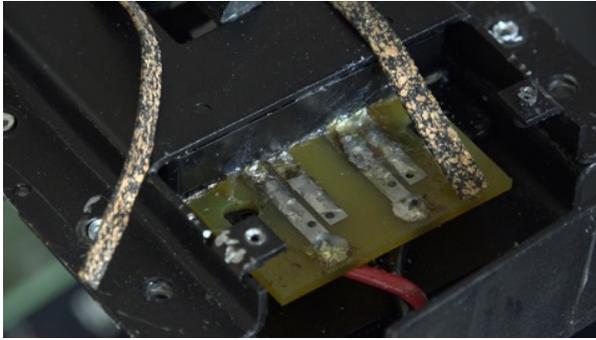
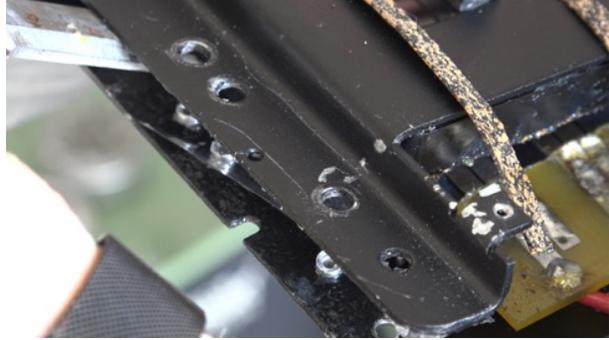
3. I had to clean the “puckey” from the contacts to get a better look at where I thought the break was. Failing that I started to pry the clamshell apart so I could get to the broken ribbon at the connecting circuit board that I had identified.

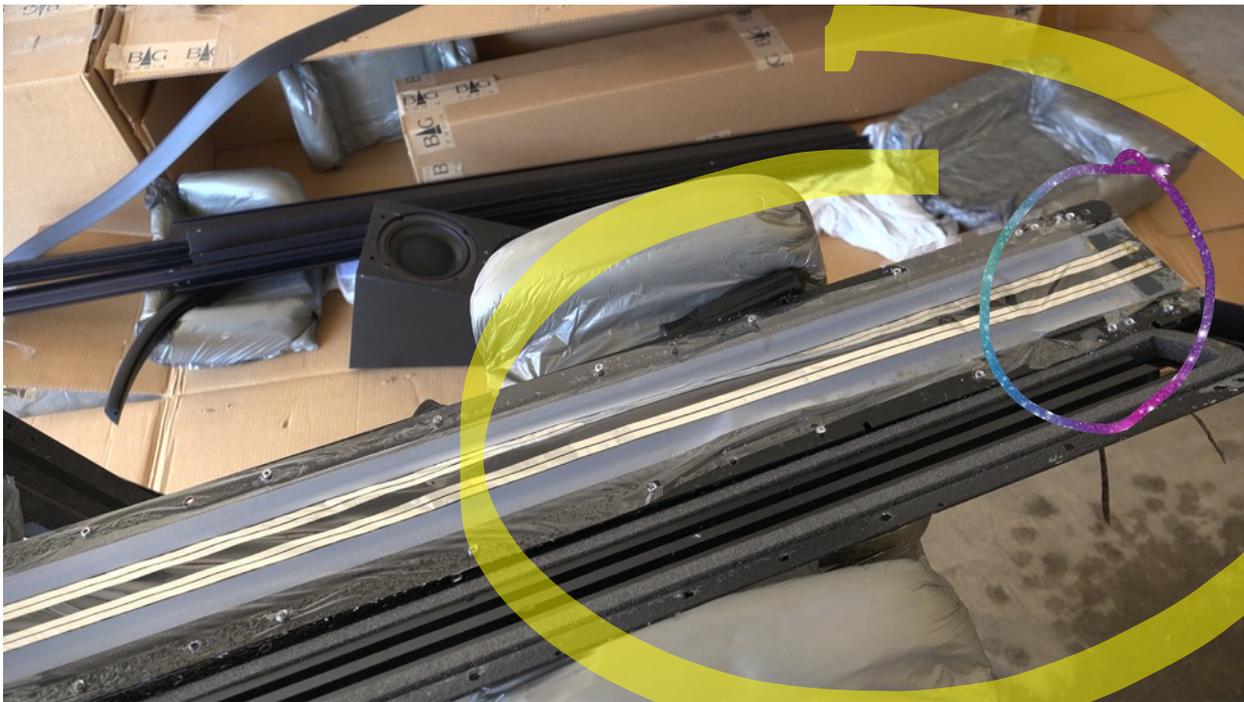
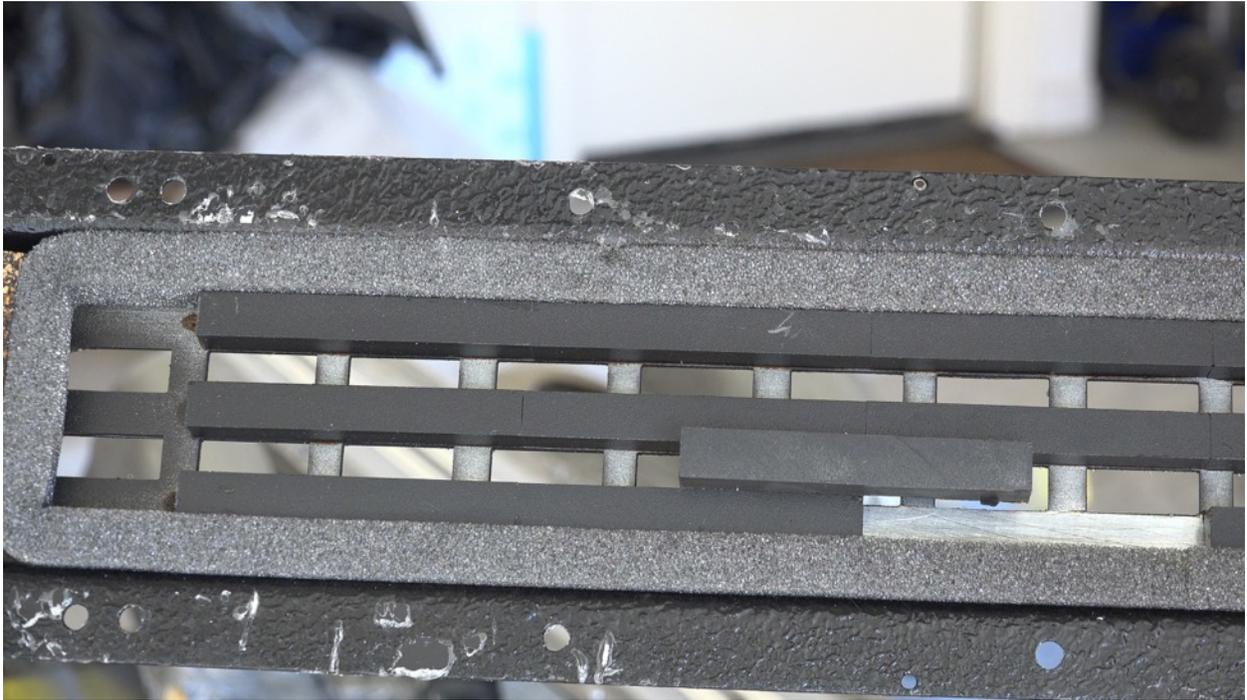
4. The magnets that surround both halves of the clamshell decided to make a break for it and jumped the top half of the clamshell to one side. Now desperate I quickly pried the clamshell completely apart to find that the ribbon had been pushed to the side with a bit of damage to the membrane that the ribbons float on.

One magnet was even pulled from it's resting place but luckily did no further damage to the ribbon!

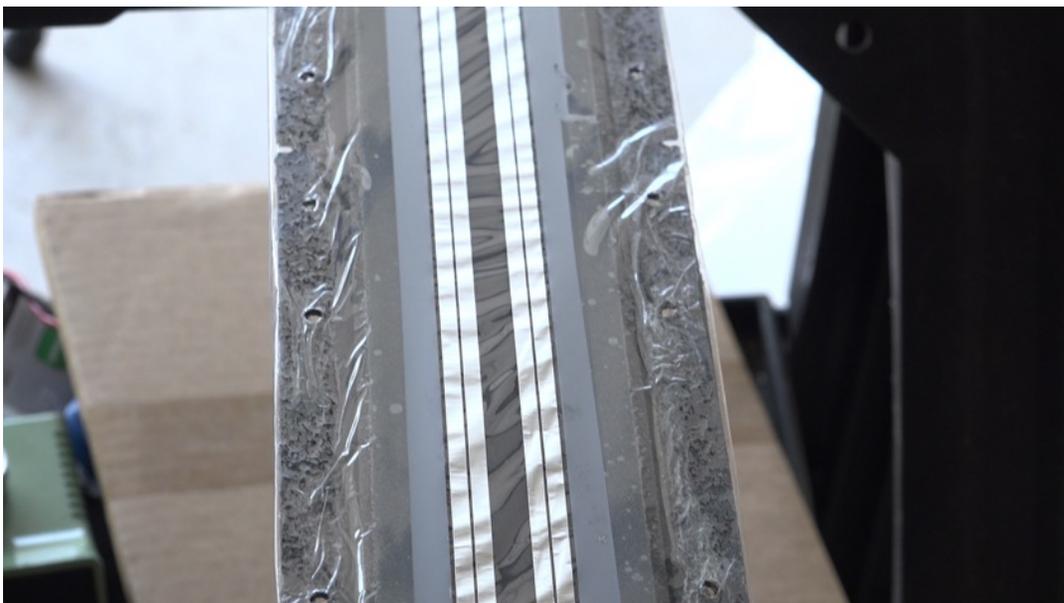
***5. In addition, the circuit board at the top of the speaker was torn off and separated from all four ribbon strips! Ugh! I considered packing it in at this point but drew a deep breath and started thinking..... Hmmmmm!***

6. I decided to forge ahead with a new plan. I reinforced the damaged membrane with clear packing tape and at the same time pulling the ribbon back into some semblance of the original shape.

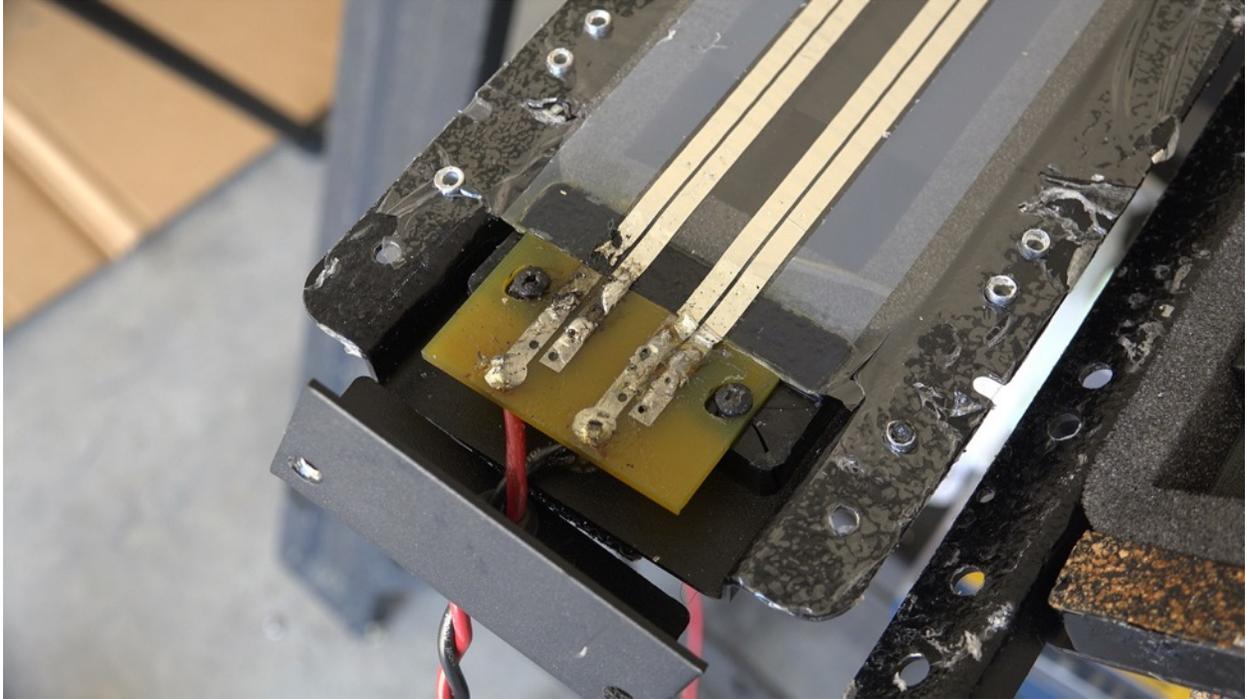
7. After trying to bridge the breaks in the connections with solder I discovered that the ribbons were too fragile to solder to effectively.

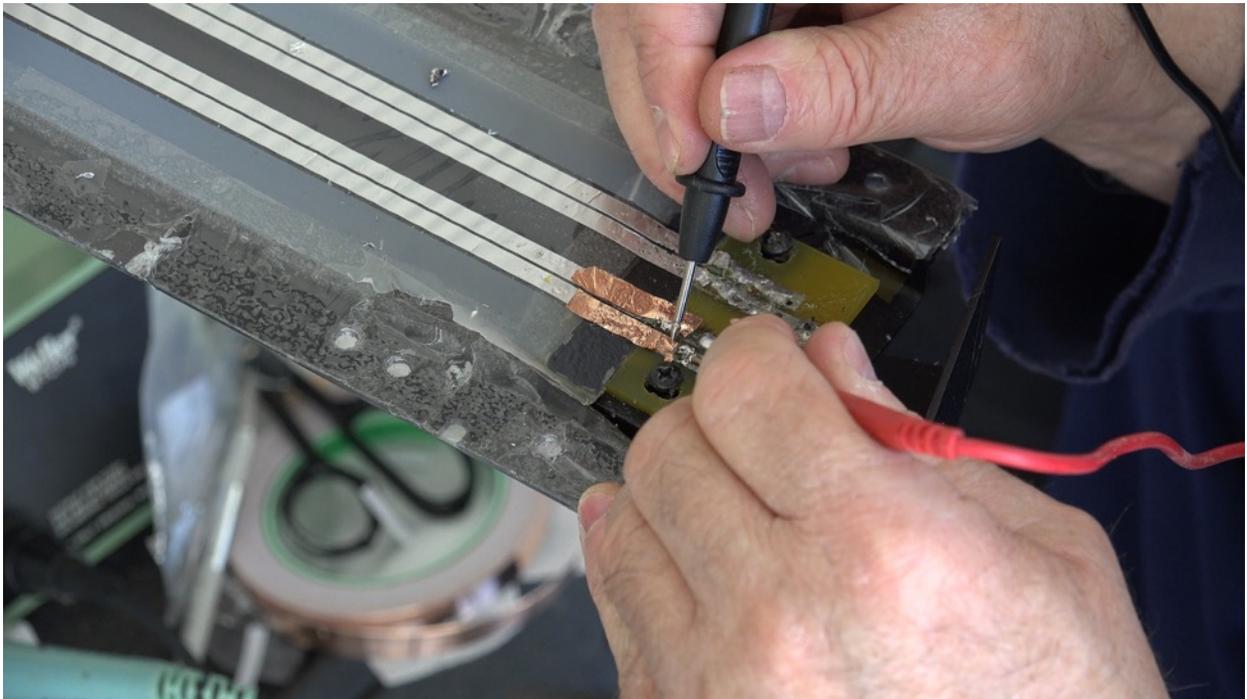
8. **New Plan Version 2.0** - I ordered some conductive foil with conductive glue to bridge the gaps but the glue would not adhere.

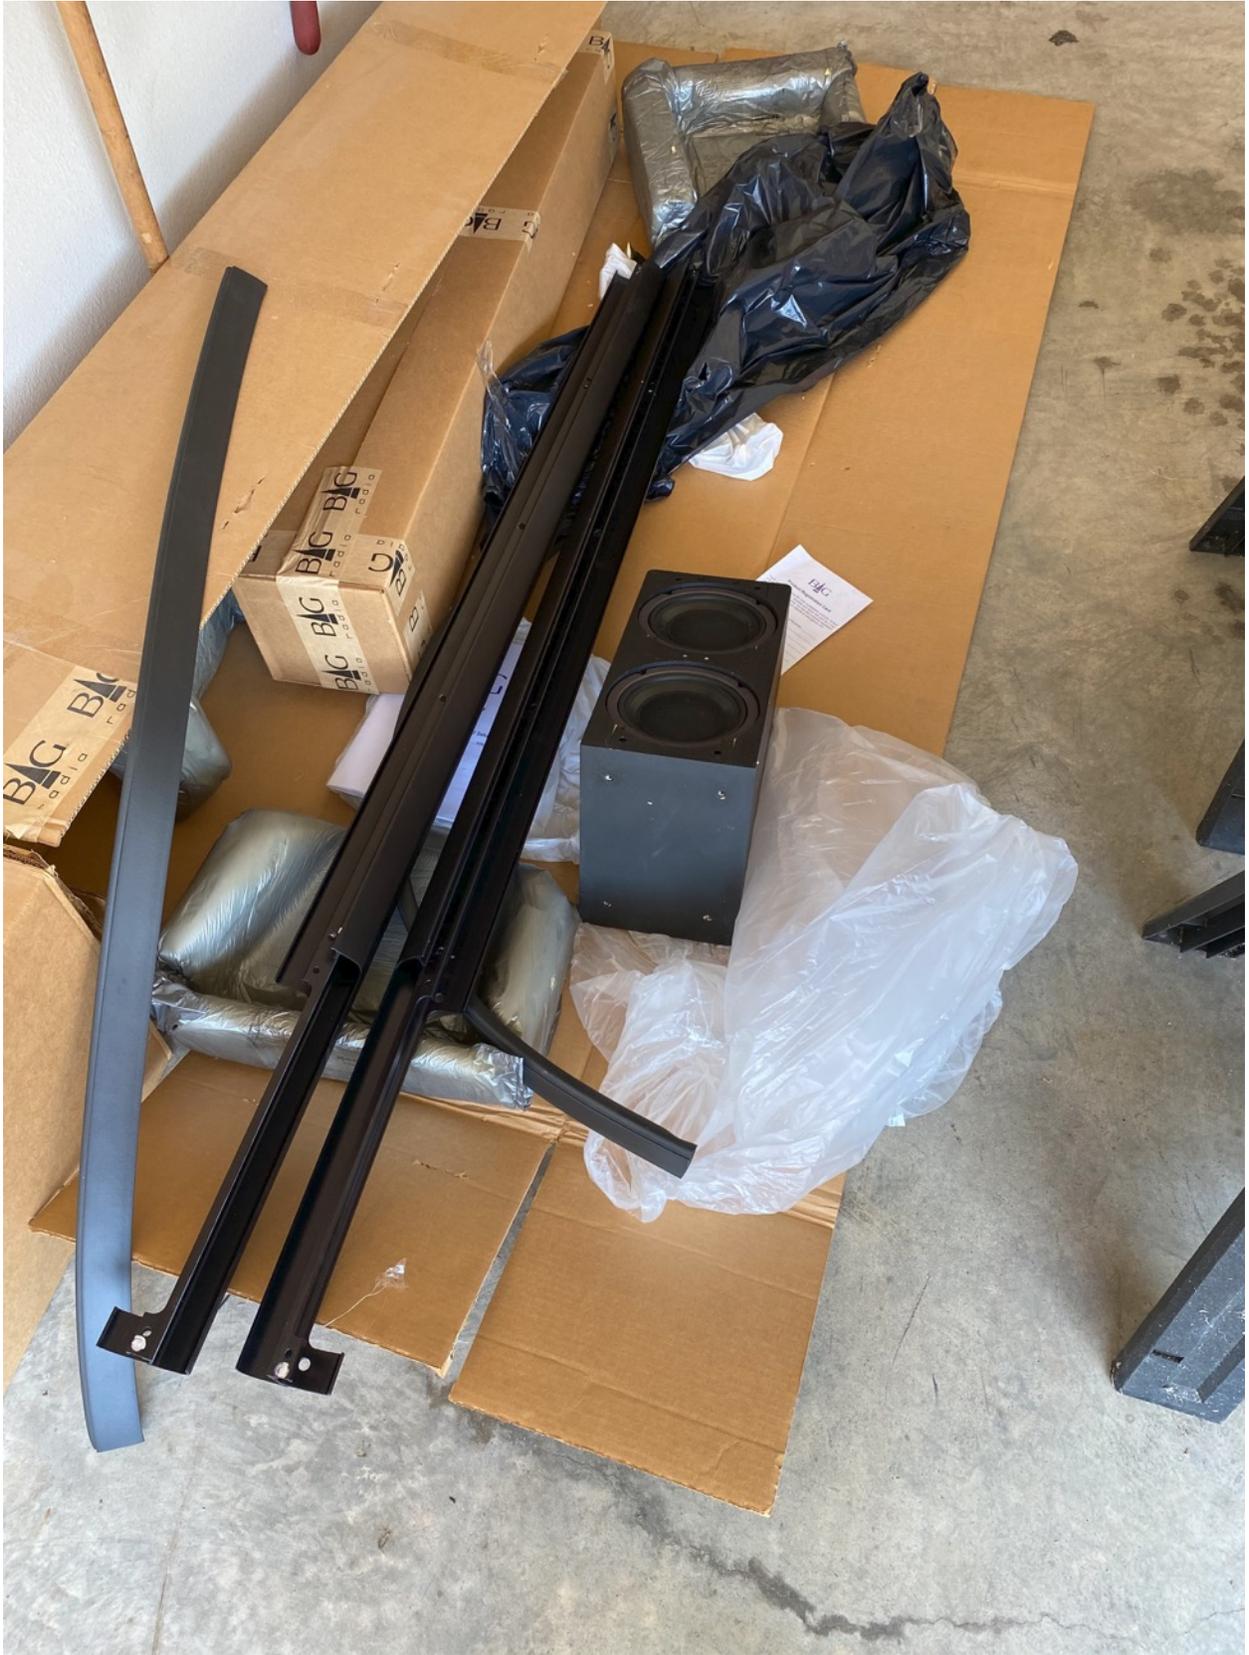
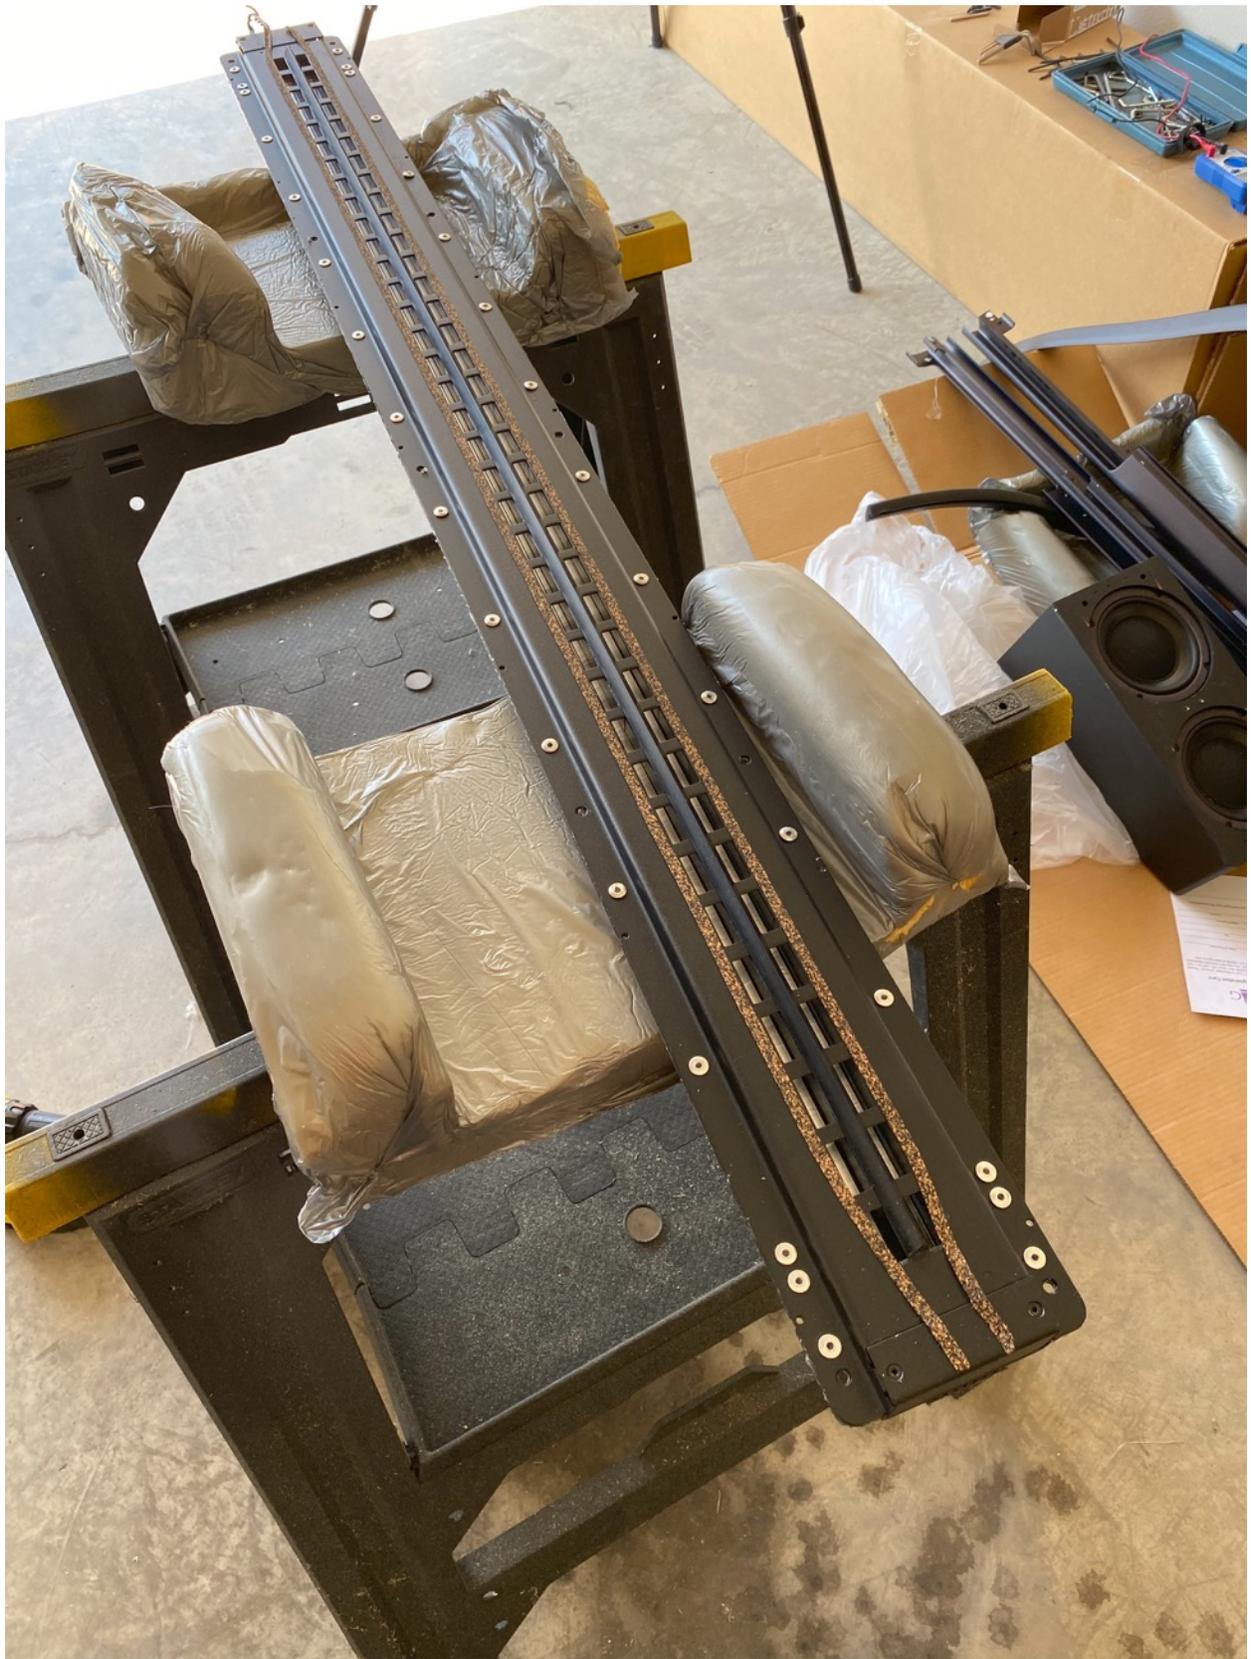
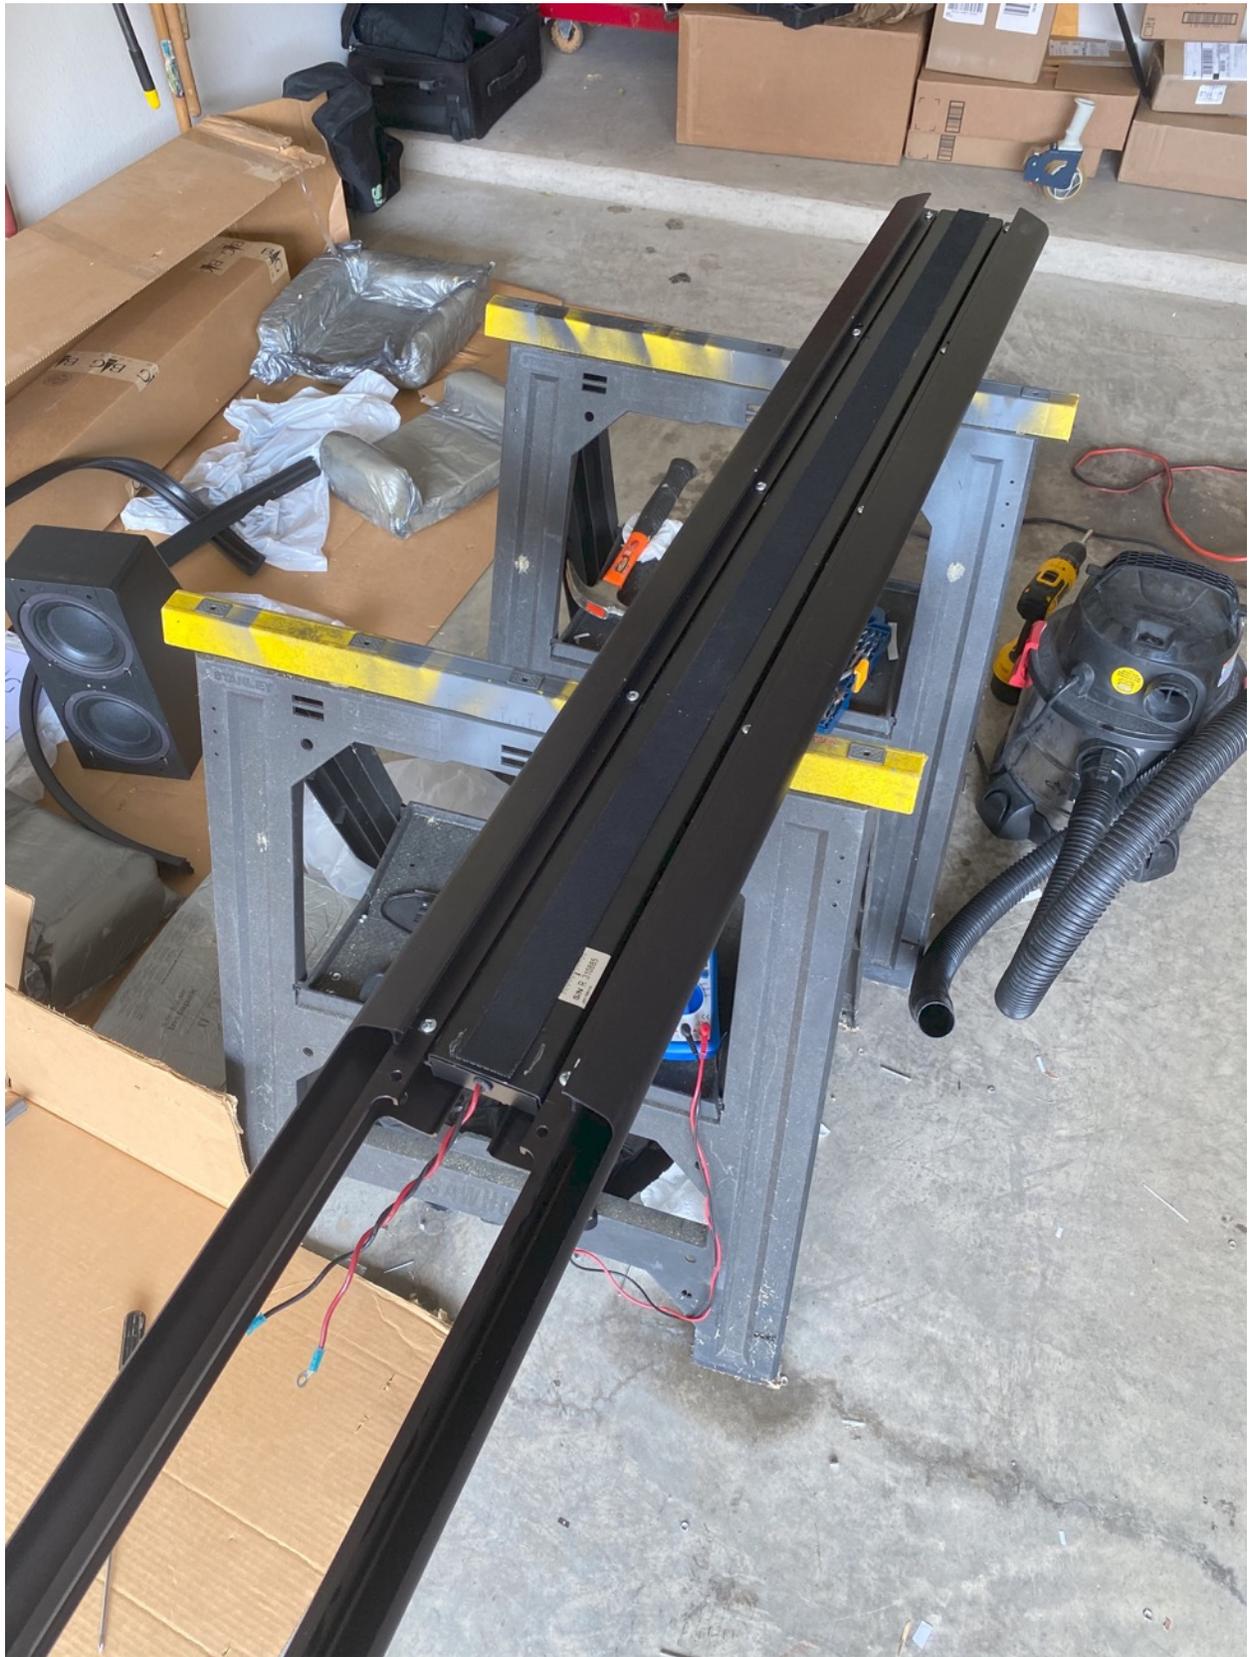
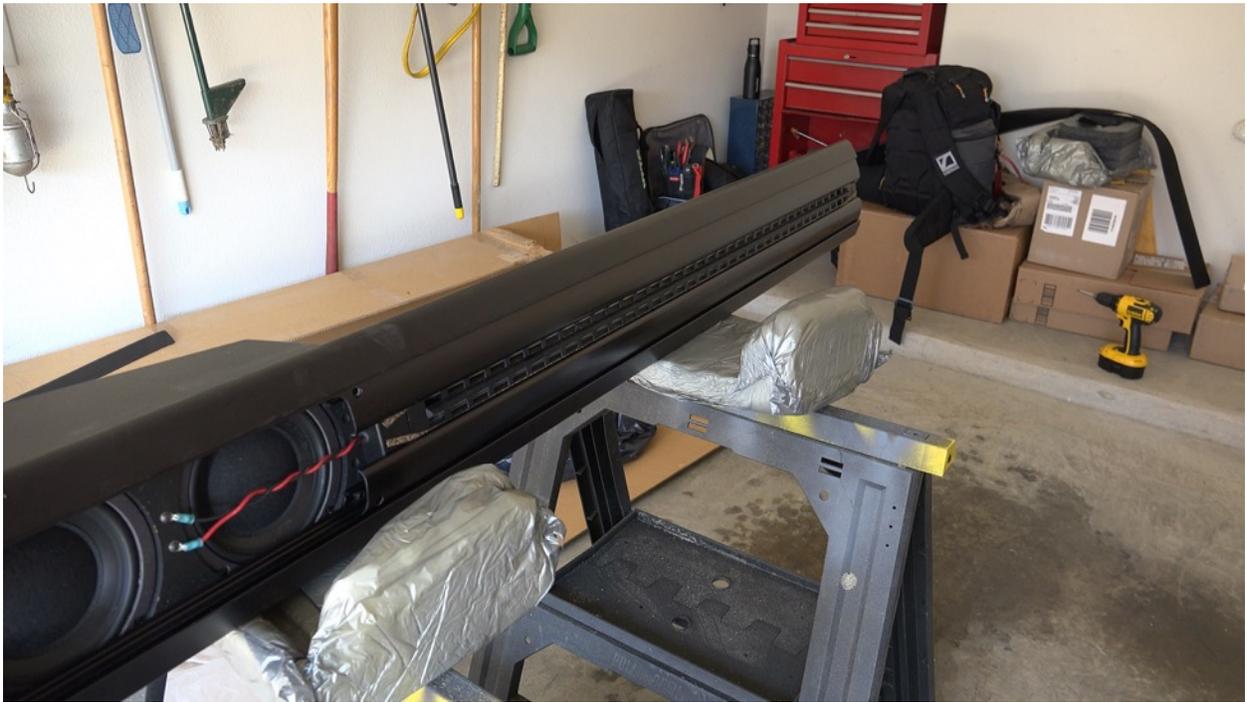
16. I started the reassembly of the speaker.

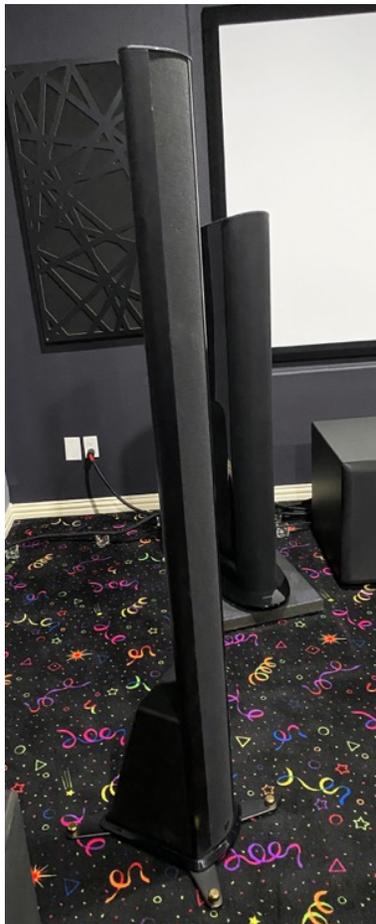
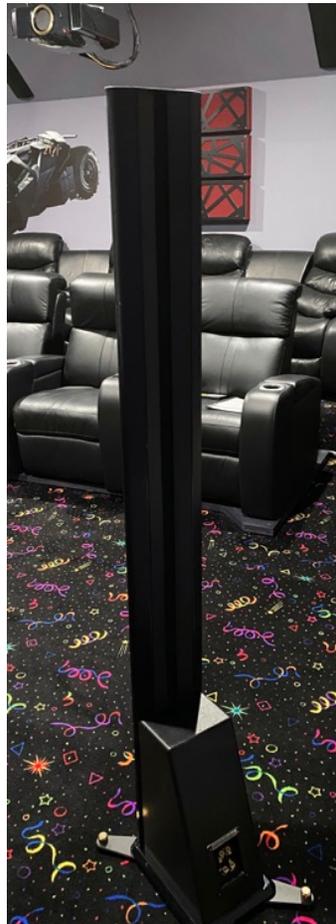
17. Once completely reassembled I carried the repaired speaker up to my listening space and connected it to the system.

**IT WORKED!** I was a little gun shy and did not turn it up too loud but instead left it playing at a moderate volume on the right side while my GoldenEar Triton One.R continued playing on the on the left.
