# The Coles Valley (Joller) Branch

by Rich Keller, d., and Vagel Keller

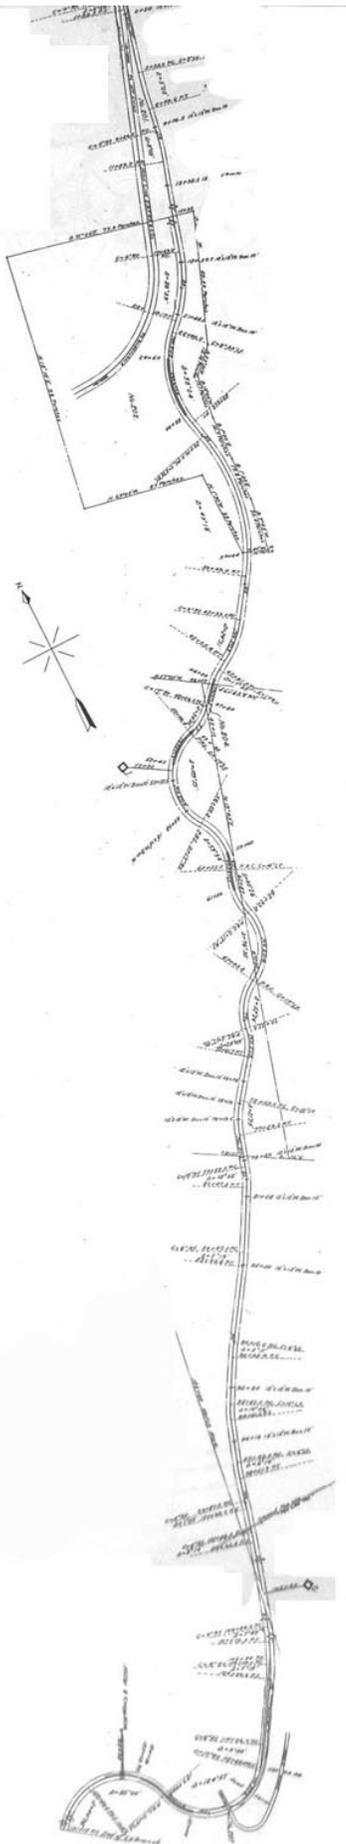
The Midvalley, or Joller, Branch, is shown in its entirety in the map from the EBT's 1917 Interstate Commerce Commission (ICC) valuation map at left. It diverged from the mainline north of the Rocky Ridge tunnel and climbed south for slightly more than 2-1/2 miles on a 2.7% grade to reach the independently owned mine of the John H. Miller Company at the village of Midvalley, opened in 1915.

**Map Study.** The ICC Valuation Map of 1917 (SEE Page 1) shows a single track into the Midvalley Mine. This line crosses the “public road” at the hairpin curve heading down the mountain toward Coles Valley. Therefore, it would pass through the higher cut on the mountain. If the lower grade and cut were the older of the two the mine opened well before the date of 1916 recorded in Rainey and Kyper’s definitive *East Broad Top* (Golden West Books, 1984, out of print), which is highly unlikely.

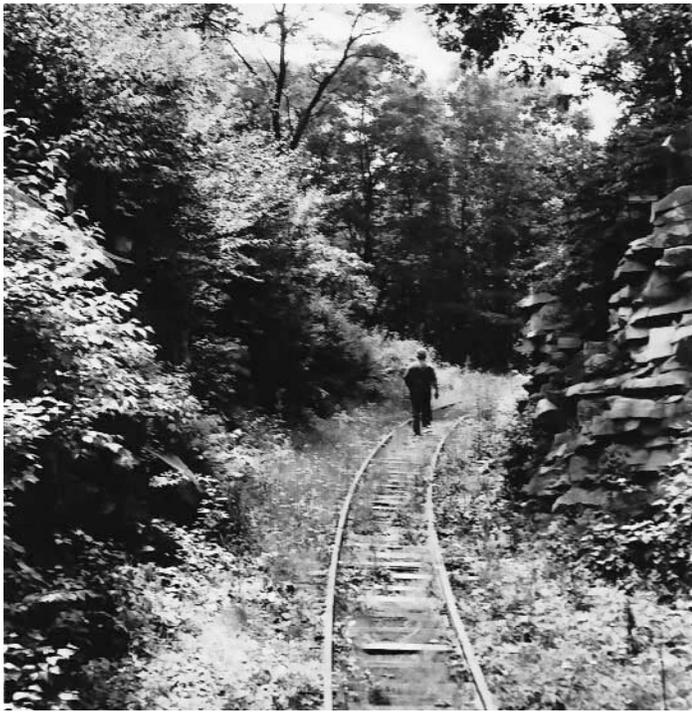
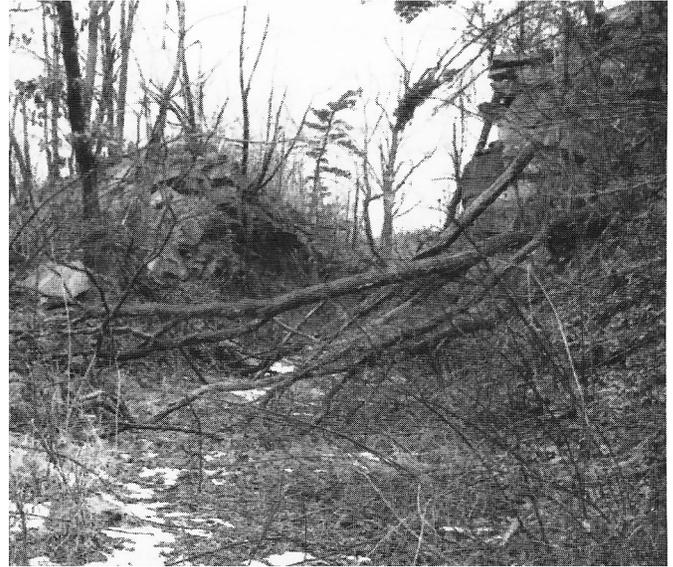
The approach to the Midvalley Mine, at left in 1940 and below in 1991, viewed from the north end of the cut just before the grade crosses the “Public Road,” present-day State Highway 994 at the far end of the cut. The 1940 photo is by a railfan on the excursion mentioned in the text.

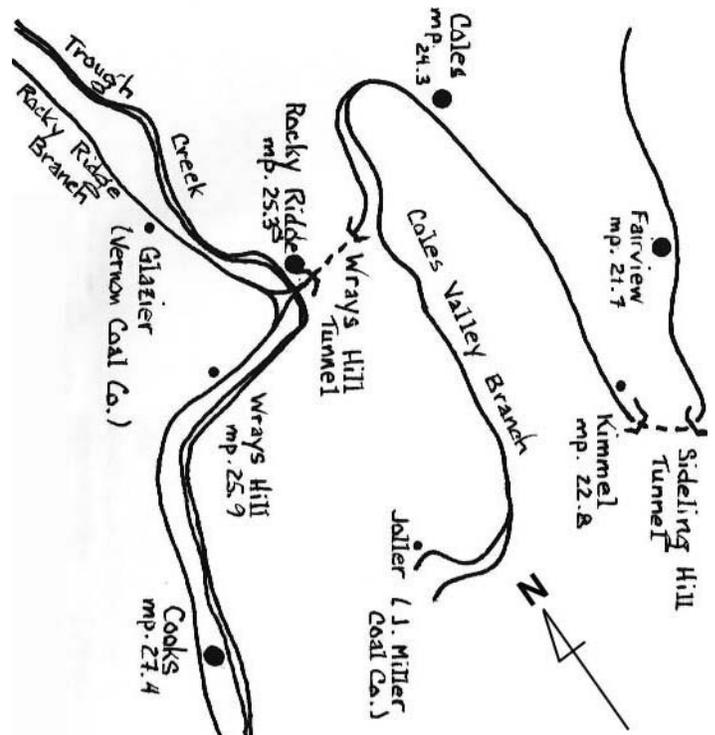
But a detail of the East Broad Top System Map of 1921, at right, shows two separate tracks going into the mines. By then the area had been renamed Joller, rather than Midvalley, apparently to avoid confusion with another post office of the same name in eastern Pennsylvania. (“Joller” is a contraction of the first two letters of Miller’s given name and the last four of his surname.) Both of the spur tracks to the mines appear to be about  $\frac{3}{4}$  mile in length and, at some point, are at least  $\frac{1}{4}$  mile apart. The map of the coalfields in *East Broad Top*, p. 15, shows two tracks serving separate openings; the upper one being Midvalley and the lower the Joller Mine. Later both of these mines were served by a shaft house and tipple on the upper grade at the site of the old Midvalley tipple.

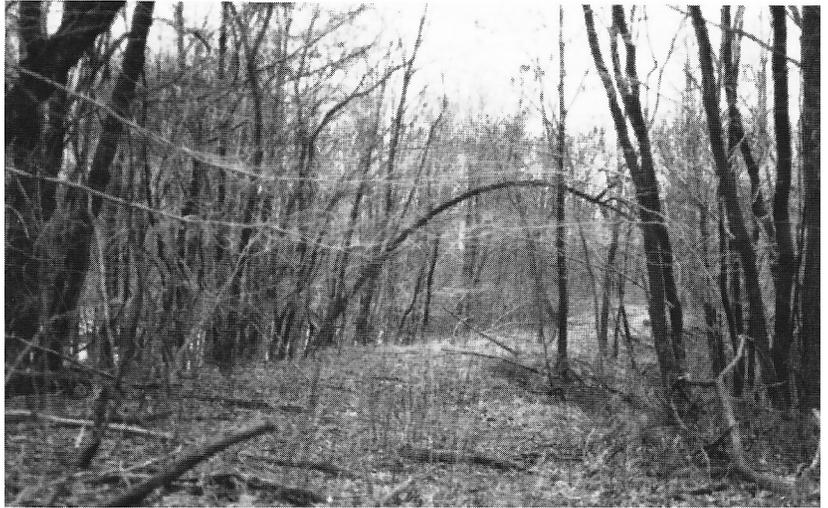
Abpve. this view of the S-curve fill at Midvalley (Joller) looks north from the location of the Miller Company store toward the highway crossing. The curve, and the trestle it replaced, was a complex structure, having both horizontal and vertical curvature. The grade descends to a low point at the middle of the reverse curve, then slopes back up to the tippie, which was behind me in this view.

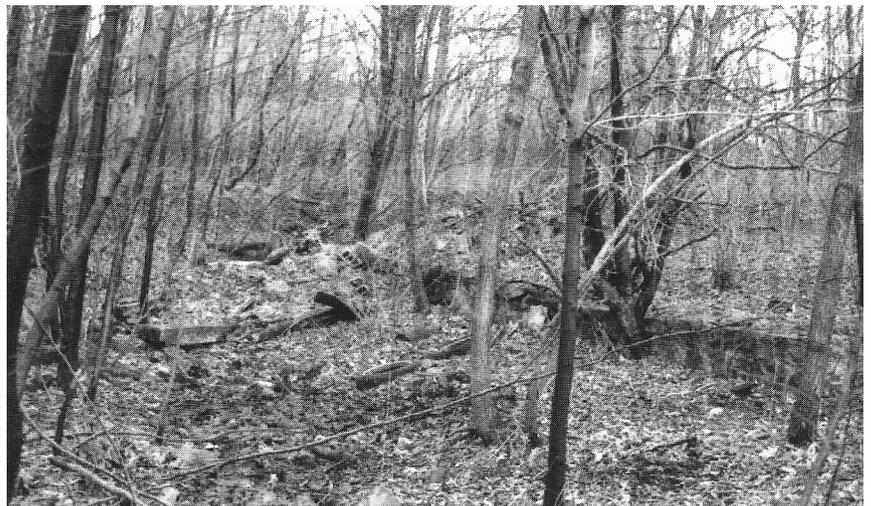
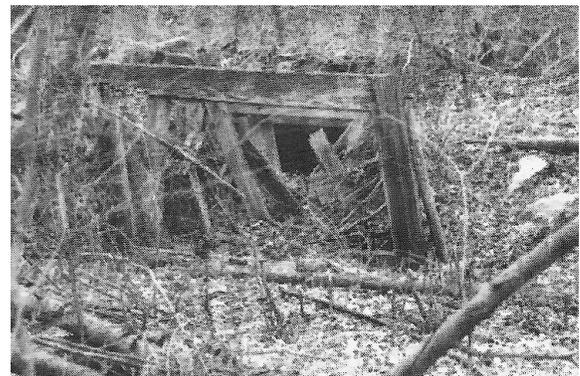
The approach to the original Miller & Knepp, or Midvalley, Mine was marked by a stone and mortar retaining wall. The caved-in entrance to the mine was left-center in this view. The timbers marking the opening to the old Martin truck mine, below, were also still visible in 1991.

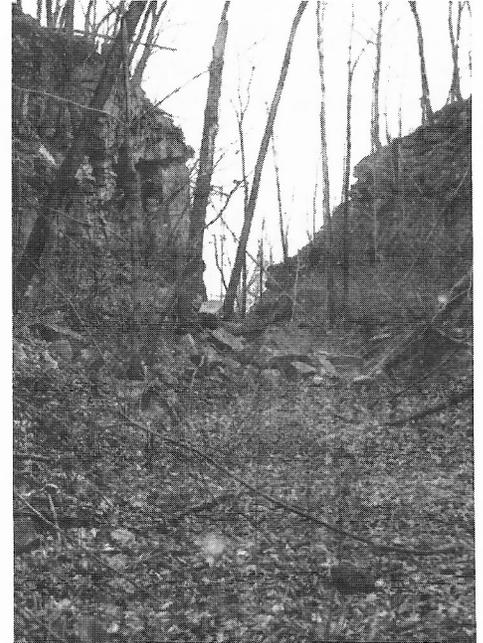
At left, the grade for the tram from the Joller slope mine to the tipple is marked by a dry masonry stone retaining wall. The tipple, destroyed by fire in 1937, was in the distance.

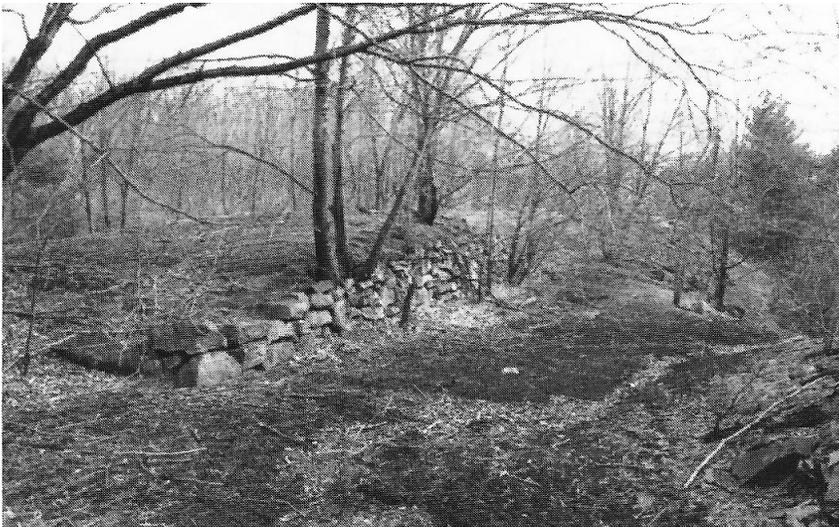
The lower cut lies over a steep drop east of and below the PA 994 hairpin curve and is longer and deeper than the older cut higher up the hillside. In this view from the south (tipple) end, above, the highway is above, left, while the grade crossing, obliterated by later road work, is beyond the far end.

**The Lower Cut and Fill.** Approaching the lower, Joller, mine, the railroad grade goes through a more massive rock cut than does the upper line; it is nearly three times as long and much deeper. In 1991 it was in very good shape, with a minimum of fallen rock, and you could walk its full length if you were determined.

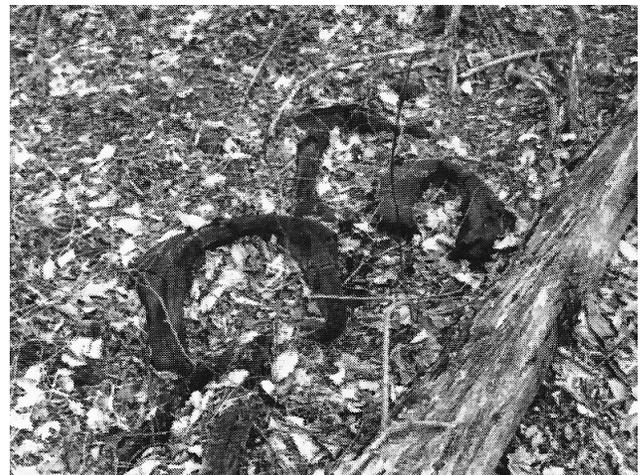
In 1991 we found the remains of the mule stable on the hillside southeast of the 1937 tipple site. Among the rotting timbers leather mule collars could still be seen. The author retrieved them, and they now reside in the FEBT's collection in Robertsdale ... saved from destruction by later environmental reclamation of the area.

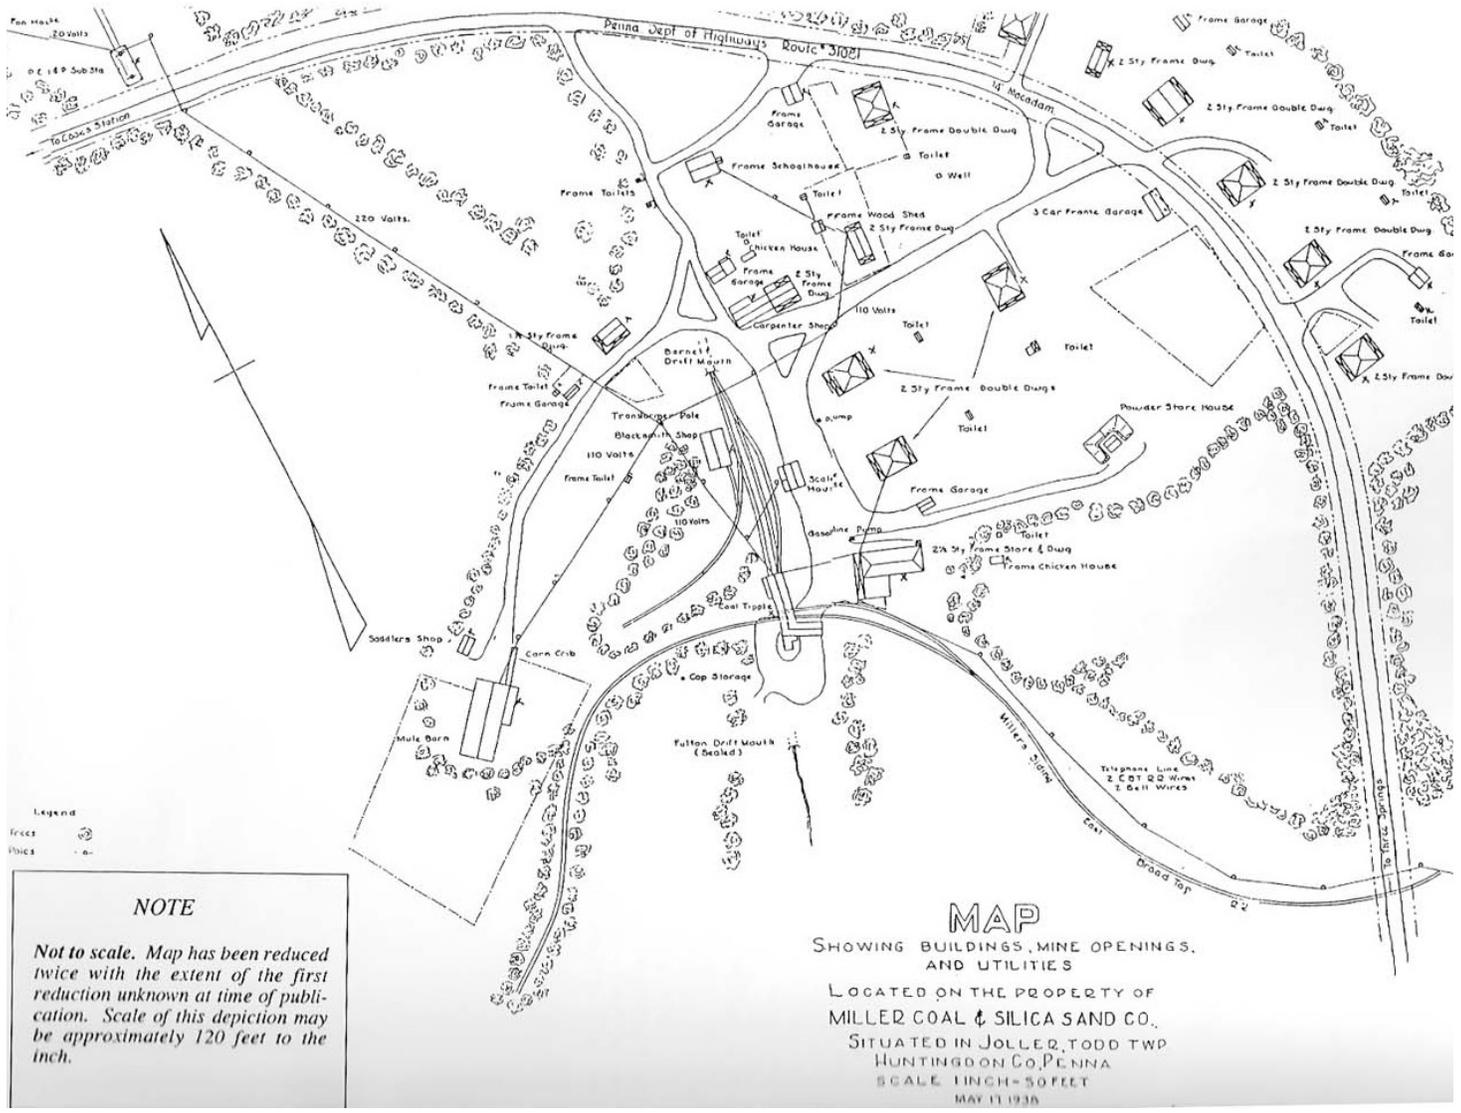
This map from the collection of the Broad Top Area Coal Miners Historical Society shows the surface mining facilities and commercial and residential structures at Joller as they were in 1938. The tipples and store are at center; the mule barn is to the left of them.
