Level 1, Premium Reserve Analysis

# Somerset Estates HOA Highway 52 & Somerset Dr. Niwot, CO. 80544

Report Period – 01/01/25 – 12/31/25

Date of Property Observation – January 28, 2025

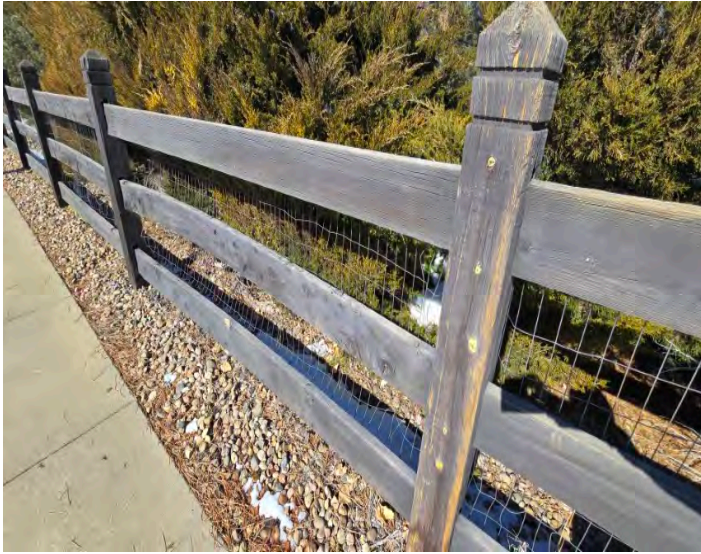
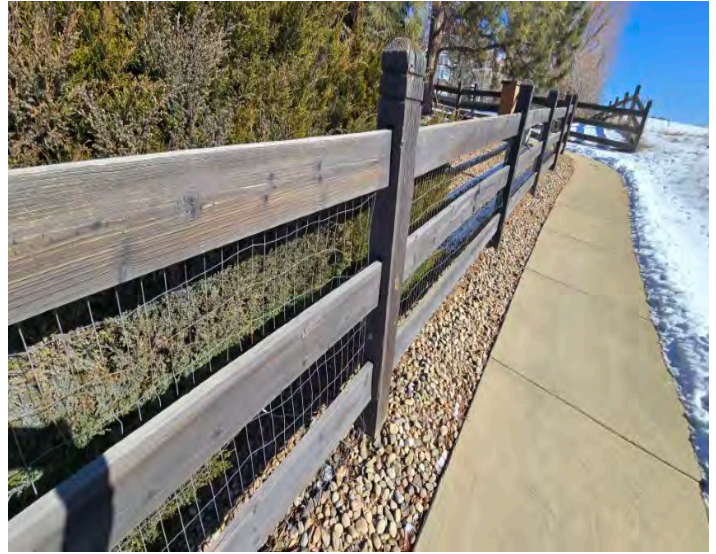
Comp #: 209      Rail Fencing - Restain

- Fences were stained in different stages in 2020, 2022, and 2023. Overall appearance reveals thin areas and exposed wood throughout.
- Based on observed condition of the majority of the fencing, we recommend addressing this again in the near future to ensure there is complete coverage.
- In this climate, we recommend staining wood fences every 2 - 3 years to maintain appearance and protect wood surfaces from exposure to elements that will cause deterioration.

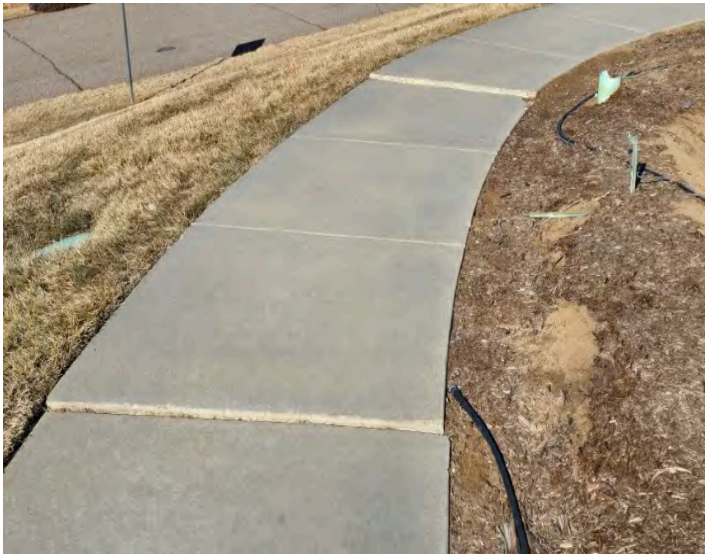
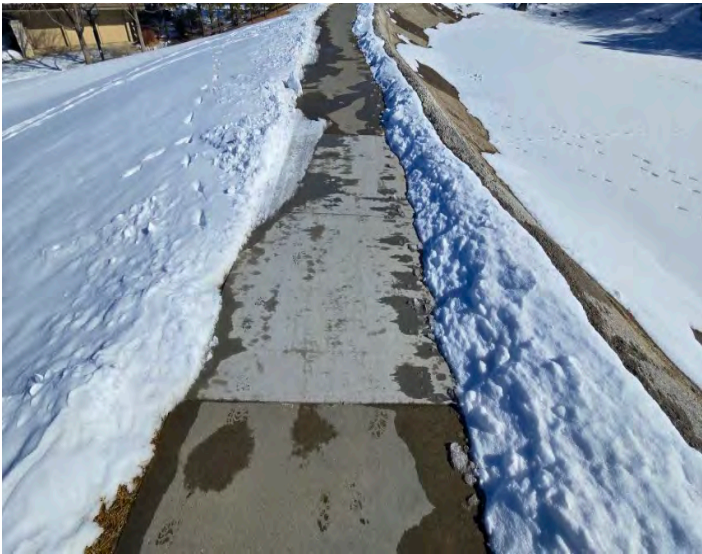
Comp #: 601      Concrete Flatwork - Partial Replace

- Observations:*
- A couple trip hazards were noted on the sidewalk around pond #2. Some repairs have been recently completed. Overall, conditions of concrete vary throughout community.
  - It is unlikely that all will fail at the same time, therefore, we recommend reserving to replace approximately 10% of the total area (1,065 GSF) every 4 years.
  - While there are no immediate concerns, we recommend being prepared for repairs to maintain a safe environment for the community.
  - If possible, coordinate this project with other concrete and/or asphalt projects for best cost estimates based on quantity of work.

*Best Cost:*                    **\$14,935**  
Allowance to repair 10% of area every 4 years

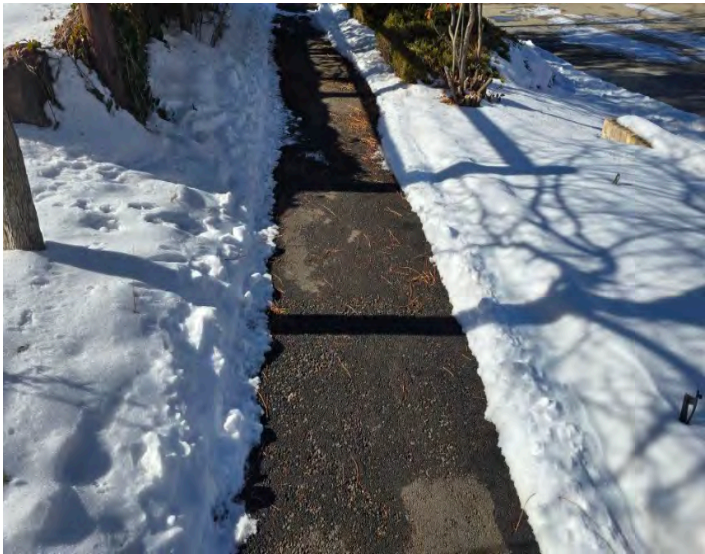
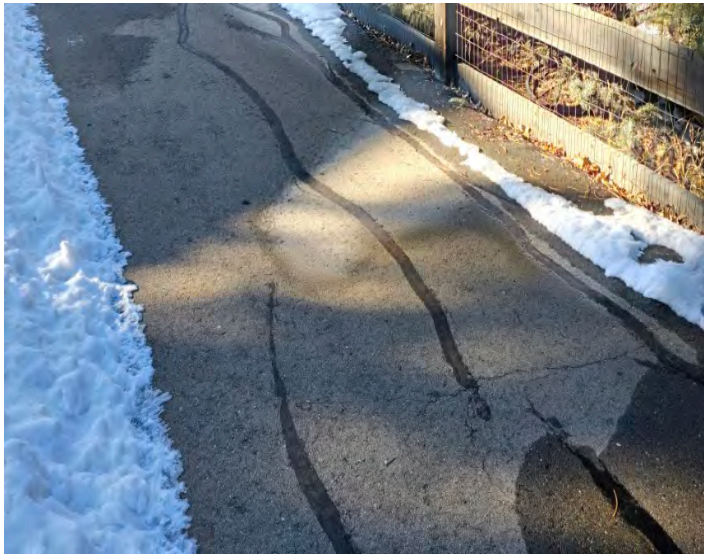
Asphalt Pathways - Major Overlay

- The average life expectancy for asphalt surfaces ranges between 15 - 20 years for surfaces that are maintained on a regular schedule.
- Maintenance includes crack fill and repairing small potholes annually as an operating expense.
- In addition, asphalt should be seal coated every 3 - 4 years, depending on the level of traffic and snow removing techniques.

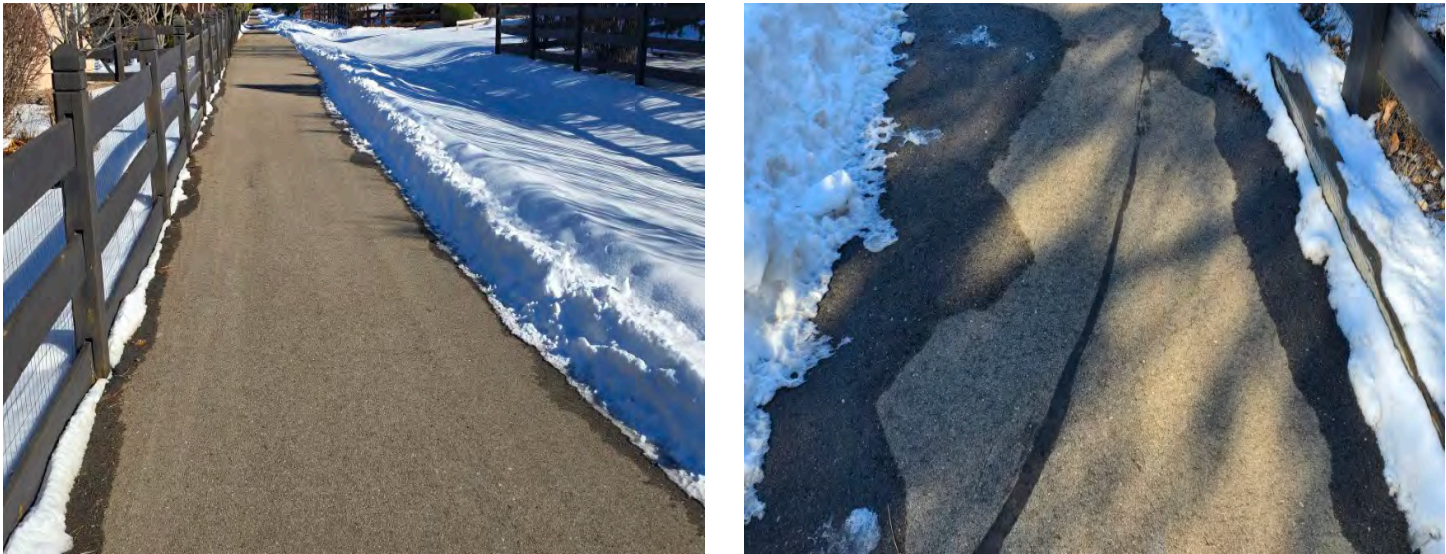
Asphalt Pathways - Surface Application

- It is important to maintain a proper seal cycle to protect the integrity of the asphalt and prevent extensive cracking, development of potholes, and loss of emulsion, which will lead to advanced deterioration.
- Depending on the type of snow removal techniques and the level of traffic, we suggest seal coating every 3-4 years.
- In between seal cycles, the asphalt should be inspected and any cracking that develops should be filled, along with any minor repairs to prolong the life of the surface.

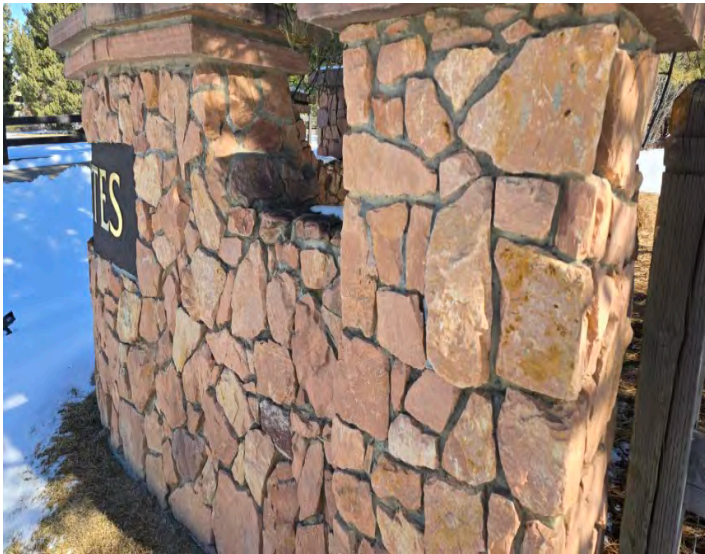
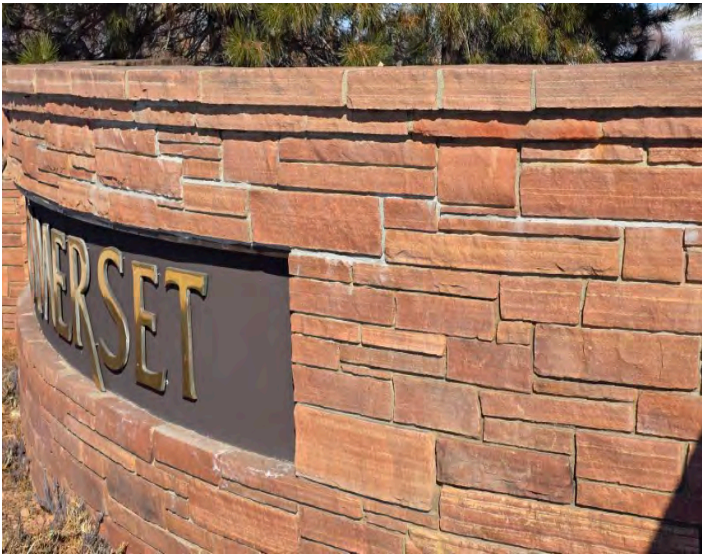
Main Monuments - Rebuild/Major Repairs

- Monuments were recently repaired with tuckpointing, stucco work, and It is unlikely that the monuments will require replacement or rebuilding due to the materials failing.
- Lettering can be replaced as needed and background painted as needed with operating funds
- Therefore, we have established an allowance to inspect and perform minor repairs/renovations to the monuments every 15 years
- Remaining life is based on observed conditions and average age of all monuments.

*Best Cost:*               **\$22,000**  
Allowance for inspection and general repairs

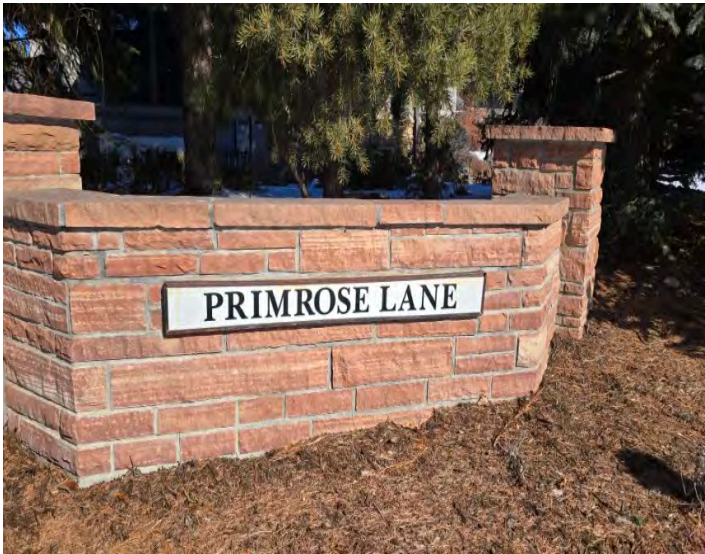
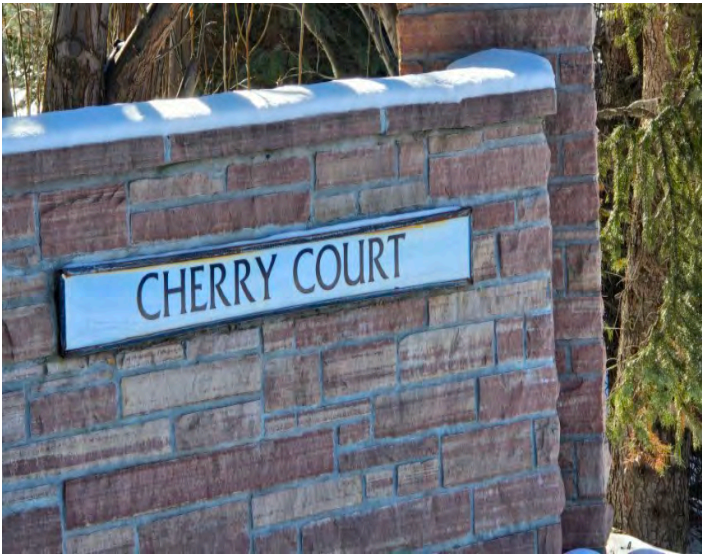
Street Monument - Rebuild/Major Repairs

- At the time of observation, one of the plastic signs on Cherry Court has been recently replaced. It was reported that new electrical has been installed at the monuments, as well as stucco repairs and tuckpointing.
- It is unlikely that the monuments will require complete replacement or rebuilding due to the materials failing.
- The plastic part of the sign with the street name can be replaced on an as needed basis with operating funds
- However, over time, it is possible some of the facade will loosen and need repairs, or the metal sign box will rust and need replacement
- Therefore, we have established an allowance to inspect and perform minor repairs/renovations to the monuments every 15 years
- Remaining life is based on observed conditions and timing of last major repairs

*Best Cost:*                    **\$67,500**  
Allowance for inspection and general repairs

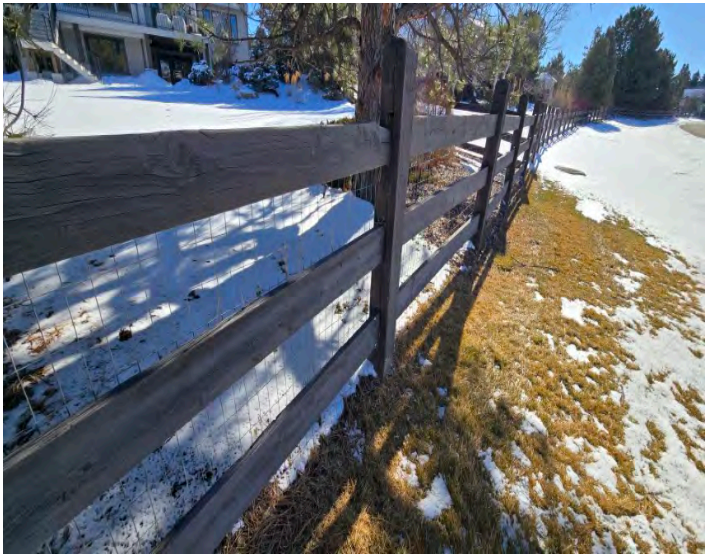
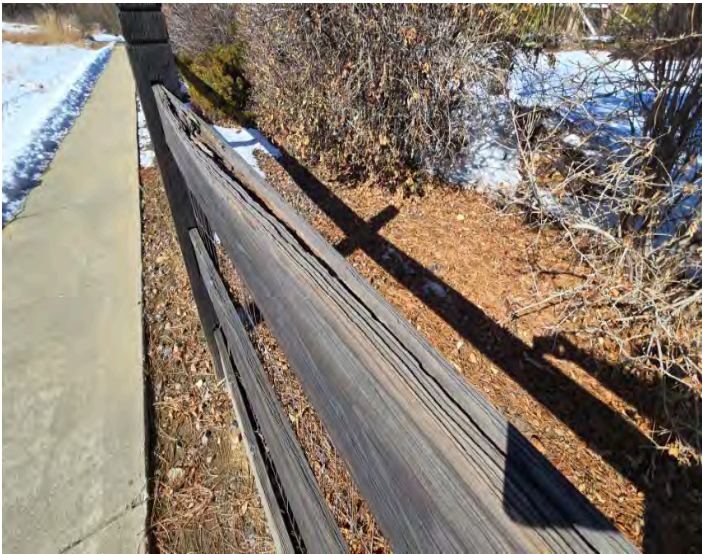
3 Rail Fencing - Major Repairs

- Due to the type of fence and the varying conditions, we have established Reserve funding for periodic repairs and have coordinated these repairs to occur at the same time as fence staining.
- Funding is for replacing failed posts, damaged, broken or warped rails and any other major issues with the fence
- Remaining life is based on overall conditions

*Best Cost:* \$21,375  
Allowance to replace approximately 5% of area with similar

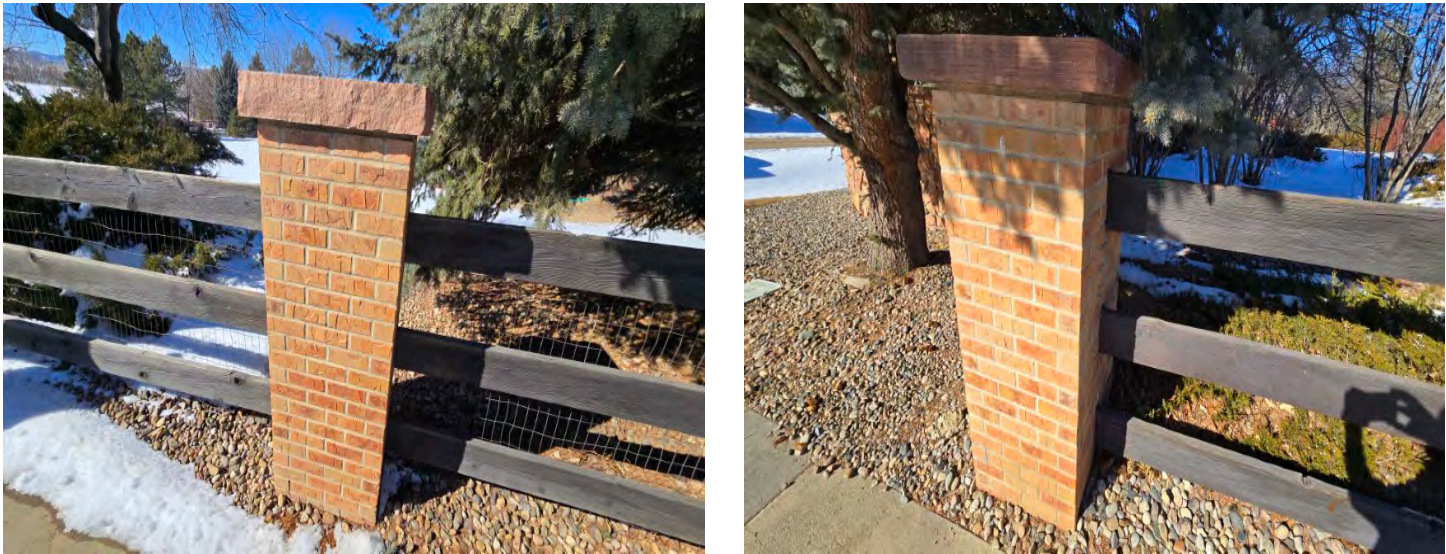
Brick Columns - Major Repairs

- While it is unlikely that the entire column will need to be replaced, it is possible that periodic repairs may be necessary to replace loose or missing grout work or deteriorated bricks.
- At this time, we recommend establishing fund requirements every 10 years for general inspections and repairs.

*Best Cost:*               **\$11,050**  
Allowance for major repairs

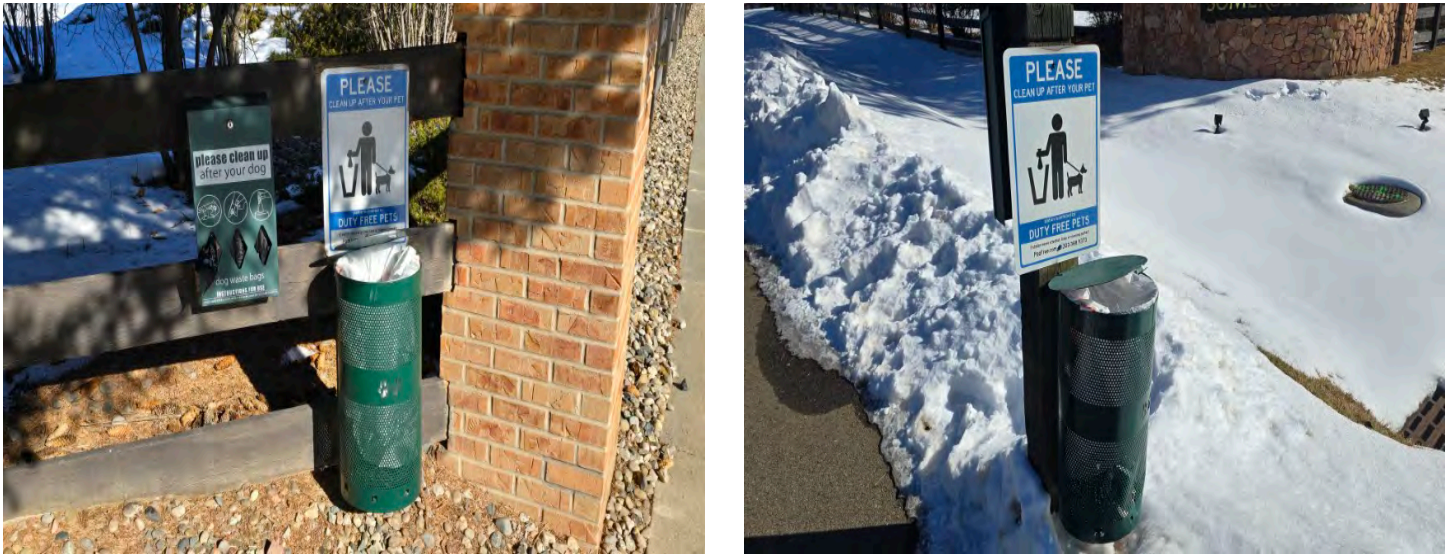
Pet Waste Pick Up Stations - Replace

- Due to the low quantity, unlikely event that all will require replacement at the same time and the relatively low cost of individual replacement, we do not recommend reserving for replacement at this time.
- Maintain and replace on an as needed basis using operating funds.

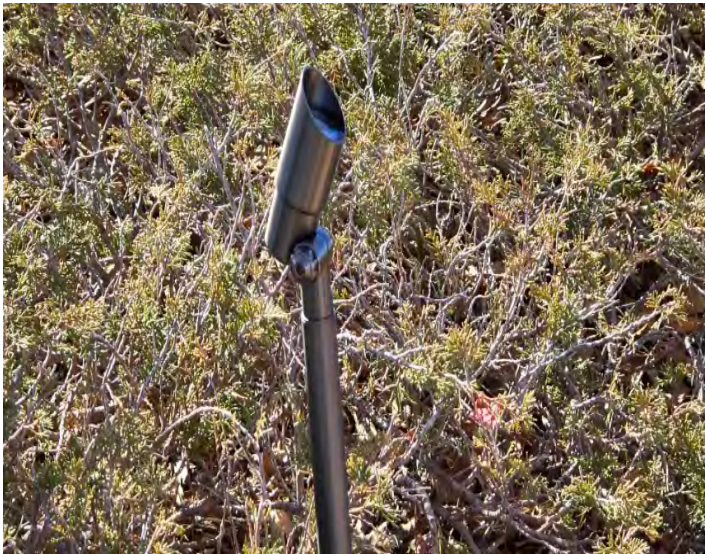
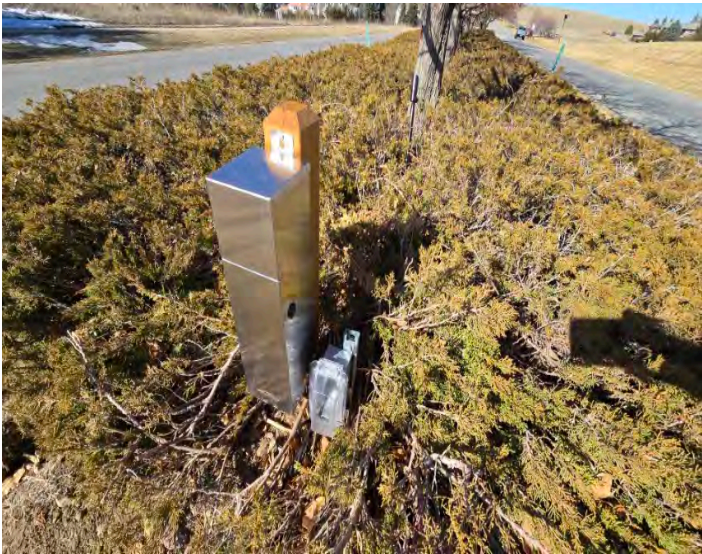
Comp #: 1603      Landscape Lights - Partial Replacement

*Observations:*  
- The cost of these fixtures range from \$65 - \$400 depending on the type of fixture selected. - This estimate does not include installation, but since the wiring is already installed, replacement labor would simply involve removing the old fixture and attaching a new fixture. - Since the cost can vary depending on the type of fixture the association decides, and the life expectancy will depend on the quality of fixture and overall care, we recommend replacing as needed with general operating funds.

*Best Cost:*      **\$9,000**  
Estimate to replace with similar

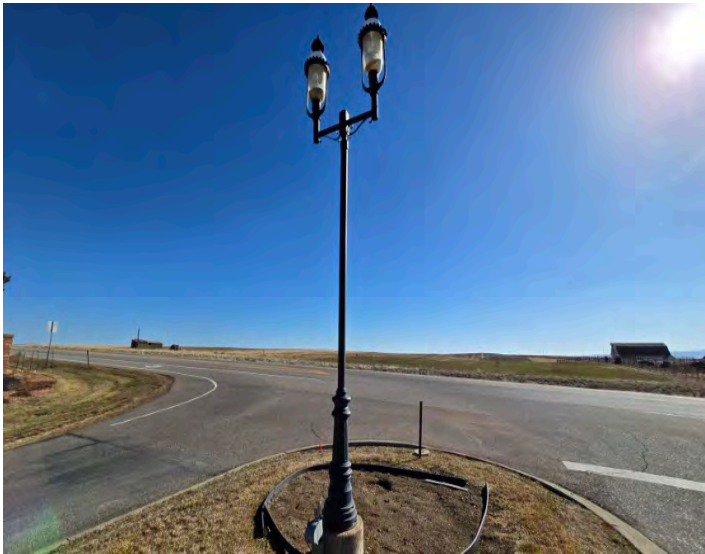
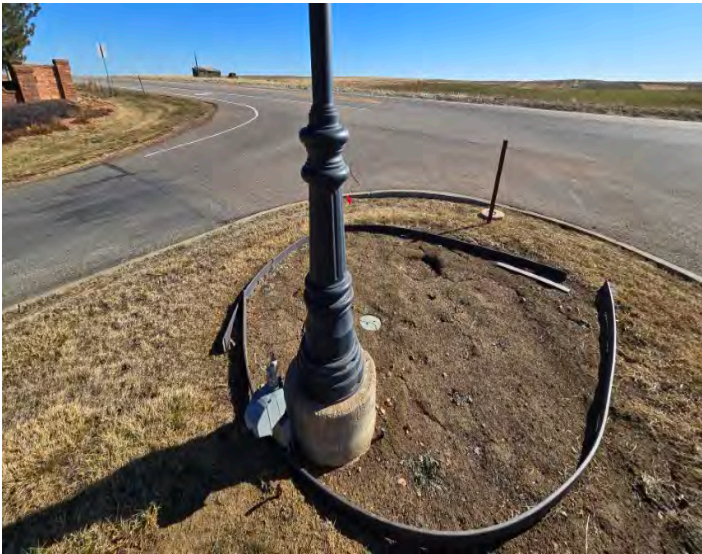
Comp #: 1604    Pole Lights - Replace

*Observations:*  
-Reported the association will be replacing this fixture in 2025

*Best Cost:*            **\$9,000**  
Estimate to replace

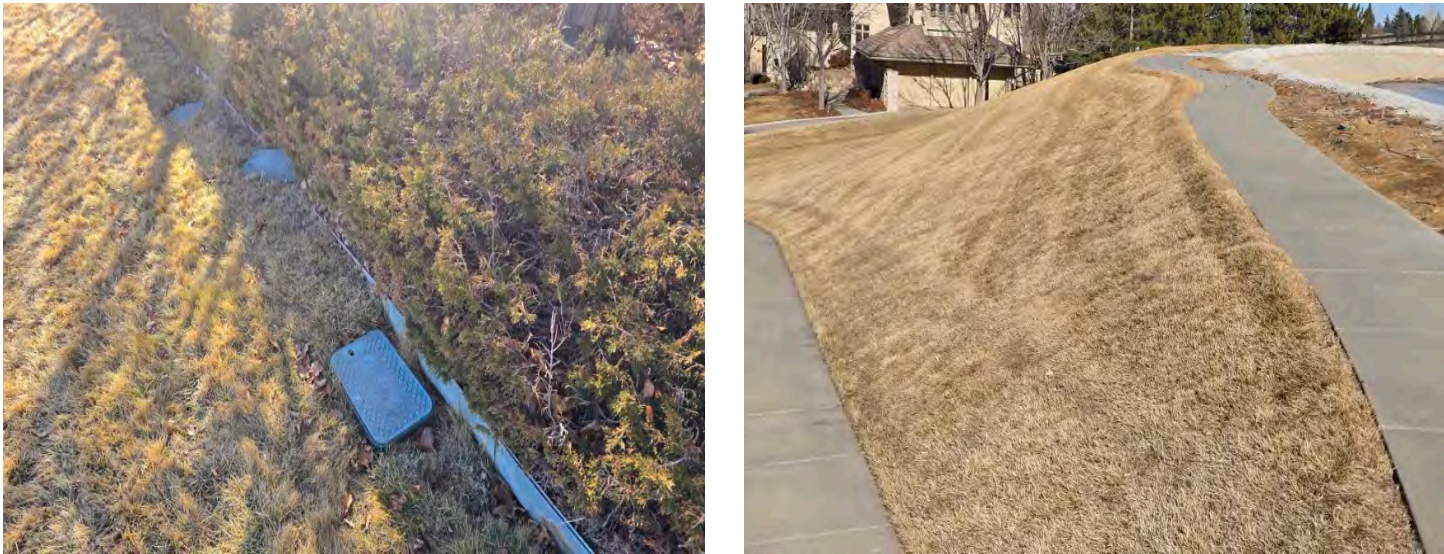
Irrigation System - Major Repairs

- It was reported the association is currently spending \$30,000 - \$40,000 annually on irrigation repairs out of the operating account.
- Based on age of community, the system is close to or at the end of its life expectancy.
- This line item is for repairs and replacement that lies outside the scope of routine operating maintenance and repairs: bulk sprinkler head replacement, bulk valve replacement, rerouting lateral lines, rewiring, etc. We have also included a line item for complete replacement of system in about 4 years.
- In order to ensure the funds are available for major repairs, we recommend reserving funds for these projects every 4 - 6 years.
- The funding on this line item is for major repairs and is not to be interpreted as complete irrigation system replacement.

*Best Cost:*                    **\$40,000**  
Estimate for major repairs and renovating system

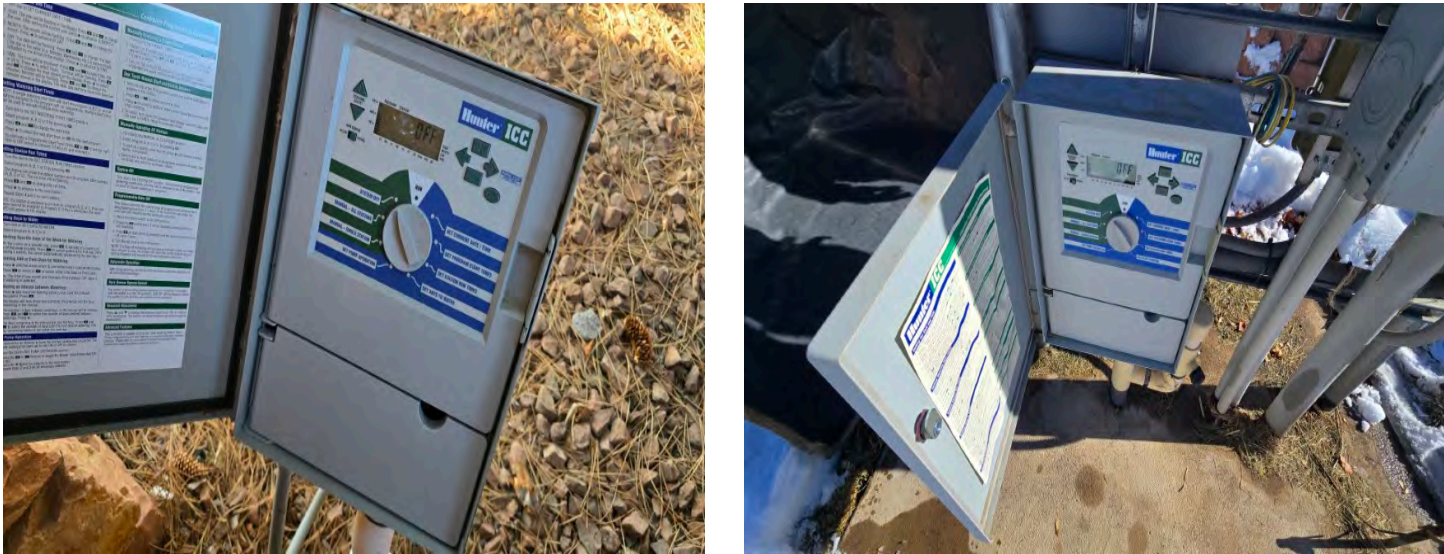
Irrigation Controllers - Replace

- Association will continue to replace controllers on an as needed basis with operating funds.
- Therefore, additional Reserve funding is not required for this component
- Association may consider replacing with a smart system in the future, but since there are no plans as of now, funding for this upgrade is not necessary for the purposes of this Reserve Study
- The new controllers are designed by combining sets of "modules" to create a system that can handle multiple stations and handle the different irrigation needs for turf, shrubs and flower beds, as well as any special watering restrictions. Due to the ability to replace the modules individually and the low replacement cost associated with this clock, we suggest replacing on an as needed basis with general operating funds.

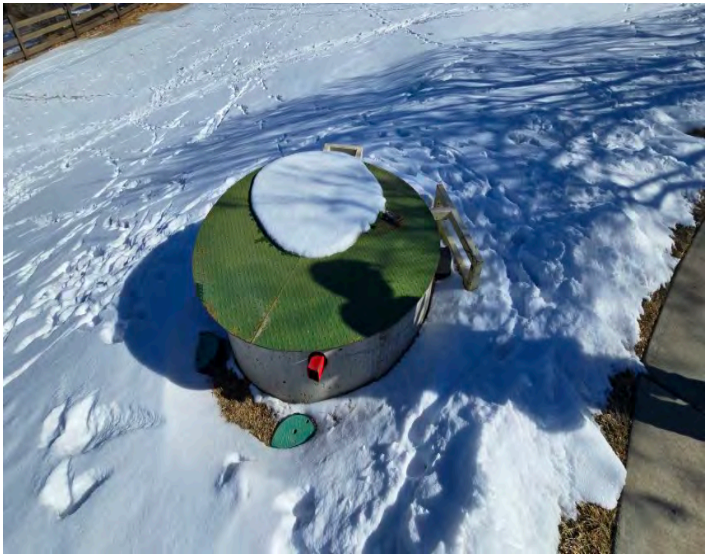
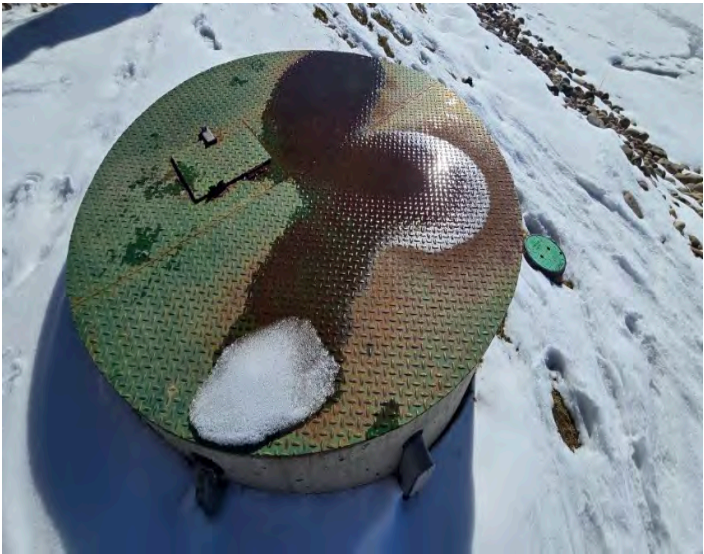
Pumps - Replace

- No well-defined life expectancy for this equipment
- Replacement cycle will depend on the level of use
- Due to varying ages and levels of use, we suggest establishing Reserve funds for periodic partial replacement or rebuilding of pumps and motors

*Best Cost:* **\$10,000**  
Allowance for partial replacement, rebuilding pumps every 4 years

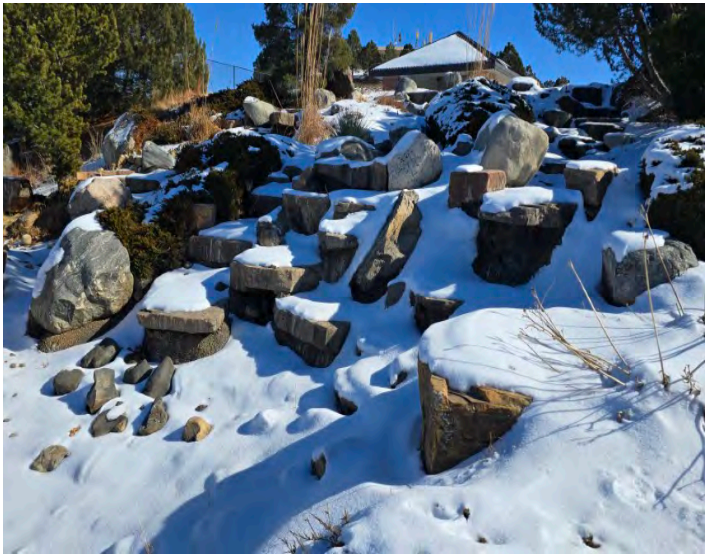
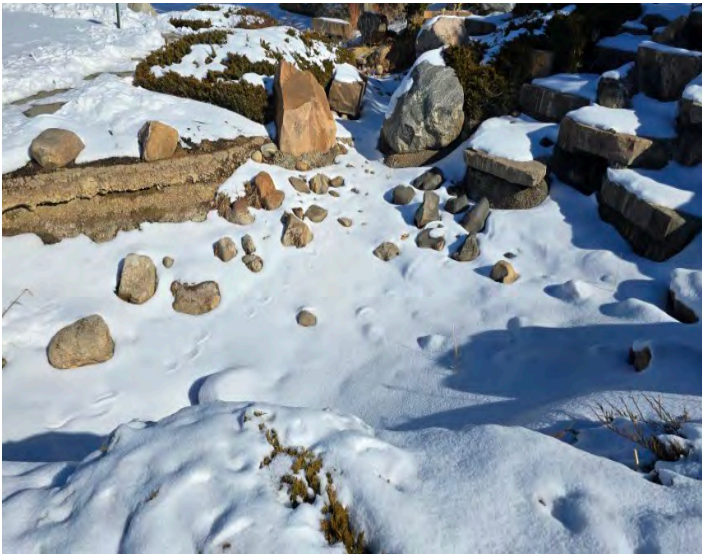
Waterfall Pumps - One Time Install Expense

- It was reported the association will be installing a new pump system for the waterfall
- The useful life is set at 99 years to indicate this is a one-time major expense coming from Reserves for this project.
- Once the pumps are installed, future replacement and rebuilding will be included in the allowance for component #1705

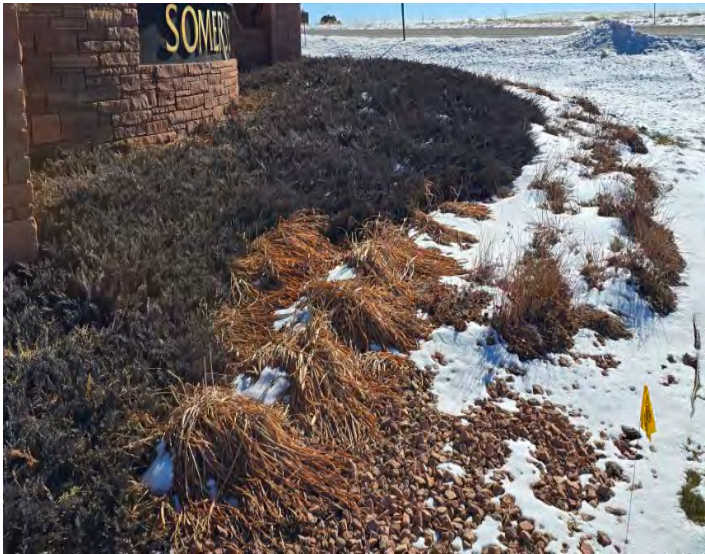
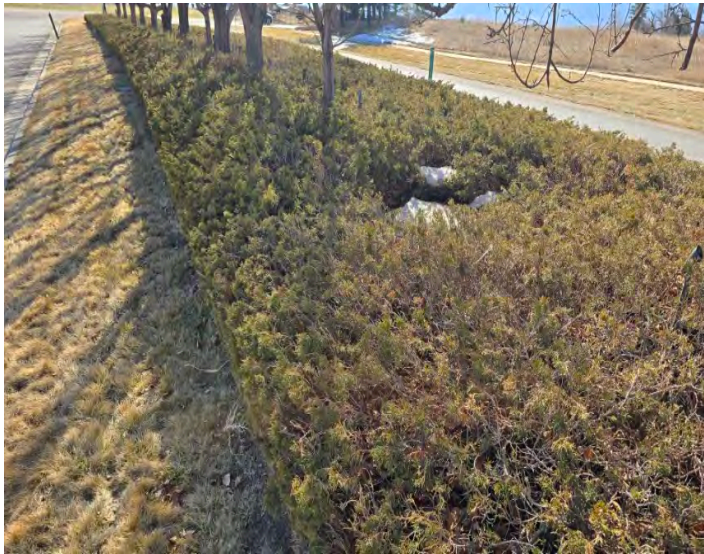
Groundcover - Full Relandscape (Hwy 52)

- Community will be relandscaping the entrance off Hwy 52 this year.
- This line item is for a complete renovation to the community entrance every 25 years.

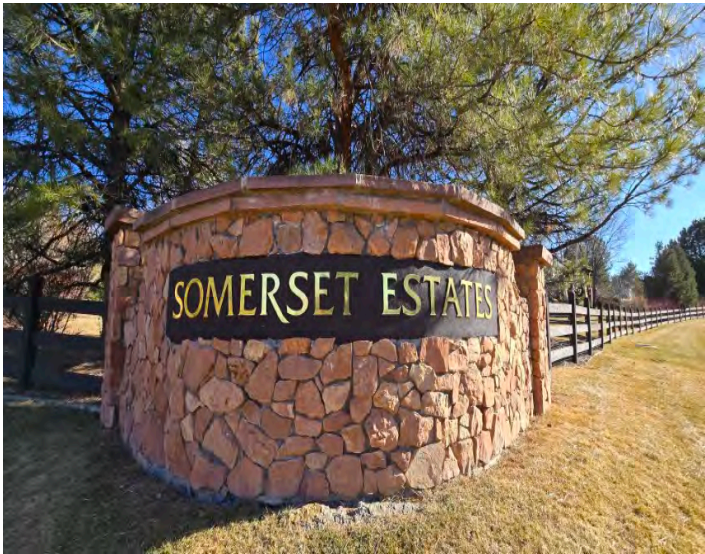
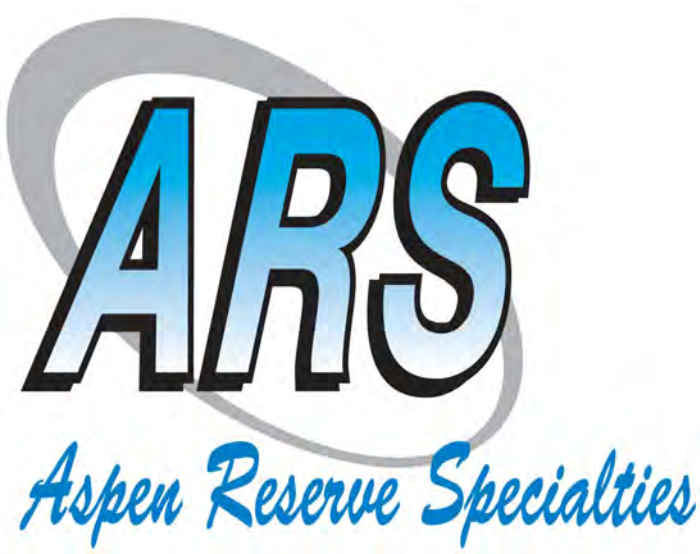
Comp #: 1801      Groundcover - Full Relandscape (Longview)

- Observations:
- Community will be relandscaping the entrance on Longview in 2026
  - This line item is for a complete renovation to the community entrance every 25 years.

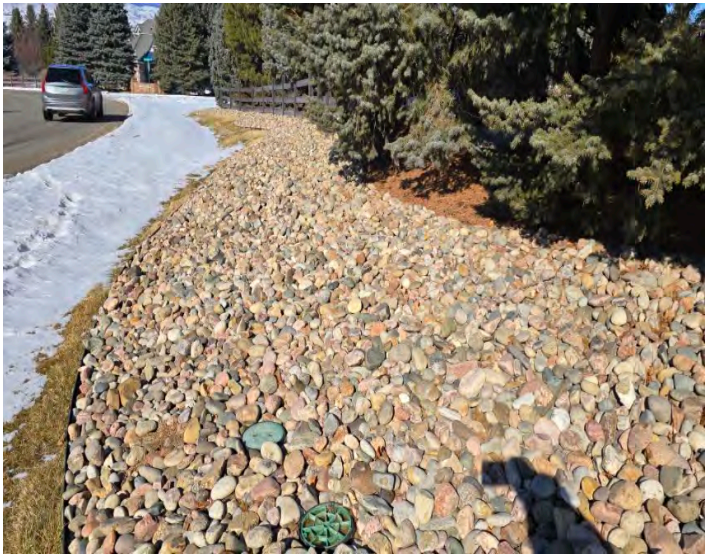
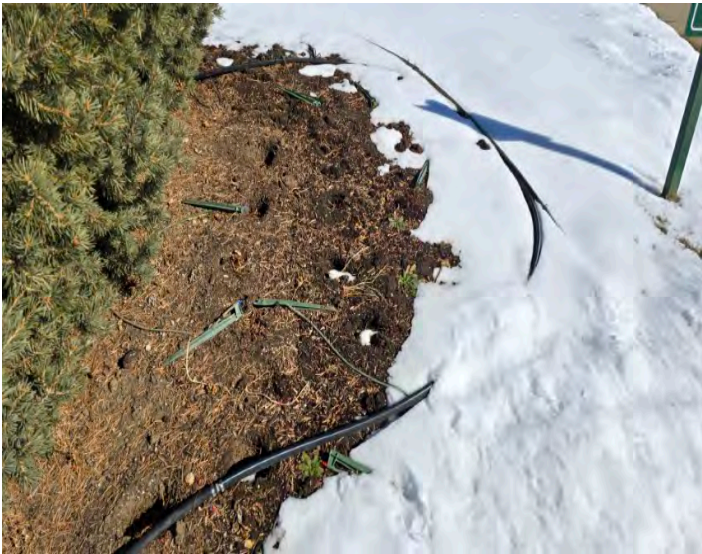
Comp #: 1801      Groundcover - Replenish

- This line item, similar to irrigation repairs, is for projects that lie outside the scope of routine maintenance.
- In order to preserve an attractive curb appeal and to maintain the health of the plants and shrubs, we recommend reserving for refurbishment projects every 2 - 5 years.
- This line item is for cyclical refurbishment and should not be considered as complete landscaping replacement.

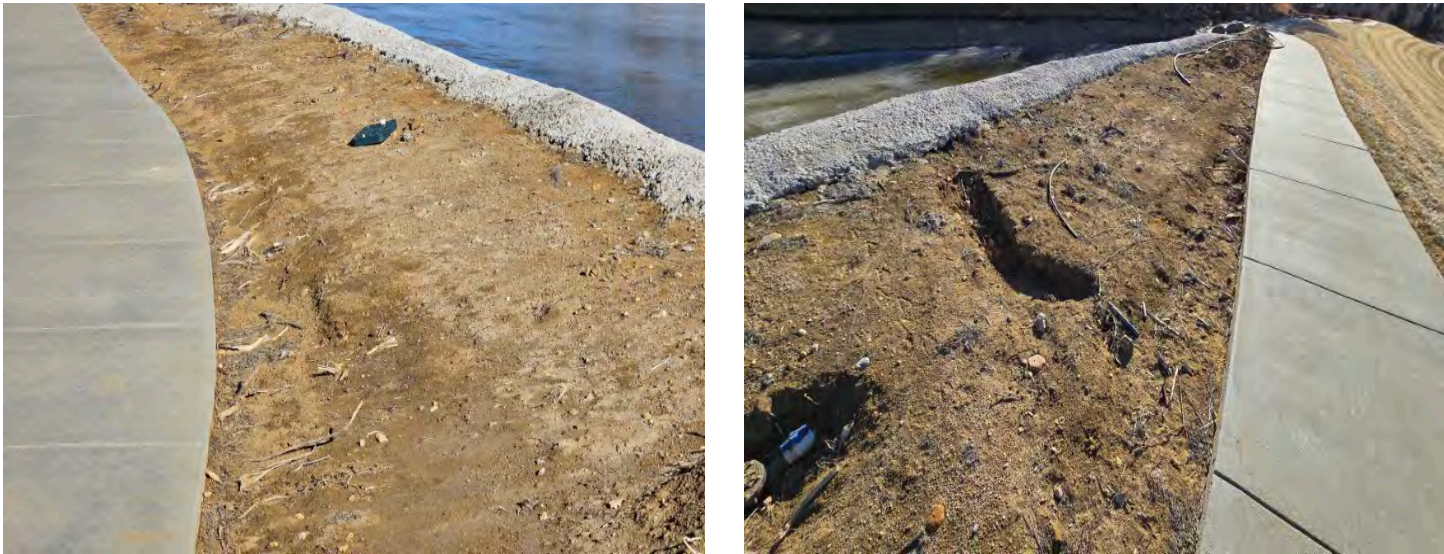
Outlot D - Relandscape

*Observations:*  
-This is a one-time major expense to relandscape the area around Pond 32 after the work that was completed in 2024

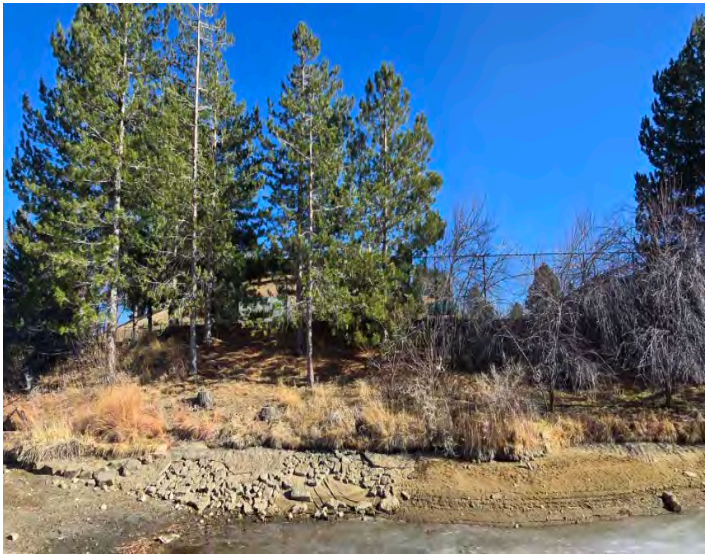
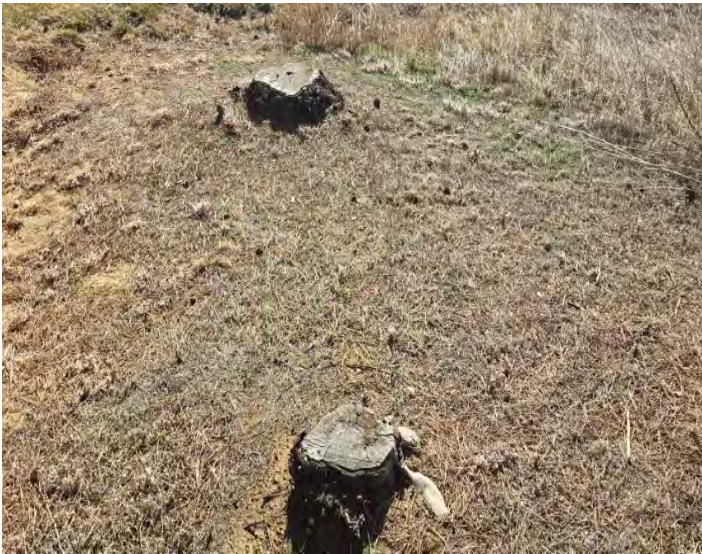
Tree - Replacement

- It is very difficult to predict a replacement cycle for trees as there are several factors that will contribute to a tree dying.
- Factors such as disease, infestation of insects, heavy snow storms, etc. can all attribute to eventual tree replacement.
- Since it is difficult to predict when the replacement will be necessary, Reserve funding is typically not a factor.
- However, based on our recent experience, an allowance for periodic replacement has been included.

*Best Cost:*                    **\$40,000**  
Allowance for major maintenance/replacement

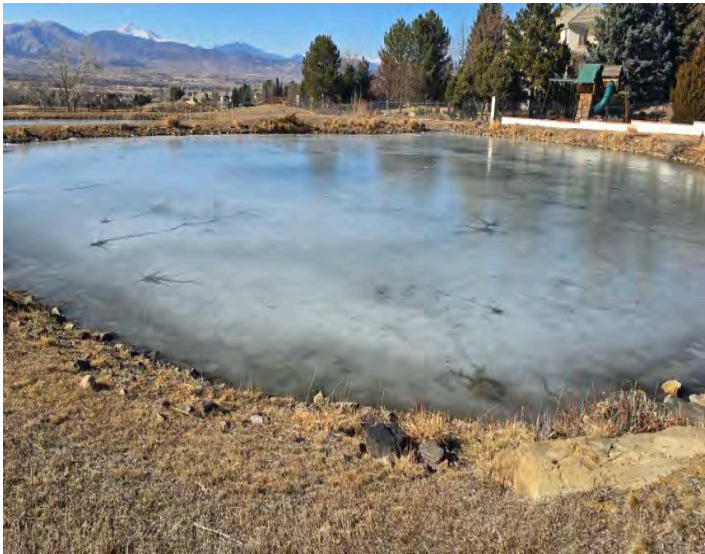
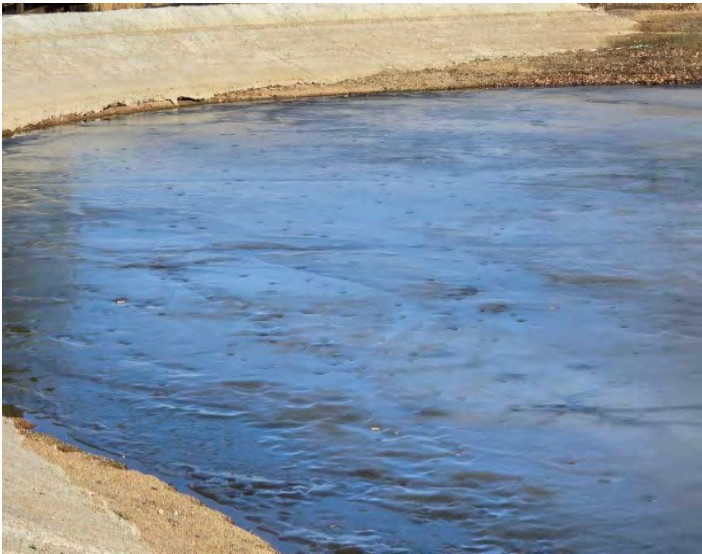
Ponds - Major Repair Allowance

- It was reported the association addresses minor repairs on an as needed basis with operating funds.
- It is important to keep the liners covered with materials to prevent exposure to UV rays that will deteriorate and break down the materials.
- Unless otherwise requested, funding for periodic repairs will not be included in the Reserve Study.

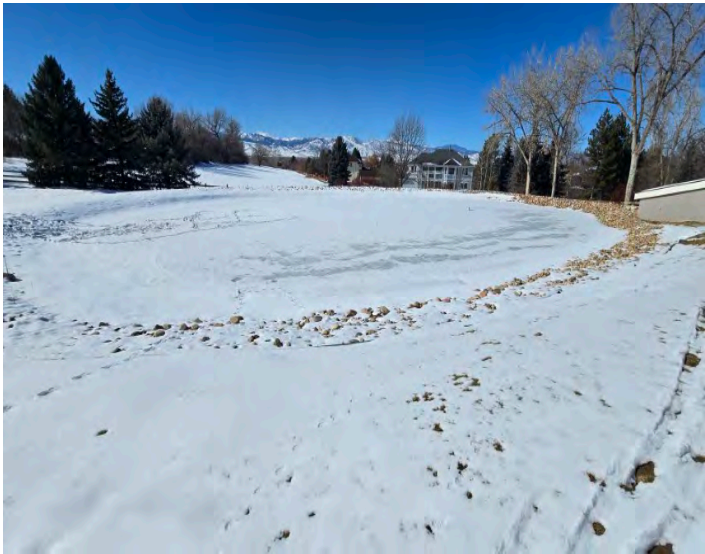
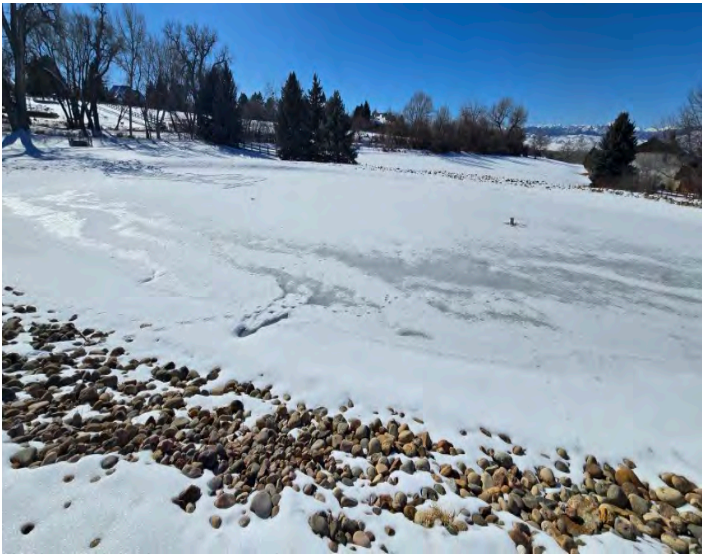
Comp #: 1807      Pond Bed - Reline (1)

- Observations:*
- Pond was relined in 2023 with Polyurea, which is a product similar to a spray in bedliner for a truck.
  - Since this is a relatively new application for the pond world, we recommend planning on reapplying the product every 30 years at this time.
  - Once this has an opportunity to age, we can adjust the life expectancies accordingly depending on how it is aging
  - NOTE: This pond is shared 50/50 with Somerset HOA as this pond serves both communities

*Best Cost:*                      **\$93,765**  
Estimate to replace liner (50% of total cost)

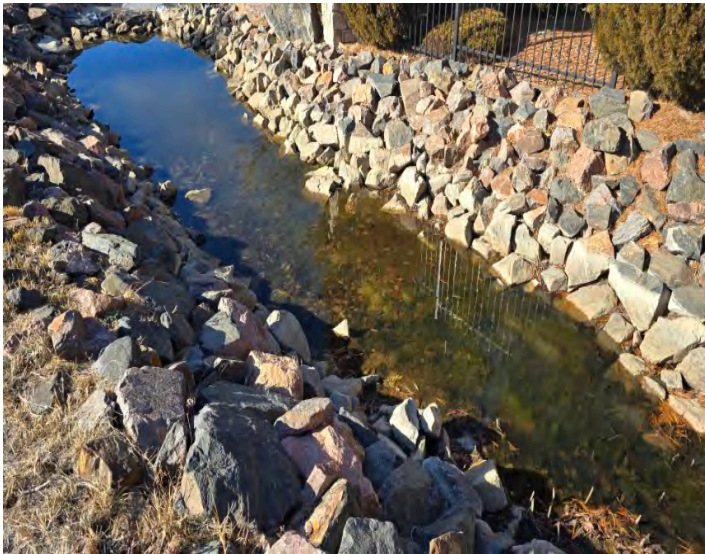
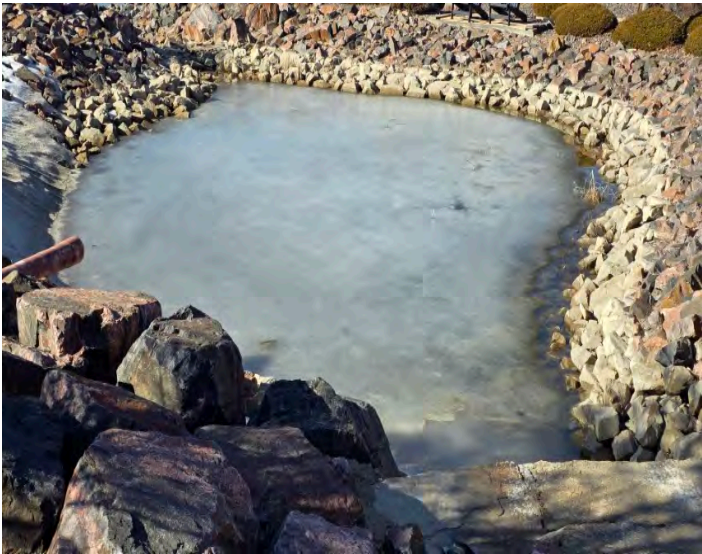
Comp #: 1807      Pond Bed - Reline (10, 11)

*Observations:*  
-Reported that pond #10 is leaking. Pond #11 has no issues, but since these are small ponds and they are connecting, we recommend refurbishing both at the same time to save money on mobilization of crews

*Best Cost:*                **\$56,515**  
Estimate to replace liner

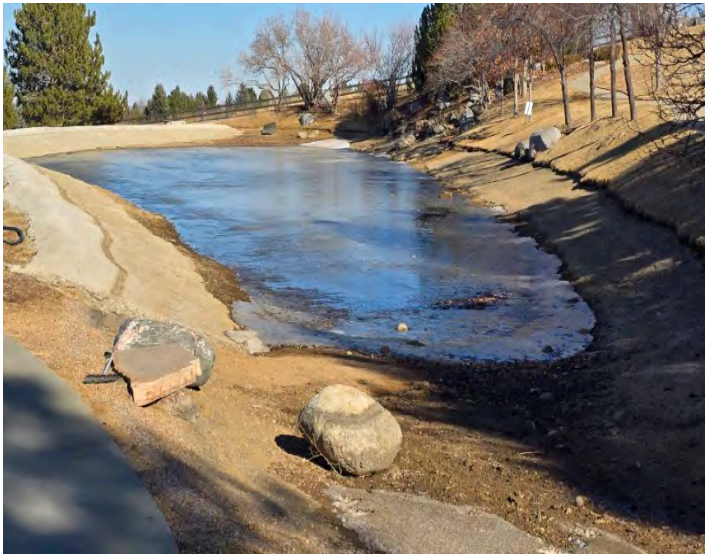
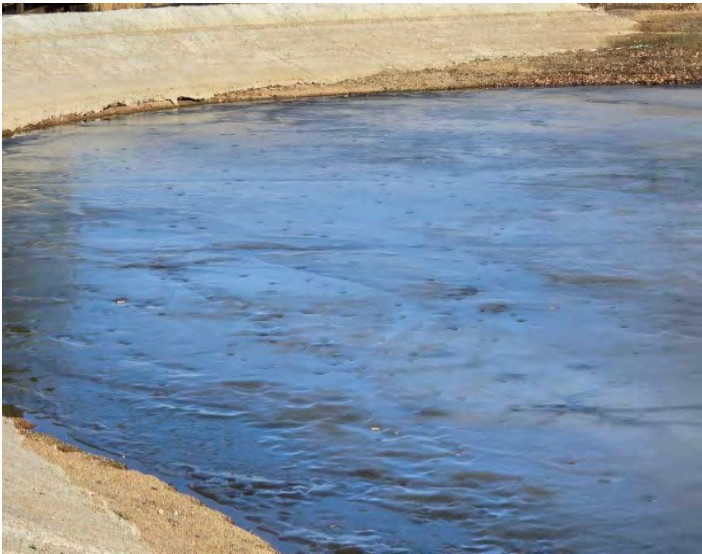
Pond Bed - Reline (2)

- Association spent approximately \$60,000 in 2024 fixing leaks in the pond. It was reported the pond still leaks, but don't know where they are coming from. About half of the area was refurbished.
- Our recommendation would be to plan for complete refurbishment of pond and avoid the expense of major repairs to try to extend the life of the pond liner. In our opinion, the "band aid" repairs would not be cost effective with the reported leaks and issues with the pond
- The recommendation from the pond contractor would be to do Pond #2 and #3 at the same time to ensure a good transition between both bodies of water.
