Level 1, Premium Reserve Analysis

# Somerset Estates HOA Highway 52 & Somerset Dr. Niwot, CO. 80544

Report Period – 01/01/25 – 12/31/25

Date of Property Observation – January 28, 2025

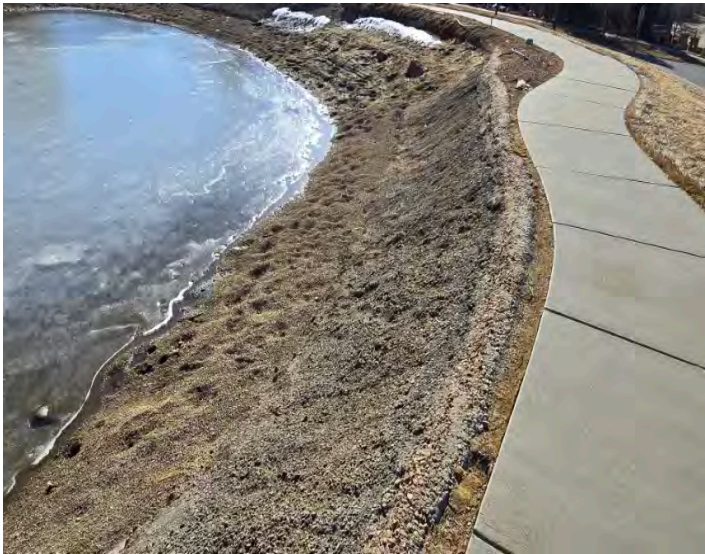
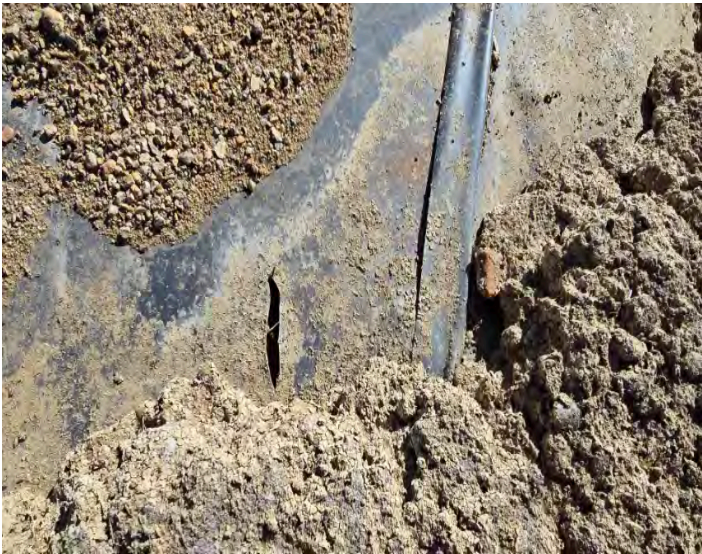
Comp #: 1807      Pond Bed - Reline (3)

- Reported this pond has the highest priority to get done as it has failed
- It would make the best financial sense to combine Ponds 2 and 3 at the same time since the equipment will be in place and the association would not be paying mobilization costs.
- Also, if done at the same time, then it would ensure a good connection between the two ponds and the stream that connects the two bodies of water also.

Best Cost:                      **\$165,000**  
Estimate to replace liner

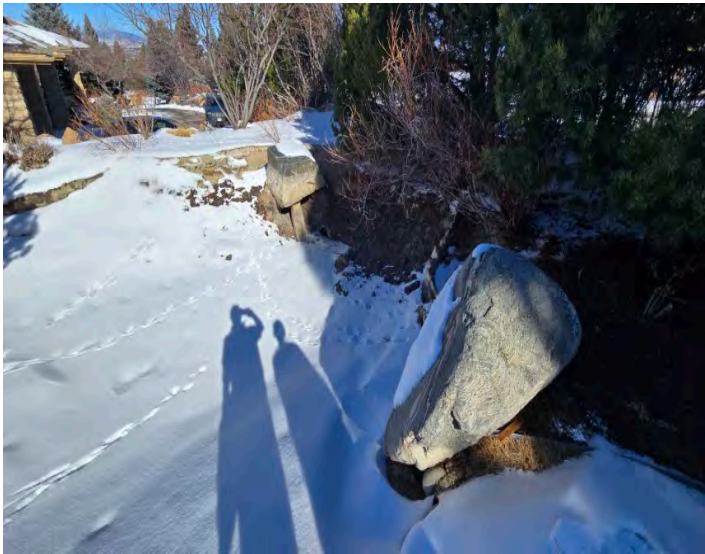
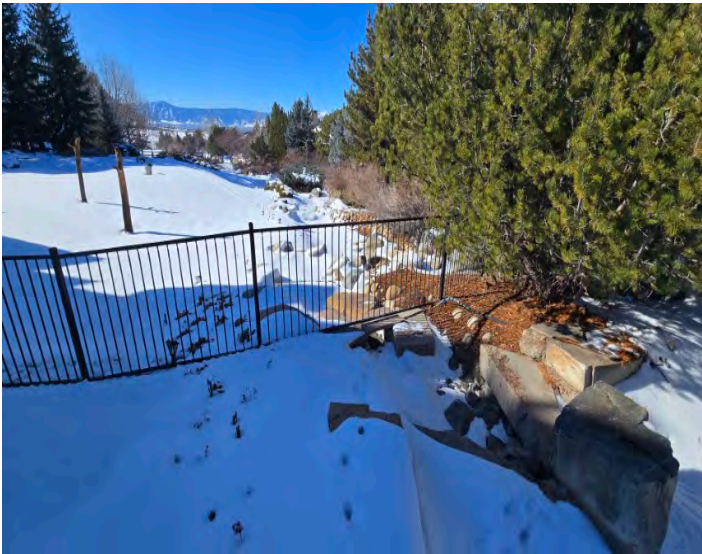
Comp #: 1807      Pond Bed - Reline (4, 5, 6)

*Observations:*  
Cost will be higher than other ponds due to the accessibility and the tight area to redo these ponds

*Best Cost:*                    **\$188,000**  
Estimate to replace liner

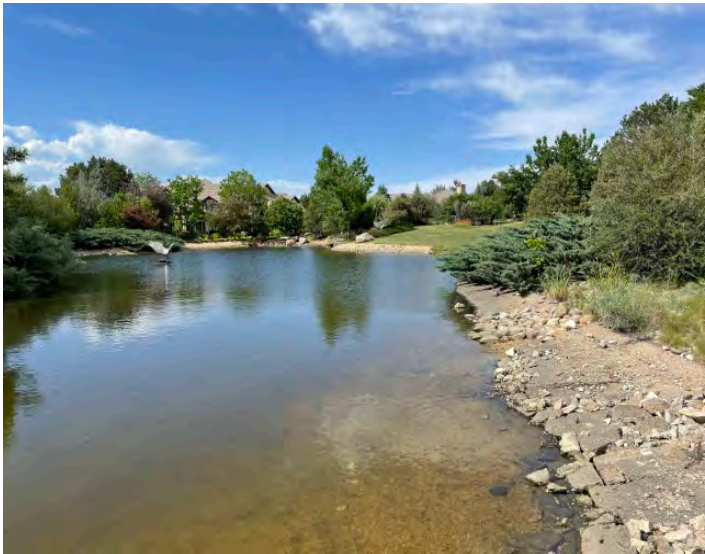
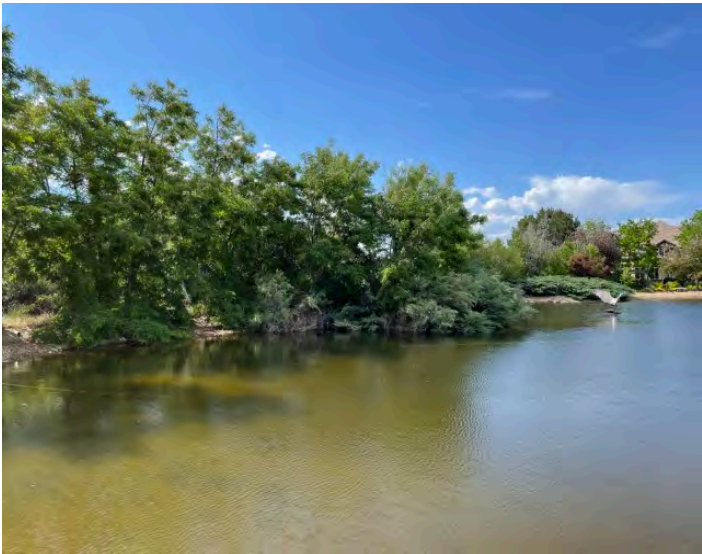
Comp #: 1807     Pond Bed - Reline (7)

*Observations:*  
-Cost for this pond will be higher than the others due to the difficulty of accessing the area and the possibility of having to relandscape the owners yard due to the equipment "traffic" damaging the landscape.

*Best Cost:*                    **\$525,000**  
Estimate to replace liner

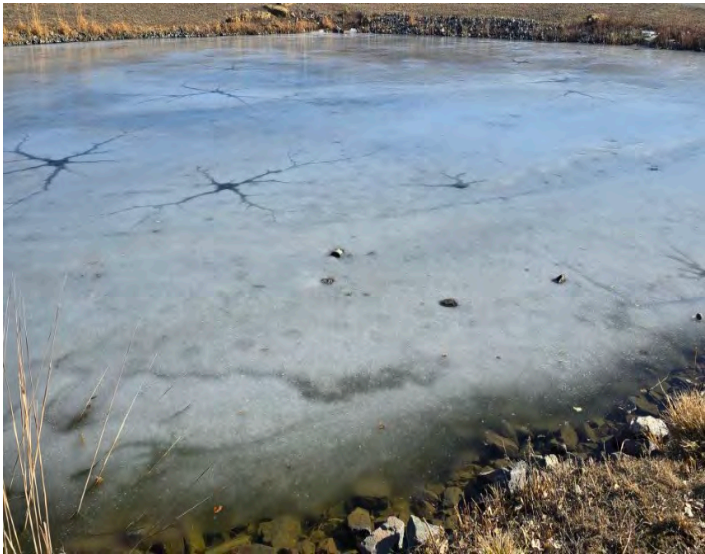
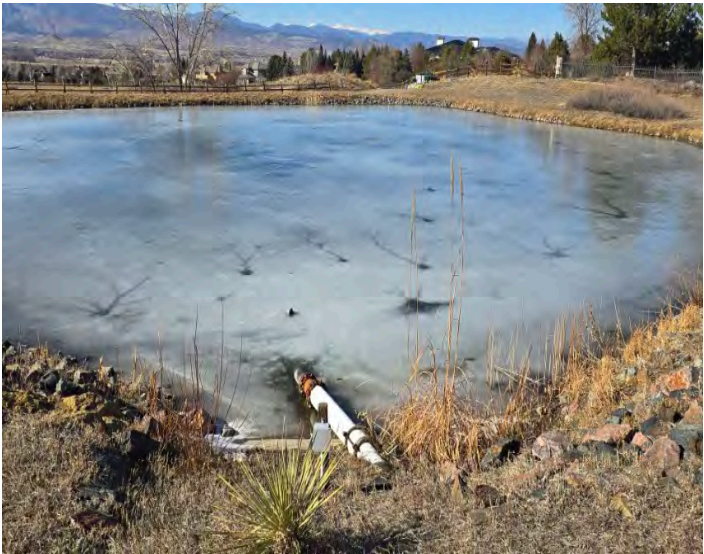
Comp #: 1807     Pond Bed - Reline (8)

*Observations:*  
- Pond was relined in 2020 with EPDM

*Best Cost:*                **\$302,500**  
Estimate to replace liner

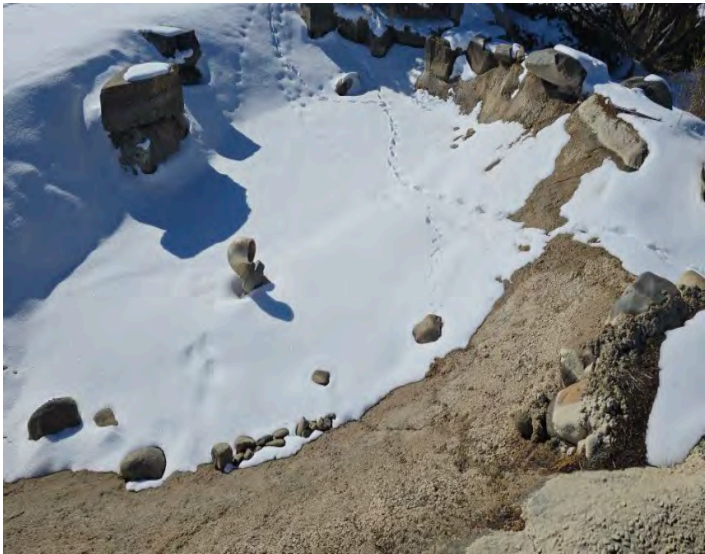
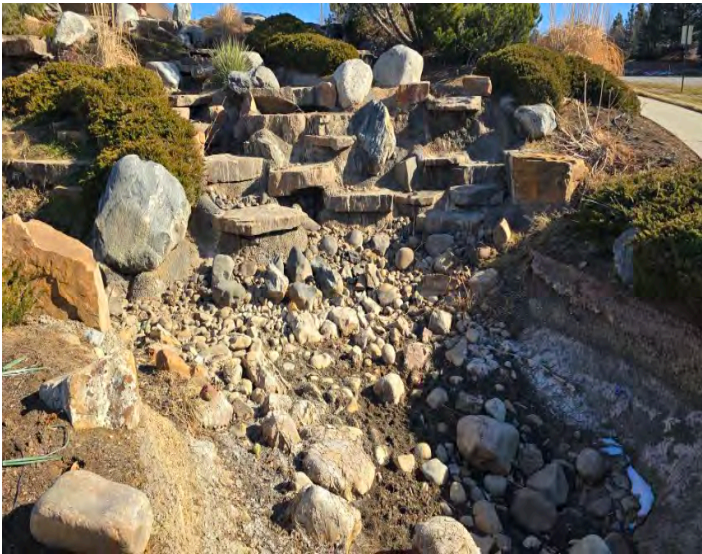
Comp #: 1809      Waterfall/Waterfall Basin - Reline/Major Repairs

Observations:

*Location:*                    **Waterfall by pool area**

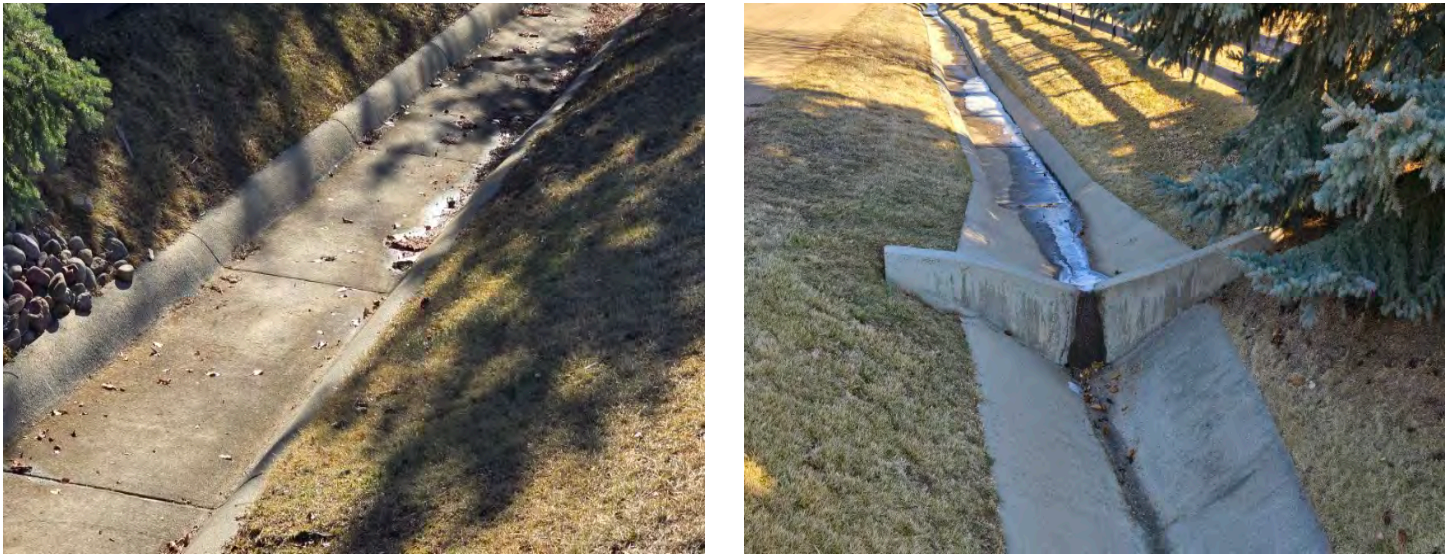
Concrete Drain Channel - Repair

- While concrete has a long life expectancy, periodic repairs should be anticipated.
- Due to the extent of the channel, we have established funding for periodic repairs every 8 years.
- Since it is unlikely that all concrete will need replaced at the same time, we recommend funding to repair 5% of the area every 8 years
- Coordinate with other concrete surfaces for best cost estimate

Best Cost:               **\$11,000**  
Allowance for repairs every 8 years

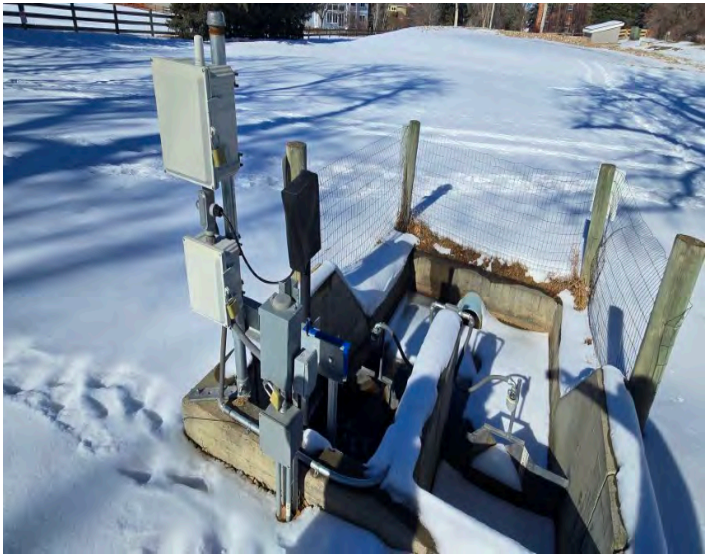
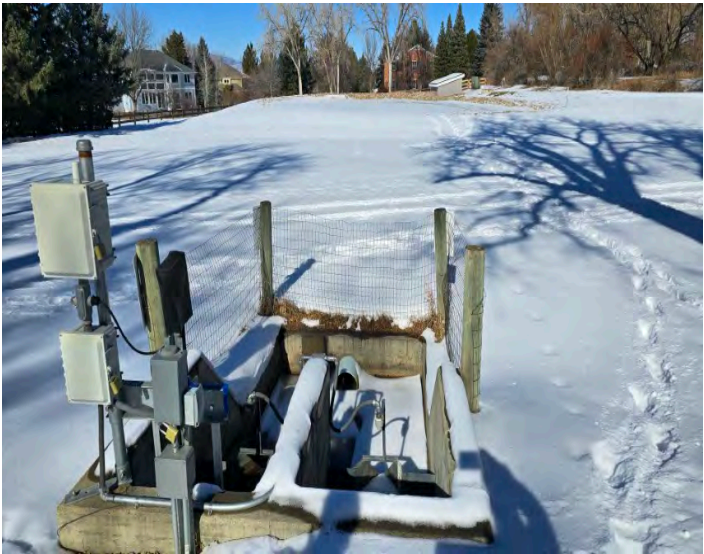
Comp #: 2005

Observations:

Location:
