**Annual Review and Compliance
Report for
Maroota Sand Quarry
DA 267-11-99
Year Ending 31st December 2021**

Maroota Sand Quarry

Annual Review and Compliance Report 2021

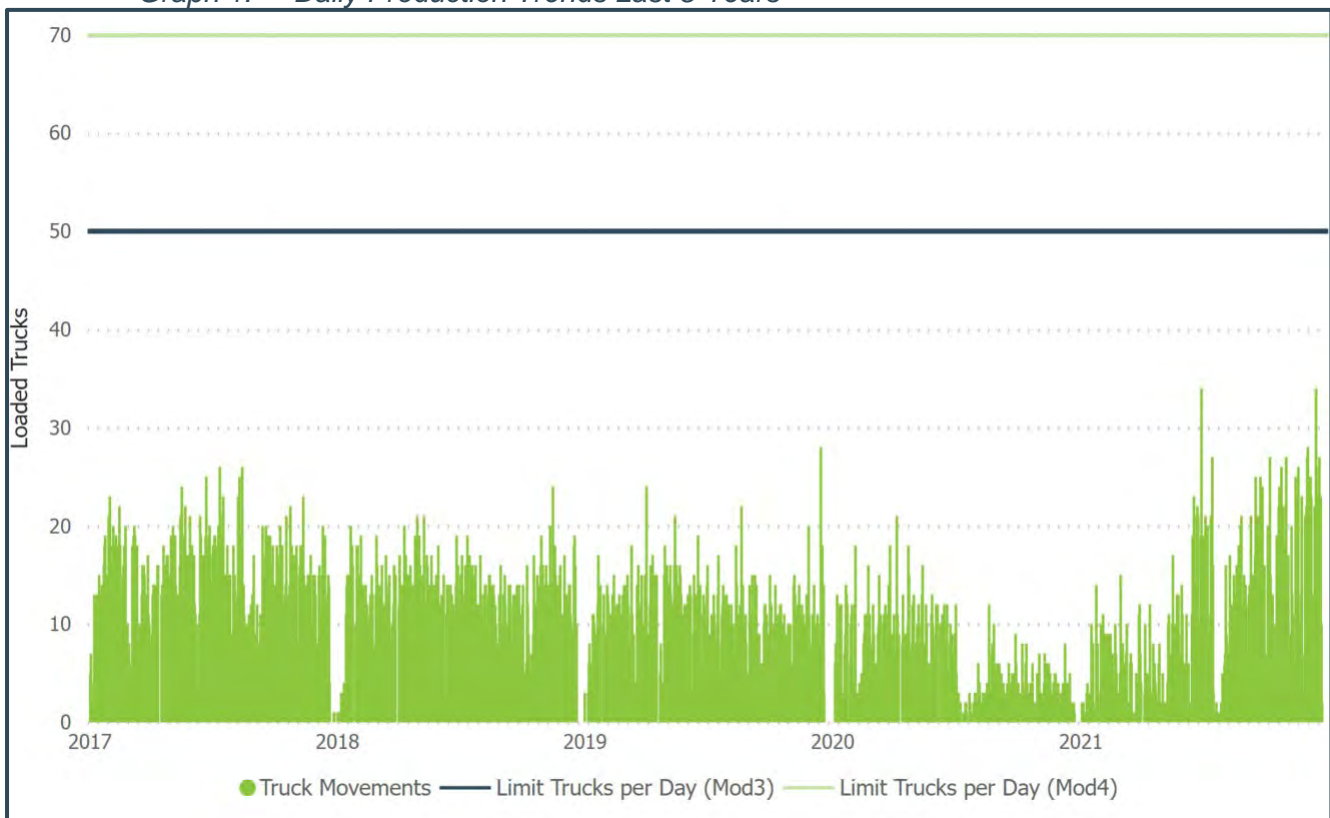
Graph 1. Daily Production Trends Last 5 Years

Approximately 96,000 tonnes of material was sold during the report period, which was higher than 2020. A condition was introduced in Mod 4 limiting the site to process or dispatch no more than 480,000 tonnes per calendar year.

Cal Year	Tonnes	Limit T per Cal Year	Truck Movements per Year	Max of Truck Movements per Day	Limit Trucks per Day (Mod3)	Limit Trucks per Day (Mod4)
2017	142633	480000	3937	26	50	70
2018	123858	480000	3361	24	50	70
2019	106907	480000	2916	28	50	70
2020	56894	480000	1638	21	50	70
2021	95988	480000	2878	34	50	70

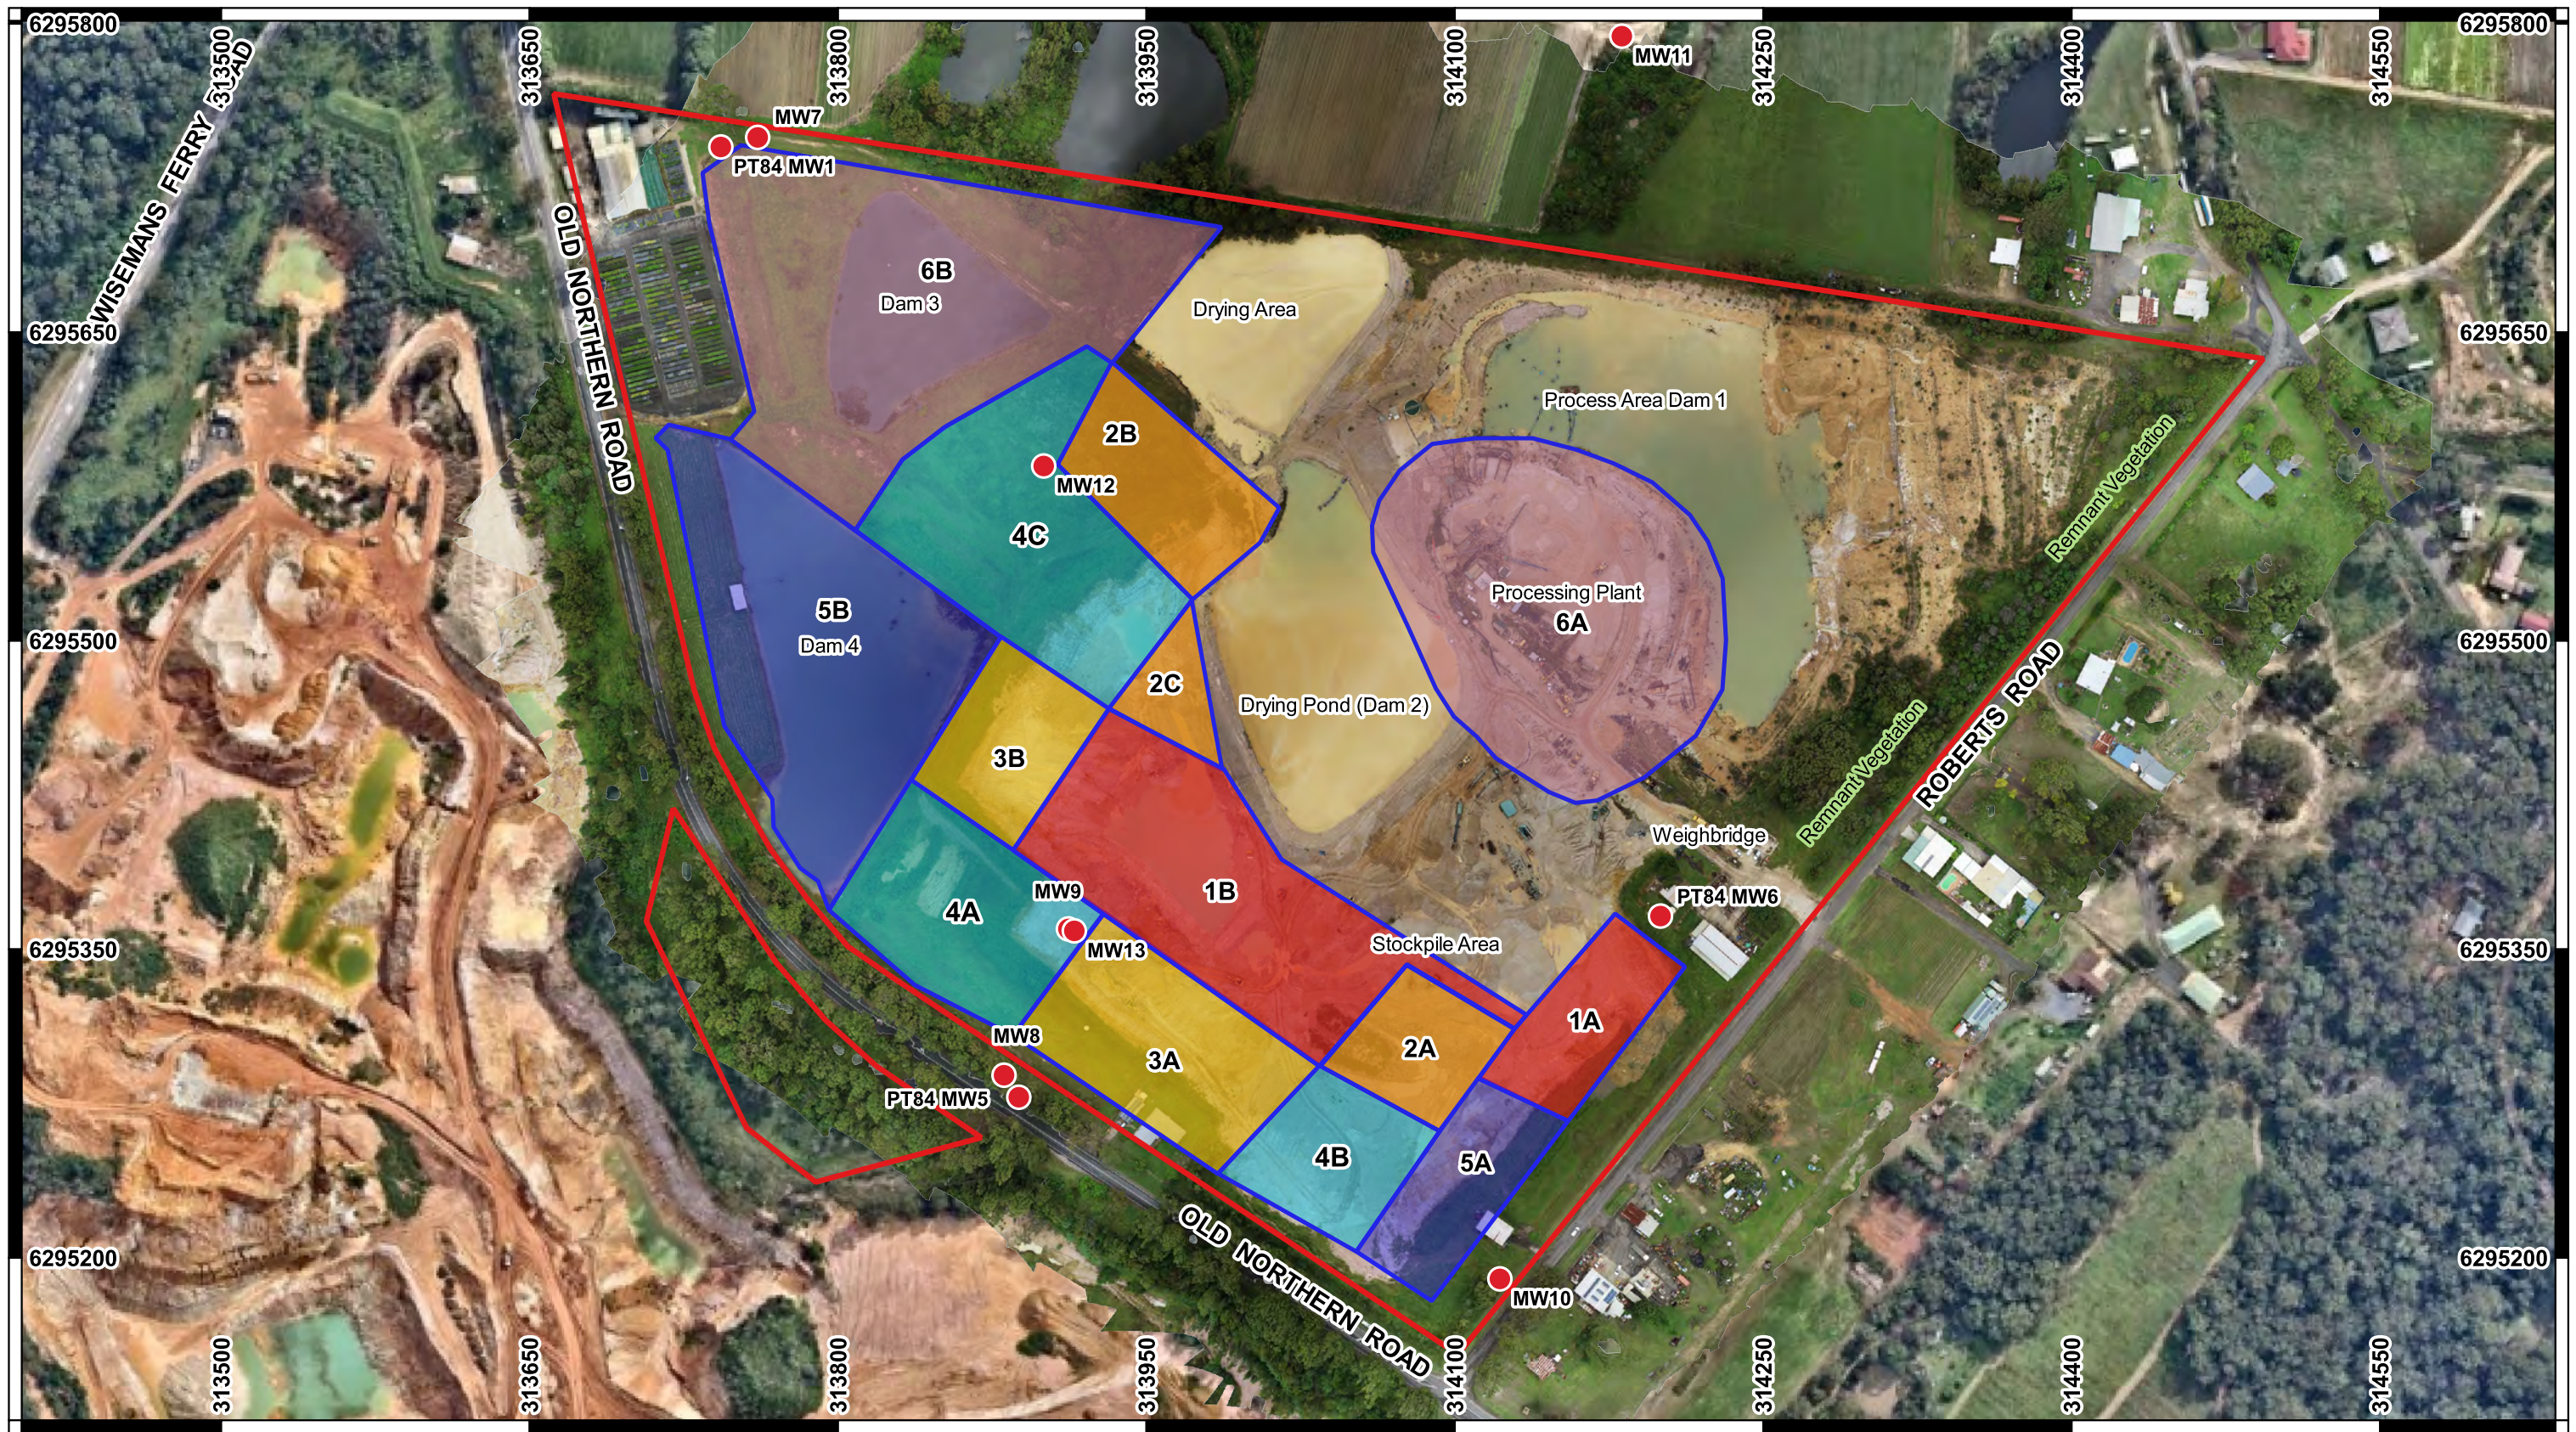
Figure Two. Sequence of Extraction

Plan of: Annual Review & Compliance Report 2021 for Roberts Road Maroota Sand Quarry - Sequence of Extraction

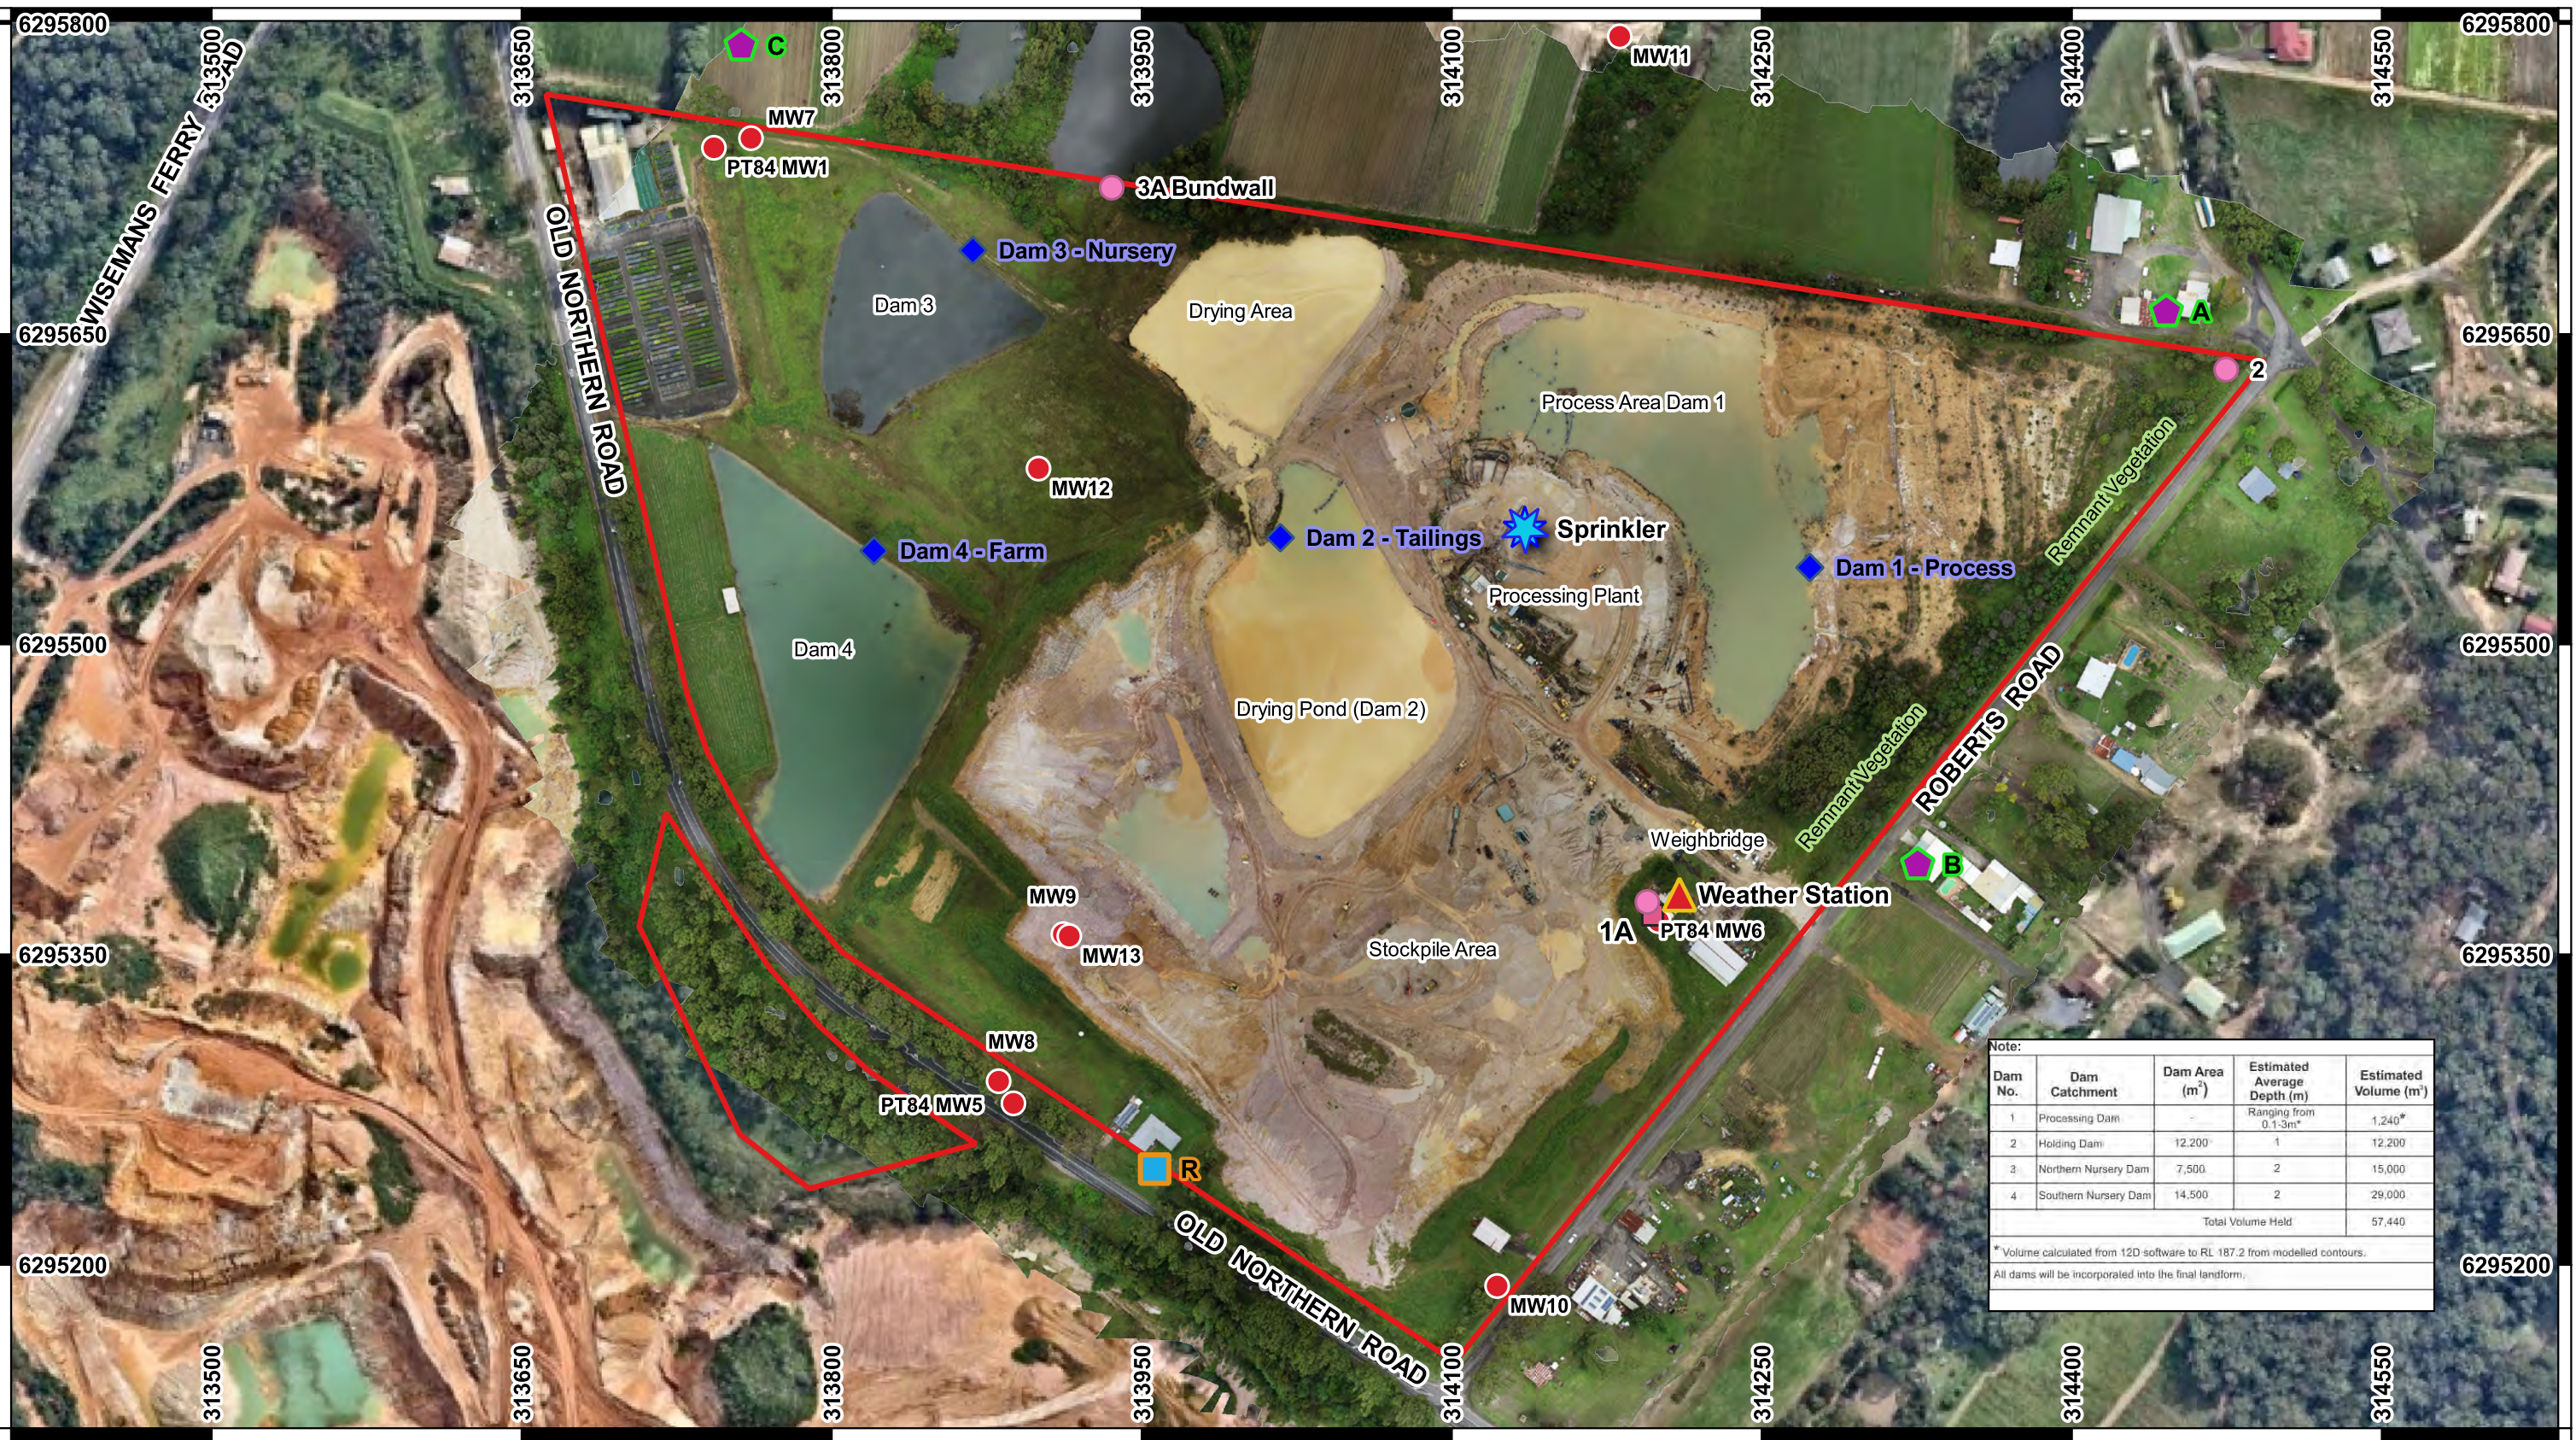
Dam No.	Dam Catchment	Dam Area (m ²)	Estimated Average Depth (m)	Estimated Volume (m ³)
1	Processing Dam	-	Ranging from 0.1-3m*	1,240*
2	Holding Dam	12,200	1	12,200
3	Northern Nursery Dam	7,500	2	15,000
4	Southern Nursery Dam	14,500	2	29,000
Total Volume Held				57,440

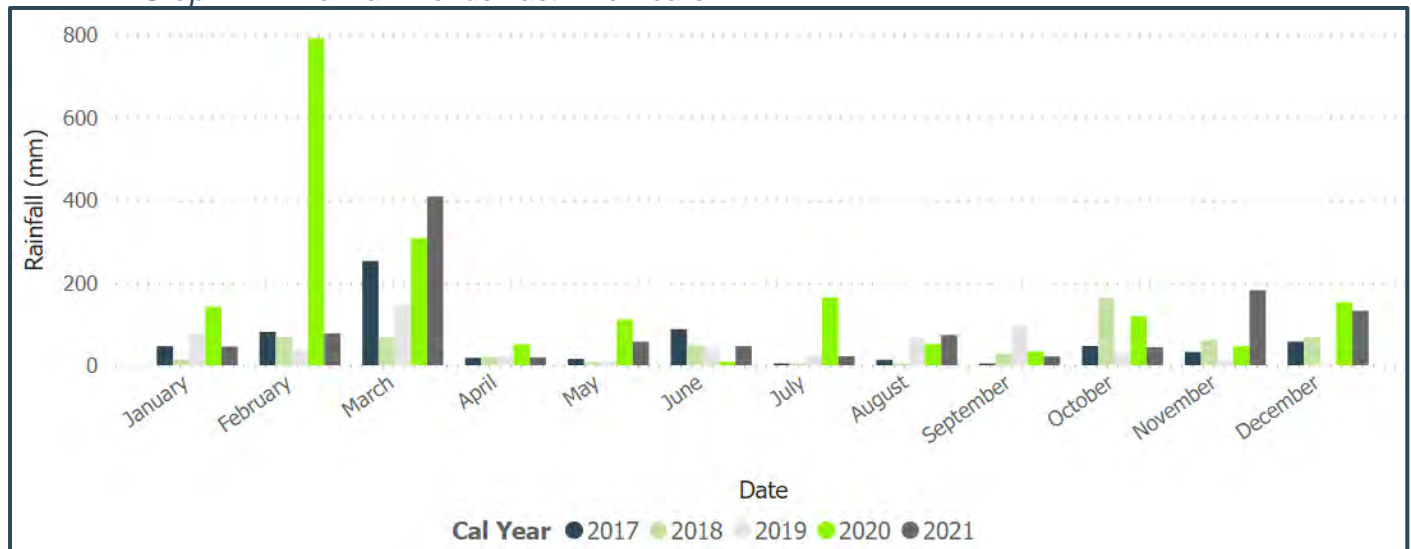
Graph 2. Rainfall Trends Last Five Years

Cal Year	January	February	March	April	May	June	July	August	September	October	November	December	Total
2017	46.2	80.8	252.6	18.0	15.4	87.6	0.8	13.2	1.6	46.6	32.2	57.2	652.2
2018	14.4	69.0	66.2	20.2	7.6	49.2	3.0	3.8	28.6	163.0	61.6	70.4	557.0
2019	76.2	37.2	146.2	22.2	7.4	42.2	24.6	64.8	94.6	30.6	13.0	0.4	559.4
2020	141.6	792.0	308.0	50.8	111.2	8.6	164.6	51.8	33.2	118.4	46.4	152.8	1,979.4
2021	45.6	77.2	408.8	19.2	57.0	46.4	22.0	73.4	21.4	43.8	181.8	132.2	1,128.8

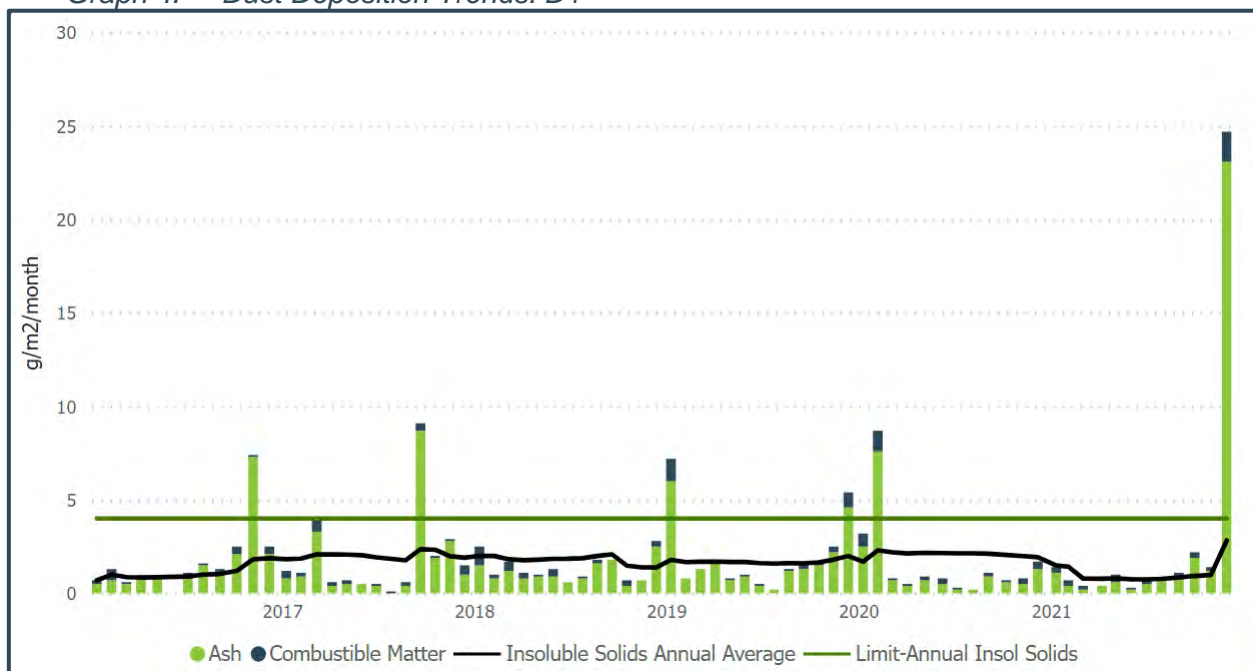
Graph 4. Dust Deposition Trends: D1

Date	Insoluble Solids	Rolling Annual Average Insol Solids	Limit-Annual Insol Solids	Ash	Combustible Matter
11/1/2021	1.4	1.5	4	1.1	0.3
3/2/2021	0.7	1.4	4	0.4	0.3
3/3/2021	0.4	0.8	4	0.2	0.2
8/4/2021	0.4	0.8	4	0.4	0.0
4/5/2021	1.0	0.8	4	0.6	0.4
2/6/2021	0.3	0.8	4	0.2	0.1
2/7/2021	0.7	0.7	4	0.5	0.2
30/7/2021	0.7	0.8	4	0.7	0.0
1/9/2021	1.1	0.8	4	0.9	0.2
1/10/2021	2.2	0.9	4	1.9	0.3
1/11/2021	1.4	1.0	4	1.2	0.2
1/12/2021	24.7	2.8	4	23.1	1.6

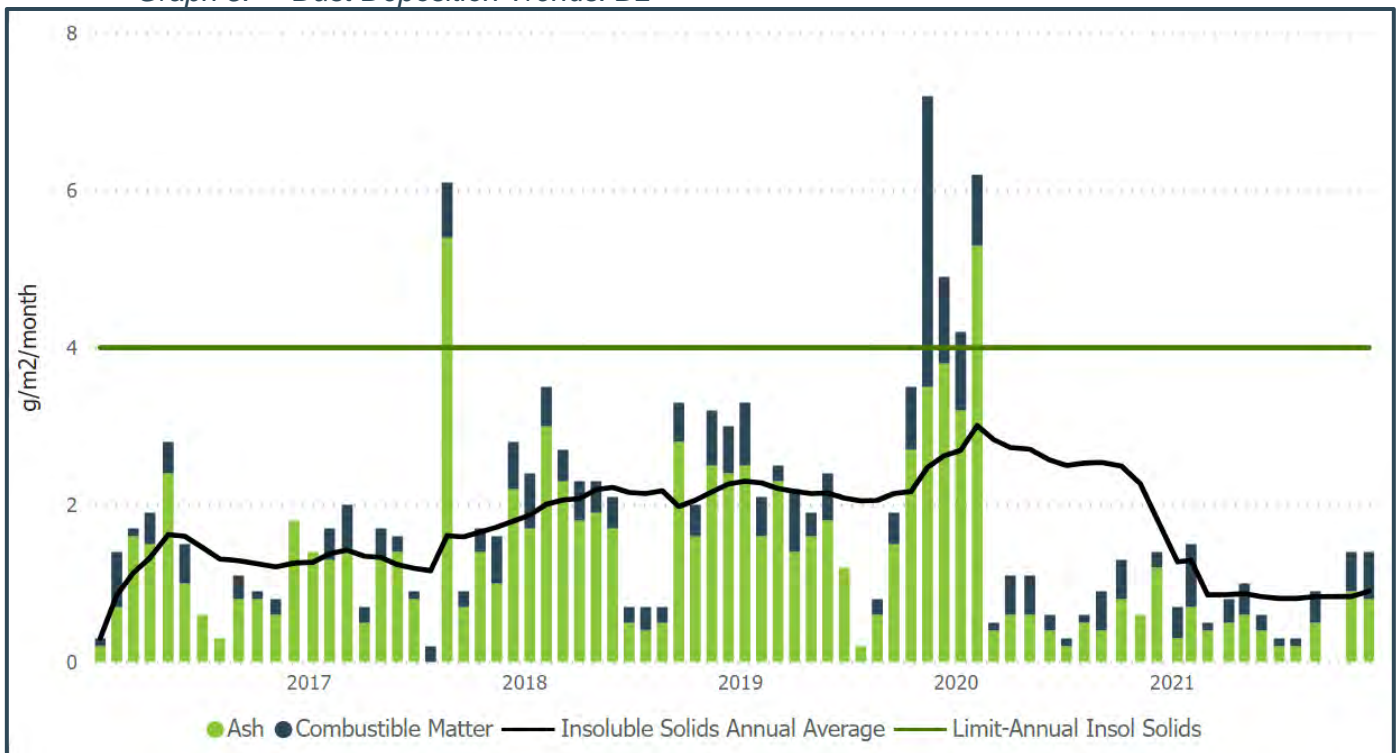
Graph 5. Dust Deposition Trends: D2

Trees encroach on the collection zone of the gauge. These trees are within the protection zone required by the flora management plan and cannot be removed. Trimming of branches is undertaken where possible. The site of this gauge does not meet AS3580.10.1, however an alternative location near the sensitive receptor is not available.

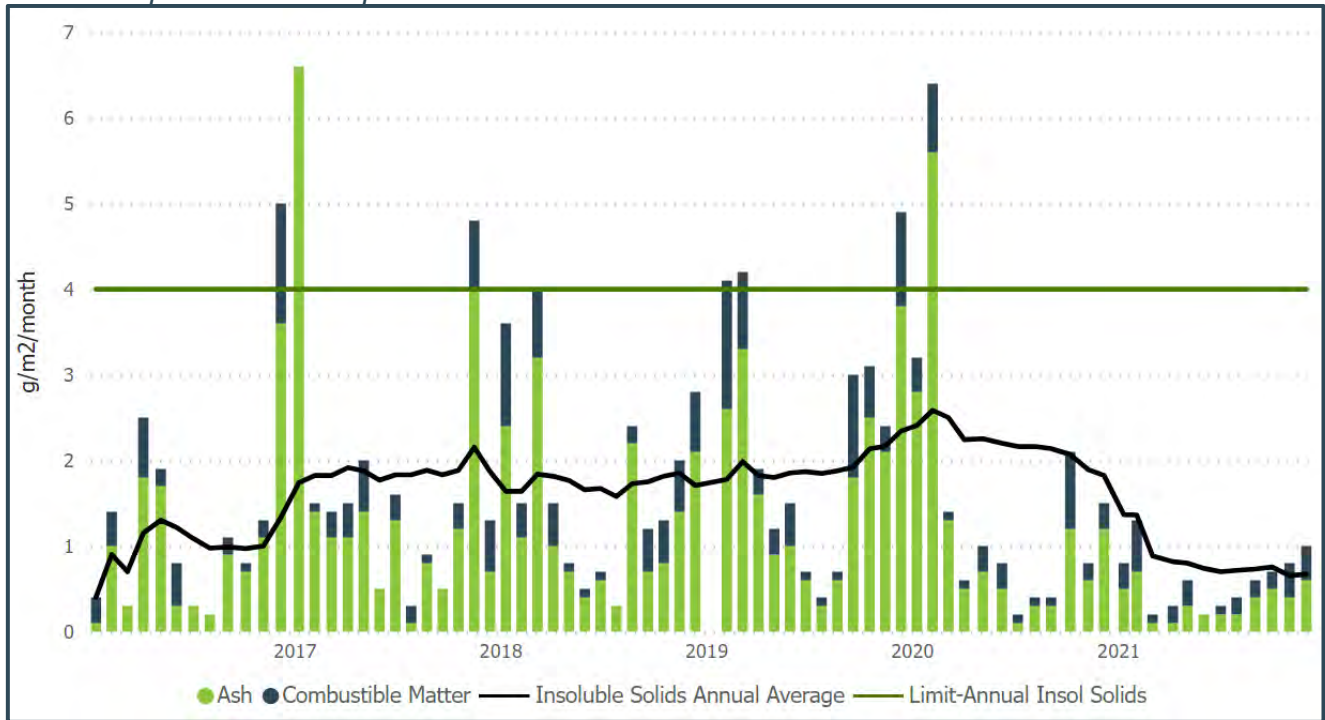
Graph 6. Dust Deposition Trends: D3

Date	Insoluble Solids	Rolling Annual Average Insol Solids	Limit-Annual Insol Solids	Ash	Combustible Matter
11/1/2021	0.8	1.4	4	0.5	0.3
3/2/2021	1.3	1.4	4	0.7	0.6
3/3/2021	0.2	0.9	4	0.1	0.1
8/4/2021	0.3	0.8	4	0.1	0.2
4/5/2021	0.6	0.8	4	0.3	0.3
2/6/2021	0.2	0.7	4	0.2	0.0
2/7/2021	0.3	0.7	4	0.2	0.1
30/7/2021	0.4	0.7	4	0.2	0.2
1/9/2021	0.6	0.7	4	0.4	0.2
1/10/2021	0.7	0.8	4	0.5	0.2
1/11/2021	0.8	0.7	4	0.4	0.4
1/12/2021	1.0	0.7	4	0.6	0.4

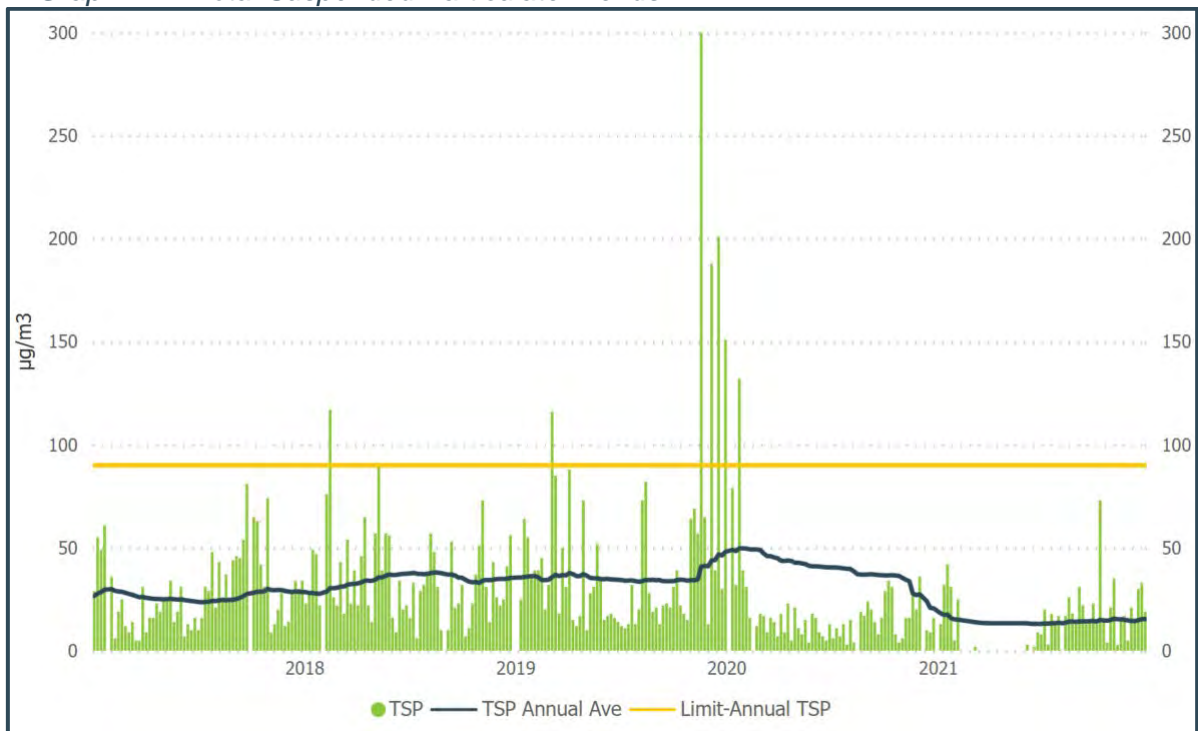
Graph 7. Total Suspended Particulate Trends

Annual Averages	TSP $\mu\text{g}/\text{m}^3$	PM10 $\mu\text{g}/\text{m}^3$	PM2.5 $\mu\text{g}/\text{m}^3$
2021	15.4	8.8	6.1
Compliant with DA	Yes	Yes	Yes
Criteria	90	30 / 25	N/A / 8
Prediction	57 (Mod 2) 43 (Mod 4)	15 (Mod 2) 22 (Mod 4)	N/A (Mod 2) 14 (Mod 4)
2020	21	11	7.8
2019	48	32	26
2018	36	19	14
2017	29	15	12

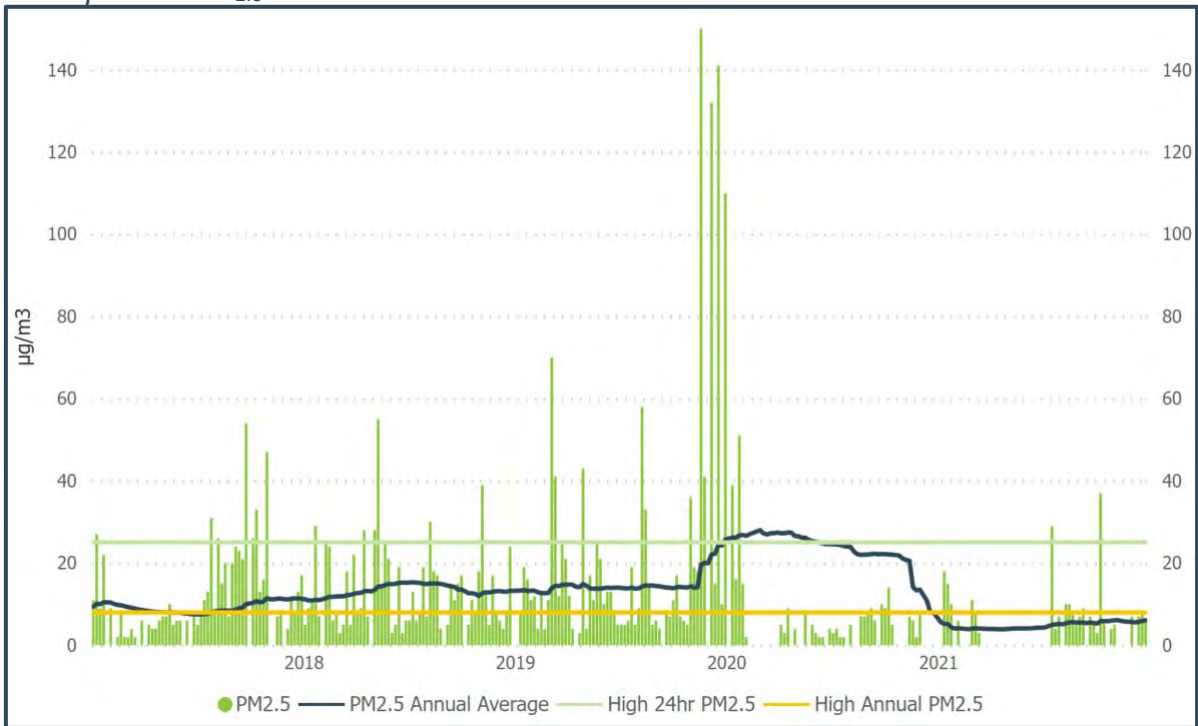
Graph 9. $PM_{2.5}$ Trends

A high 24-hour PM2.5 reading in September 2021 caused by local grassfire was not reported as an incident as it was not considered caused by site operations. Future exceedances will be reported to ensure compliance with Mod 4.

Date	PM2.5 $\mu\text{g}/\text{m}^3$	Criteria	Comments
9/10/2021	37	25	Local grass fire

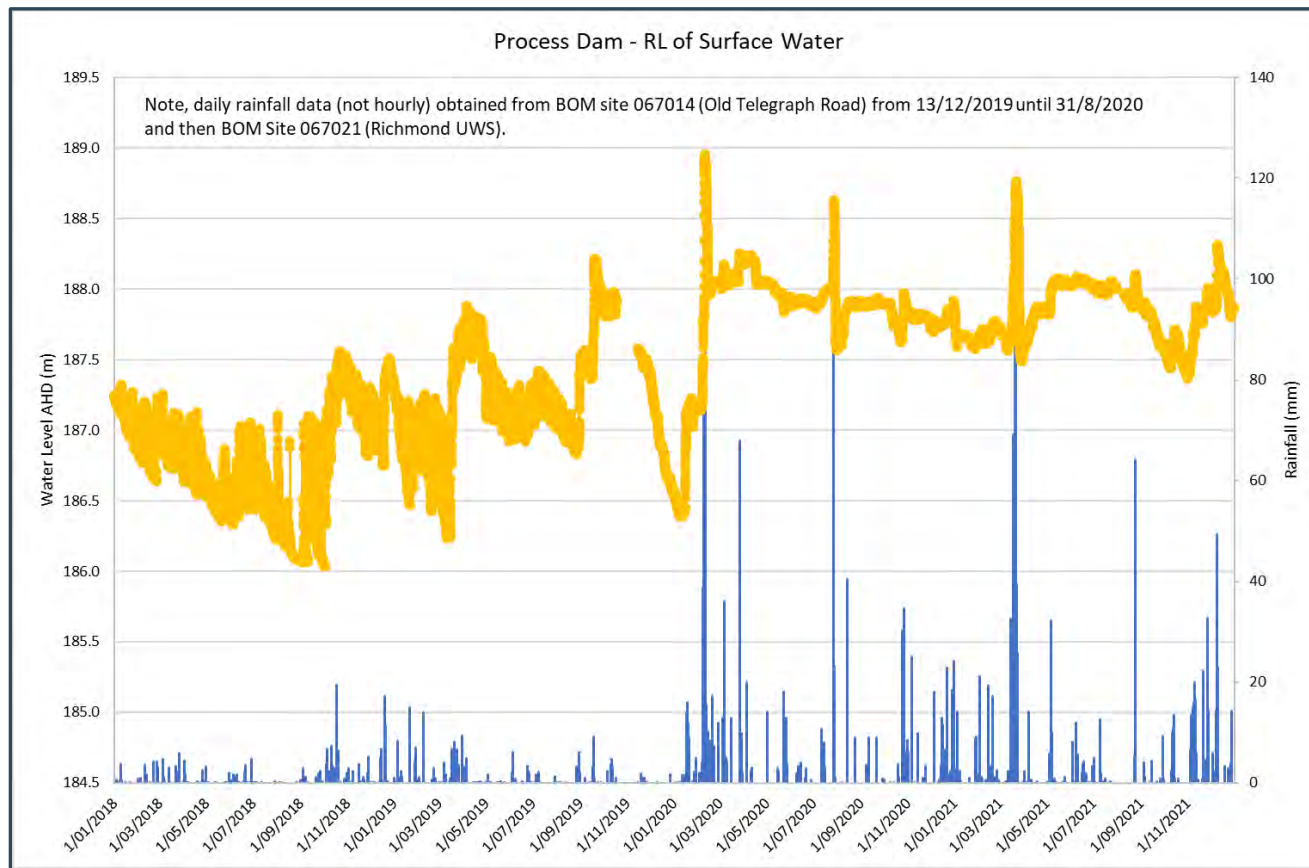
Graph 13. Process Dam Water Level

The extraction of sand on the site relies on an adequate supply of water for washing and screening of material. After processing, residual clay/silt is delivered to the designated drying areas and liberated water is drained into a holding dam (currently Drying Dam 2) to settle sediment entrained in the process. Water from the holding dam is then released back into the process dam (Dam 1) for re-use. Release from Dam 2 to Dam 1 is through a riser pipe that can be manually adjusted to maximise the water draining to Dam 1. During processing Dam 2 fills with sediment as well as water resulting in the upward displacement of water in the dam. The overall effect is that whilst a nominal small volume is held at all times in Dam 2, virtually all processing water makes its way back to Dam 1 overnight.

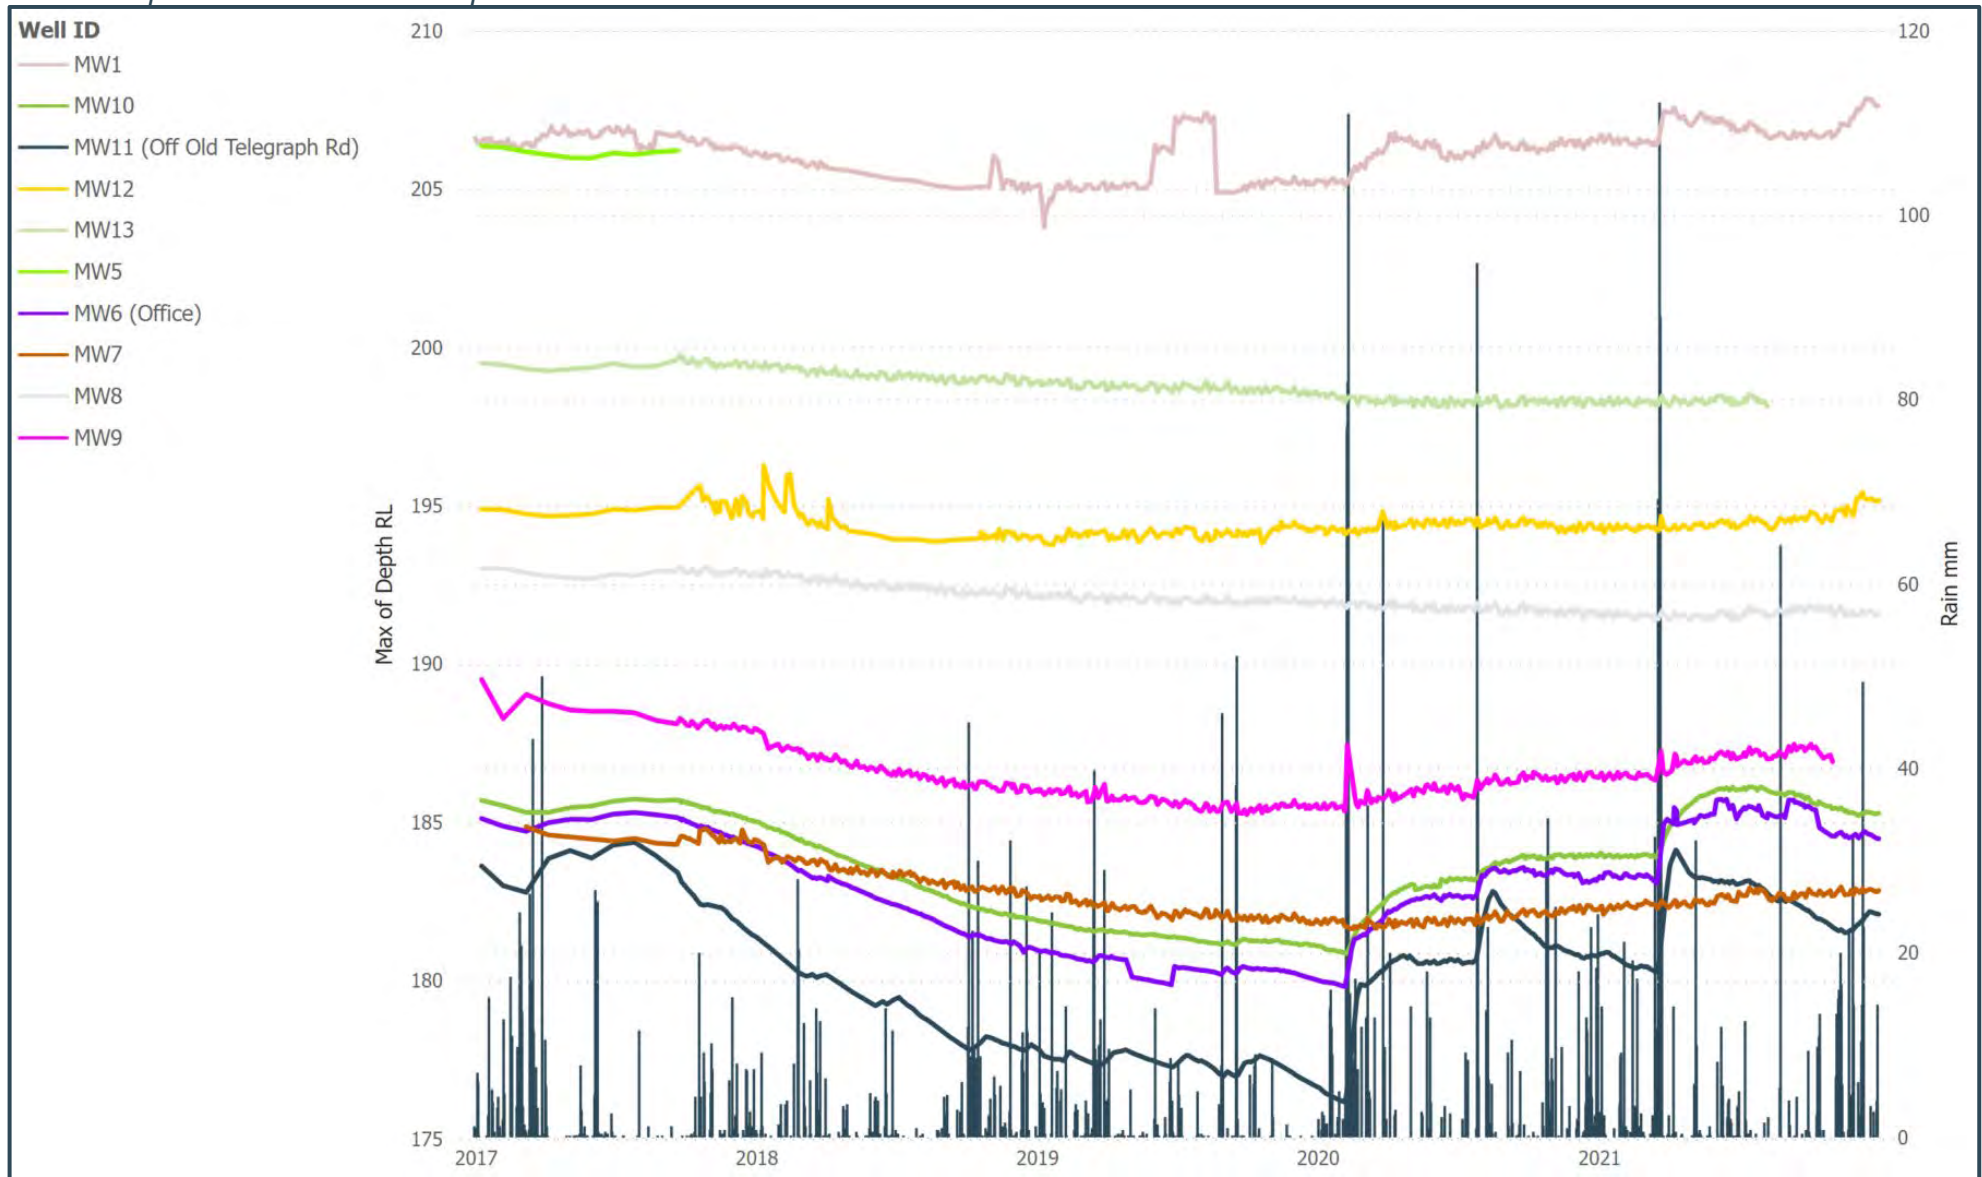
Graph 15. Groundwater Depth Trends

Groundwater level monitoring results from the continuous automatic data loggers are corrected for barometric pressure and calibrated to manual measurements undertaken each month. Groundwater levels are currently monitored in eight boreholes located on the site. MW1 logger was installed prior to 2015; the remaining loggers were installed in 2017. Following anomalous readings from the MW5 logger during 2017, the bore was investigated and discovered to have collapsed. The logger was relocated to a functioning bore and MW5 abandoned and replaced by nearby MW8.

Loggers in MW1 and MW12 were reinstated in November 2018 following repairs undertaken between May/June 2018 and October 2018. During this time manual readings continued. MW13 stopped functioning in February 2020 and has yet to be replaced or repaired. MW9 has been decommissioned due to expansion of the quarry in November 2021. MW1 logger stopped functioning in November 2021 and may be replaced during 2022.

- Continue groundwater and surface water level monitoring and report in accordance with the approved Groundwater Monitoring Program and Groundwater Management Plan.
- Review loggers on site and replace faulty loggers if required.
- Undertake water quality monitoring and reporting in accordance with the approved Groundwater Monitoring Program and Water Management Plan.

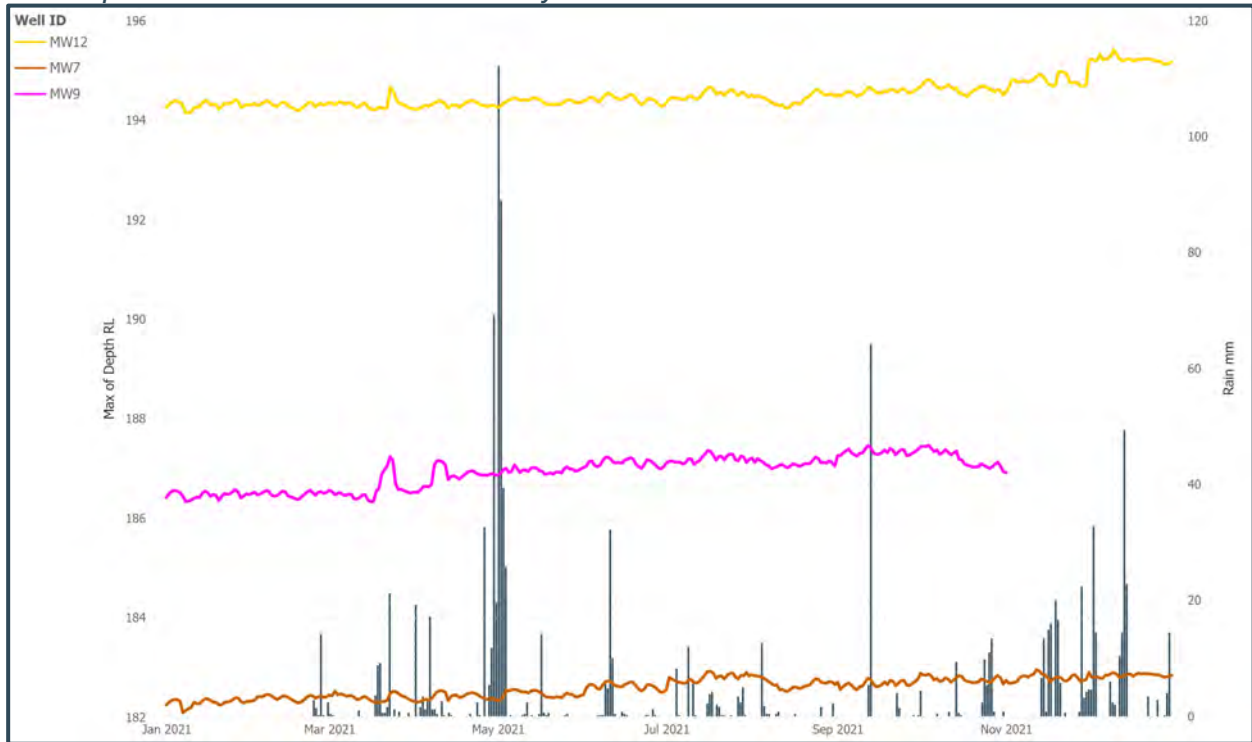
Graph 16. Water Level in Hawkesbury Sandstone with Rainfall 2021

Groundwater Levels have risen across the site during 2021 in response to higher rainfall. The largest rise was in March after some steady rainfall, and levels have been slowly rising since then. The Maroota Sands channel has risen to levels approximately equal and slightly higher than those used in 2018 for the original groundwater modelling. The Hawkesbury Sandstone regional aquifer has also remained at approximately similar levels. These are illustrated on *Figure Seven*.
