**Annual Review and Compliance
Report for
Maroota Sand Quarry
DA 267-11-99
Year Ending 31st December 2021**

Maroota Sand Quarry

Annual Review and Compliance Report 2021

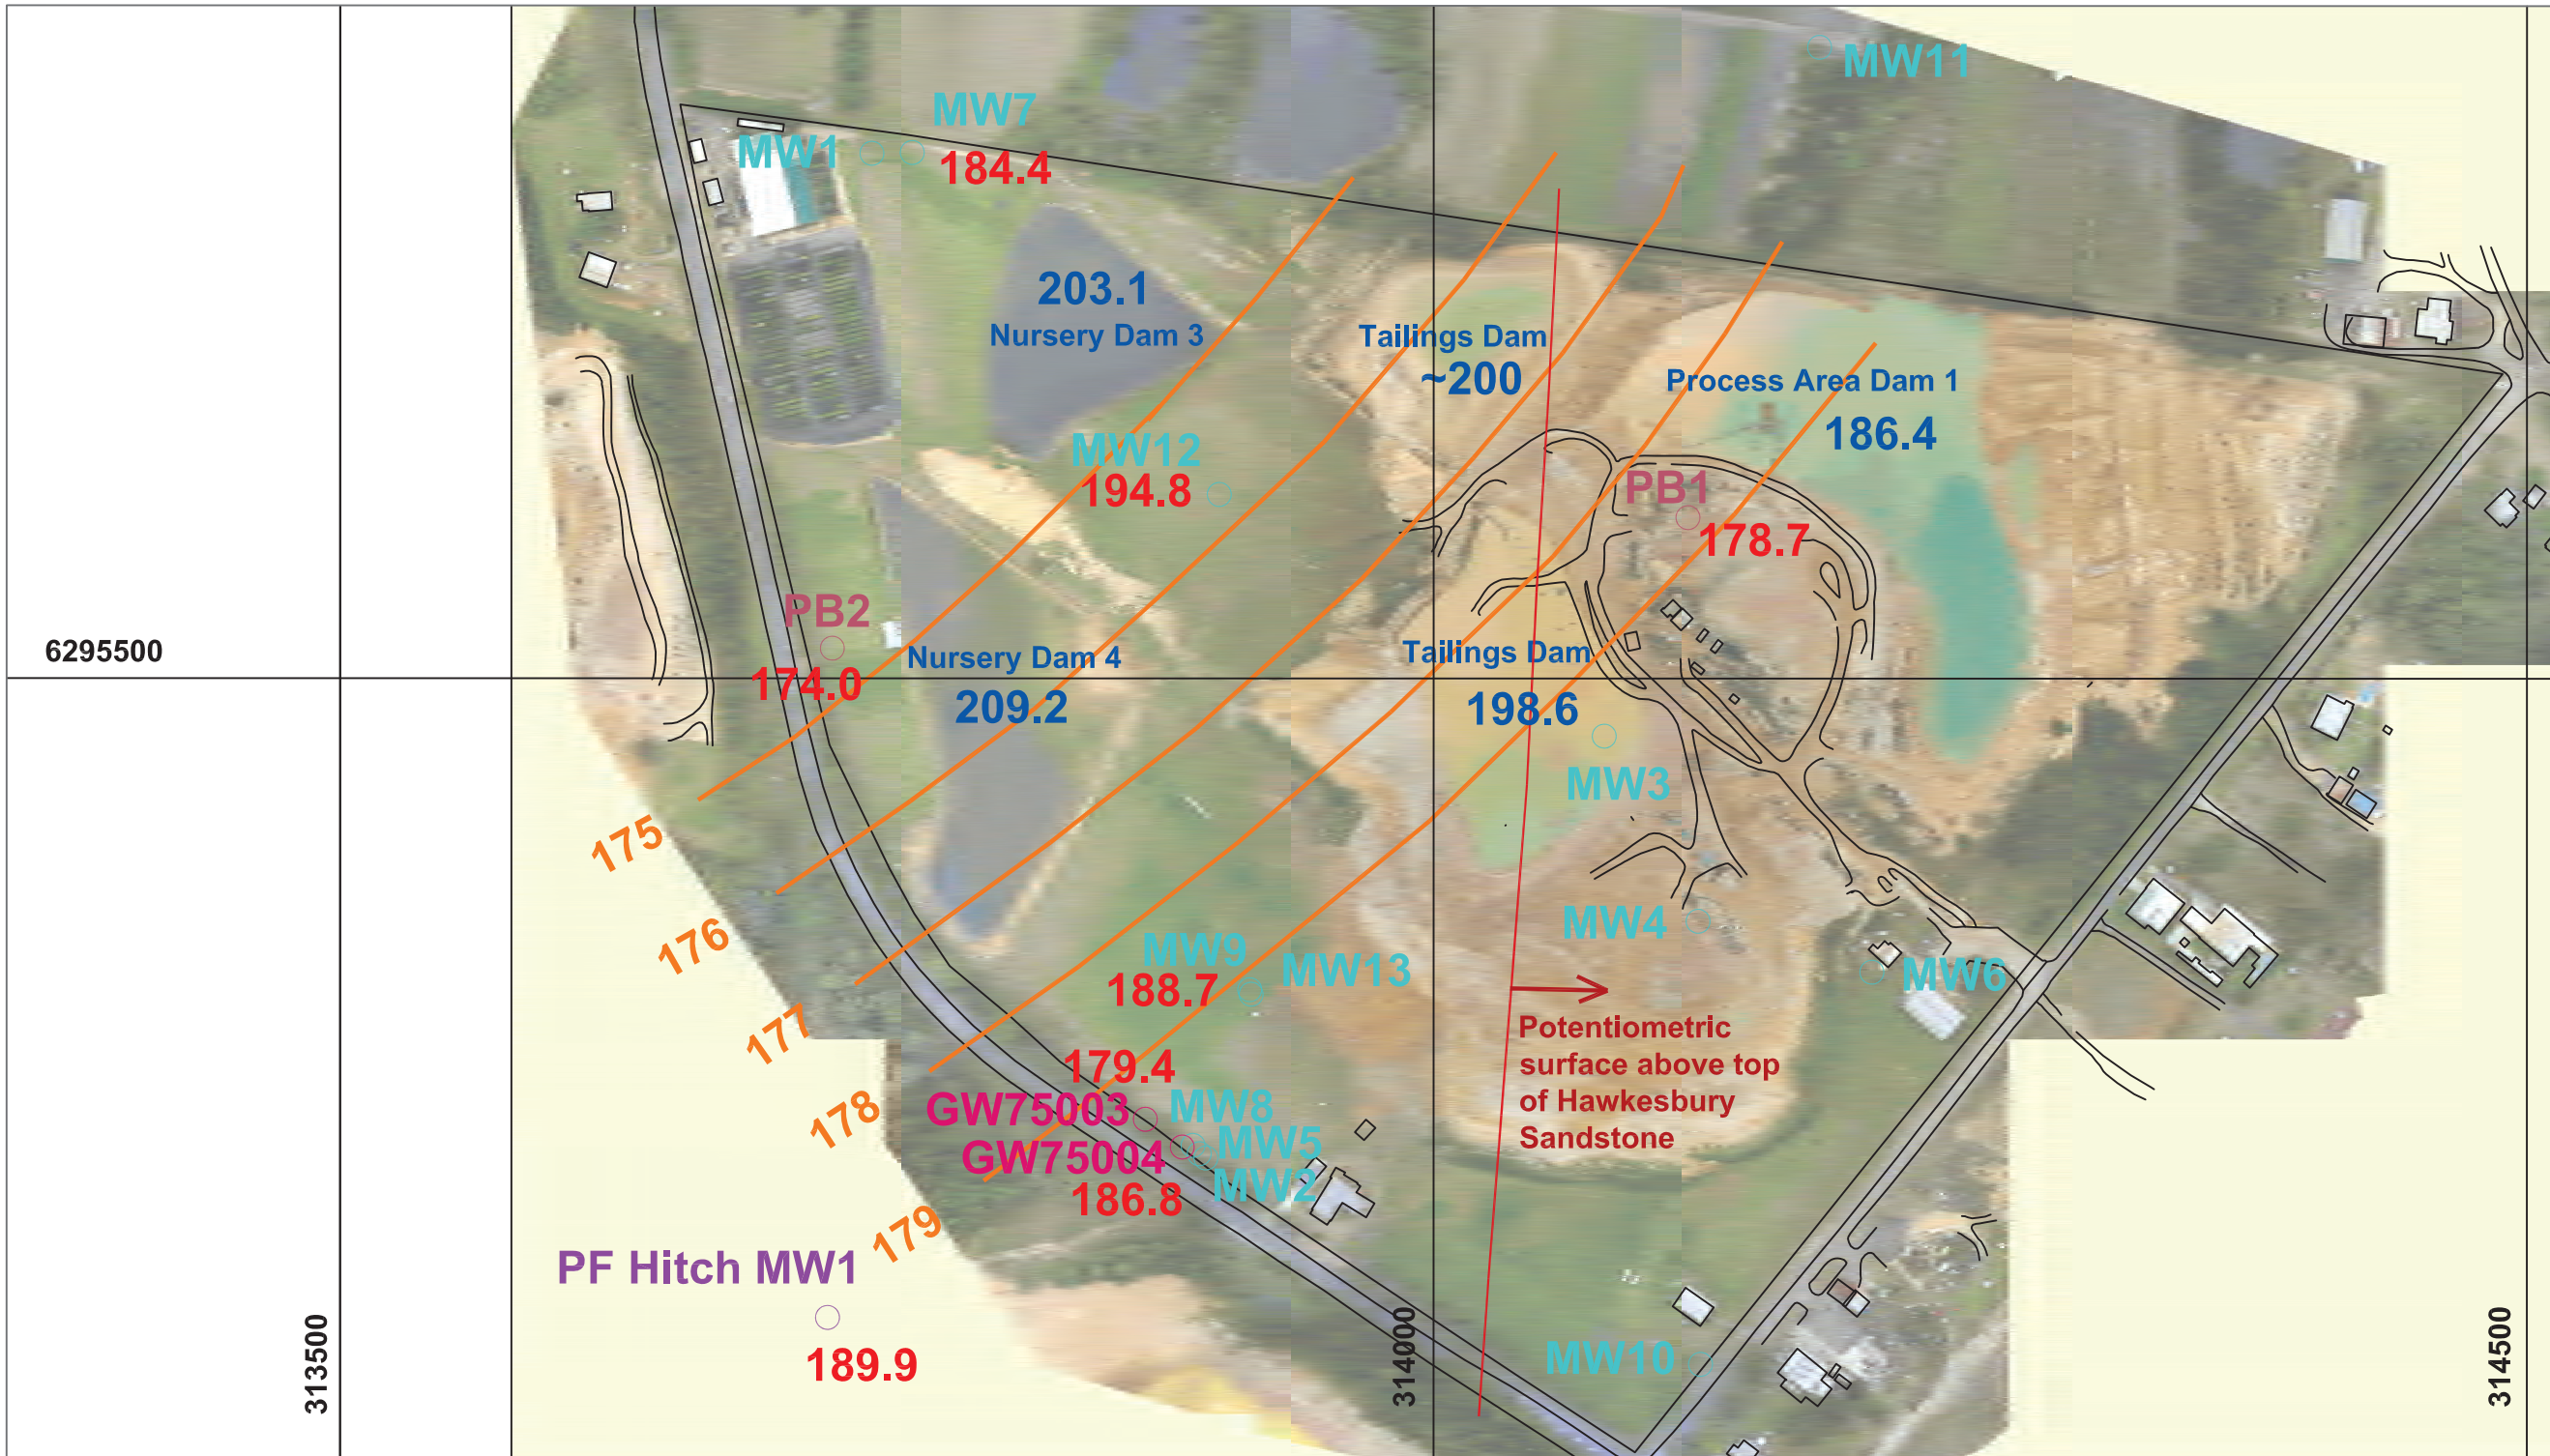
Figure Eight. Wet Weather High Groundwater Level – B

The quarry floor levels are 2 metres above the Wet Weather High Groundwater Level, therefore the quarry floor is compliant.

Plan of:	Annual Review & Compliance Report 2021 for Roberts Road Maroota Sand Quarry - Wet Weather High Groundwater Level Hawkesbury Sandstone (Feb 2018)	Location:	Maroota Quarry, Roberts Road, Maroota, NSW	Source:	Dundon Consulting Pty Ltd Figure 16 Dwg No. 06-0318-021d 08/03/2018	Our Ref:	10418_HMA_ARC2021_C007_V0_F7B.cdr
Figure:	SEVEN-B	Council:	Hills Shire Council	Survey:	Dundon Consulting Pty Ltd 08/03/2018	Plan By:	LT/JD
Sheet:	2 of 2	Tenures:	N/A	Projection:	MGA	Project Manager:	LT
Version/Date:	V0 24/03/2022	Client:	Hodgson Quarries & Plant Pty Ltd	Contour Interval:	1m	Office:	Thornton

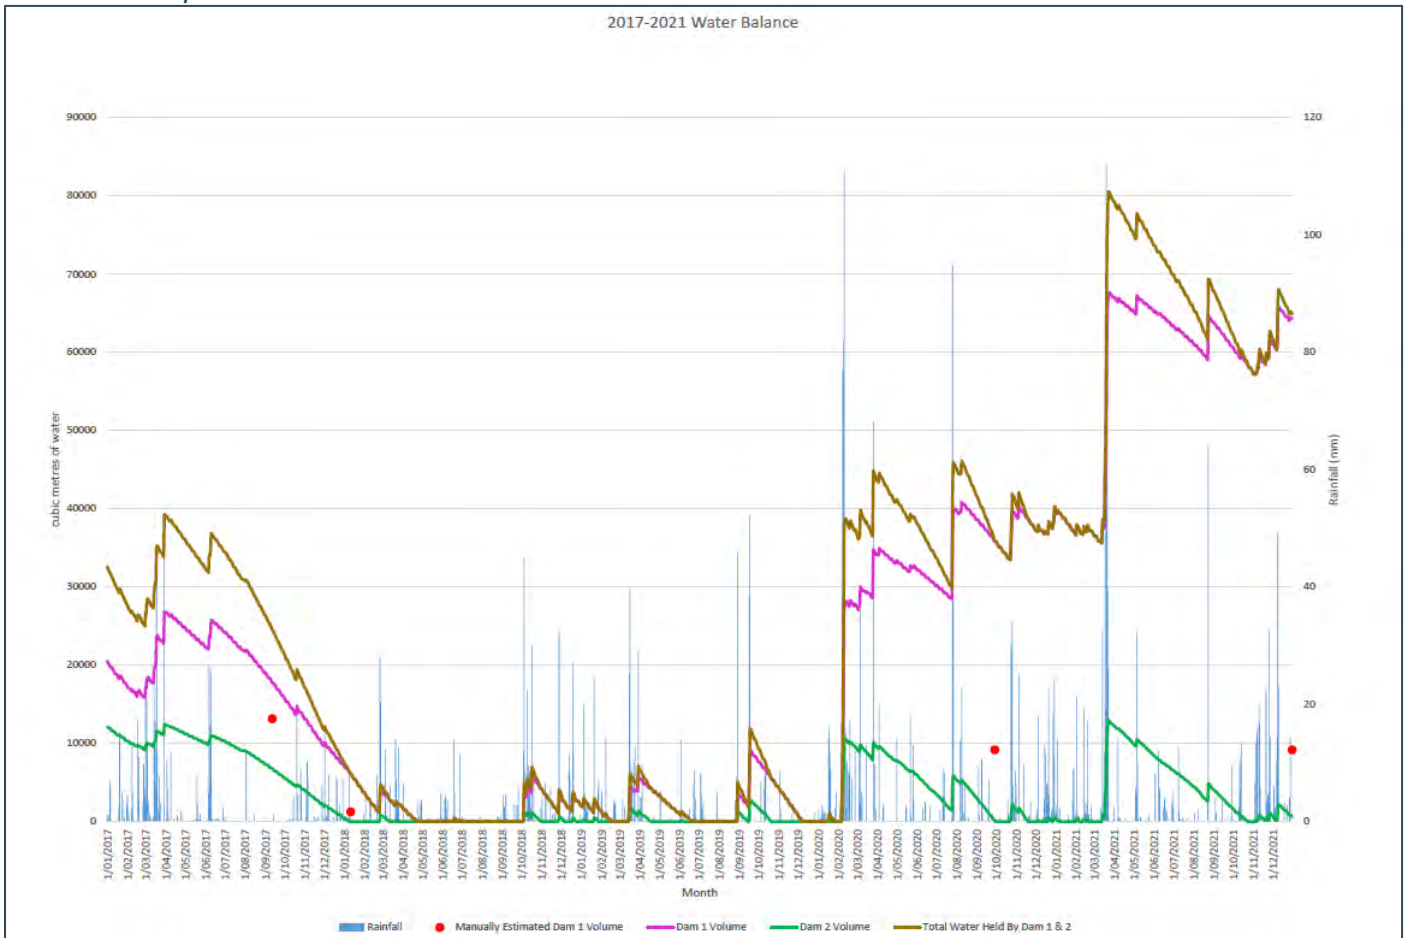
Graph 18. Site Water Balance 2021

The water balance has focused on the currently disturbed catchments and Dams 1 and 2. Dams 3 and 4 are not controlled by the operator and usage/pumping rates are unknown. At present they play no part in the site operations and therefore are not included in the water balance. Rainfall from data obtained onsite and from the BOM observations over 2021 was used to correlate site observations and measured dam water levels.

A level logger was installed in Dam 1 in late September 2017 and data obtained during 2021 has been applied to the model. At the time the logger was installed, the RL of the water in Dam 1 was recorded. Measurements were taken over the area of the dam to determine the depth of water to the base of the silt. The dam was found to be only up to 0.5m deep over the vast majority of its extent with the exception of a deeper void (up to 3m deep) around the pump intake. This data was used to project an approximate contour model of the base of the dam. From the model, the volume of the water within the dam has been estimated at various depths (RLs). These volumes have then been correlated with the monthly average depth recorded by the logger and plotted against the volume of water held predicted by the water balance to assess its reliability. No dissipation from the dams has been accounted for in the amended assumptions.
