**ANNUAL
BIODIVERSITY
MONITORING
REPORT
2021**

Prepared for Hodgson Quarries and Plant Pty Ltd

October 2021 V.1

**Hodgson Quarries and Plant Pty Ltd
Roberts Road Maroota NSW**

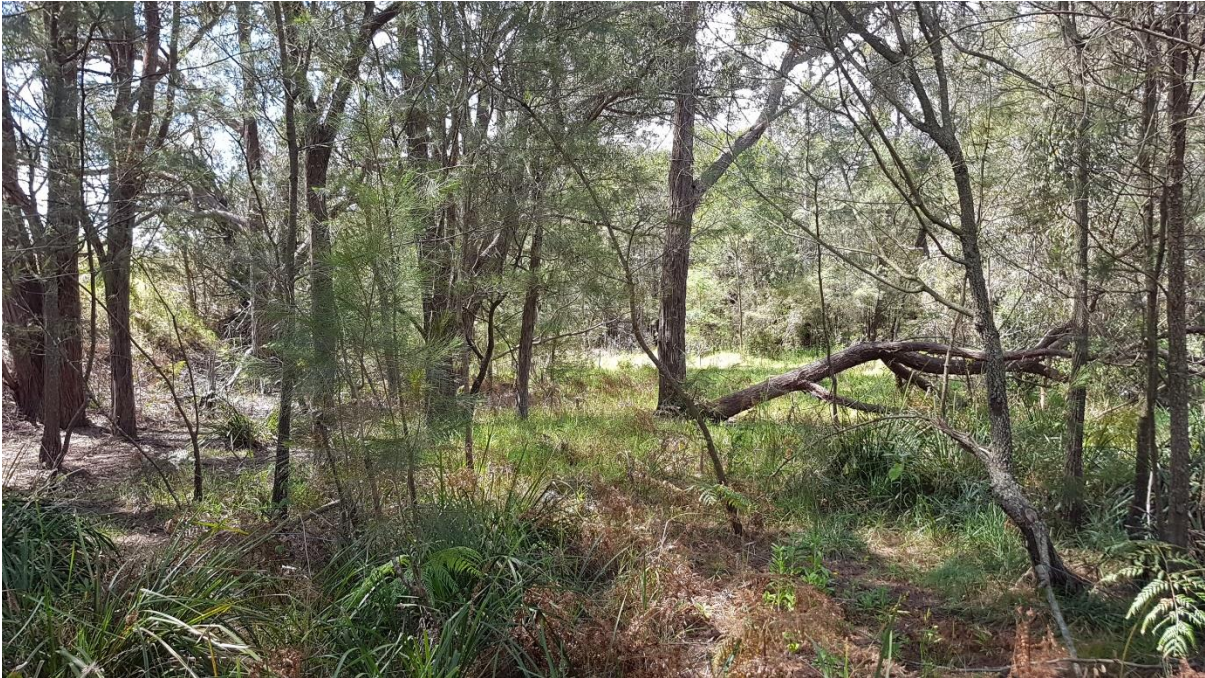
The remnant native vegetation within this area has a mature canopy of Eucalyptus and Angophora species. Lower strata are present including midstorey canopy, shrubs and ground cover. The exclusion of livestock grazing within this area has resulted in an increase of native ground cover species which over time will contribute to a much richer biodiversity value.

Biodiversity functional attributes such as size class of canopy species, litter cover, fallen timber and natural regeneration of species occurring is present within the area. Such attributes are likely to increase over time providing disturbance remains excluded within the area.

Figure 1. Remnant vegetation located immediately north of Roberts Road site entry gate Oct 2021

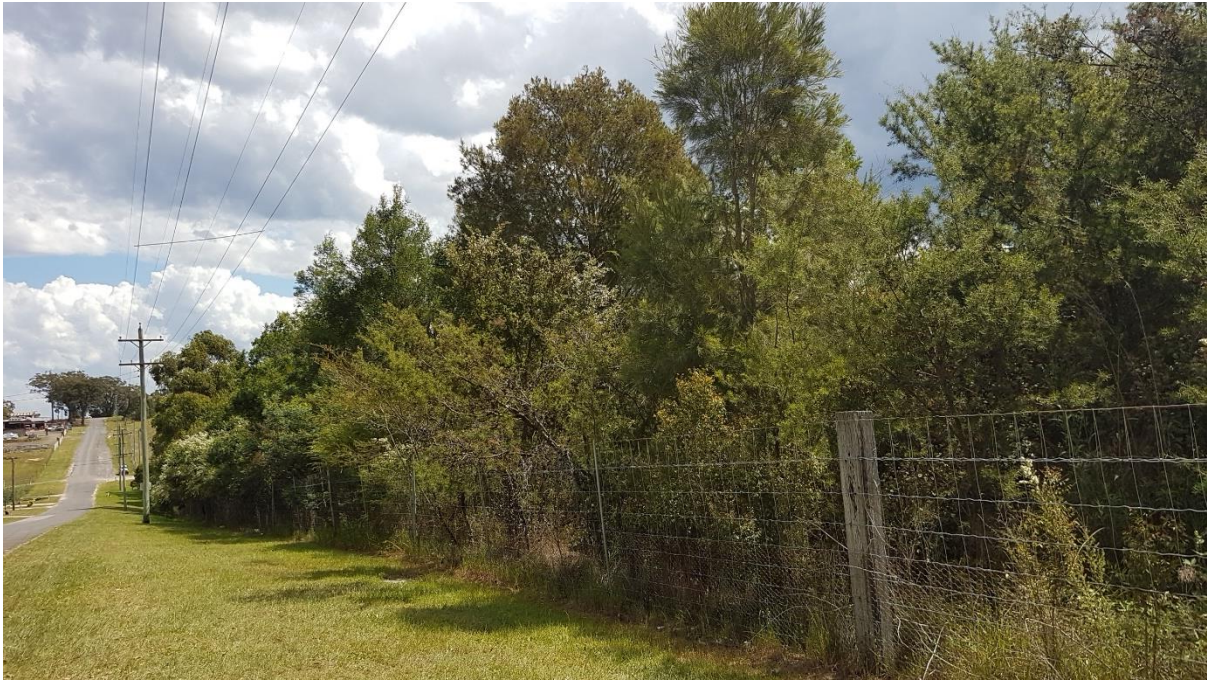
The remnant vegetation within the area of the far north eastern corner of the site has undergone past disturbance which has left the canopy broken. Eucalyptus and Angophora species are recovering throughout much of the area however the mature specimens are spaced apart providing little in canopy protection to the stratum below. The shrub stratum in this area is dominant and in some areas almost impenetrable. In other areas the shrub stratum is sparse and bare ground occurs.

Leaf litter is abundant throughout most of this area however fallen timber and size class of canopy species is limited.

Figure 2. Remnant vegetation located in the north eastern corner adjacent to Roberts Road Oct 2021

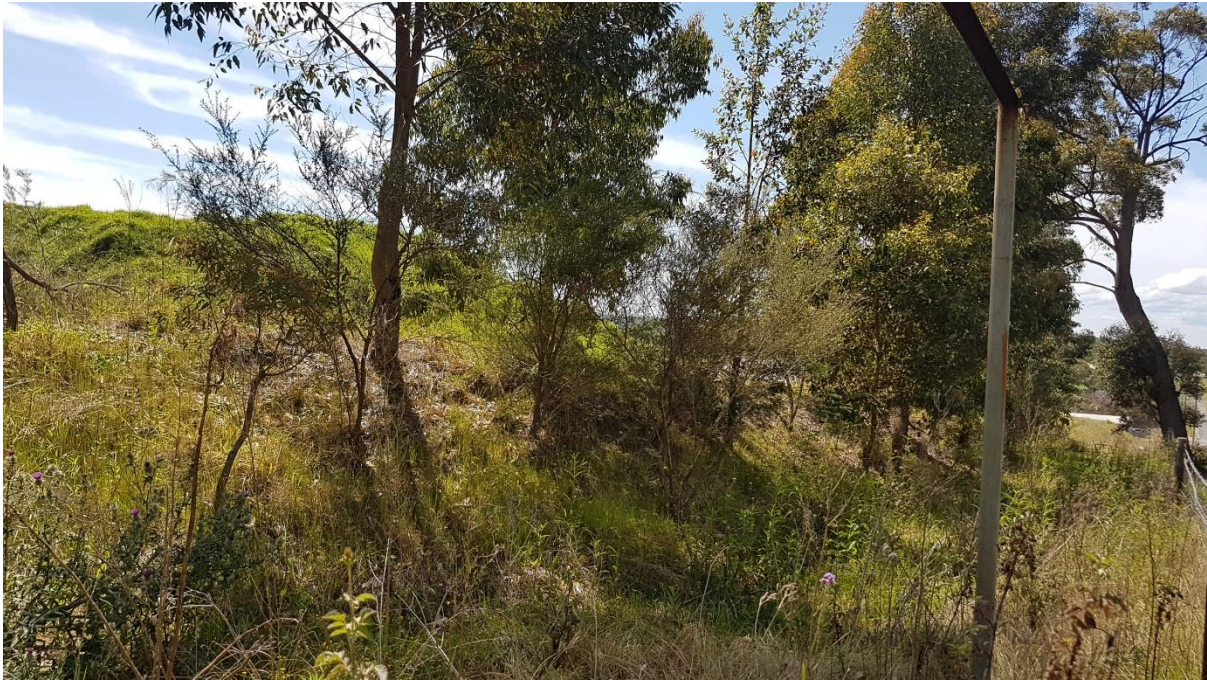
Exotic grasses dominate the agricultural land along Roberts Road. Some native species are present, particularly along the large bund wall which provides protection from the hot westerly sun, including Three-awned Speargrass *Aristida vagans*, Slender Rat's Tail Grass *Sporobolus creber* and Weeping Grass *Microlaena stipoides*. Agricultural weeds occur within the area although they are not considered to be dominant within the landscape. One Weed of National Significance (WoNS) was identified, Fireweed *Senecio madagascariensis*. However, due to no grazing pressure on grass over the past 12 month period, the Fireweed density appears to be less this reporting period due to being outcompeted by thick grass growth.

The native species which have been planted on a bund wall bordering Roberts Road and Old Northern Road are growing well. Almost all of these species have reached reproductive maturity and have had a strong flowering season this year.

Figure 3. Bund wall adjacent to Roberts Road.

There is an intention to undertake some infill native planting over time on the bund wall along the southern end of Roberts Road and the eastern bund wall facing Old Northern Road. Due to overhead powerlines in the immediate area, low growing native shrub species suitable for planting in these locations is highly recommended.

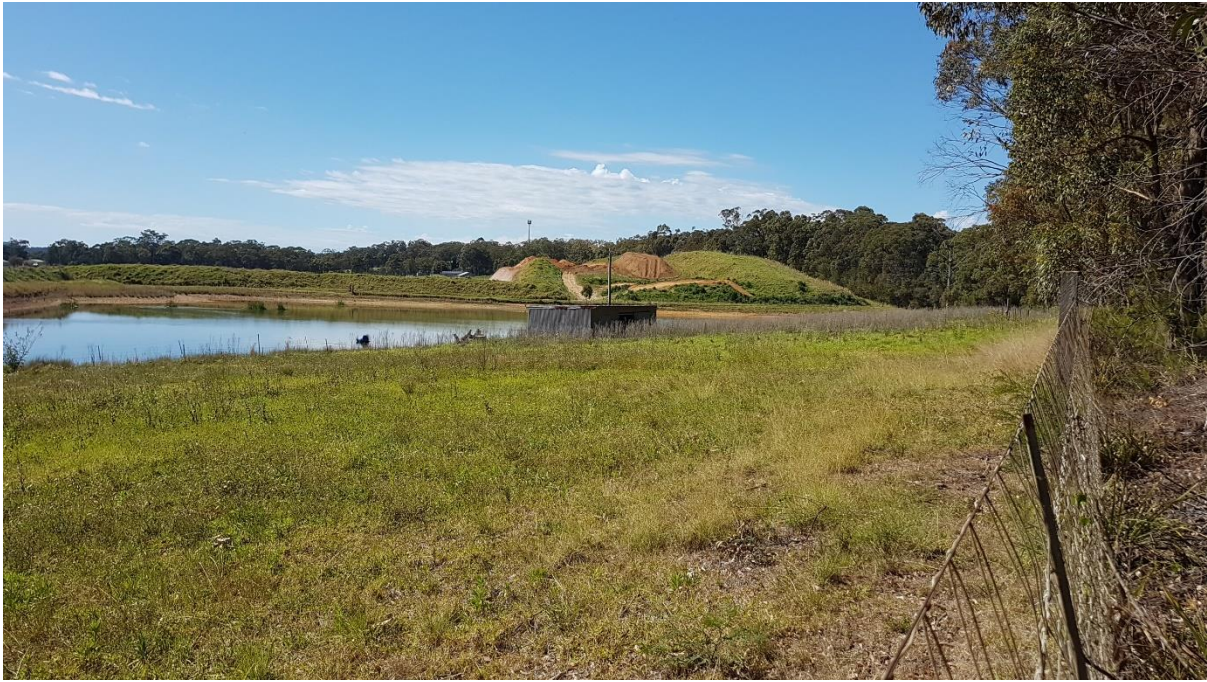
This area of agricultural land is dominated by exotic grass species suitable for livestock grazing. Some agricultural weed species occur although they do not dominate the landscape. A WoNS species, Fireweed *Senecio madagascariensis*, was observed in low density within this area. The Common Eastern Toadlet *Crinia signifera* was heard calling from the large dam adjacent to Old Northern Road along the western boundary. Several Eastern Snake-necked Tortoise's *Chelodina longicollis* were observed foraging within the large dam while a Red-bellied Black Snake *Pseudechis porphyriacus* was commonly observed sunbaking along the edge of the same dam during the reporting period.

Figure 4. Agricultural land with grassed bund wall adjacent to Old Northern Road

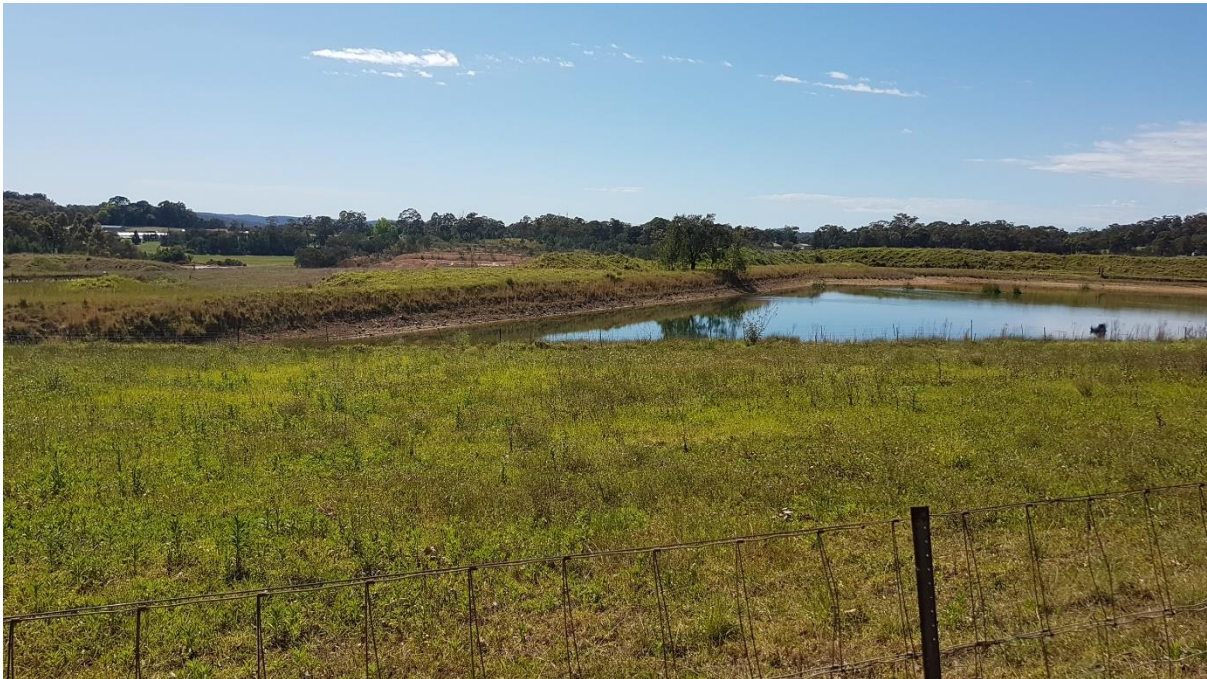
A plant nursery is established in the far north western corner of the site. The nursery makes use of water in the farm dams located on site. The agricultural land directly to the east of the nursery site is dominated by exotic grass species suitable for livestock grazing. One WoNS was identified in low density in this location, Fireweed *Senecio madagascariensis*.

Figure 5. Agricultural land along Old Northern Road in the west/south west of the site

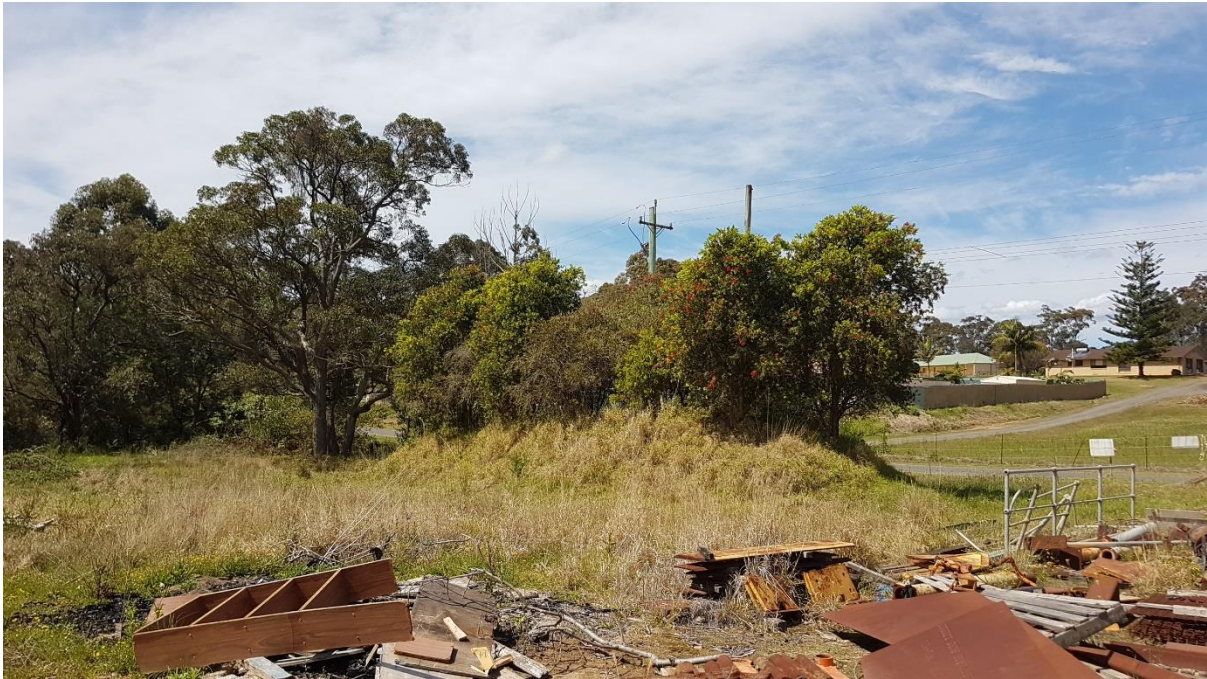
Bottlebrush *Callistemon* species have been planted along the eastern boundary of the property adjacent to the existing native vegetation. These shrubs are well established and provide a screen to Roberts Road. The shrubs provide habitat for small birds and food resources for a range of mammals, birds and invertebrate.

Figure 6. Bund wall immediately north of Roberts Road site entrance

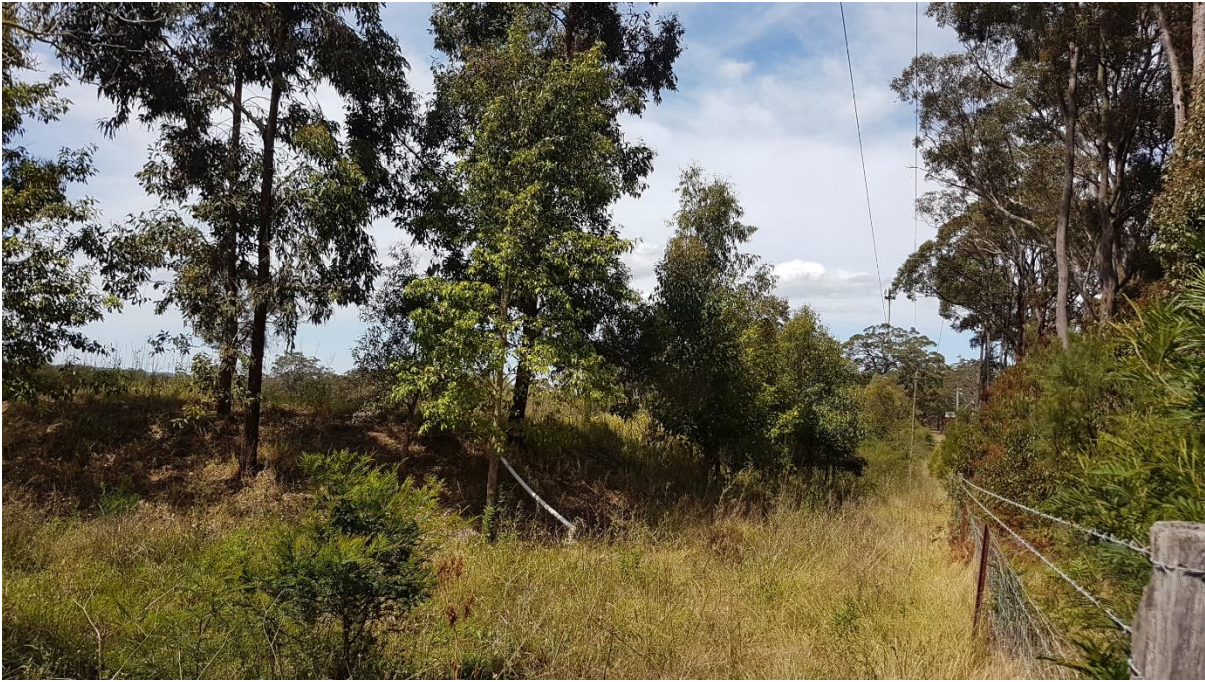
The southeastern corner and southern boundary of the site has small bund walls with planted native trees and shrubs. The trees along Old Northern Road have required pruning due to their close proximity to electrical power lines. As a result some of the trees have perished. The remaining plants appear to be growing well despite the pruning. The bund walls have good coverage of native vegetation with reproduction maturity demonstrated by most species during this monitoring period.

Figure 7. Planted native vegetation along Old Northern Road

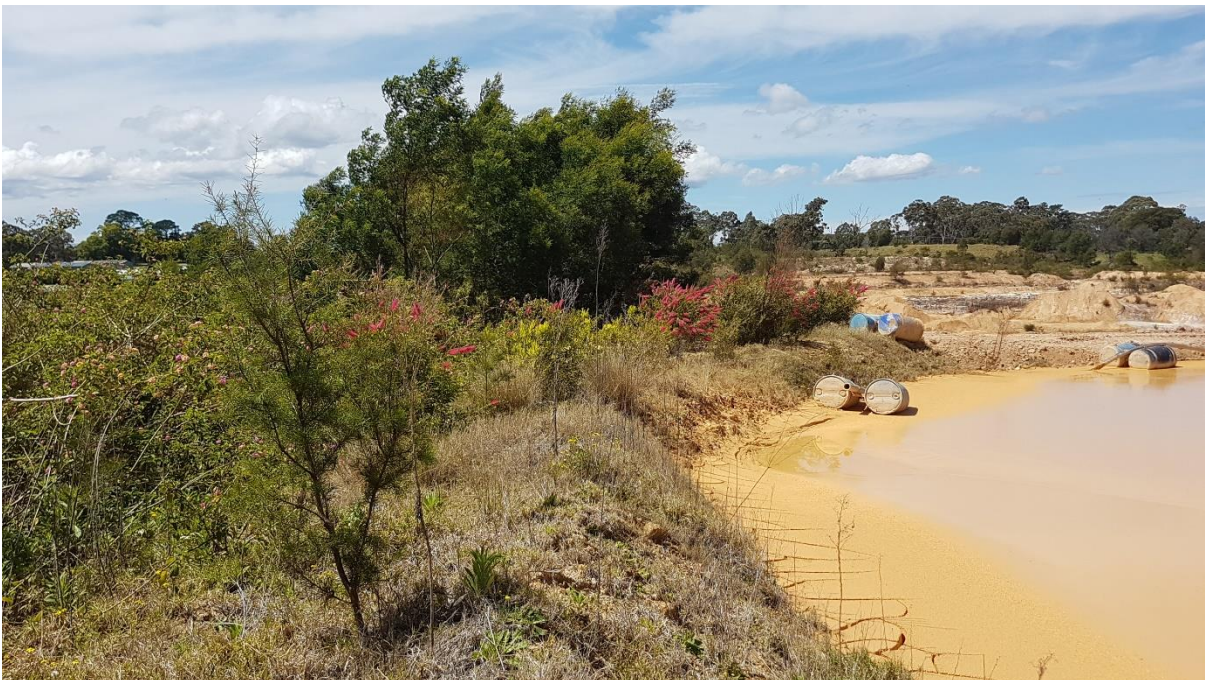
A variety of Bottlebrush *Callistemon* species have been planted in two locations along the northern boundary of the property. Exclusion fencing has been undertaken and success to date appears to be high. There were two WoNS species present along the fence line of the neighboring property, *Lantana* *Lantana camara* and Blackberry *Rubus fruticosus* sp. aggregate.

Figure 8. Planted native vegetation along northern property boundary

Weeds are present throughout the property with WoNS occurring in low density within the agricultural areas and in higher density within the planted native vegetation along the northern boundary bund wall. High Threat Weeds (HTW), as determined by the DPIE BAM Calculator, are also present although most of these weeds can be found within the agricultural land area. It is highly recommended these weeds are managed to maintain control of their growth and spread. Recommended weed control methods suitable for use throughout the year is supplied in Appendix D.

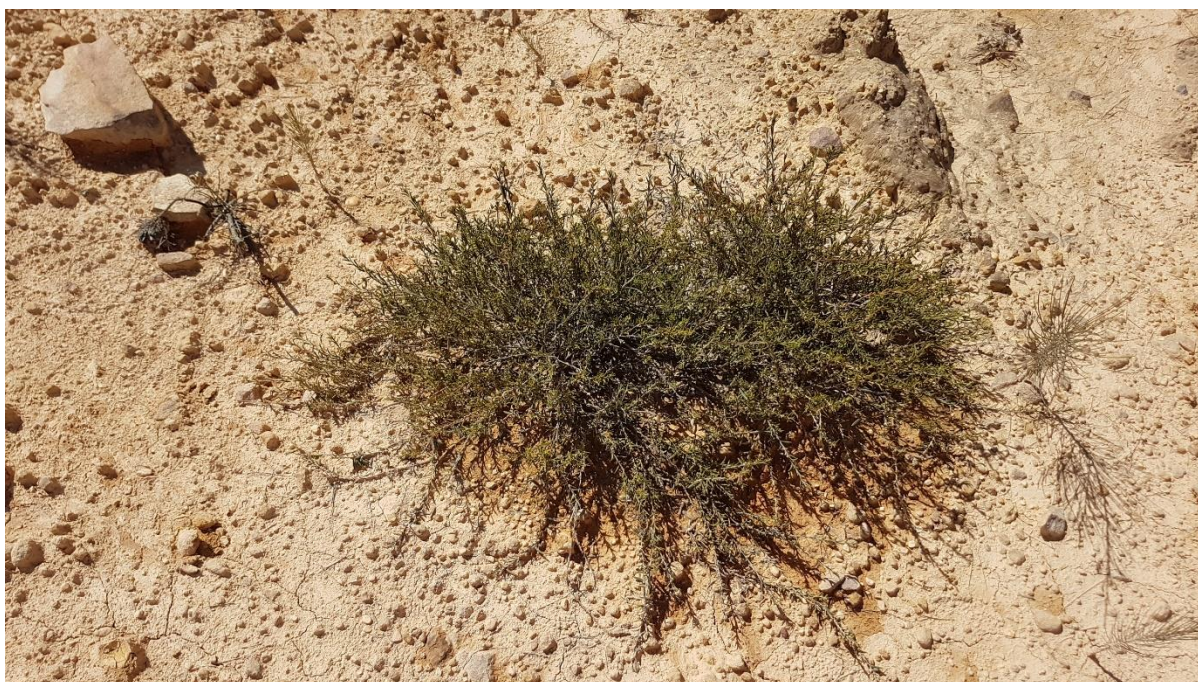
A single threatened flora species was previously identified within the property boundary. During the site survey in October 2021 five *Acacia bynoeana* individuals were located and identified onsite within the verge of the remnant native vegetation area and the sand quarry operational area. Plants varied in size from approximately 50mm – 200mm high, 50mm - 400mm in diameter. Four plants had multi-stems which were all healthy and had ample foliage and seed pod indicating the plant had reached reproductive maturity. The fifth plant was a small single stemmed seedling. All these plants appear to be new recruits.

Figure 9. *Acacia bynoeana* identified and located onsite

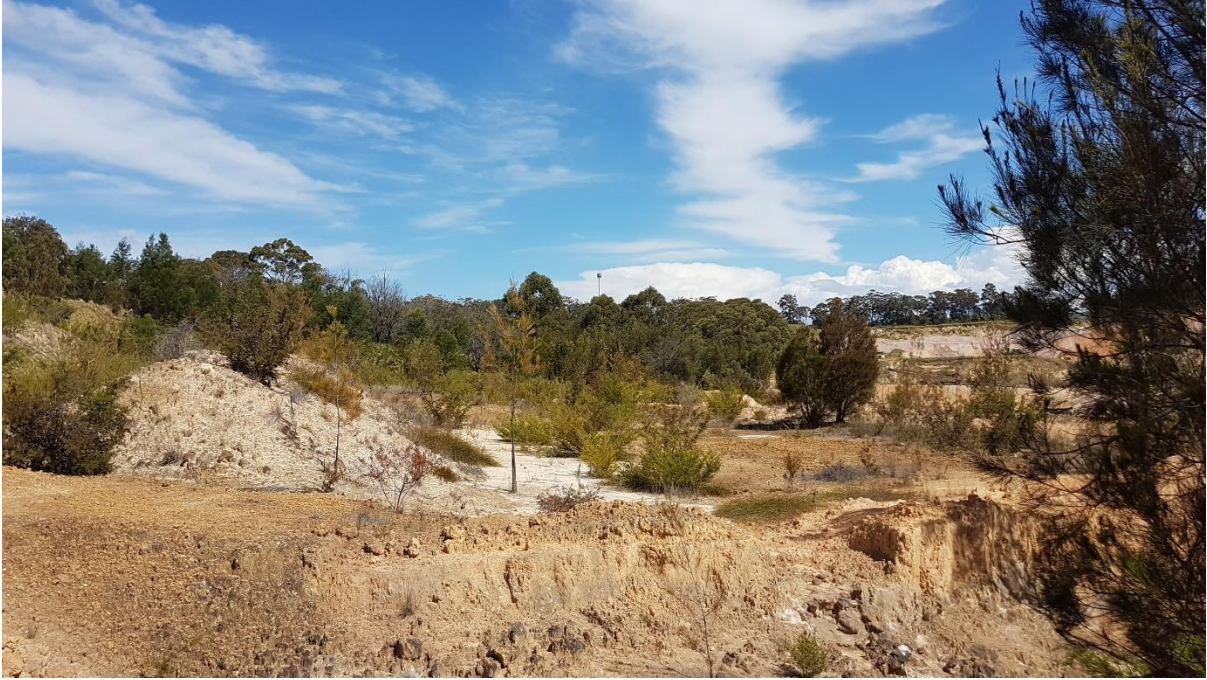
The location in which these plants occurs is a spoil mound pushed up from the silt pond adjacent. There is no canopy nearby which can be associated with the habitat.

Figure 10. Typical habitat where *Acacia bynoeana* has been identified and located onsite

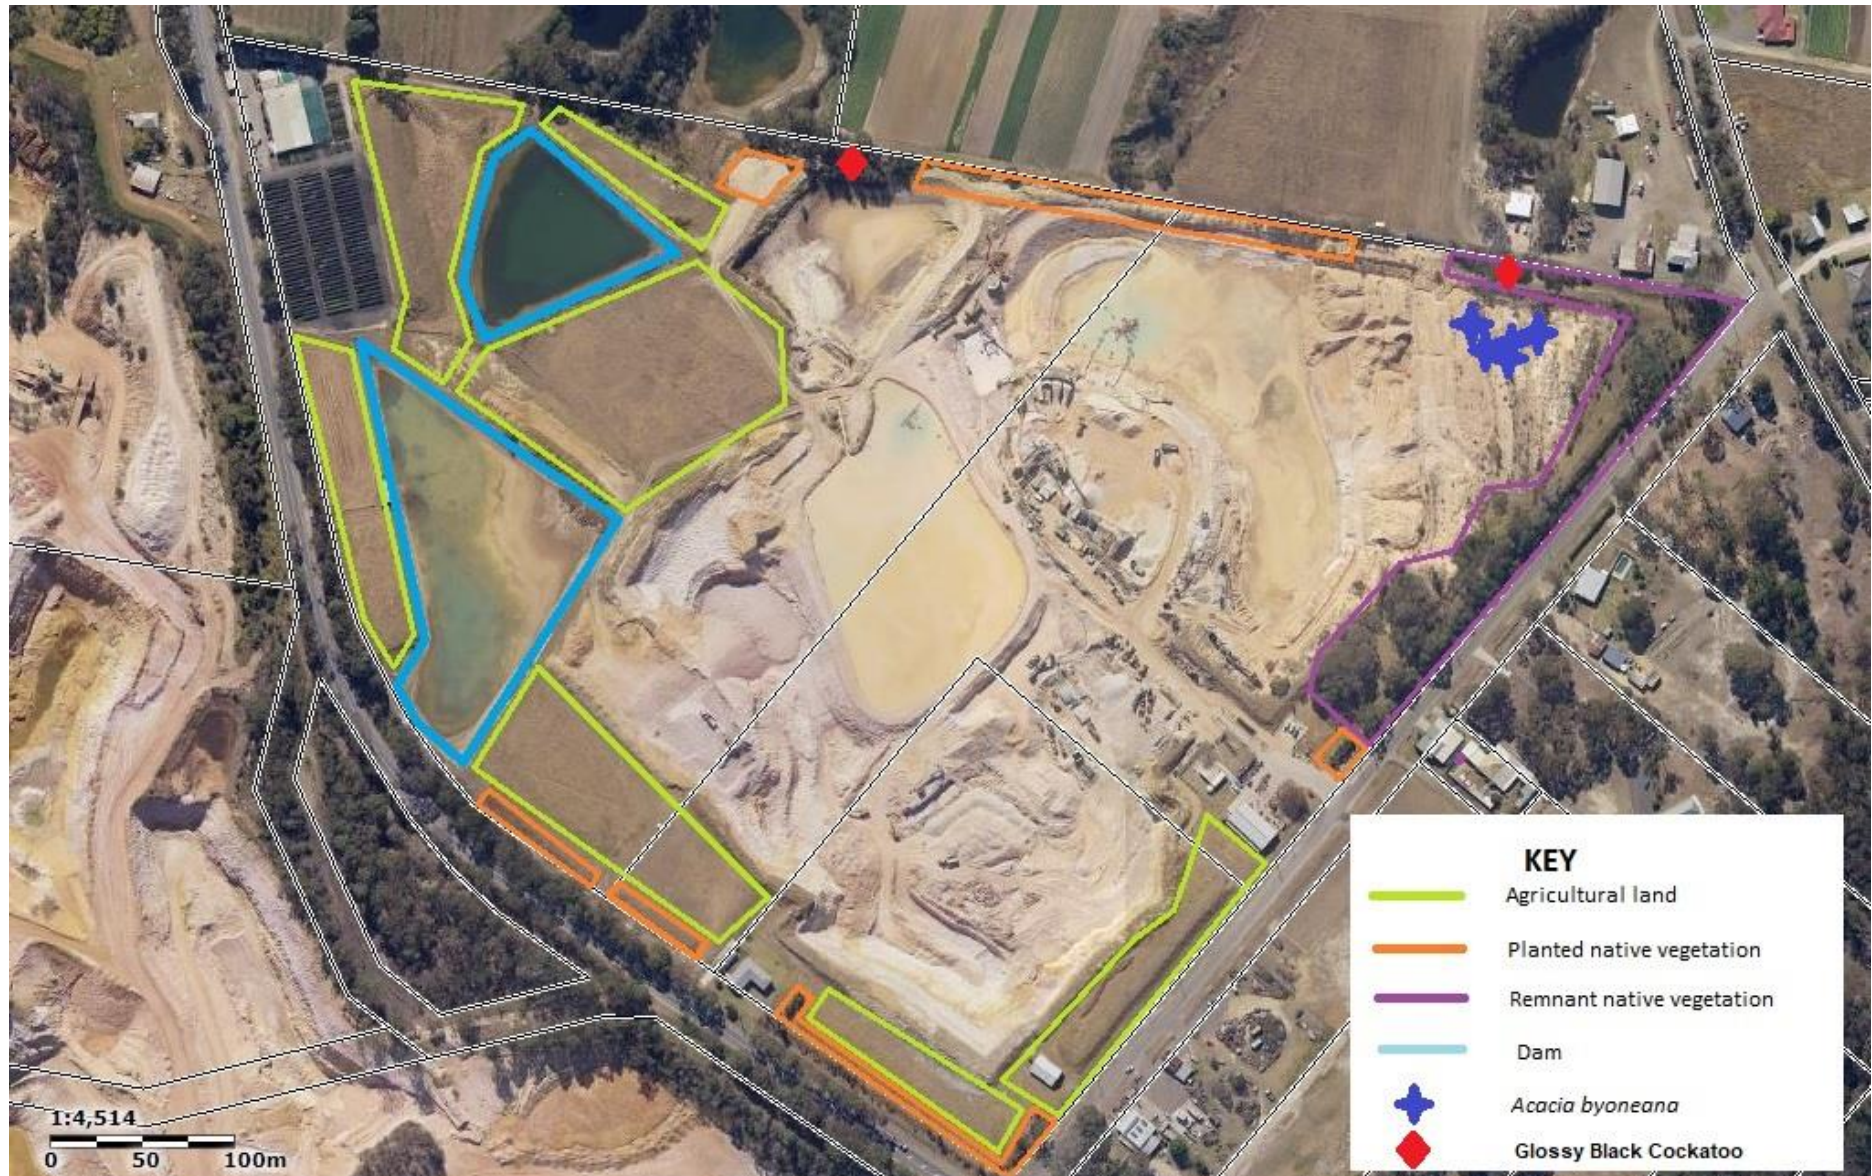
Figure 11. Location of vegetation zones within the Hodgson Quarries Roberts Road site
