14<sup>th</sup> March 2023 Monthly Groundwater and Climate Summary

1<sup>st</sup> February 2023 – 1<sup>st</sup> March 2023

Hodgson Quarries and Plant Pty Ltd Sand Quarry,
Roberts Road, Maroota, NSW

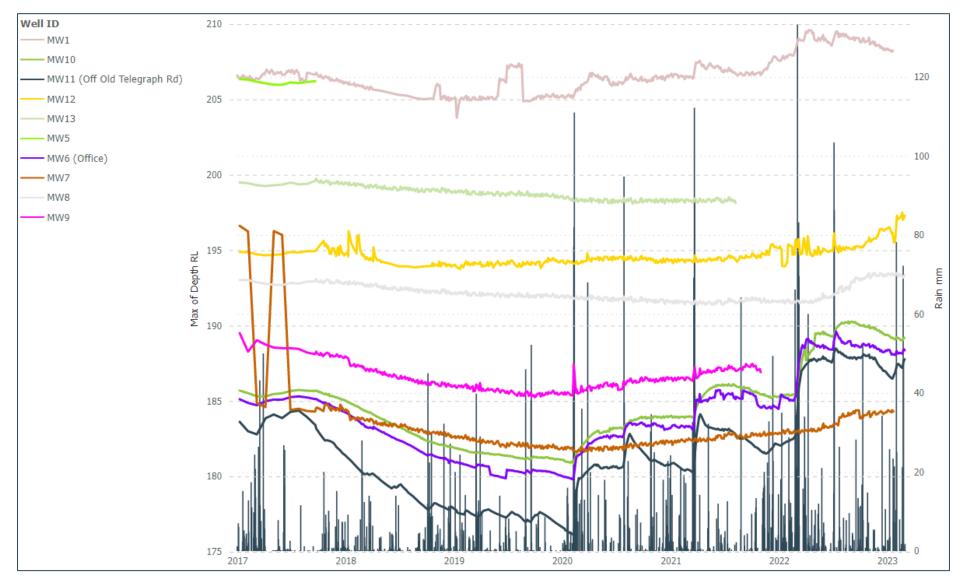
Figure Two. Groundwater Depths with Rainfall 1st January 2017 to 1st March 2023

*Figure Two* displays the depths as of January 2017. *Figure Three* shows depths between 1<sup>st</sup> February 2023 and 1<sup>st</sup> March 2023.

Following anomalous readings from the MW5 logger, the bore was investigated and discovered to have collapsed. The logger was relocated to a functioning bore and the bore abandoned and replaced by nearby MW8.

MW1 and MW12 were taken away for repairs during April 2018 and returned in October 2018, hence the gap in reporting on the following graphs.

Due to rain gauge malfunctions, rainfall was not recorded in 2020 until a new weather station was installed onsite 29<sup>th</sup> May 2020. Where available, daily rainfall received in the interim was been sourced from the Bureau of Meteorology.

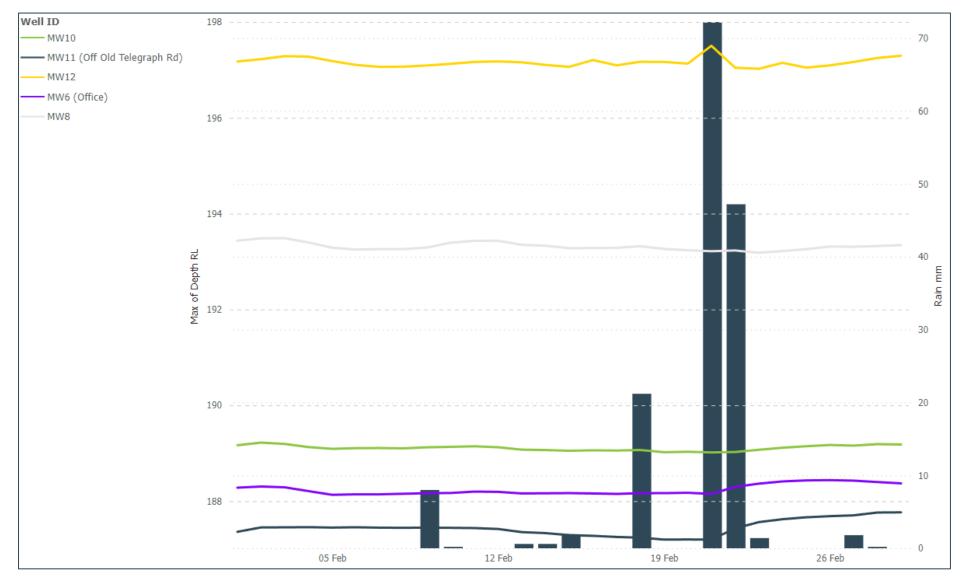
Figure Three. Groundwater Depths with Rainfall 1st February 2023 to 1st March 2023

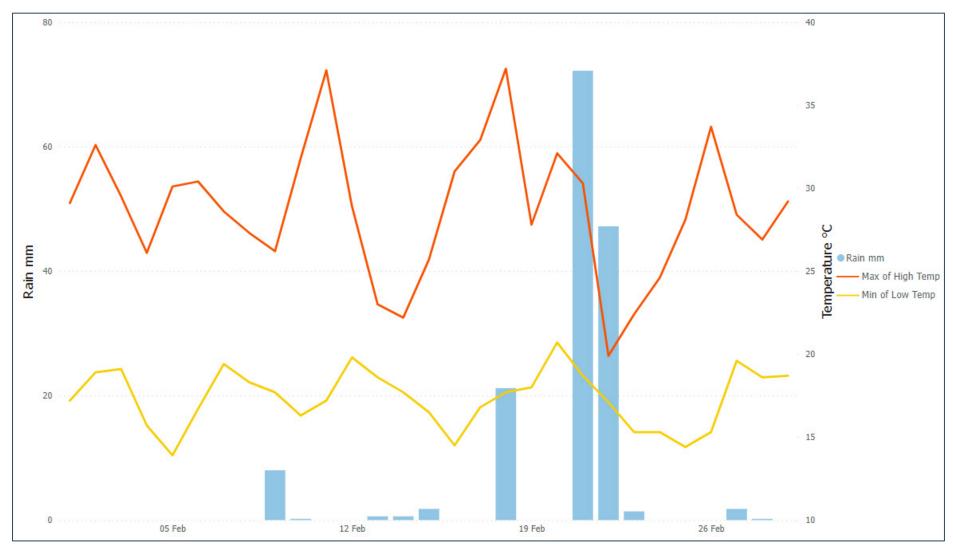
Figure Four. Temperature and Rainfall Summary

A new weather station was installed 29<sup>th</sup> May 2020. A summary of the climate during the reporting period is shown below to 1<sup>st</sup> February 2023 to 1<sup>st</sup> March 2023.
