HODGSON QUARRY AND PLANT PTY LIMITED

ROBERTS ROAD MAROOTA SAND QUARRY

GROUNDWATER STUDY REPORT

DUNDON CONSULTING PTY LTD

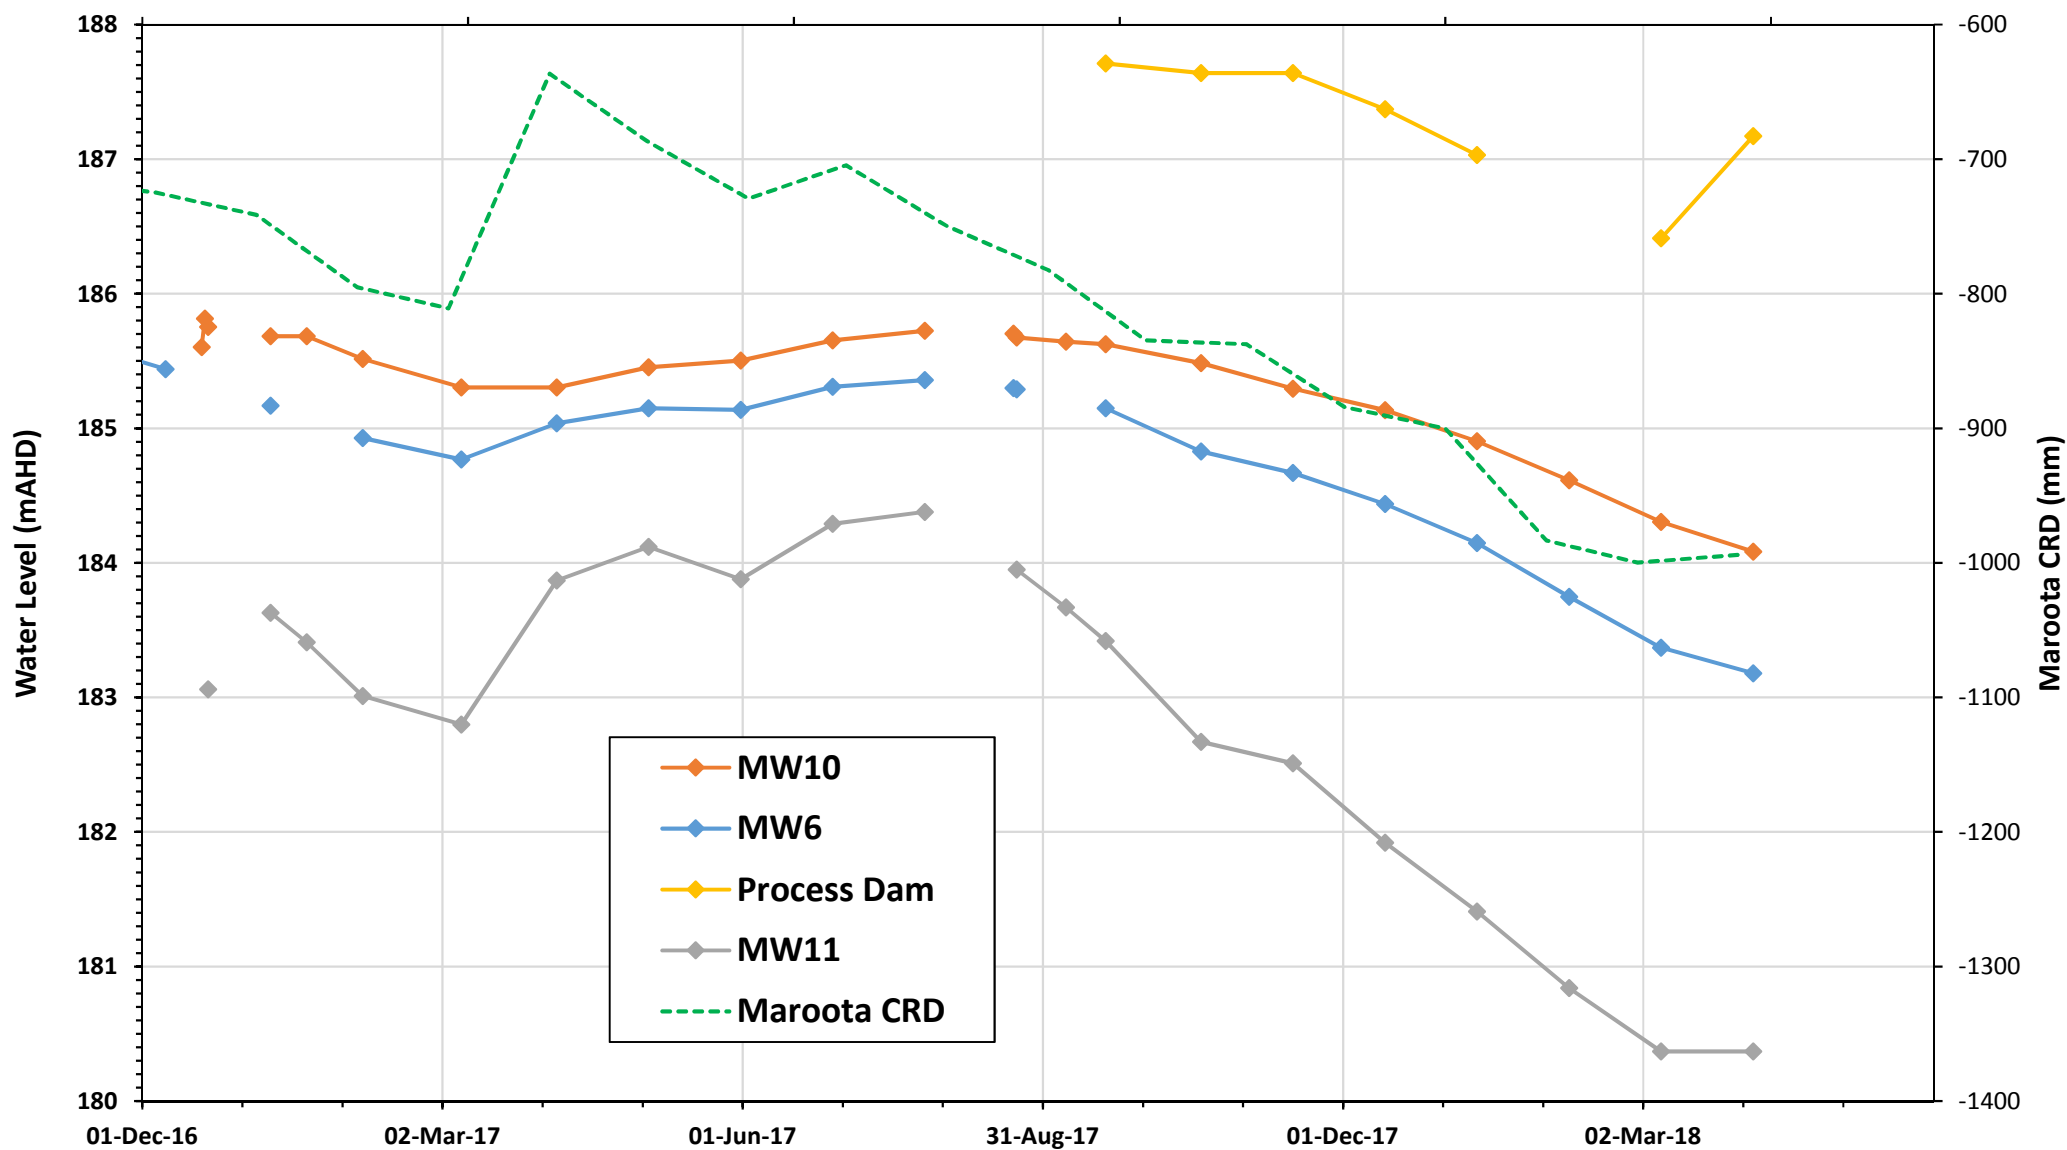
Figure 5: Composite Hydrograph - MW10, MW6, Process Dam and MW11

The three groundwater bore levels are at all times several metres lower than the Dam 1 water level. Any leakage from the dam would be expected to result in relatively higher groundwater levels beneath and down-gradient from the dam. However, no such mounding on the water table is apparent, and there is no evidence that the groundwater downstream of the Dam is receiving more recharge than is being received upstream.

Leakage from Dam 1 would also be expected to result in a gentler downstream recession trend during periods of low rainfall, due to the recharging effect of the leakage from the Dam. However, the down-stream recession trend at MW11 is steeper than the upstream recession trends and the Dam recession trend.

Any downward leakage from the dam would have been reflected in a mounding beneath the dam, and a recharge effect in the downstream bore MW11. Both these effects are absent, suggesting strongly that there is negligible leakage from Dam 1, and therefore the residual clay and silt in the base of the dam has very low permeability.

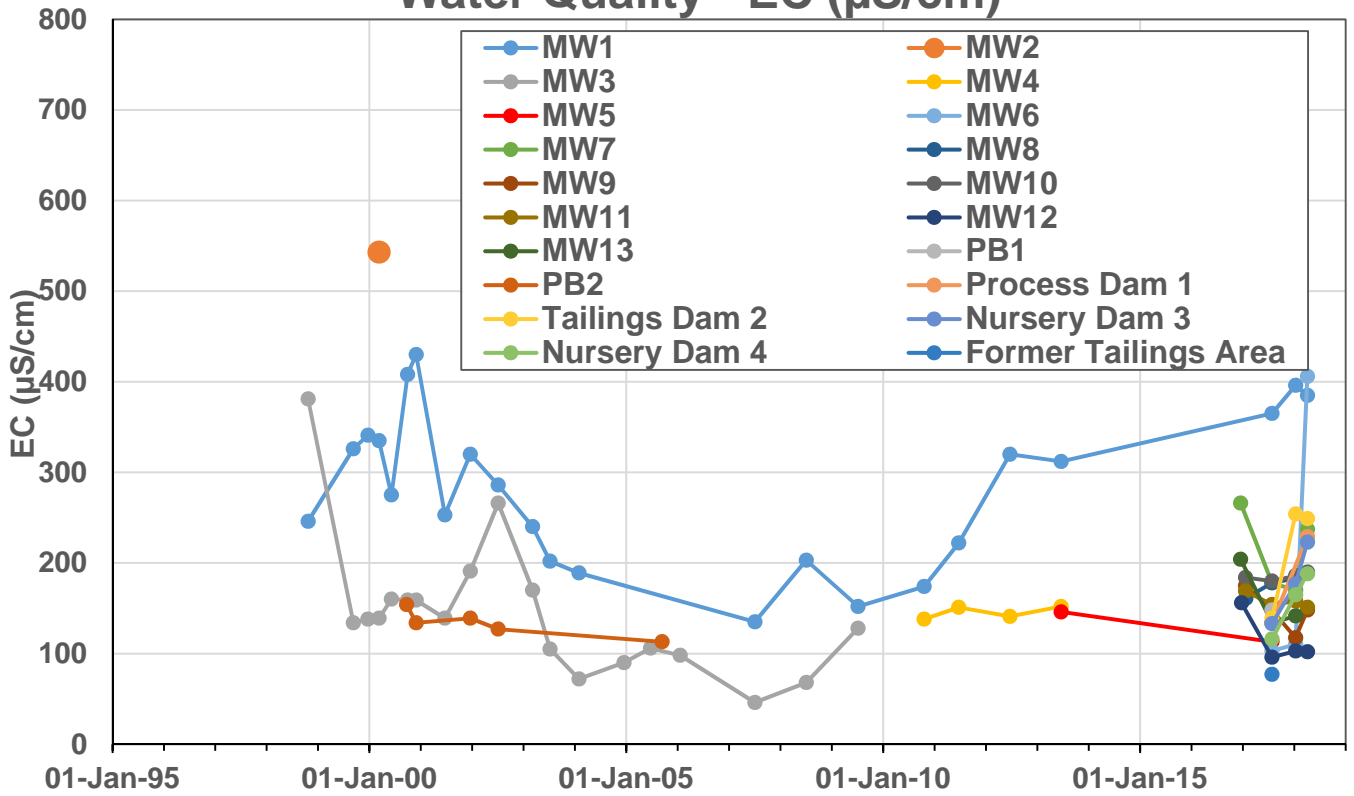
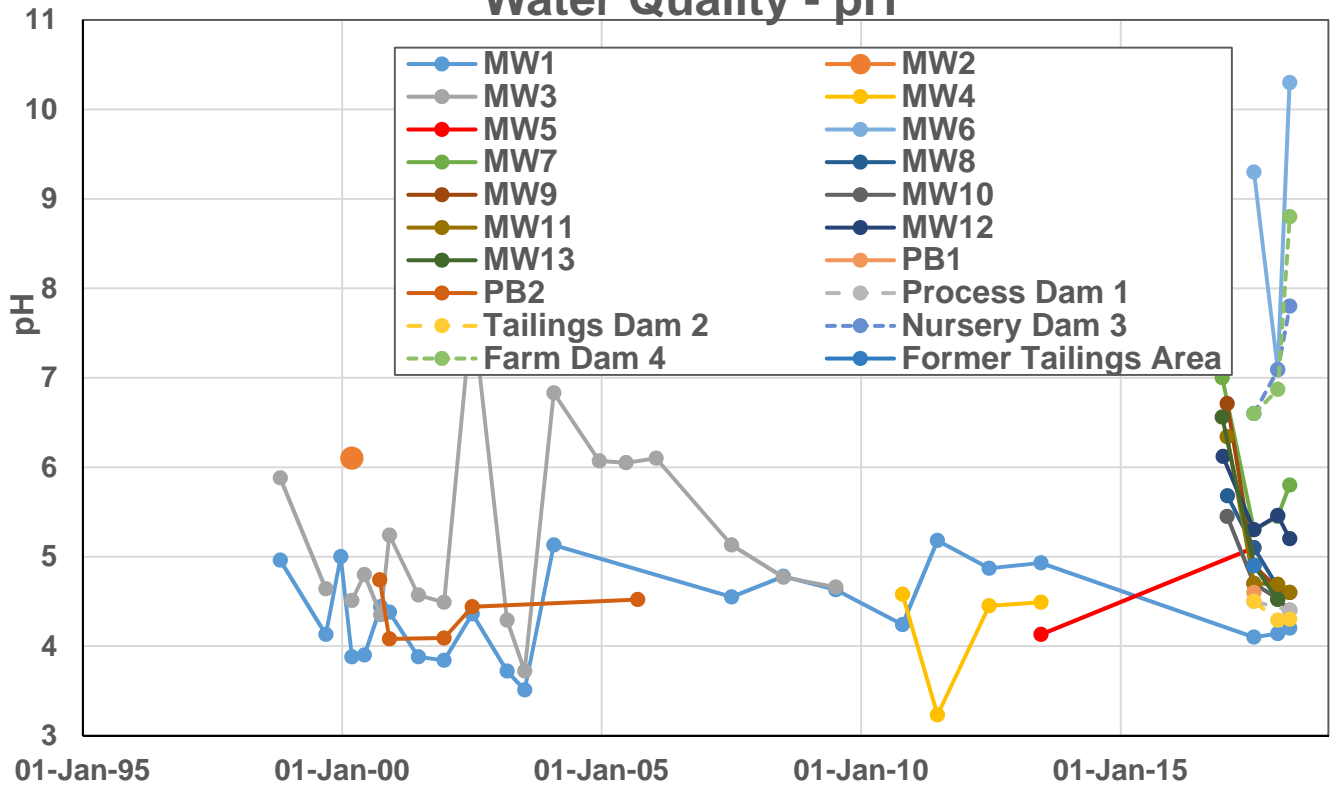
Date: 15 April 2018		Scale: as shown	Hodgson Quarry and Plant Pty Limited ROBERTS ROAD MAROOTA SAND QUARRY Water Quality Data Plots – EC and pH (1998-2018)
Author: PD	Checked: PD	Project No: 16-0318	
Dwg No: 0318-075	Revision: 0		
Dundon Consulting Pty Ltd		Figure 6

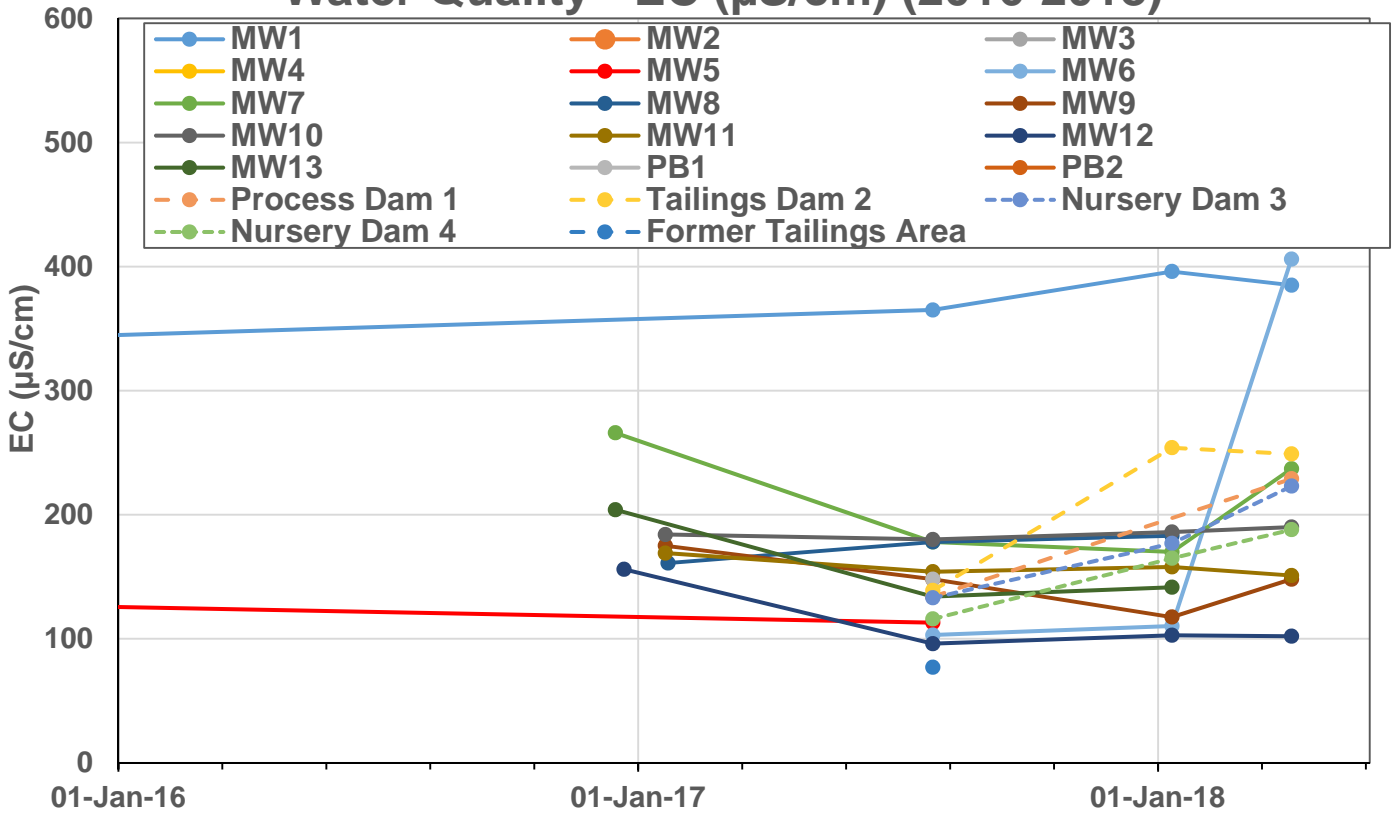
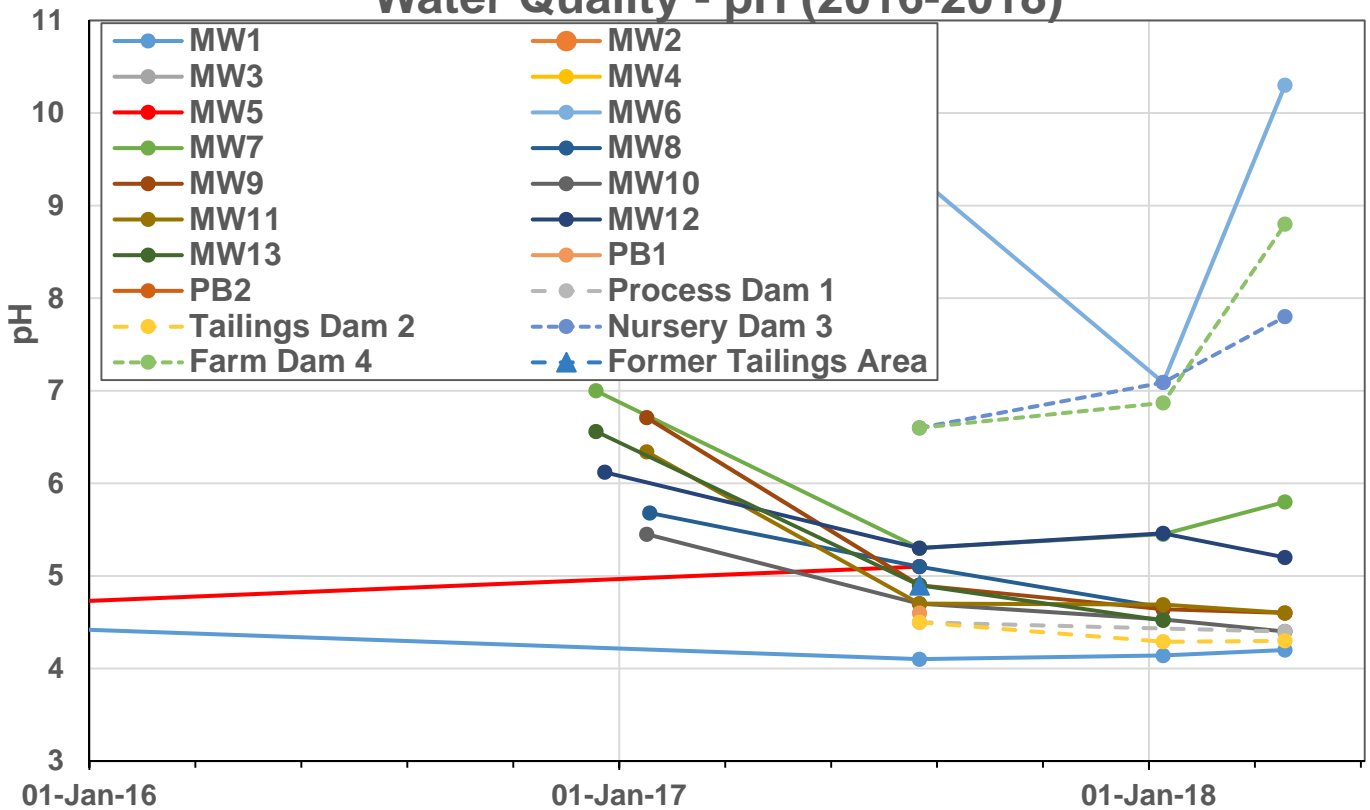
Date: 15 April 2018		Scale: as shown	Hodgson Quarry and Plant Pty Limited ROBERTS ROAD MAROOTA SAND QUARRY Water Quality Data Plots – EC and pH (2016-2018)
Author: PD	Checked: PD	Project No: 16-0318	
Dwg No: 0318-076	Revision: 0		
Dundon Consulting Pty Ltd		Figure 7

The April 2018 sample from MW6 appears to be anomalous, with pH and EC both higher than past values (10.3 and 406 $\mu\text{S}/\text{cm}$ respectively). The quality at the up-gradient bore MW10 remained consistent with previous months (pH 4.4 and EC 190 $\mu\text{S}/\text{cm}$). Likewise the water sampled from the Process Dam 1 on that date reported a pH of 4.4 and EC of 190 $\mu\text{S}/\text{cm}$, hence the change in quality at MW6 was not due to leakage from Dam 1.

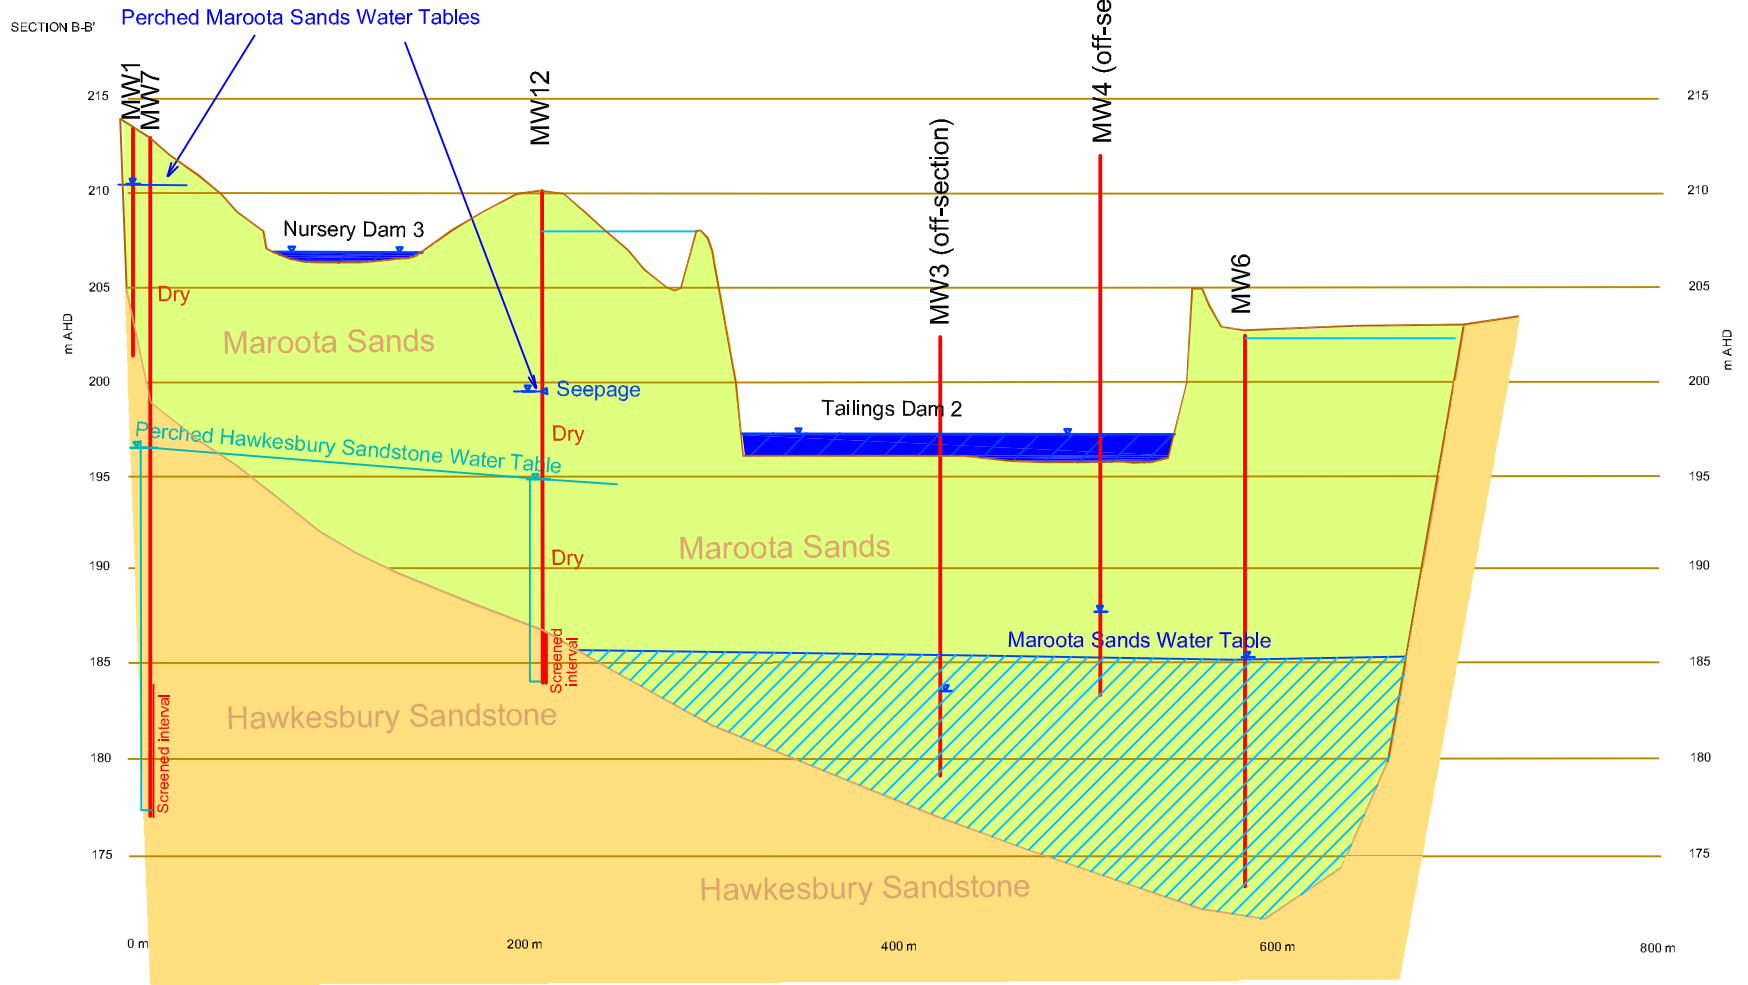
DATE:	15 April 2018	SCALE:	N/A	Hodgson Quarry and Plant Pty Ltd	
AUTHOR: PD	CHECKED: PD	PROJECT NO:	16-318	ROBERTS ROAD MAROOTA SAND QUARRY CROSS-SECTION A-A' (through piezometers MW1, MW7, MW12, MW3, MW4 and MW6)	
DRAWING NO:	0318-008a	REVISION:	A		
Dundon Consulting Pty Ltd					
				Figure 11

Five cross-sections have been prepared to illustrate the relationship between the observed groundwater levels in the monitoring bores. The cross-sections are presented as **Figures 11 to 15**. The locations of the cross-sections are shown on **Figure 2**.

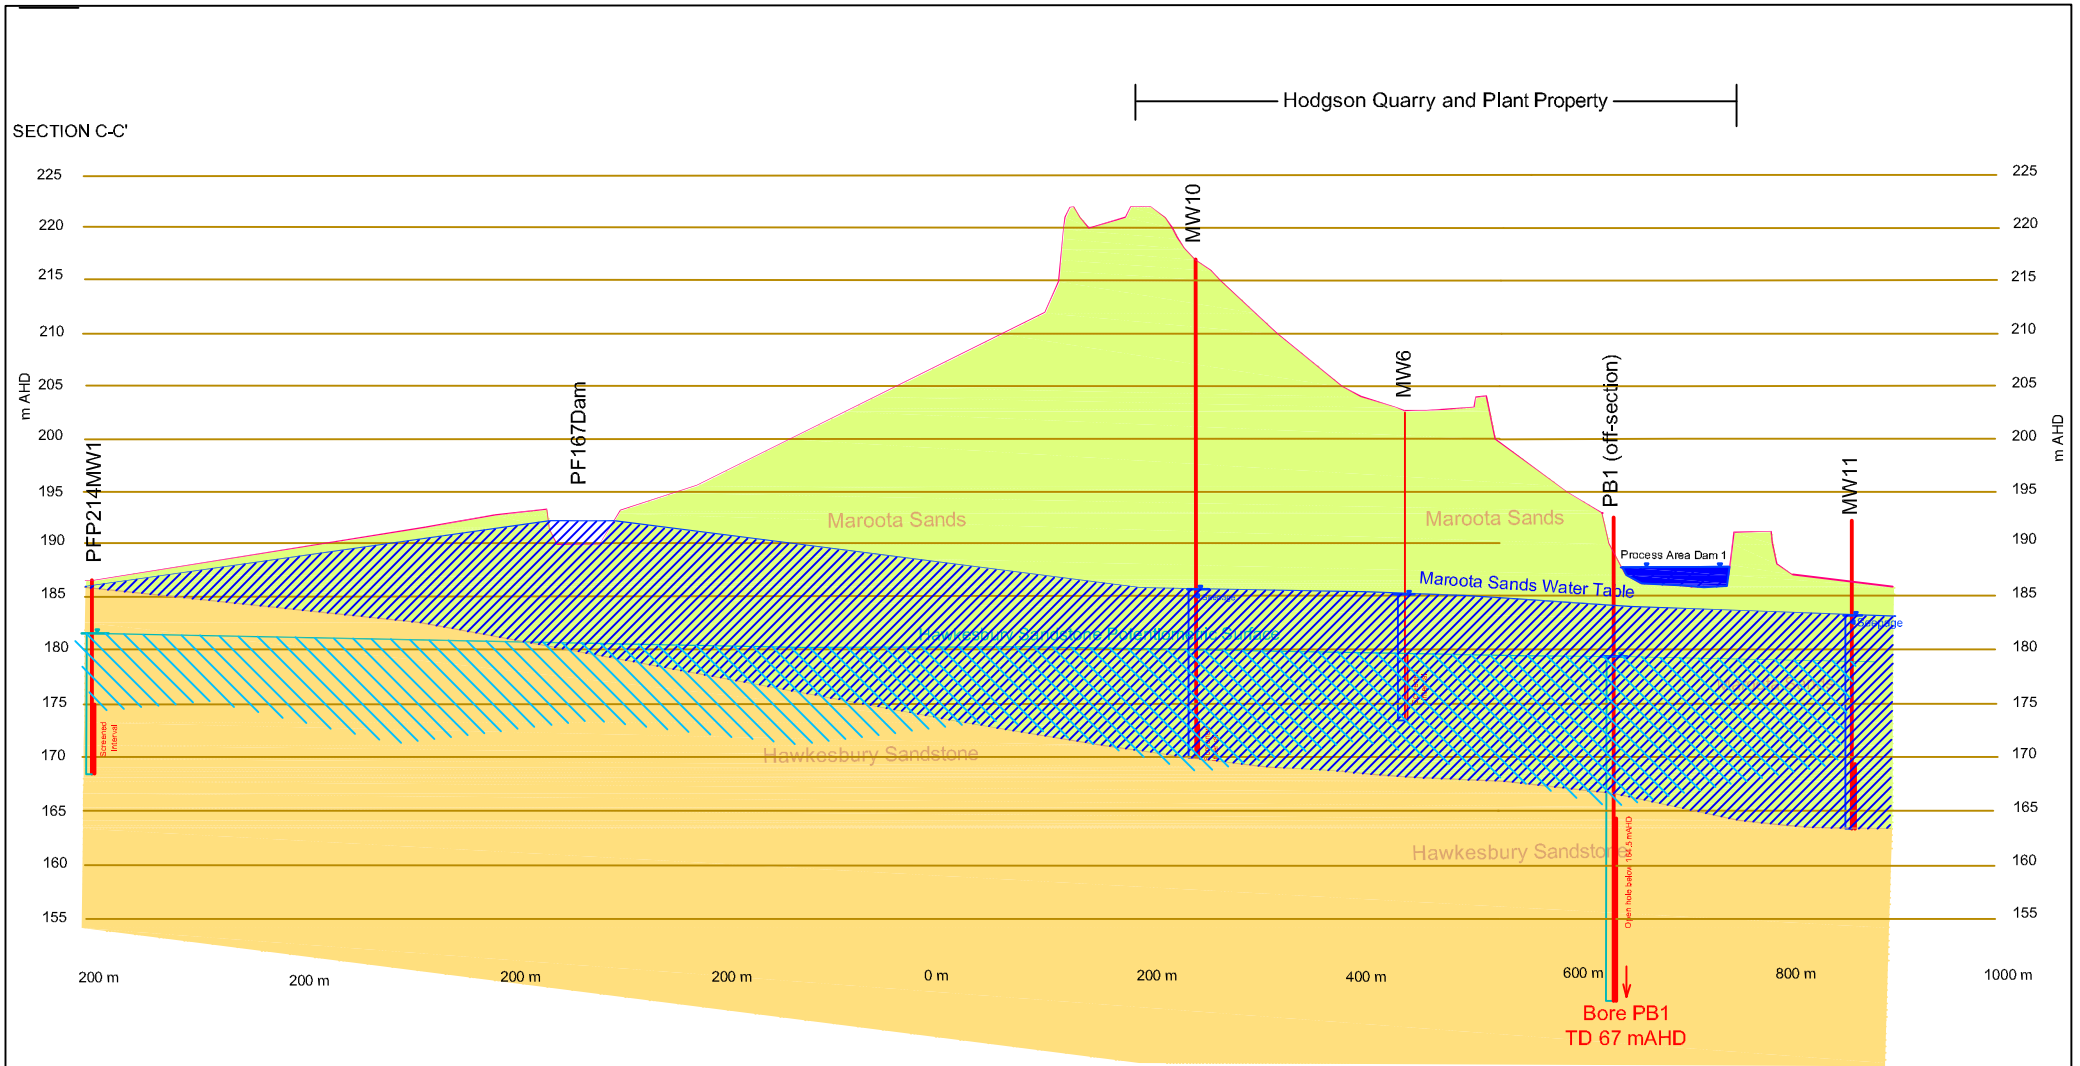
DATE:	15 April 2018	SCALE:	N/A	Hodgson Quarry and Plant Pty Ltd ROBERTS ROAD MAROOTA SAND QUARRY CROSS-SECTION C-C' (through piezometers PF214MW1, PF166Dam, MW10, MW6 and MW12)
AUTHOR: PD	CHECKED: PD	PROJECT NO:	16-318	
DRAWING NO:	0318-010d	REVISION:	D	
Dundon Consulting Pty Ltd				Figure 13

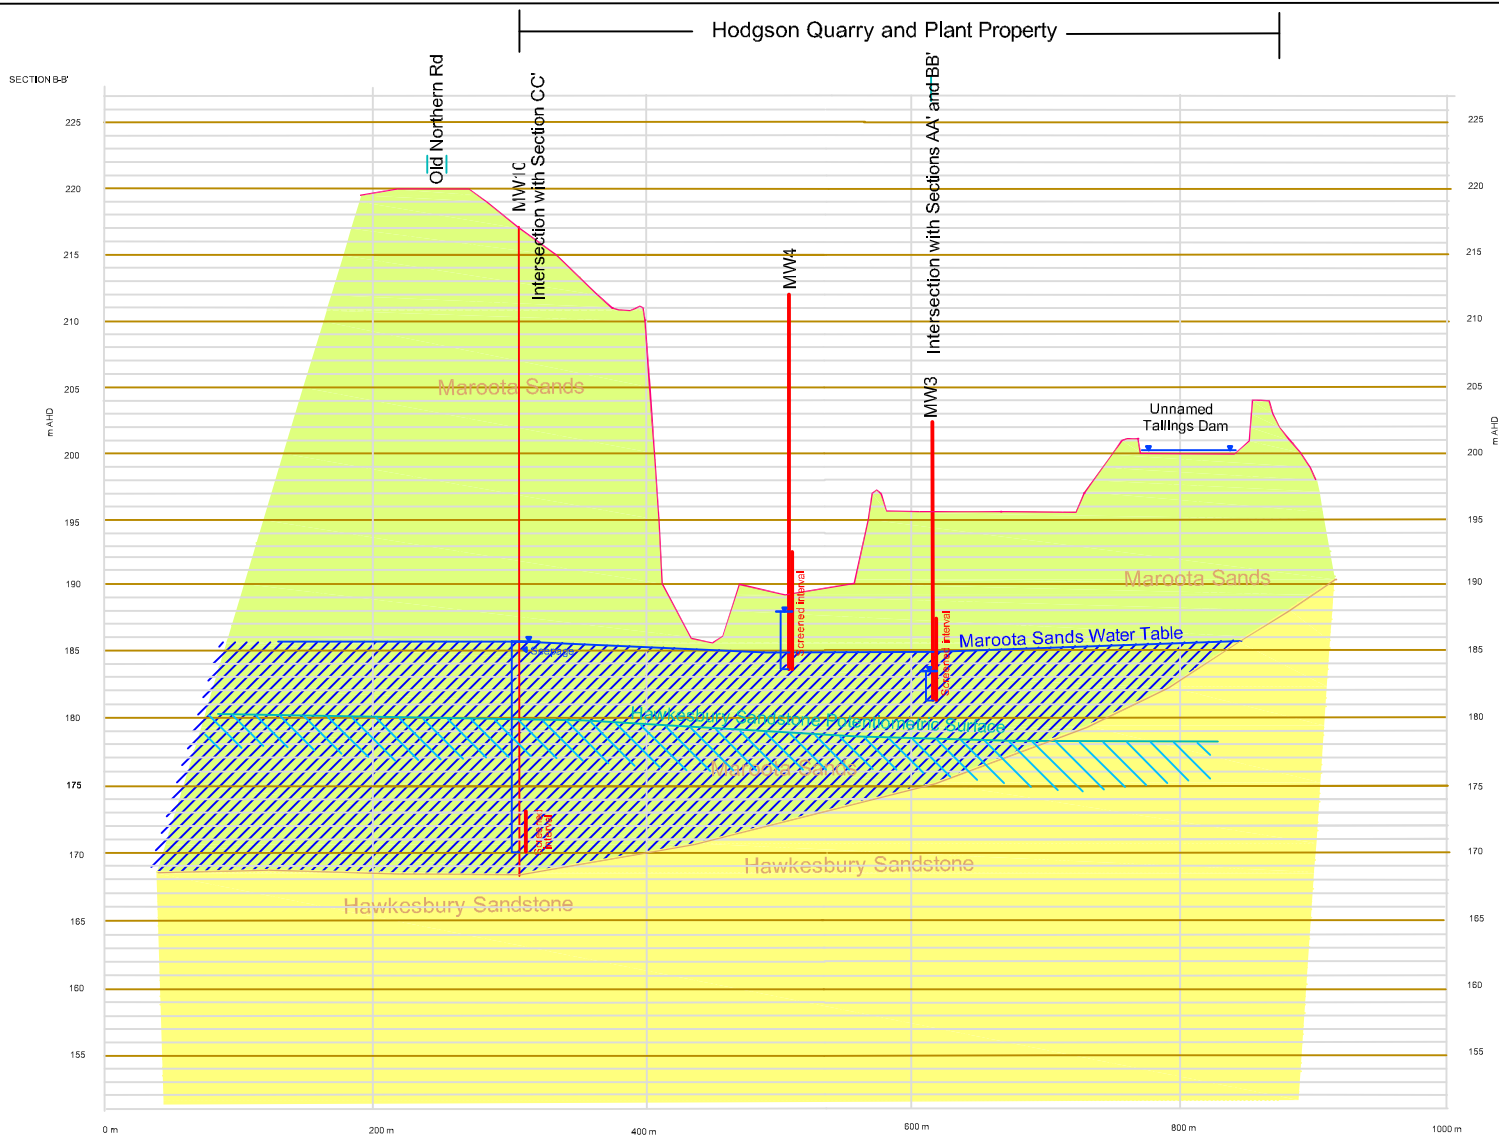
Figure 14

**ROBERTS ROAD MAROOTA SAND QUARRY
CROSS-SECTION D-D'
(through piezometers MW3, MW4 and MW10)**

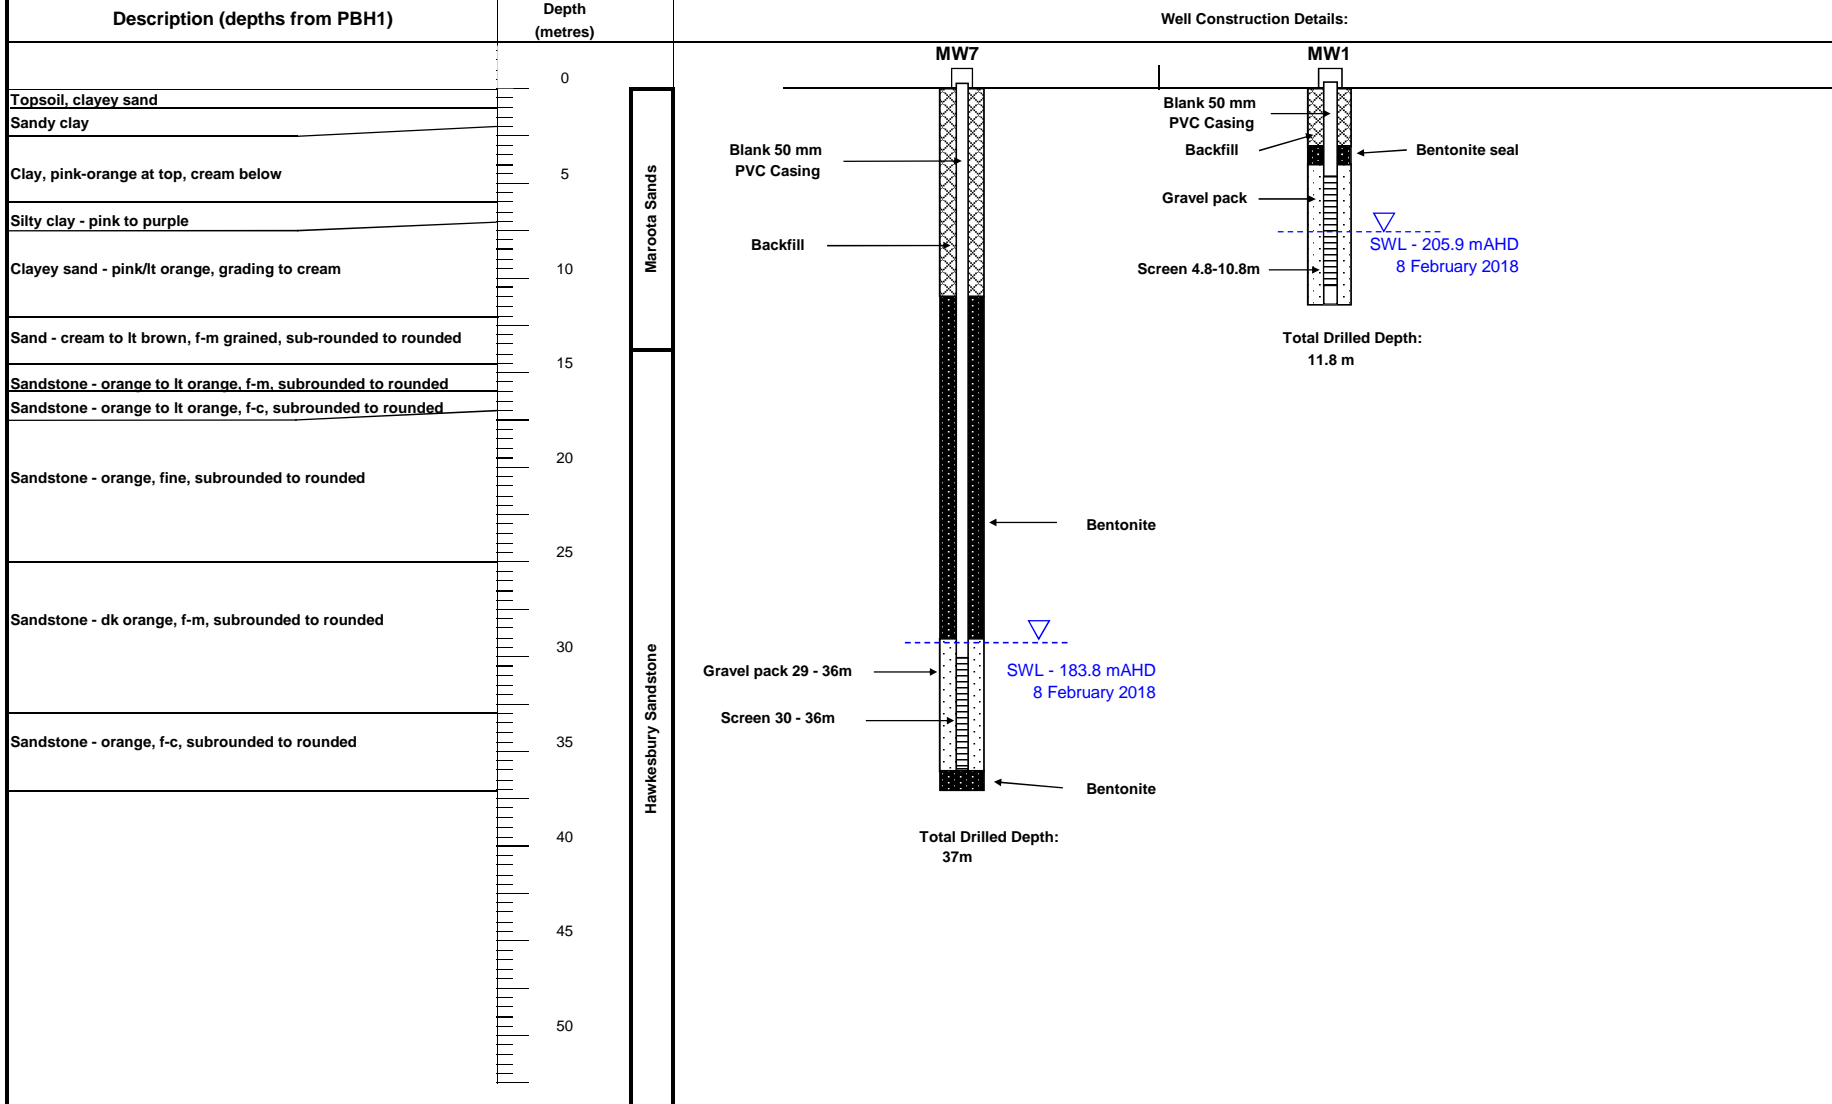
Figure 16: Composite Bore Logs - MW1 and MW7

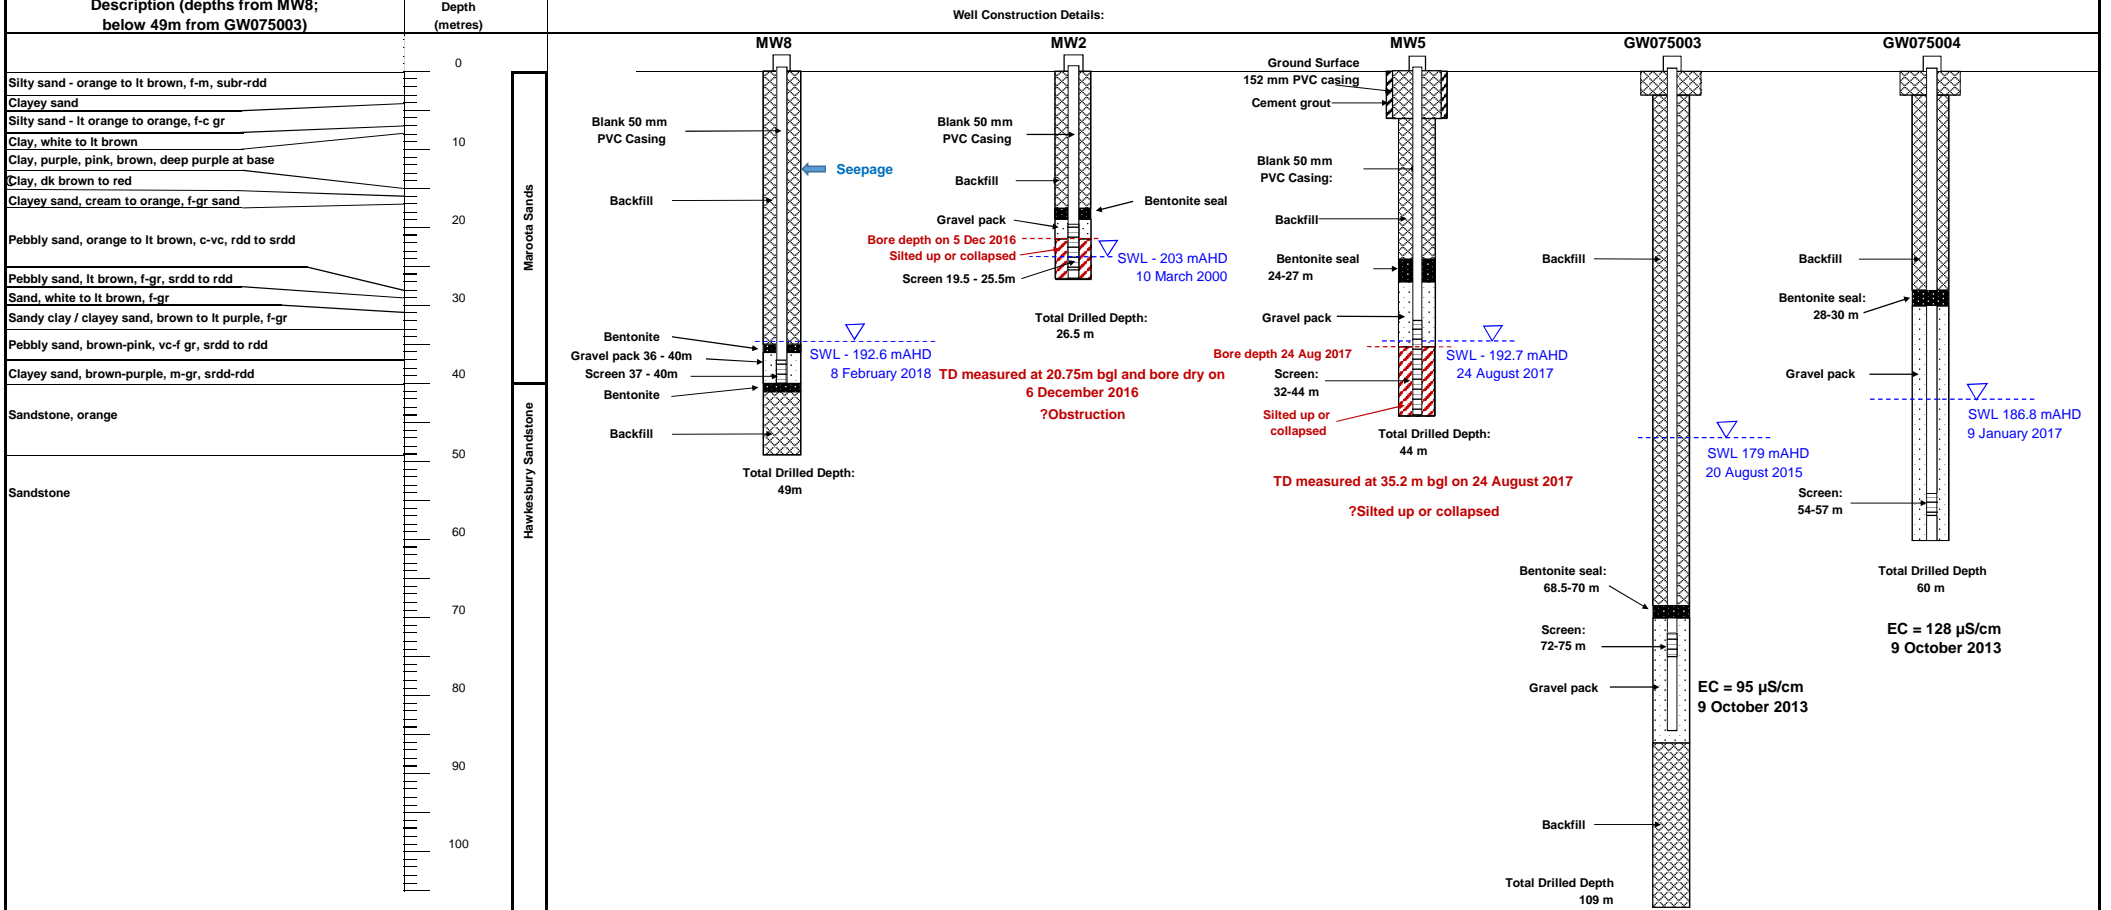
Figure 17: Composite Bore Logs - MW2, MW5, MW8, GW075003 and GW075004

- There is a cluster of bores at the site of MW2, MW5 and MW8 (see **Figure 2**), all completed (screened) in Maroota Sands. MW2 was drilled to only 26.5m and screened from 19.5-25.5m, and reported a water level in the range 23.7 to 24.7 m BGL (202-203 mAHD), until the bore was found to be obstructed at shallower depth². Bore MW5 was drilled to 44m and was reported to be still in Maroota Sands at that depth. Bore MW8 was drilled in December 2016 to verify whether the water level in MW5 was perched, as MW8 had not reached the Hawkesbury Sandstone. MW8 was drilled to a depth of 49m BGL, and the top of the Hawkesbury Sandstone was interpreted from the drill cuttings to be at approximately 40m. The bore is screened only in Maroota Sands (see log in **Appendix A**). MW5 and MW8, both screened only in Maroota Sands, have a consistent water level at around 192-193 mAHD, about 10m lower than the level previously measured in MW2. The relative water levels at this cluster site are shown on a composite log **Figure 17**, as well as on cross-section BB' (**Figure 12**).

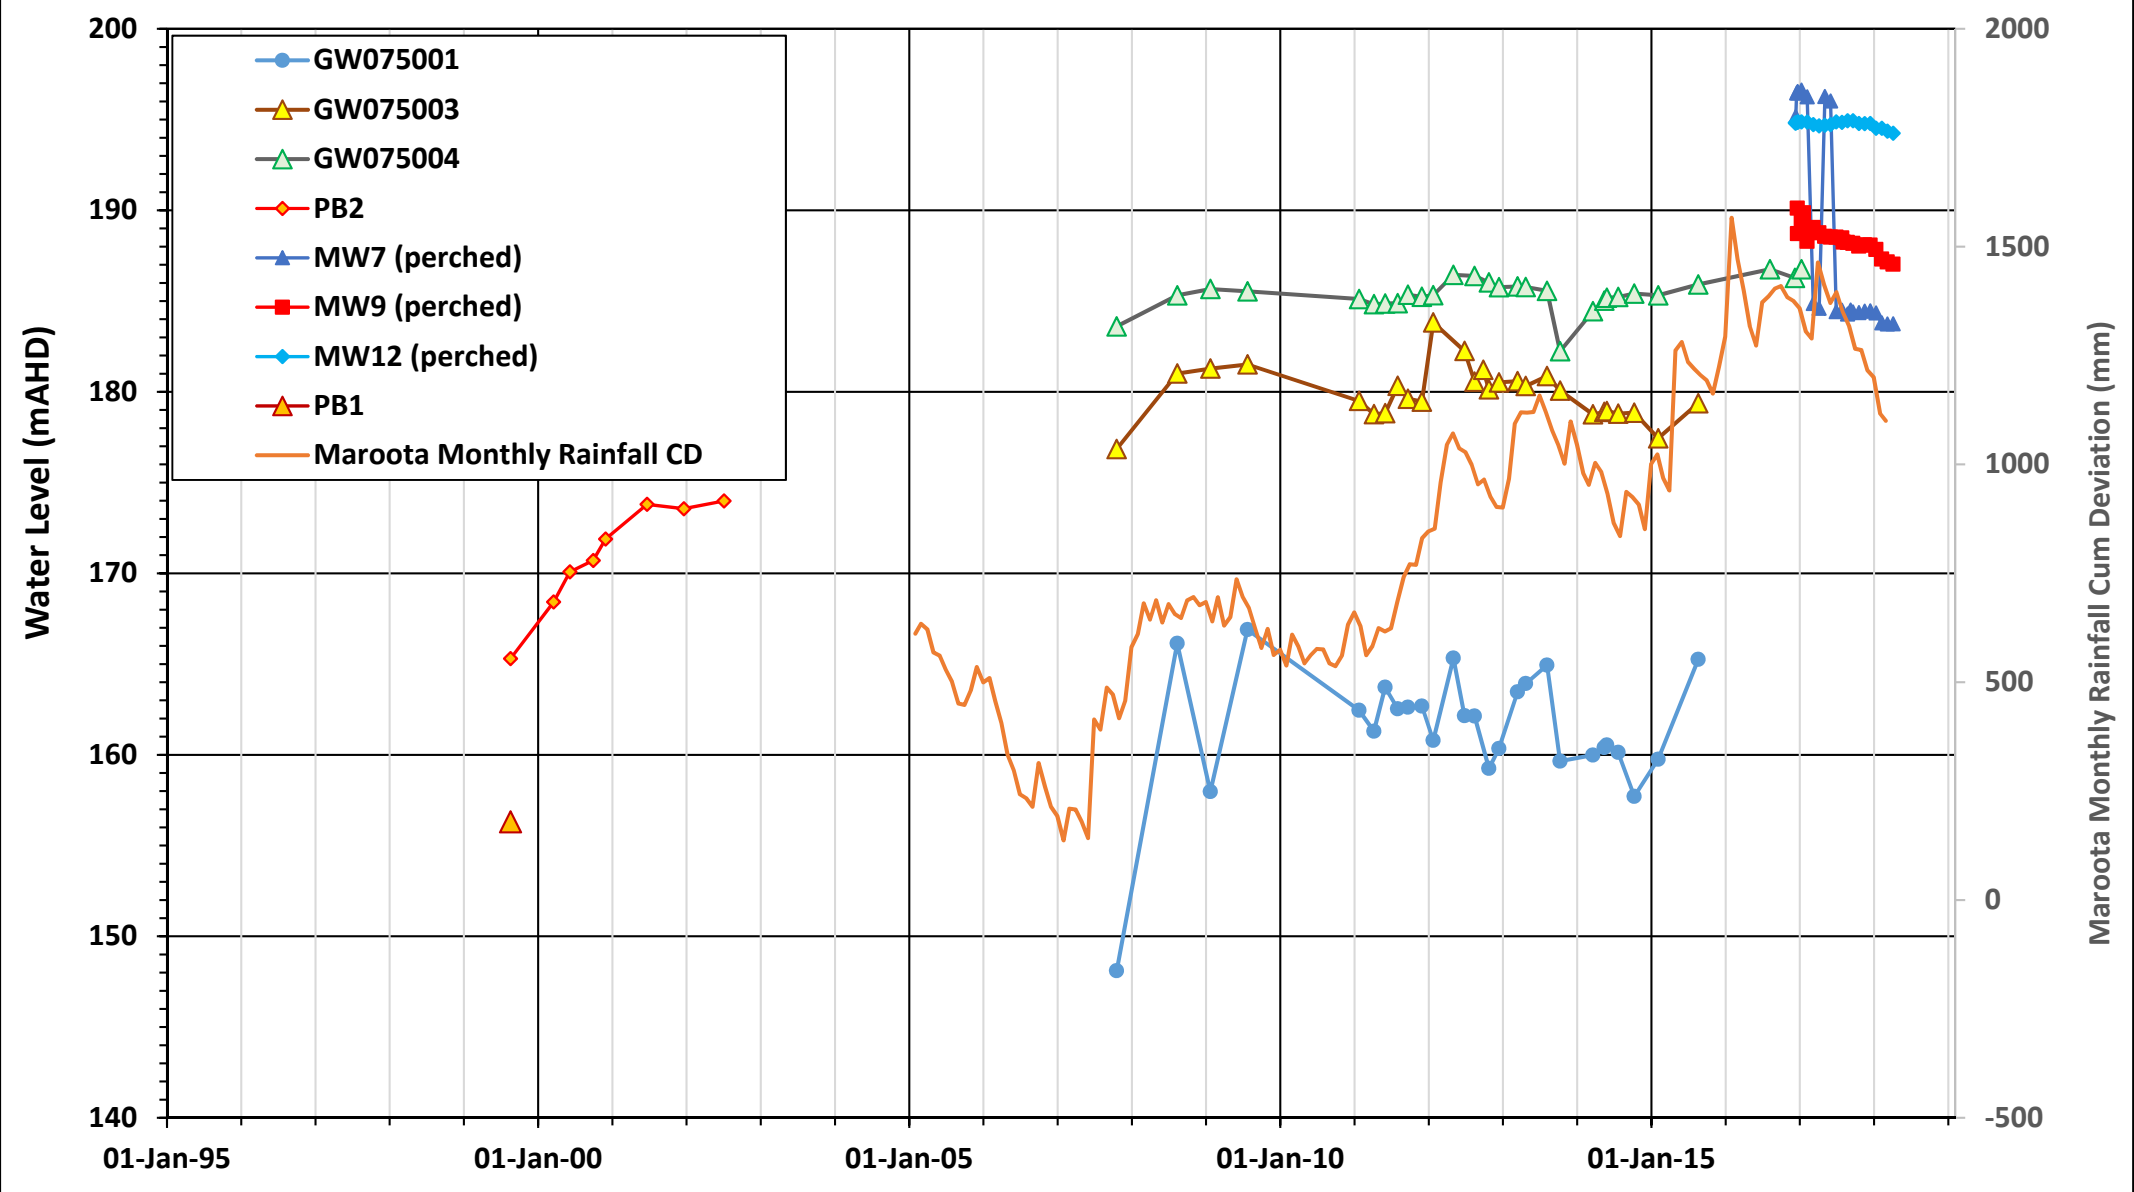
Figure 20: Bore Water Level Hydrographs - Hawkesbury Sandstone Bores

The regional groundwater level is interpreted to be at 170-180 mAHD (as illustrated by water levels in bores PB2, GW075003 and GW075004). However, like the Maroota Sands, there is perched groundwater within the Hawkesbury Sandstone, either naturally perched above shale bands or possibly artificially elevated by leakage from the site dams. Evidence for the latter is the rising trends seen on the hydrographs for PB2, GW075003 and GW075004 (**Figure 20**).

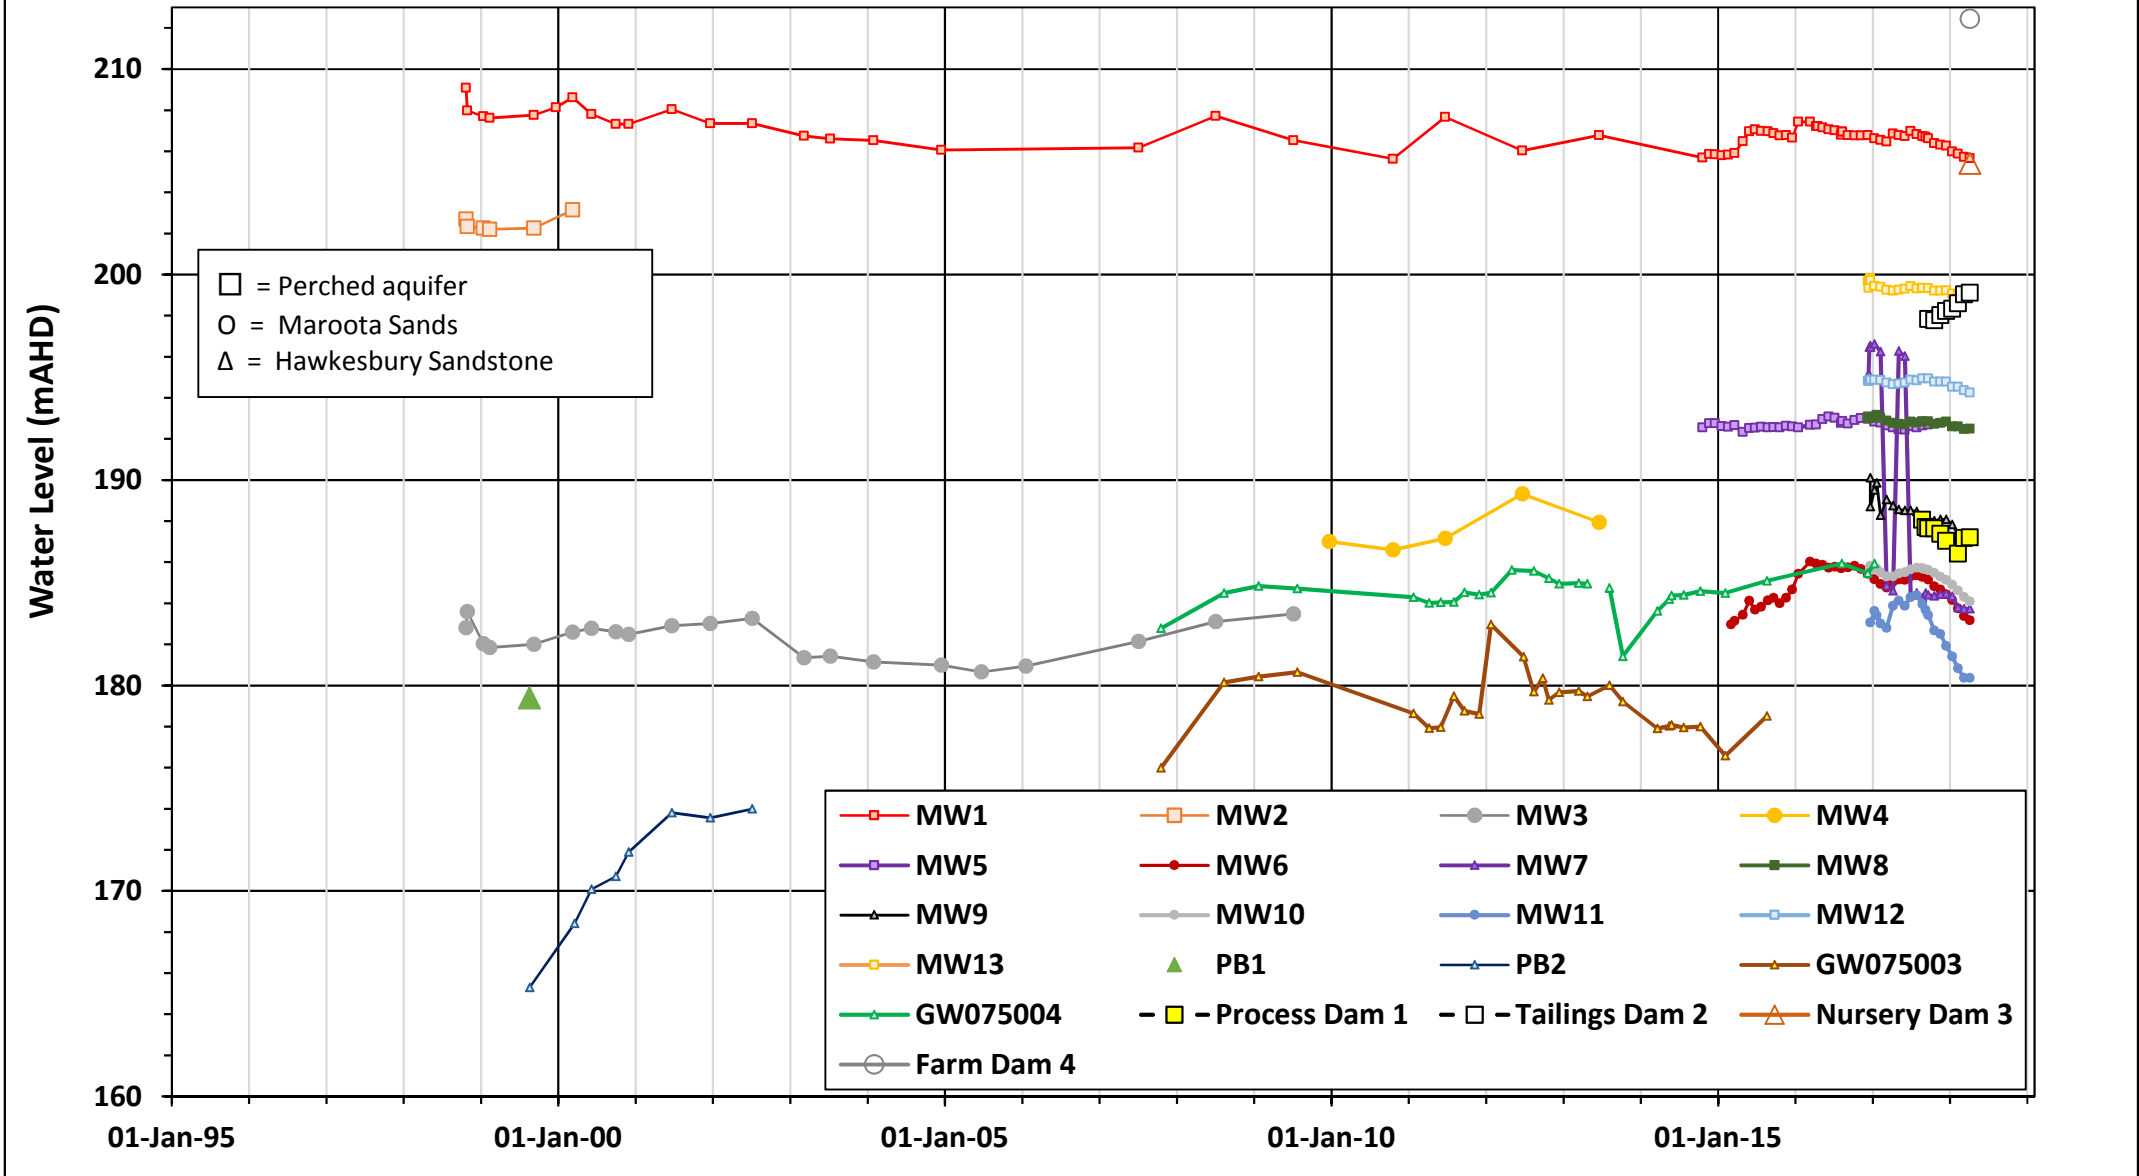
Figure 22: Bore Water Level Hydrographs - Composite Plot

Most hydrographs display a marked fluctuation in response to episodic rainfall recharge and natural discharge. The shallow groundwater responds quite quickly to recharge from larger rainfall events. This is typified by the hydrograph for bore MW1 (**Figure 18**), which shows short-term sharp rises in water level following many of the larger rainfall events, followed by a steady downward recession trend reflecting natural discharge from the shallow perched aquifer. Superimposed on the short-term fluctuations is a longer-term trend, which reflects the overall climatic conditions.
