HODGSON QUARRY AND PLANT PTY LIMITED

ROBERTS ROAD MAROOTA SAND QUARRY

GROUNDWATER STUDY REPORT

DUNDON CONSULTING PTY LTD

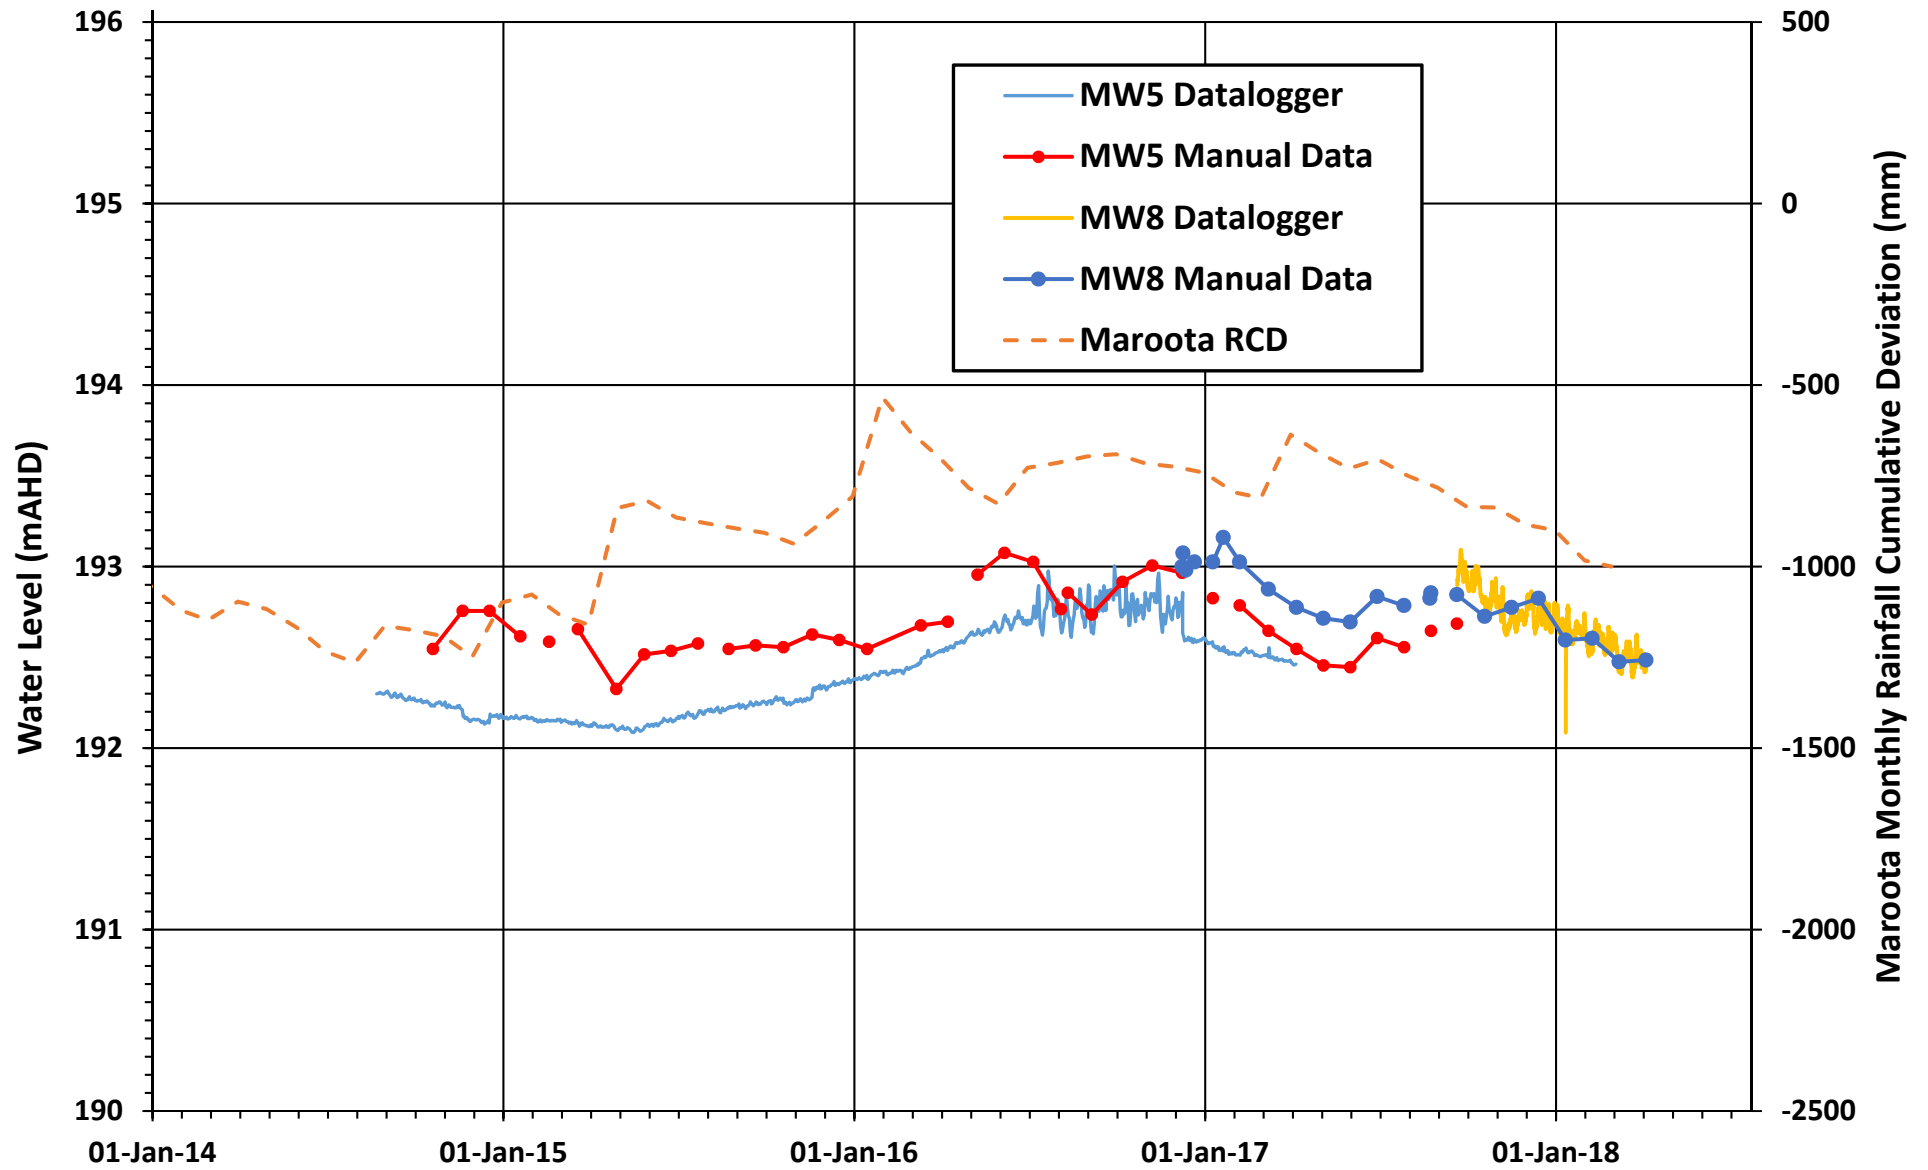
Figure 27: Bore Water Level Hydrographs - MW5 and MW8

MW5 has also been found to be obstructed, some 9m above its original constructed depth but still below the water level in the bore. Hence, it can still be monitored, however as the nature and cause of the obstruction are unknown, and there is less than 1m of water depth above the obstruction, MW5 has been removed from the monitoring network. Comparison of water levels between MW5 and MW8 (**Figure 27**), both of which are screened in the basal part of the Maroota Sands, shows that these two bores have similar absolute water levels and almost identical trends. Hence, MW8 is considered a suitable replacement for MW5.
