A Dodge County, Wisconsin river shoreline, spanning 150 linear feet, was experiencing significant destabilization due to fluctuations in water levels, a steep vertical bank, and shallow-rooted invasive vegetation dominating the shoreline and banks. The client also wished to gain better access to the river. Eco-Resource Consulting, Inc. (ERC) regraded the shoreline and permanently stabilized the banks with a reinforced Enviro-lok® wall. An access to the river was also cut-in. The Enviro-lok® wall was then capped with Native Vegetated Mat (NVM) comprised of deep-rooted perennial native plants which served to help anchor the Enviro-lok® bags and enhance the ecological value and aesthetics of the property.

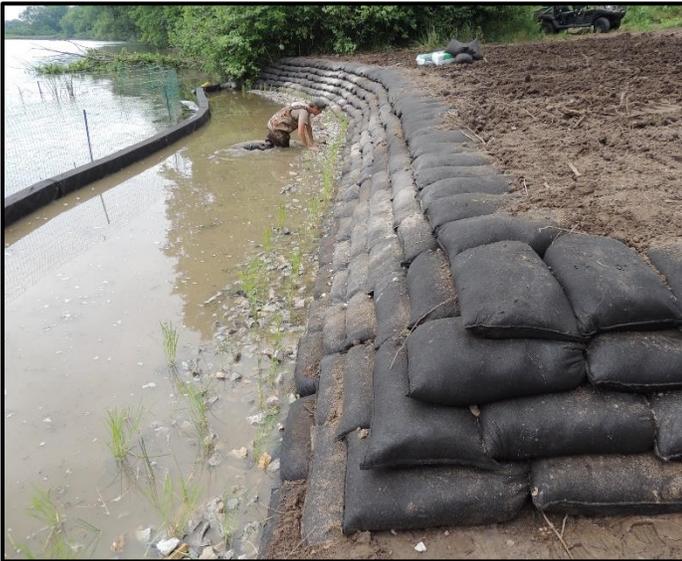
ENVIRO-LOK® INSTALLATION

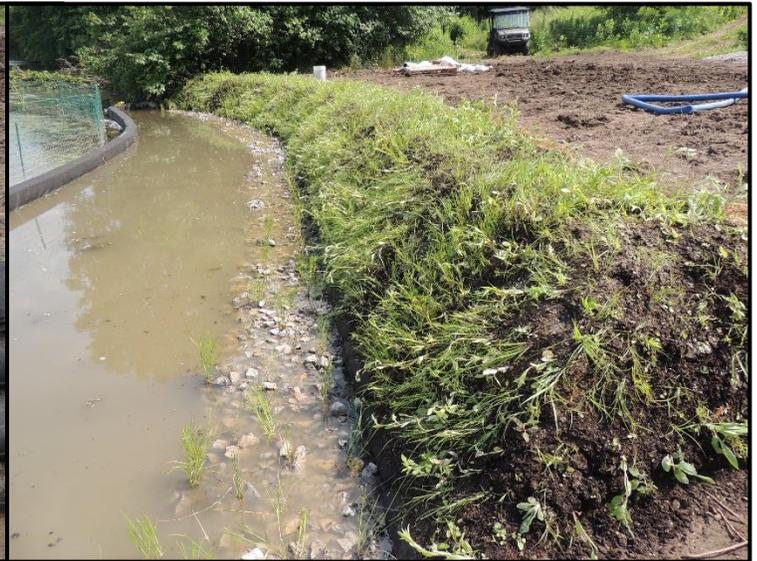
NATIVE VEGETATED MAT CAPPED WITH ENVIRO-LOK®

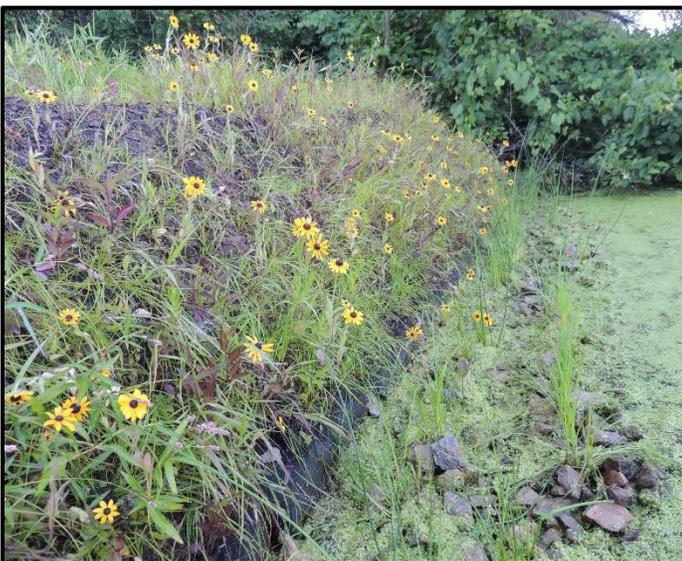
THREE WEEKS FOLLOWING INSTALLATION

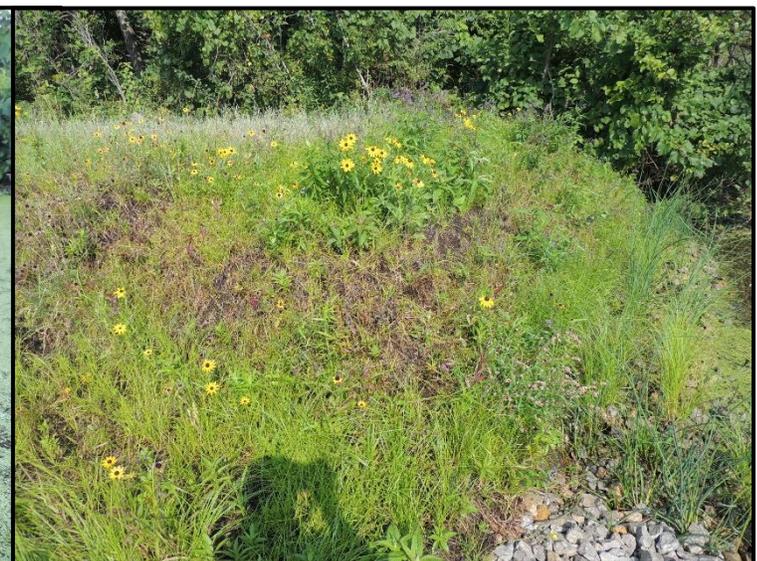
EIGHT WEEKS FOLLOWING INSTALLATION
