## **Phase I Environmental Site Assessment**

The Halmos College of Natural Sciences and Oceanography  
I.e. Oceanographic Campus  
8000 N Ocean Dr.  
Dania Beach, FL 33004

Dr. Paul Baldauf  
Project Report I  
ENVS 3000

**Phase I Environmental Site Assessment of NSU Oceanographic Center.**

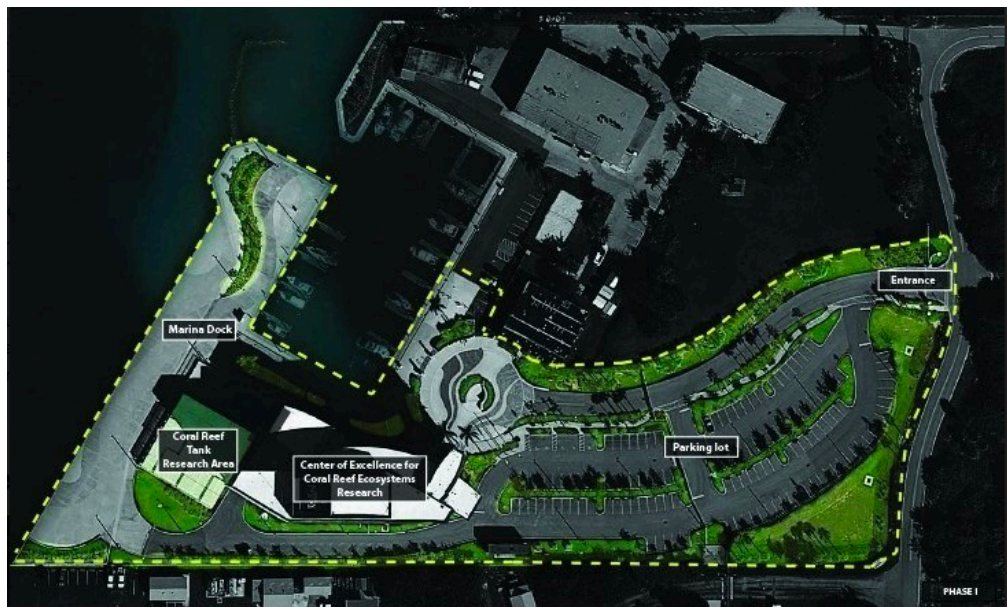
Figure 2. Phase I landscape elements at NSU Oceanographic Center.

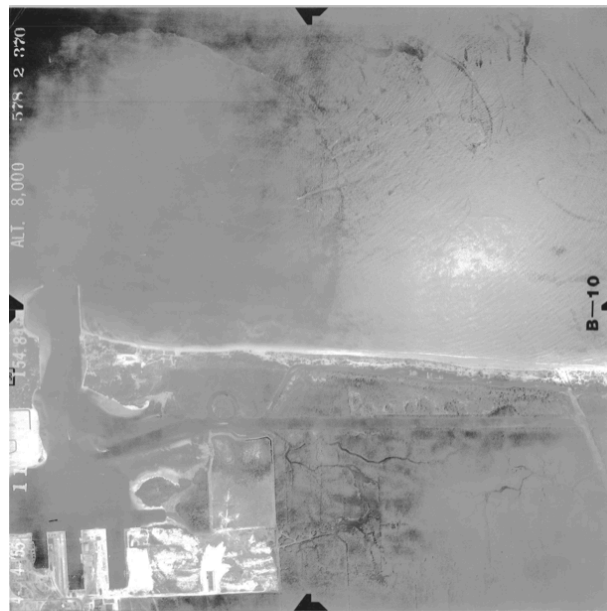
Figure 6. The Oceanographic Campus 1955.

With the assistance of an ArcGIS map layer created by the Everglades Project of the Soil Conservation Service was investigated to determine the change in soil composition from 1948 until present day. The layer was created by digitizing 1948 soil maps to understand water control for agricultural land. This can be used to understand the change in soil within the last 71 years. According to the 1948 soil maps, the OC Campus site was classified as wet rockland shown throughout Figure 8. A rockland hammock is classified as a rich hardwood forest where limestone is very near the surface while oftentimes exposed (Snyder, 1990). This type of community is often susceptible to fire and ground water reduction. Additionally, rockland hammock communities often have well drained organic soil covering the underlying limestone. The map also shows the wet marl and Calcareous soils to the east, south and south west of the site. Figure 7 demonstrates the presence of more trees and vegetation in 1955 then in present day. While Figure 6 shows the minimal construction that took place prior to 1955.

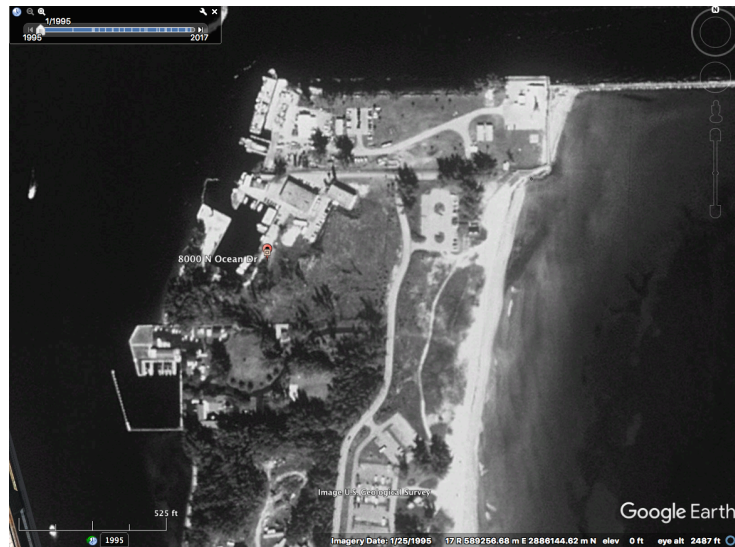
Figure 7. The Oceanographic Campus 1995.
