Phase II Environmental Site Assessment

The Halmos College of Natural Sciences and Oceanography
I.e. Oceanographic Campus
8000 N Ocean Dr.
Dania Beach, FL 33004

Dr. Paul Baldauf
Project Report I
ENVS 3000

Phase II Environmental Site Assessment of NSU Oceanographic Center.

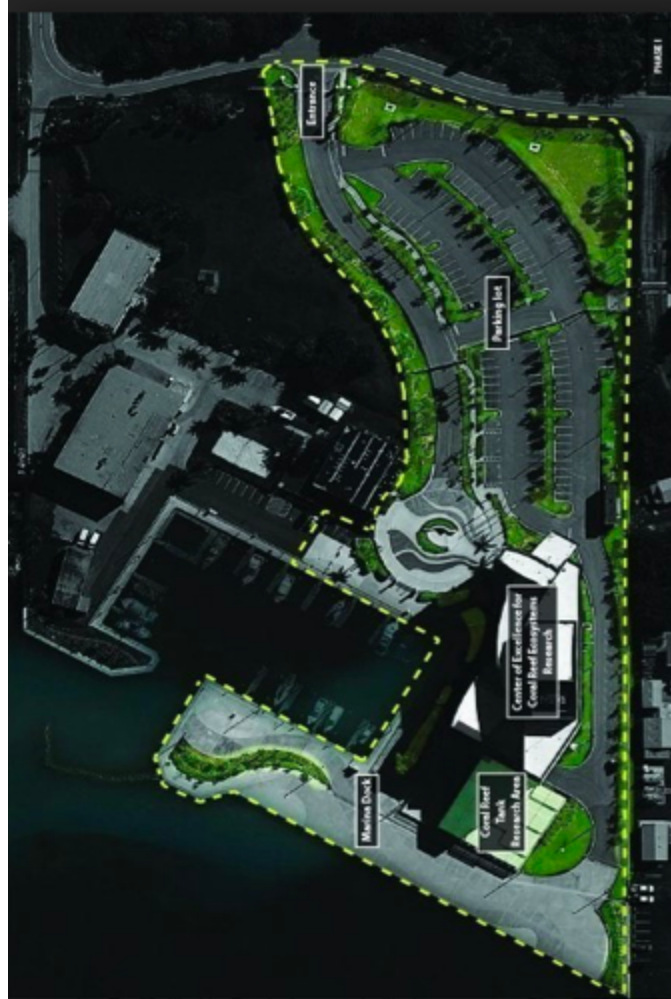
Figure 2. Phase I landscape elements at NSU Oceanographic Center. Each aspect of the facility is labeled on the map.

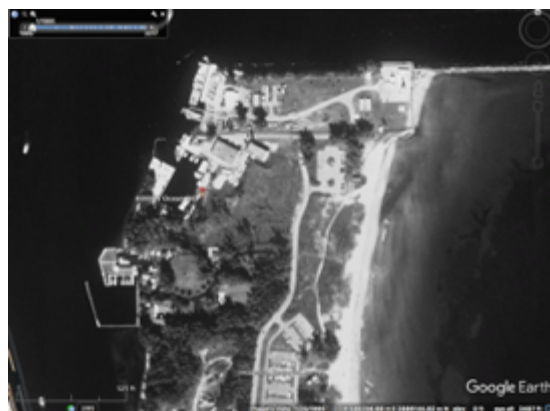
Figure 6. The Oceanographic Campus 1955.

Figure 7. The Oceanographic Campus 1995.

Figure 6 and Figure 7. The layer was created by digitizing 1948 soil maps to understand water control for agricultural land. This can be used to understand the change in soil within the last 71 years. According to the 1948 soil maps, the OC Campus site was classified as wet Rockland shown throughout Figure 8. A Rockland hammock is classified as a rich hardwood forest where limestone is very near the surface while oftentimes exposed (Snyder, 1990). Additionally, Rockland hammock communities often have well drained organic soil covering the underlying limestone. The map also shows the wet marl and calcareous soils to the east, south and southwest of the site. Figure 7 demonstrates the presence of more trees and vegetation in 1955 than in present day. While Figure 6 shows the minimal construction that took place prior to prior to 1955.

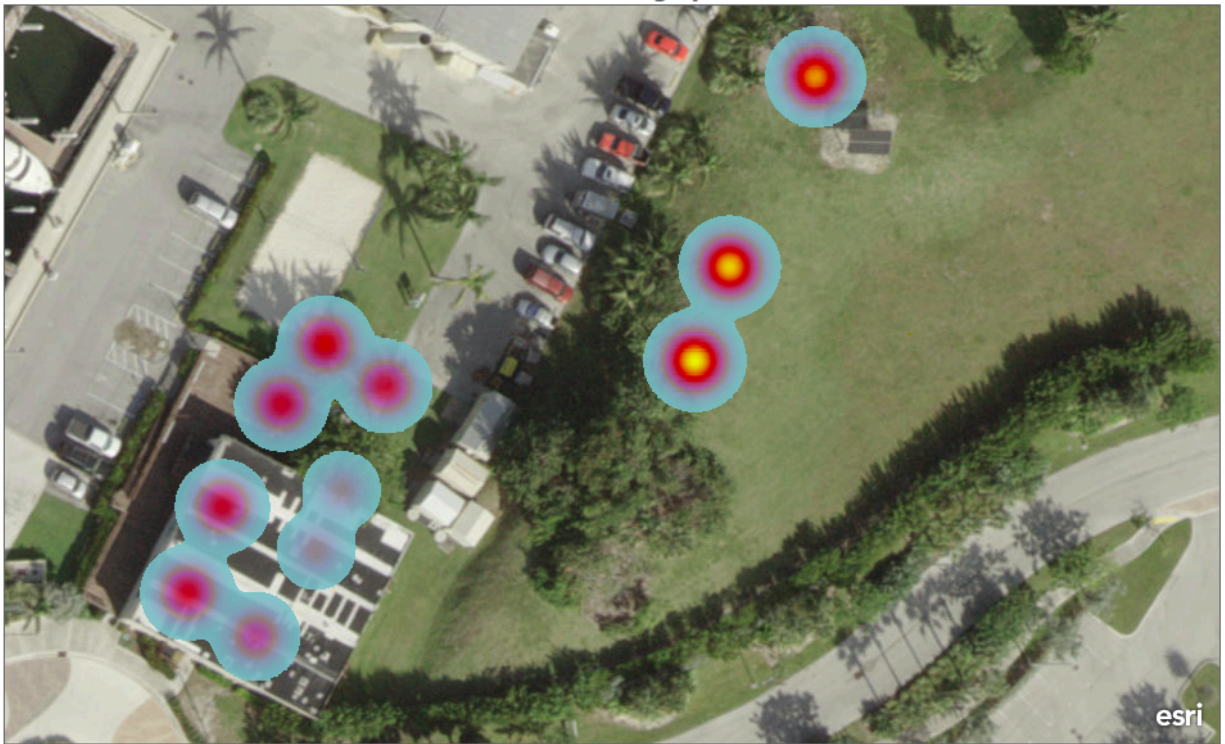
Based on Figure 11, the risk of the environmental contaminant is relatively high along the eastern line of sampling. This was determined through the use of ArcGIS online heatmap tool. Five soil samples had unnatural concentration levels of adamantium which ranged from 800 ppm-1,000 ppm. The highest concentration among the sampling points was 1,200 ppm adamantium. This sample was found near the benches by the OC roundabout. The sample with the concentration of 1,000 ppm was on the hill by the solar panels. Thus, the location of the soil

Figure 11. Soil Map Survey.

1. Remediation of grounds to rid the facility of the environmental contaminant Adamantium.

2. Perform additional soil analysis of the surrounding vicinity local to the ocean, the intercoastal waterway and various other locations to determine the quality of the soil throughout the entire property.
3. Collect groundwater samples as well as around the vicinity where the Adamantium was found. A water quality analysis will be beneficial in determining whether the environmental contaminant is present in the water supply underground.
