Ground Investigation
at Former Quinn Radiator Factory

Newport, Wales, NP10 8FS
for
Pinnacle Consulting Engineers Limited

Factual and Interpretative Report

Project No:
PN214233
September 2021

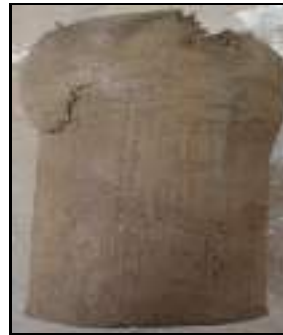
Specimen Post Test

Moisture Content (%)	25
Bulk Density (Mg/m ³)	1.81
Dry Density (Mg/m ³)	1.46
Specimen Length (mm)	210
Specimen Diameter (mm)	105
Cell Pressure (kPa)	100
Deviator Stress (kPa)	60
Undrained Shear Strength (kPa)	30
Failure Strain (%)	9
Mode Of Failure	Plastic
Membrane Used/Thickness	Rubber/0.3mm
Rate of Strain (%/min)	1.43

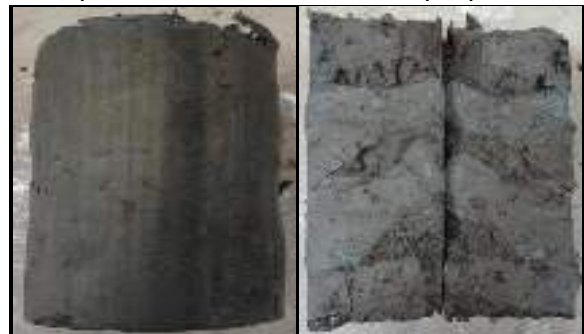
Sample Split

Moisture Content (%)	51
Bulk Density (Mg/m ³)	1.94
Dry Density (Mg/m ³)	1.28
Specimen Length (mm)	210
Specimen Diameter (mm)	105
Cell Pressure (kPa)	30
Deviator Stress (kPa)	50
Undrained Shear Strength (kPa)	25
Failure Strain (%)	9
Mode Of Failure	Plastic
Membrane Used/Thickness	Rubber/0.3mm
Rate of Strain (%/min)	1.43

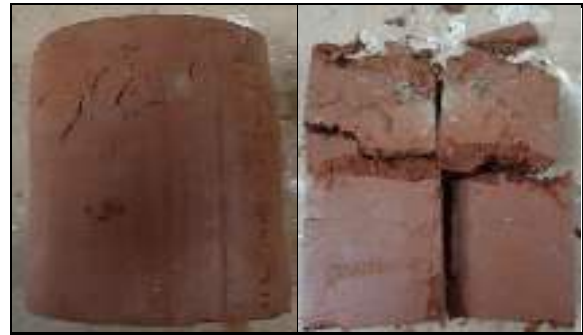
Sample Split

Moisture Content (%)	16
Bulk Density (Mg/m ³)	2.08
Dry Density (Mg/m ³)	1.80
Specimen Length (mm)	210
Specimen Diameter (mm)	105
Cell Pressure (kPa)	60
Deviator Stress (kPa)	270
Undrained Shear Strength (kPa)	135
Failure Strain (%)	9
Mode Of Failure	Brittle
Membrane Used/Thickness	Rubber/0.3mm
Rate of Strain (%/min)	1.43

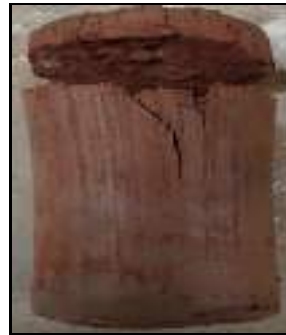
Specimen Post Test

Moisture Content (%)	16
Bulk Density (Mg/m ³)	2.21
Dry Density (Mg/m ³)	1.91
Specimen Length (mm)	210
Specimen Diameter (mm)	105
Cell Pressure (kPa)	60
Deviator Stress (kPa)	196
Undrained Shear Strength (kPa)	98
Failure Strain (%)	6
Mode Of Failure	Brittle
Membrane Used/Thickness	Rubber/0.3mm
Rate of Strain (%/min)	1.43

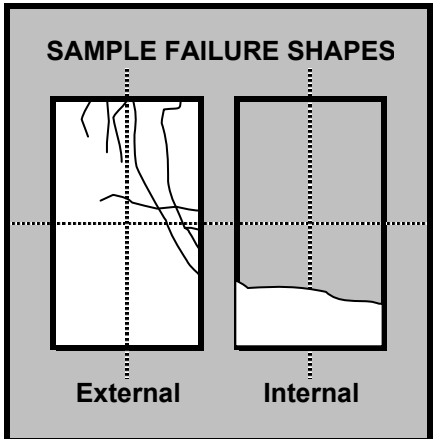
<p>SAMPLE FAILURE SHAPES</p> <p>External Internal</p>
SAMPLE		C	
DEPTH	m	12.62-12.88	
SAMPLE DIAMETER	mm	85.71	
SAMPLE HEIGHT	mm	180.38	
TEST CONDITION		As Received	
RATE OF LOADING	kN/s	0.1	
TEST DURATION	min.sec	3.08	
DATE OF TESTING		29/06/2021	
LOAD FRAME USED		50kN	
LOAD DIRECTION WITH RESPECT TO LITHOLOGY		Unknown	
FAILURE LOAD	kN	20.8	
UNCONFINED COMPRESSIVE STRENGTH	MPa	3.60	
WATER CONTENT (ISRM Suggested Methods)	%	7.6	
BULK DENSITY (ISRM Suggested Methods)	Mg/m ³	2.29	
DRY DENSITY (ISRM Suggested Methods)	Mg/m ³	2.13

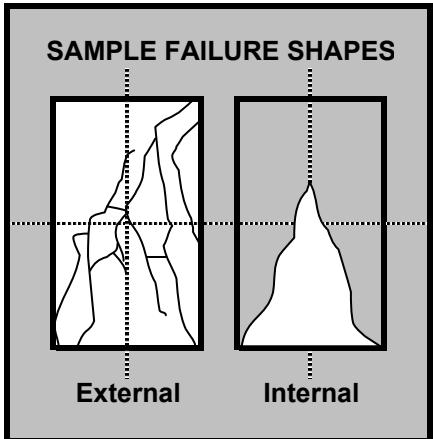
SAMPLE		C	
DEPTH	m	9.98-10.18	
SAMPLE DIAMETER	mm	85.56	
SAMPLE HEIGHT	mm	148.88	
TEST CONDITION		As Received	
RATE OF LOADING	kN/s	0.1	
TEST DURATION	min.sec	4.21	
DATE OF TESTING		29/06/2021	
LOAD FRAME USED		50kN	
LOAD DIRECTION WITH RESPECT TO LITHOLOGY		Unknown	
FAILURE LOAD	kN	23.9	
UNCONFINED COMPRESSIVE STRENGTH	MPa	4.16	
WATER CONTENT (ISRM Suggested Methods)	%	6.3	
BULK DENSITY (ISRM Suggested Methods)	Mg/m ³	2.41	
DRY DENSITY (ISRM Suggested Methods)	Mg/m ³	2.27

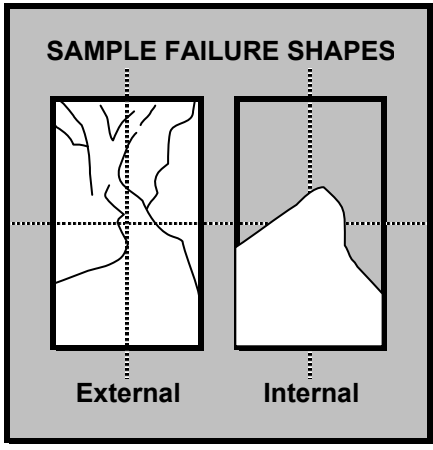
<p style="text-align: center;">SAMPLE FAILURE SHAPES</p> <p style="text-align: center;">External Internal</p>
SAMPLE		C	
DEPTH	m	8.06-8.34	
SAMPLE DIAMETER	mm	86.63	
SAMPLE HEIGHT	mm	181.72	
TEST CONDITION		As Received	
RATE OF LOADING	kN/s	0.01	
TEST DURATION	min.sec	2.01	
DATE OF TESTING		29/06/2021	
LOAD FRAME USED		50kN	
LOAD DIRECTION WITH RESPECT TO LITHOLOGY		Unknown	
FAILURE LOAD	kN	1.6	
UNCONFINED COMPRESSIVE STRENGTH	MPa	0.271	
WATER CONTENT (ISRM Suggested Methods)	%	17.2	
BULK DENSITY (ISRM Suggested Methods)	Mg/m ³	2.07	
DRY DENSITY (ISRM Suggested Methods)	Mg/m ³	1.77
