Former Quinn Radiator Factory Site, Newport, Wales

Factual and Interpretative Report

Project Number: PN224395

February 2023

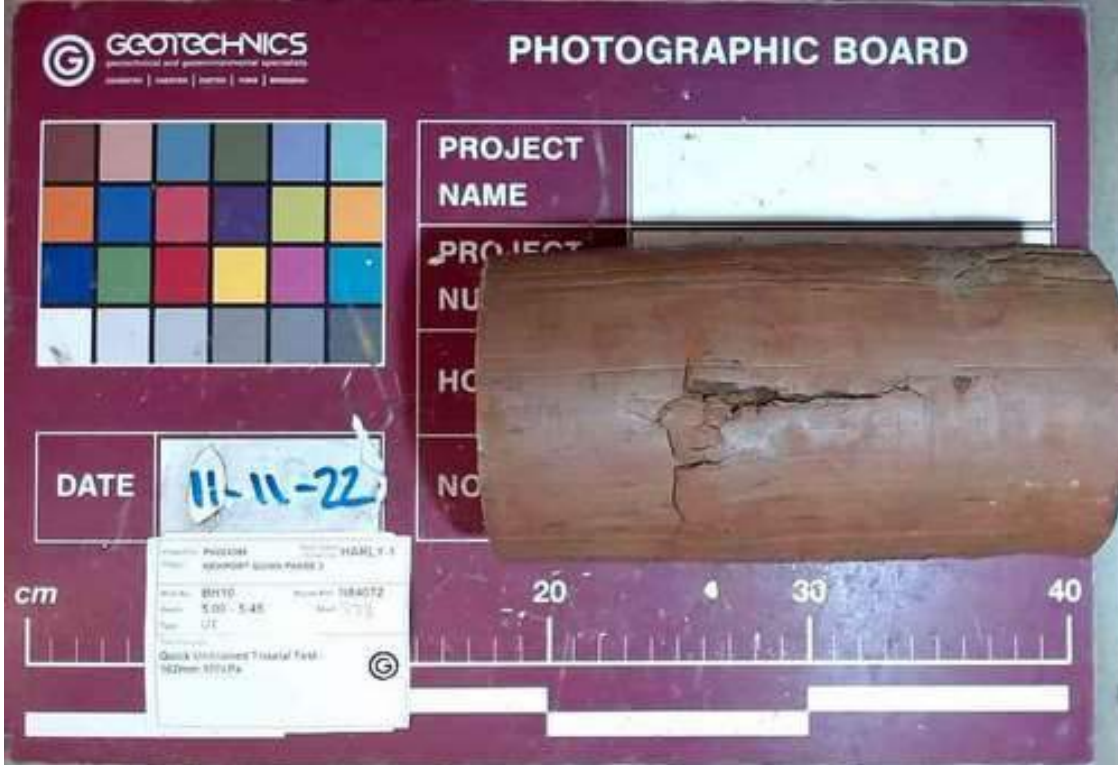
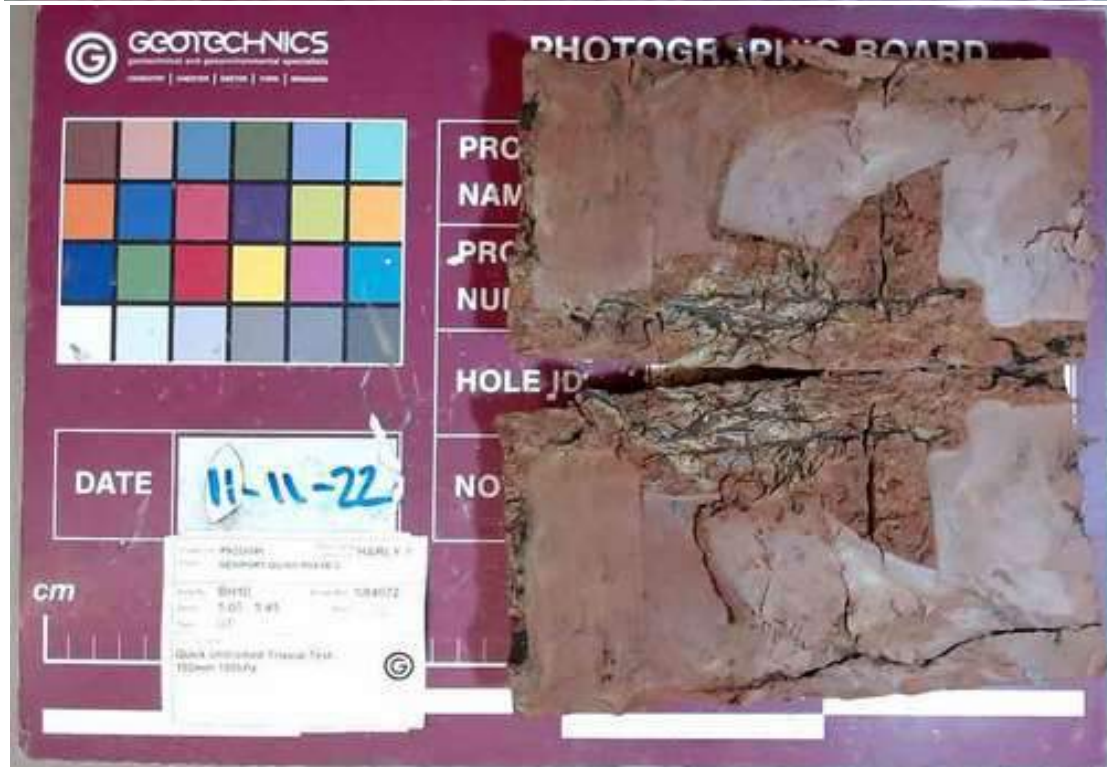
Hole: BH10
Sample Depth: 5.00-5.45m
Sample Type: UT
Sample Ref: N84072

Stage 1	Stage 2	Stage 3	Strain %	Corrected Deviator Stress kN/m ²	Strain %	Corrected Deviator Stress kN/m ²
Test Type	Single Stage						
Sample Condition	Undisturbed						
Orientation of sample	Vertical						
Initial Diameter (mm)	102.18			0.2	29.4		
Initial Length (mm)	210.62			0.5	47.6		
Initial Water Content (%)	32.2			0.7	63.4		
Initial Bulk Density (Mg/m ³)	1.98			0.9	77.0		
Initial Dry Density (Mg/m ³)	1.50			1.4	91.9		
Particle Density (Mg/m ³)	2.65 Assumed			1.9	102.5		
Cell Pressure (kPa)	100			2.4	111.6		
'Specimen Height' at start of Shearing Stage (mm)	210.56			2.8	119.1		
Membrane Thickness/Correction (mm/kPa)	100 / 0.0000			3.3	125.7		
Rate of Strain (%/min)	1.9			3.8	131.2		
Corrected Deviator Stress (kPa)	152			4.3	135.5		
Undrained Shear Strength (kPa)	76			4.7	139.4		
Strain at Failure (%)	7.6			5.2	145.3		
Failure Zone Water Content (%)	26.2			5.7	149.6		
Water Content (after test) (%)				6.2	150.9

Mode of Failure	Intermediate			6.6	151.3		
				7.1	151.7		
				7.6	151.7		
				8.1	150.6		
				8.5	149.7

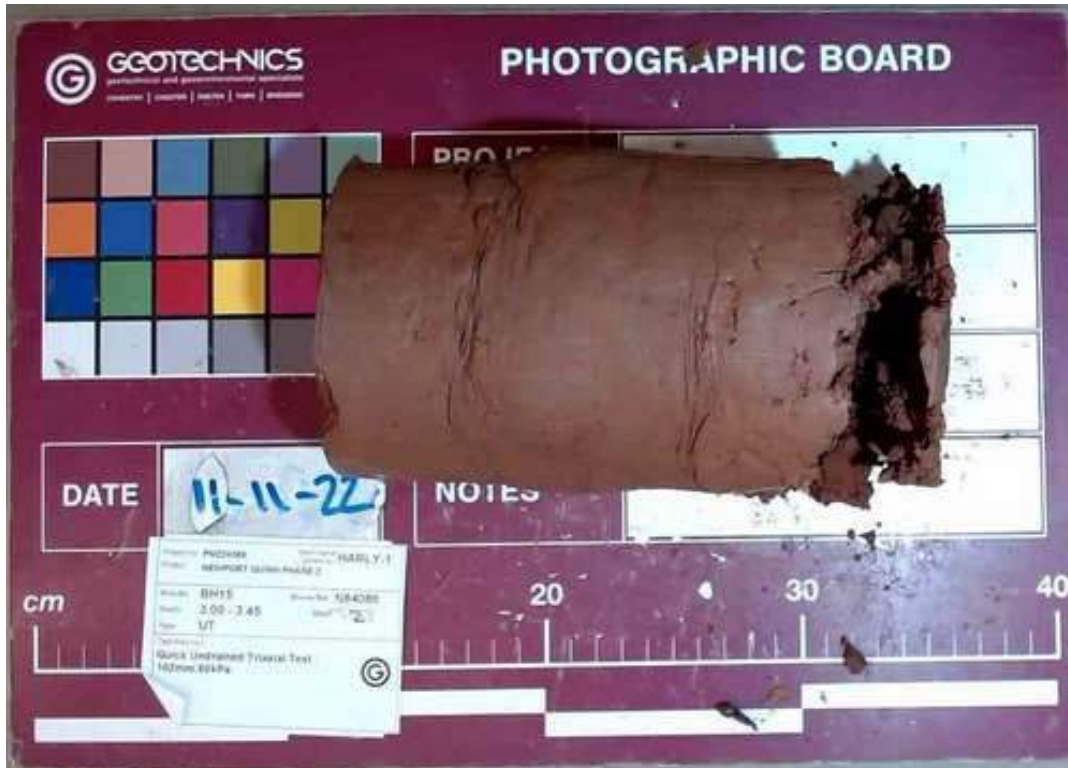
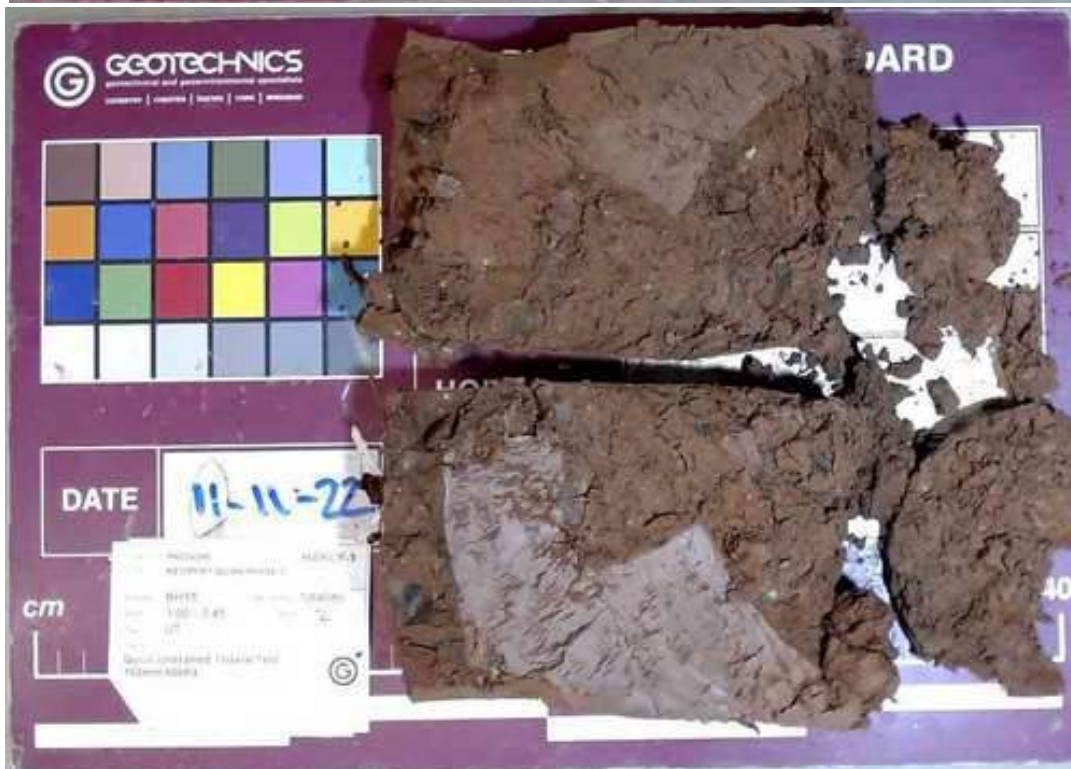
Hole BH15
Sample Depth 3.00-3.45m
Sample Type UT
Sample Ref N84086

Stage 1	Stage 2	Stage 3	Strain %	Corrected Deviator Stress kN/m ²	Strain %	Corrected Deviator Stress kN/m ²
Test Type	Single Stage						
Sample Condition	Undisturbed						
Orientation of sample	Vertical						
Initial Diameter (mm)	102.34			0.2	24.0	9.9	118.7
Initial Length (mm)	211.24			0.5	32.0	10.4	120.1
Initial Water Content (%)	23.6			0.7	37.4	10.9	121.0
Initial Bulk Density (Mg/m ³)	2.00			0.9	45.1	11.4	121.7
Initial Dry Density (Mg/m ³)	1.62			1.4	54.1	11.8	123.0
Particle Density (Mg/m ³)	2.65 Assumed			1.9	62.0	12.3	123.8
Cell Pressure (kPa)	60			2.4	68.5	12.8	124.5
'Specimen Height' at start of Shearing Stage (mm)	211.19			2.8	74.3	13.3	125.1
Membrane Thickness/Correction (mm/kPa)	100 / 0.0000			3.3	79.2	13.7	125.5
Rate of Strain (%/min)	1.9			3.8	83.7	14.2	125.6
Corrected Deviator Stress (kPa)	127			4.3	88.1	14.7	125.8
Undrained Shear Strength (kPa)	64			4.7	91.5	15.1	126.2
Strain at Failure (%)	16.1			5.2	94.9	15.6	126.9

Failure Zone Water Content (%)	24.8			5.7	98.7	16.1	127.3
Water Content (after test) (%)				6.2	103.2	16.6	126.8
Mode of Failure	Plastic			6.6	106.9	17.0	126.1
