Tech Tip

How to repair 4th gen. F-body door panels

Subject: 1999 Trans Am – Driver's and passenger's door panels both cracked all the way through.

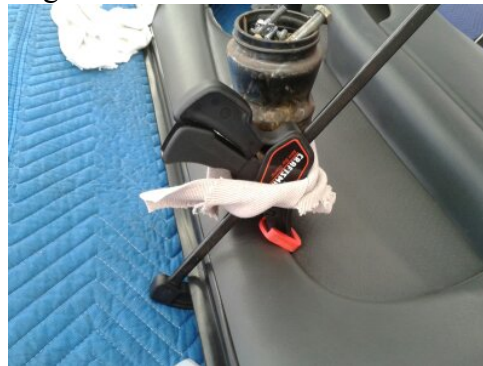
My door panels were cracked all the way through which took me longer, about 2 hours each per door panel, but it would have required less effort and time if I could have caught them in the beginning stages.

Here is everything that I bought to repair both door panels about \$10.00, because I already had the lock tight;-) 2 part epoxy, metal screen patches and #4 phillip screws 1/2" long, nuts and washer. After you remove the staples, you drill a 1/8" hole in each staple hole (1 hole for each staple) then insert 1 screw, apply a little lock tight and finger tighten the nut and washer. Apply a light coat of the 2 part epoxy to the crack and as it is setting up, put a piece of the screen mesh on the epoxied area. Then mix a generous portion of 2 part epoxy and cover the screen and surrounding area of the repair. Below is a jig (with a empty can of brake clean behind panel) that I set up to hold the door panel while it dried overnight. The screw jar is on the door panel for weight.
