| Project Number: | 223157.00 (030) |
| Project Name: | Smith v. Liscott |
| Location: | 101 Mule Deer Court |

Subject: Construction and Contract Forensic Review

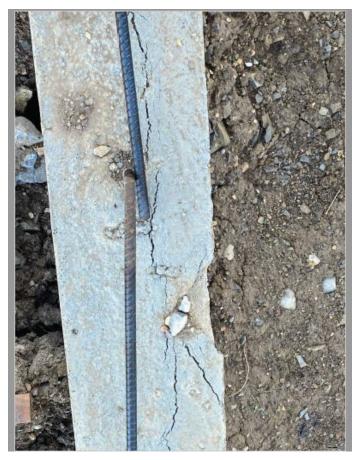
Owner provided photograph of foundation damage at the porch foundations (Bates Number Smith_000507).

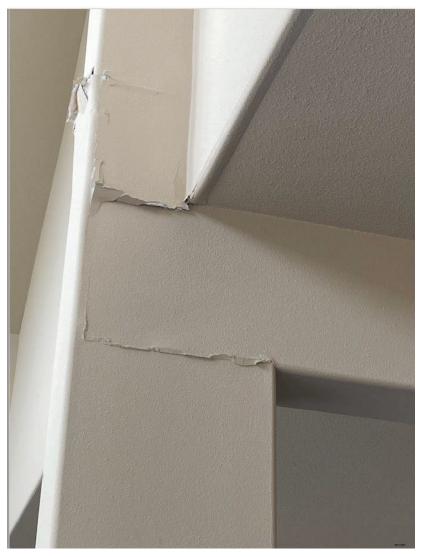
Interior damages related to the setting of the modular components and foundation movement or interior post issues (Bates Number Smith_000521).

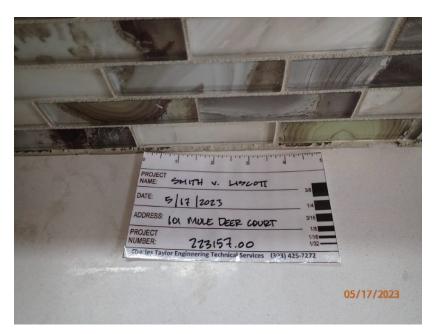
May 17, 2023, Disc OBS1, Photograph 155, DLC, 101 Mule Deer Court, base cabinet pulled away from west kitchen wall.

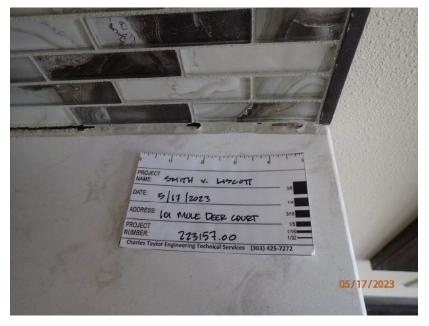
May 17, 2023, Disc OBS1, Photograph 156, DLC, 101 Mule Deer Court, base cabinet pulled away from west kitchen wall.

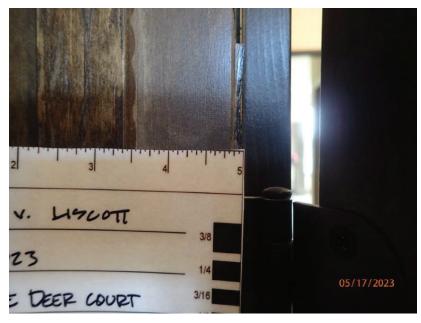
May 17, 2023, Disc OBS1, Photograph 184, DLC, 101 Mule Deer Court, width dimension at top of door frame – approx. 1-1/4-inch.

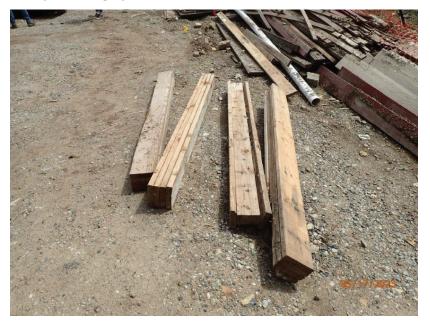
May 17, 2023, Disc OBS1, Photograph 97, DLC, 101 Mule Deer Court, lumber reported by the Smiths as those used to support structural steel beam.

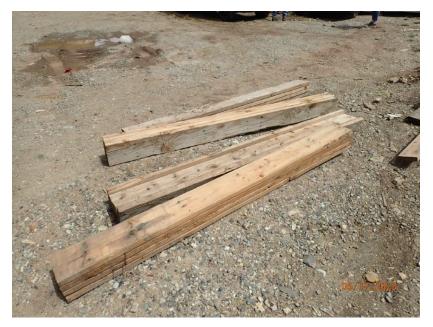
May 17, 2023, Disc OBS1, Photograph 98, DLC, 101 Mule Deer Court, lumber reported by the Smiths used to support structural steel beam.

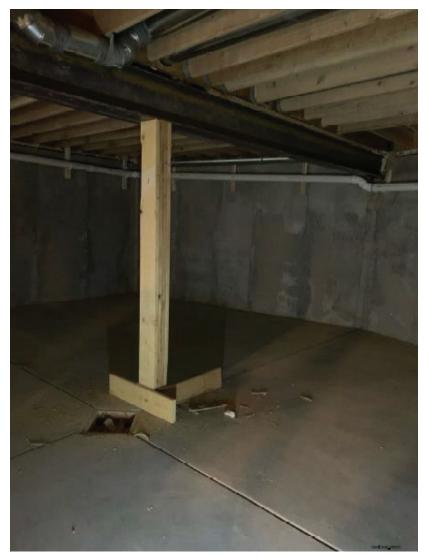
Construction photo of beam support, screen captured from Bates Number HERITAGE_000055.

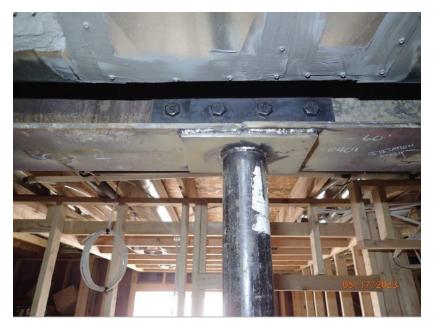
May 17, 2023, Disc OBS1, Photograph 124, DLC, 101 Mule Deer Court, repaired connection between support post and steel beam. This attachment detail was done at both the north and south support post. North post location does not have a splice connection plate.

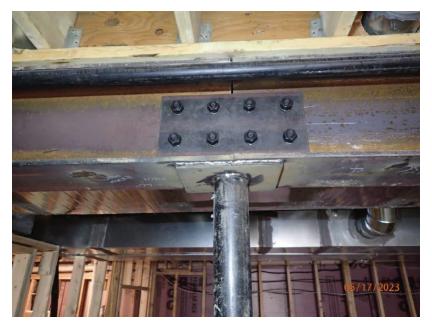
May 17, 2023, Disc OBS1, Photograph 125, DLC, 101 Mule Deer Court, approved beam splice plate installed at the south beam support location.

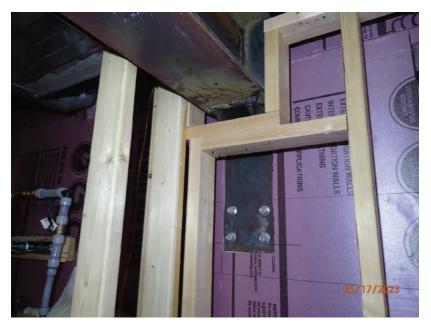
May 17, 2023, Disc OBS1, Photograph 126, DLC, 101 Mule Deer Court, approved beam bearing seat as installed at the south and north foundation wall bearing points.

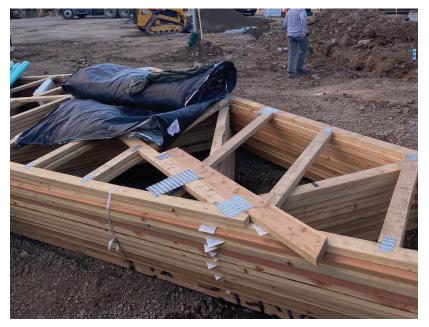
Owner provided photo, trusses delivered to the site and stored directly on the ground without dunnage.

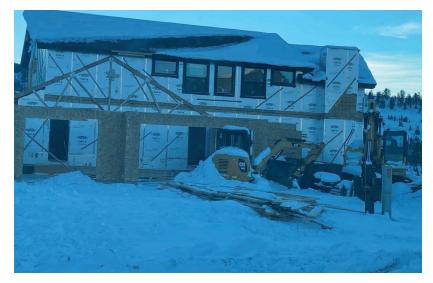
Owner provided photo, trusses and other building materials stored directly on the ground without dunnage with no protective covering, and covered with snow and ice.

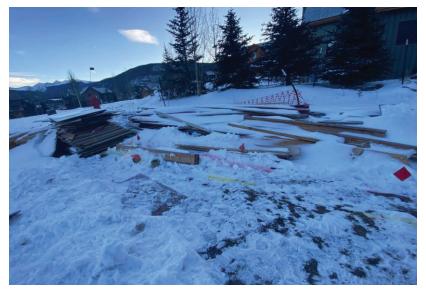
Owner provided photo, trusses and other building materials stored directly on the ground without dunnage with no protective covering, and covered with snow and ice.

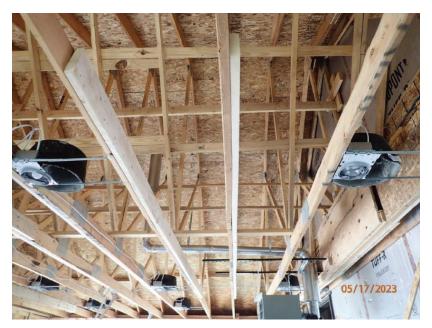
May 17, 2023, Disc OBS1, Photograph 103, DLC, 101 Mule Deer Court, repairs at bottom chord of garage trusses.

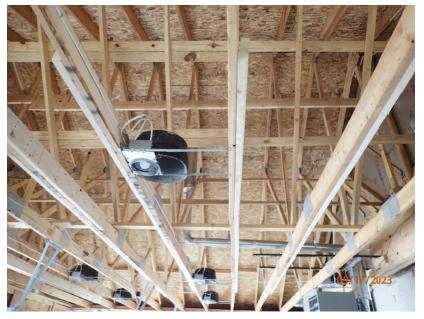
May 17, 2023, Disc OBS1, Photograph 104, DLC, 101 Mule Deer Court, repairs at bottom chord of garage trusses.

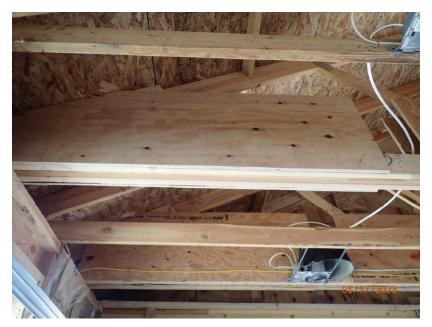
May 17, 2023, Disc OBS1, Photograph 106, DLC, 101 Mule Deer Court, repairs at bottom chord of garage trusses.

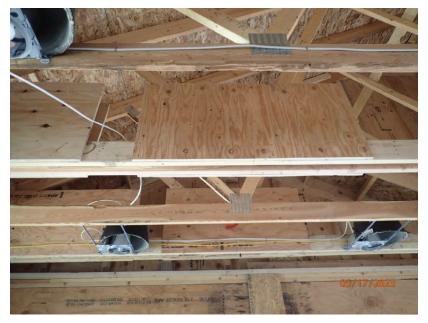
May 17, 2023, Disc OBS1, Photograph 107, DLC, 101 Mule Deer Court, repairs at bottom chord of garage trusses.

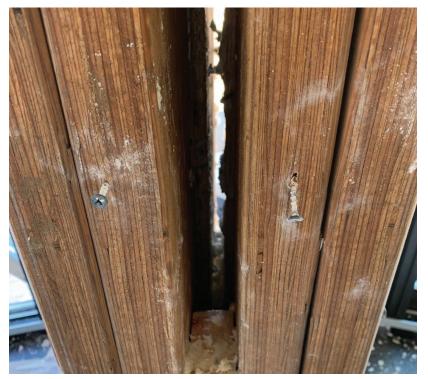
Owner provided photo showing the gap between the modular units prior to Liscott's application of spray foam insulation in this gap.

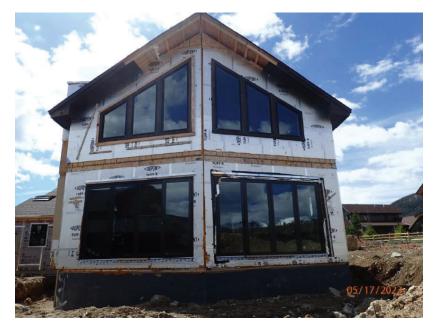
May 17, 2023, Disc OBS1, Photograph 11, DLC, 101 Mule Deer Court, overall view of the north elevation. 2x12 band board is missing at second story floor line.

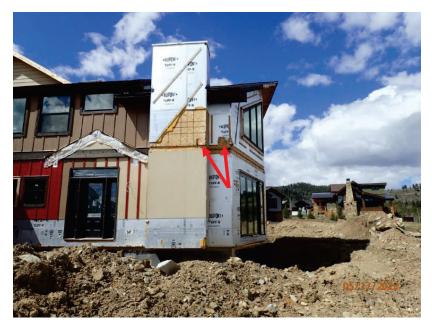
May 17, 2023, Disc OBS1, Photograph 12, DLC, 101 Mule Deer Court, modular unit construction and damage at NE corner from use of a mini-excavator.

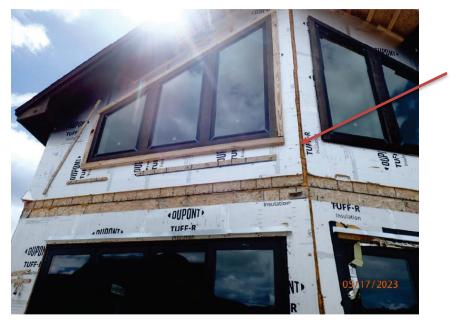
May 17, 2023, Disc OBS1, Photograph 49, DLC, 101 Mule Deer Court, east half of the north elevation showing incomplete modular unit installation and 2-inch gap at centerline.

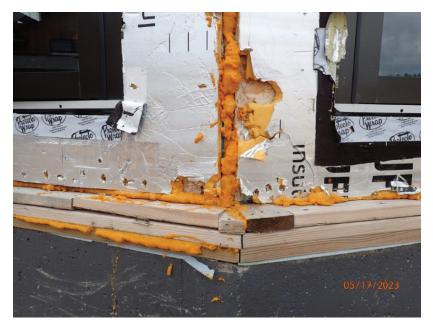
May 17, 2023, Disc OSB1, Photograph 51, DLC, 101 Mule Deer Court, 2-inch gap between east and west modular units gap filled with spray foam.

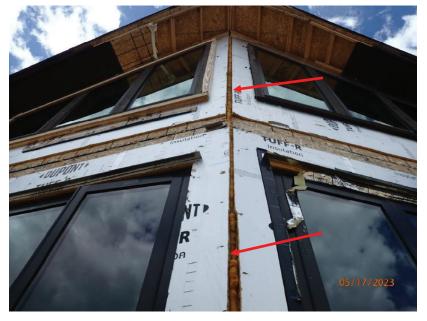
May 17, 2023, Disc OSB1, Photograph 52, DLC, 101 Mule Deer Court, gap between east and west modular units. Gap offset between upper and lower levels.

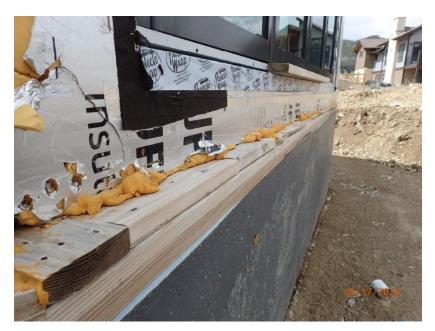
May 17, 2023, Disc OSB1, Photograph 53, DLC, 101 Mule Deer Court, modular units mis-aligned with the foundation wall.

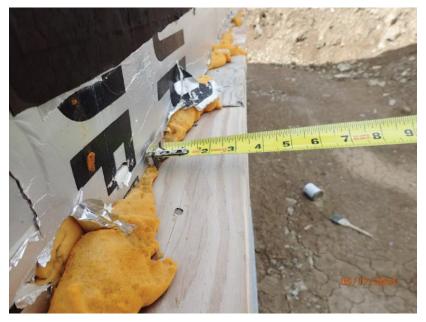
May 17, 2023, Disc OBS1, Photograph 54, DLC, 101 Mule Deer Court, modular units mis-aligned with the foundation wall at west half.

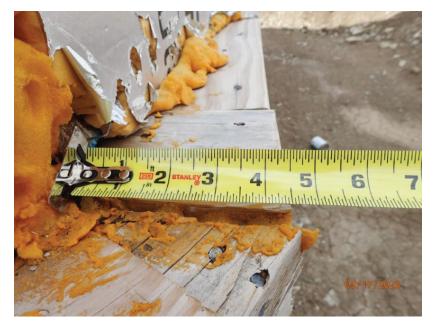
May 17, 2023, Disc OBS1, Photograph 55, DLC, 101 Mule Deer Court, modular units mis-aligned with the foundation wall at west half.

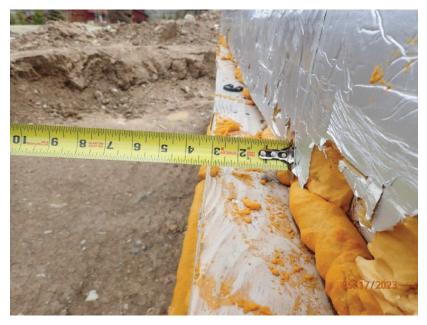
May 17, 2023, Disc OBS1, Photograph 65, DLC, 101 Mule Deer Court, modular units mis-aligned with the foundation wall at east half.

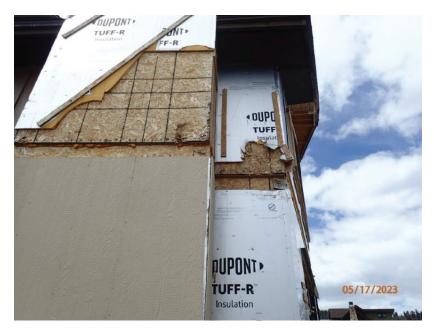
May 17, 2023, Disc OBS1, Photograph 69, DLC, 101 Mule Deer Court, damage at NE corner from use of a mini-excavator pushing on the units.

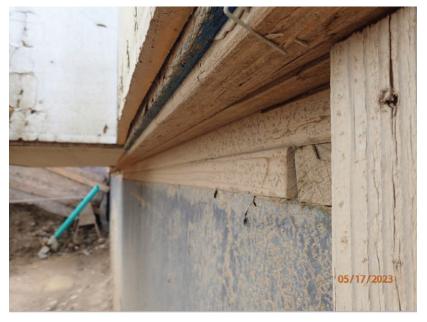
May 17, 2023, Disc OBS1, Photograph 72, DLC, 101 Mule Deer Court, overhang of modular unit to foundation wall east elevation.

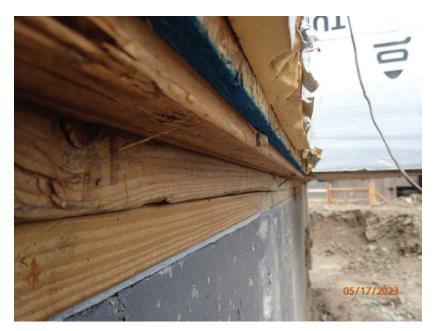
May 17, 2023, Disc OBS1, Photograph 73, DLC, 101 Mule Deer Court, overhang of modular unit to foundation wall east elevation.

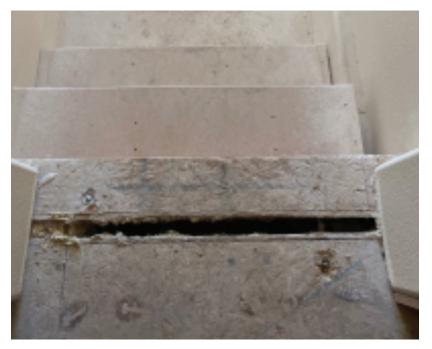
Owner provided photo showing the 2-inch gap at the mating line between the modular units. Top of stairs at second floor level.

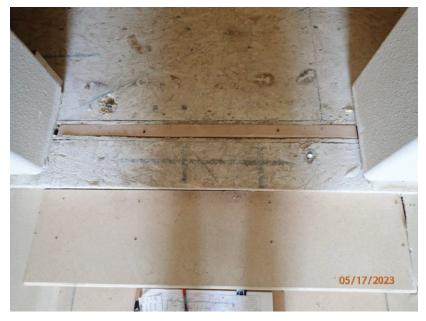
May 17, 2023, Disc OBS1, Photograph 227, DLC, 101 Mule Deer Court, 2-inch gap between east and west unit at subfloor at top of stairs.

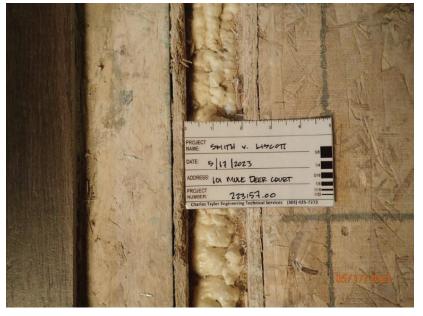
May 17, 2023, Disc OBS1, Photograph 242, DLC, 101 Mule Deer Court, 2-inch gap between units filled with spray foam at sill into upstairs Bath #4.

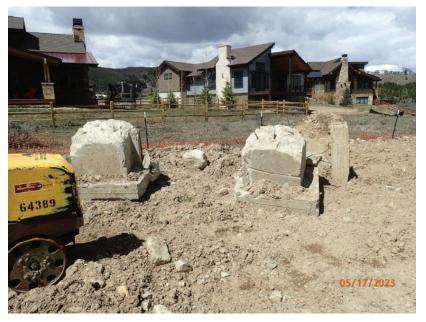
May 17, 2023, Disc OBS1, Photograph 30, DLC, 101 Mule Deer Court, demolished footing setting at SW corner of property.

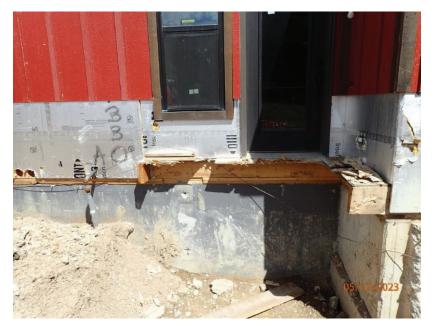
May 17, 2023, Disc OBS1, Photograph 21, DLC, 101 Mule Deer Court, south elevation entry foundation and porch framing have been removed.

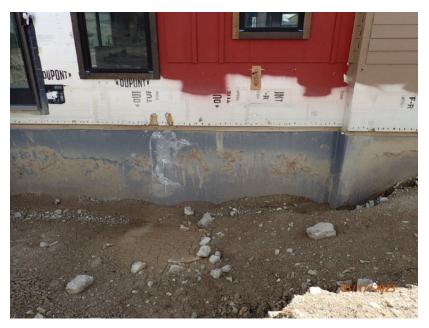
May 17, 2023, Disc OBS1, Photograph 37, DLC, 101 Mule Deer Court, west elevation location where foundation has been removed.

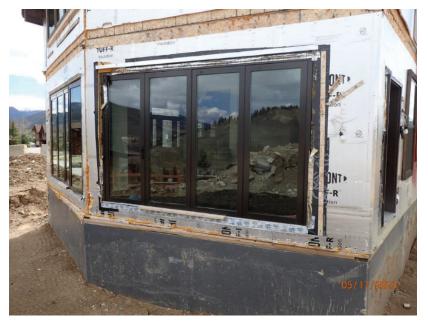
May 17, 2023, Disc OBS1, Photograph 46, DLC, 101 Mule Deer Court, north elevation concrete work has been removed and backfill materials being placed.

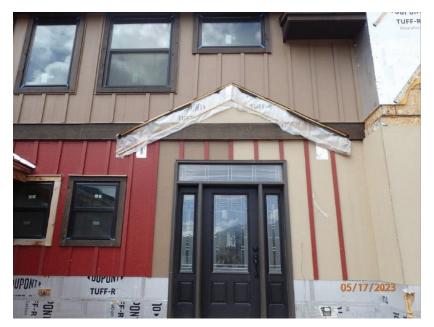
May 17, 2023, Disc OBS1, Photograph 78, DLC, 101 Mule Deer Court, east elevation porch structure has been removed.

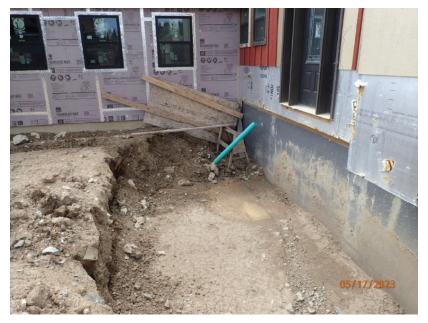
May 17, 2023, Disc OBS1, Photograph 82, DLC, 101 Mule Deer Court, east elevation entry footing have been removed and looking toward the front door location.

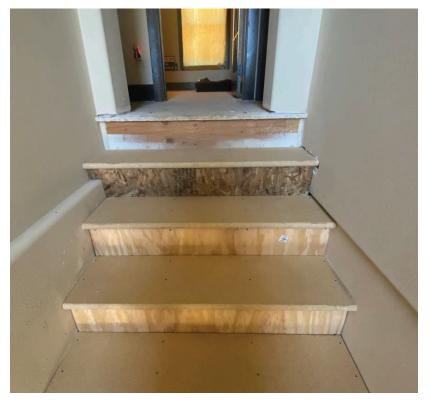
Owner provided photo prior to the re-framing showing non-compliant dimensional variance between the treads and risers at the second floor.

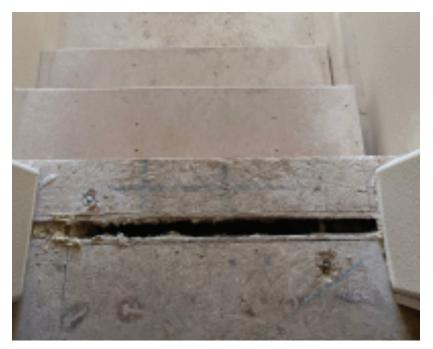
Owner provided photo showing the 2-inch gap at the mating line between the modular units. Top of stairs at second floor level.

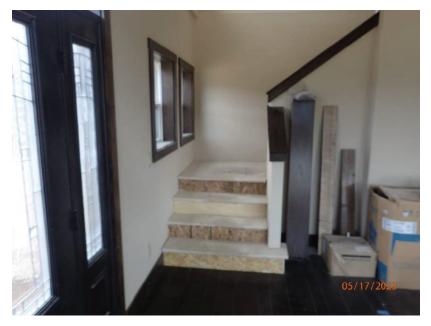
May 17, 2023, Disc OBS1, Photograph 224, DLC, 101 Mule Deer Court, lower landing stairs from first floor to second.

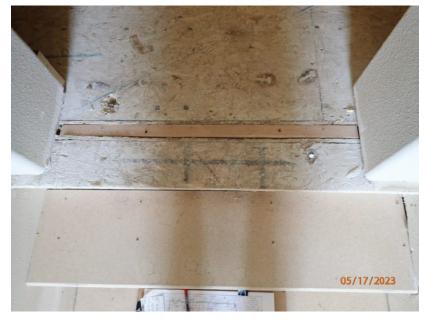
May 17, 2023, Disc OBS1, Photograph 227, DLC, 101 Mule Deer Court, 2-inch gap at top of stairs, 2x lumber used to fill to gap between the east and west modular units.

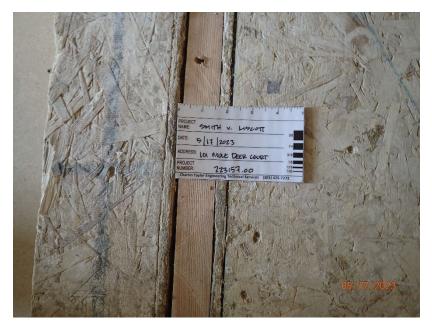
May 17, 2023, Disc OBS1, Photograph 228, DLC, 101 Mule Deer Court, 2x lumber used to fill to gap between the east and west modular units. The lumber does not sufficiently fill the gap.
