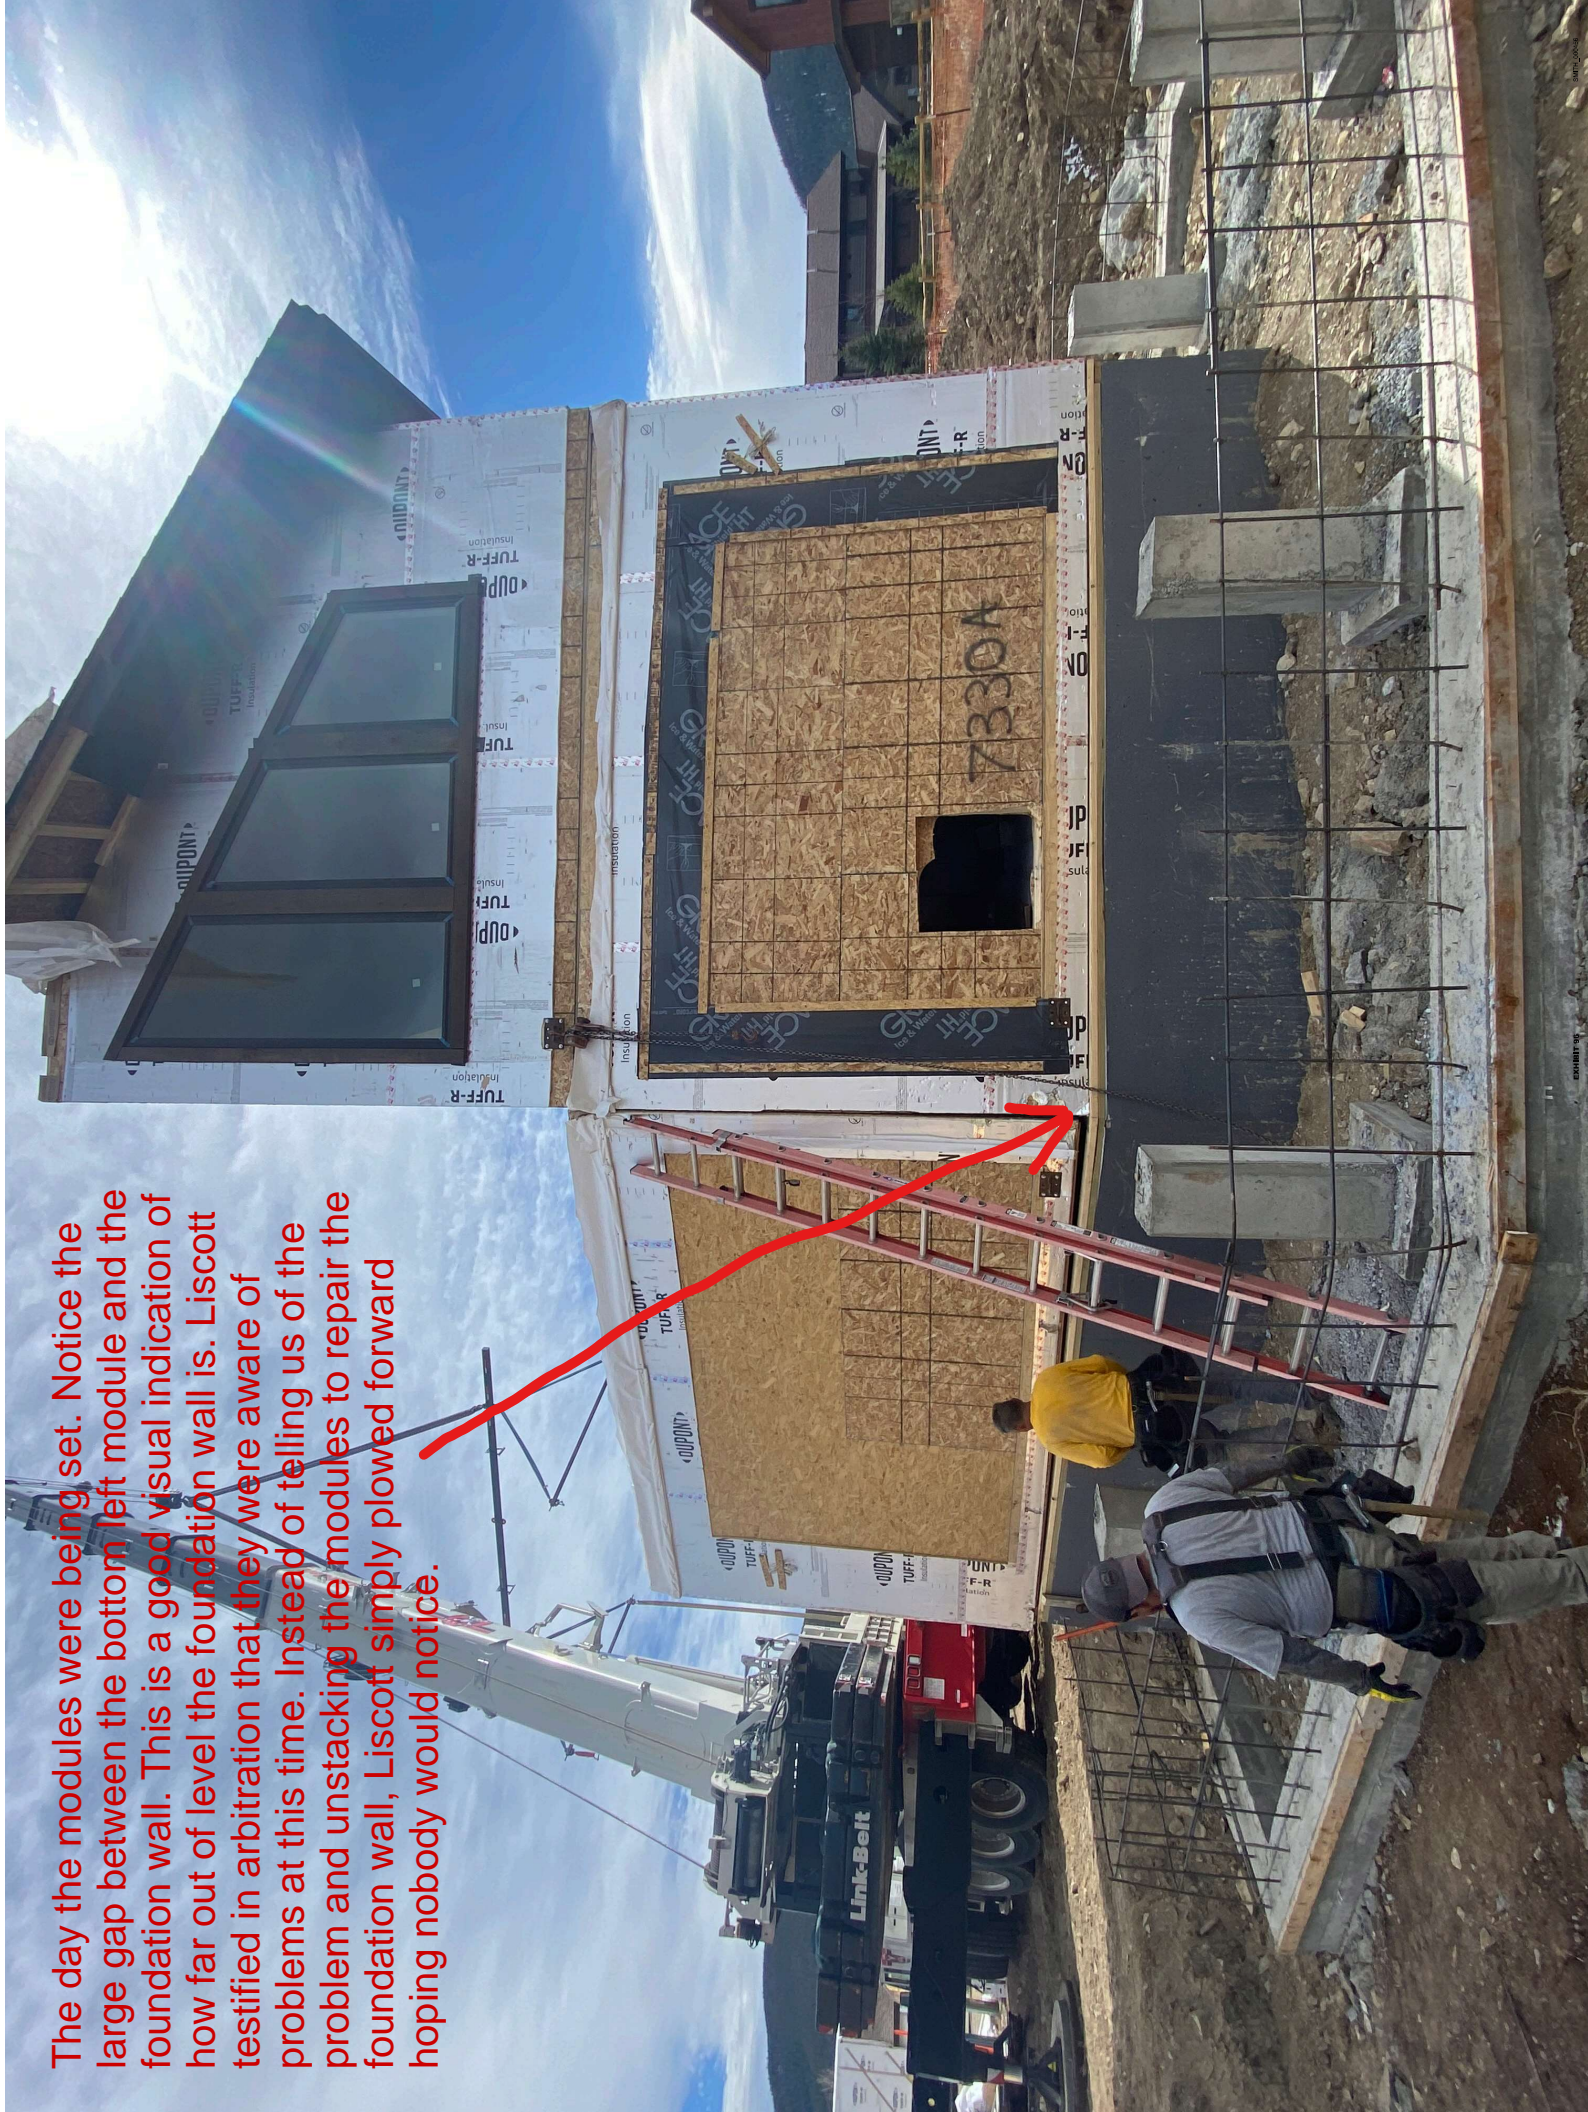
The day the modules were being set. Notice the large gap between the bottom left module and the foundation wall. This is a good visual indication of how far out of level the foundation wall is. Liscott testified in arbitration that they were aware of problems at this time. Instead of telling us of the problem and unstacking the modules to repair the foundation wall, Liscott simply plowed forward hoping nobody would notice.
