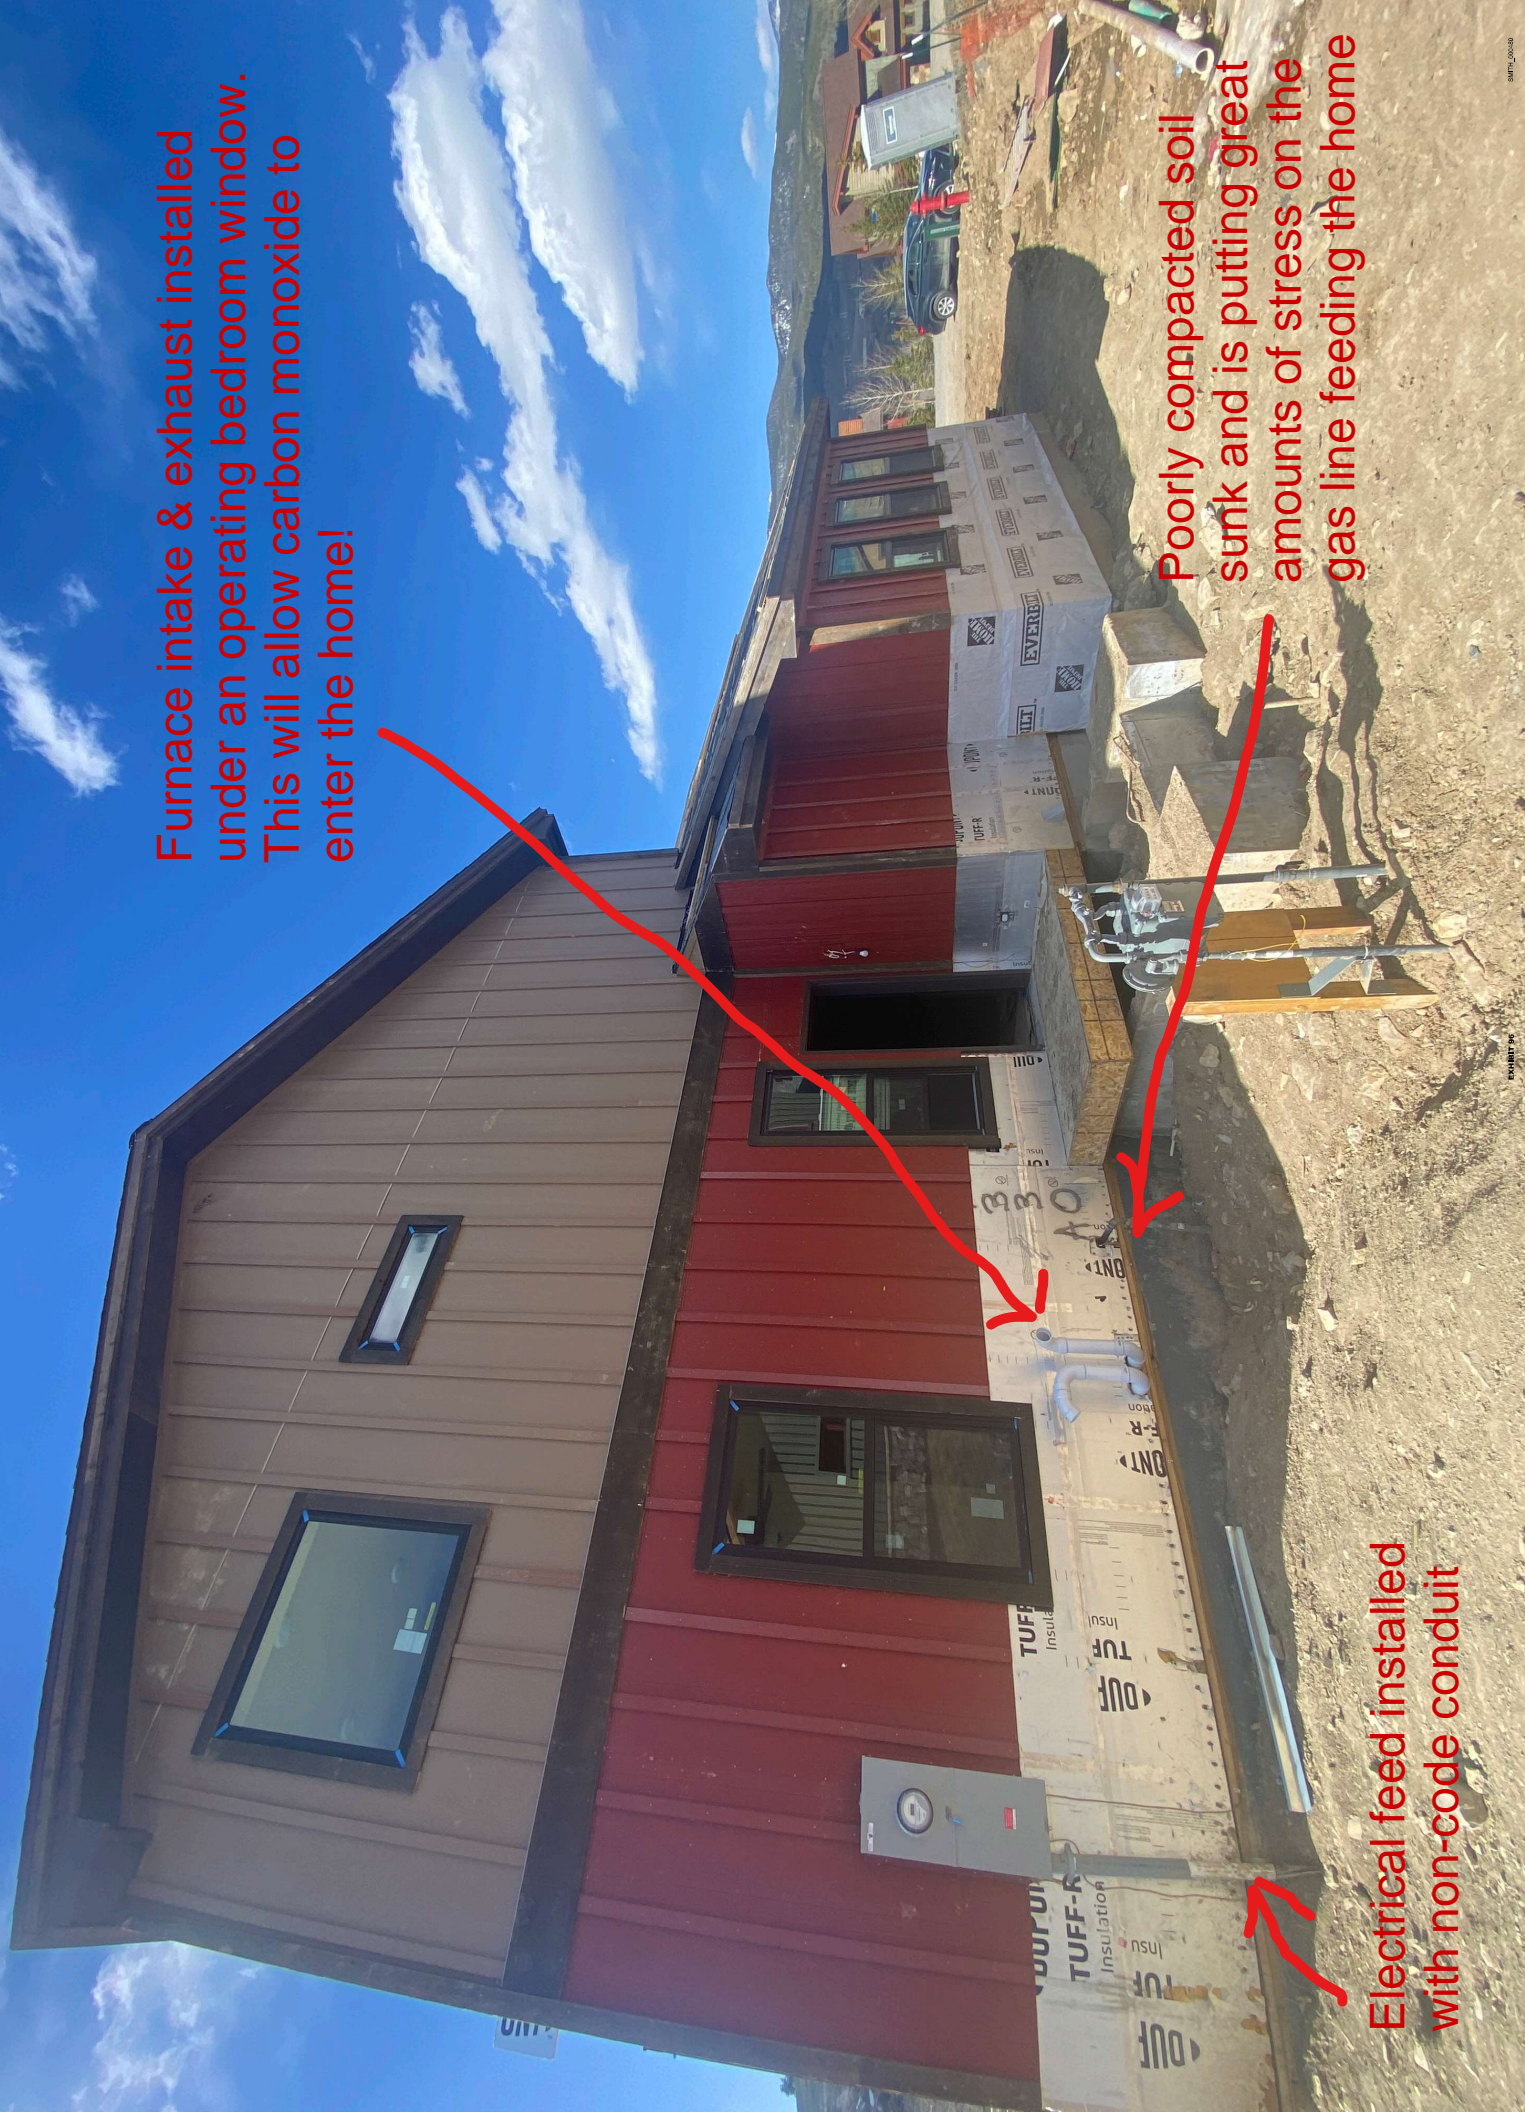
Furnace intake & exhaust installed under an operating bedroom window. This will allow carbon monoxide to enter the home!

Poorly compacted soil sunk and is putting great amounts of stress on the gas line feeding the home

Electrical feed installed with non-code conduit
