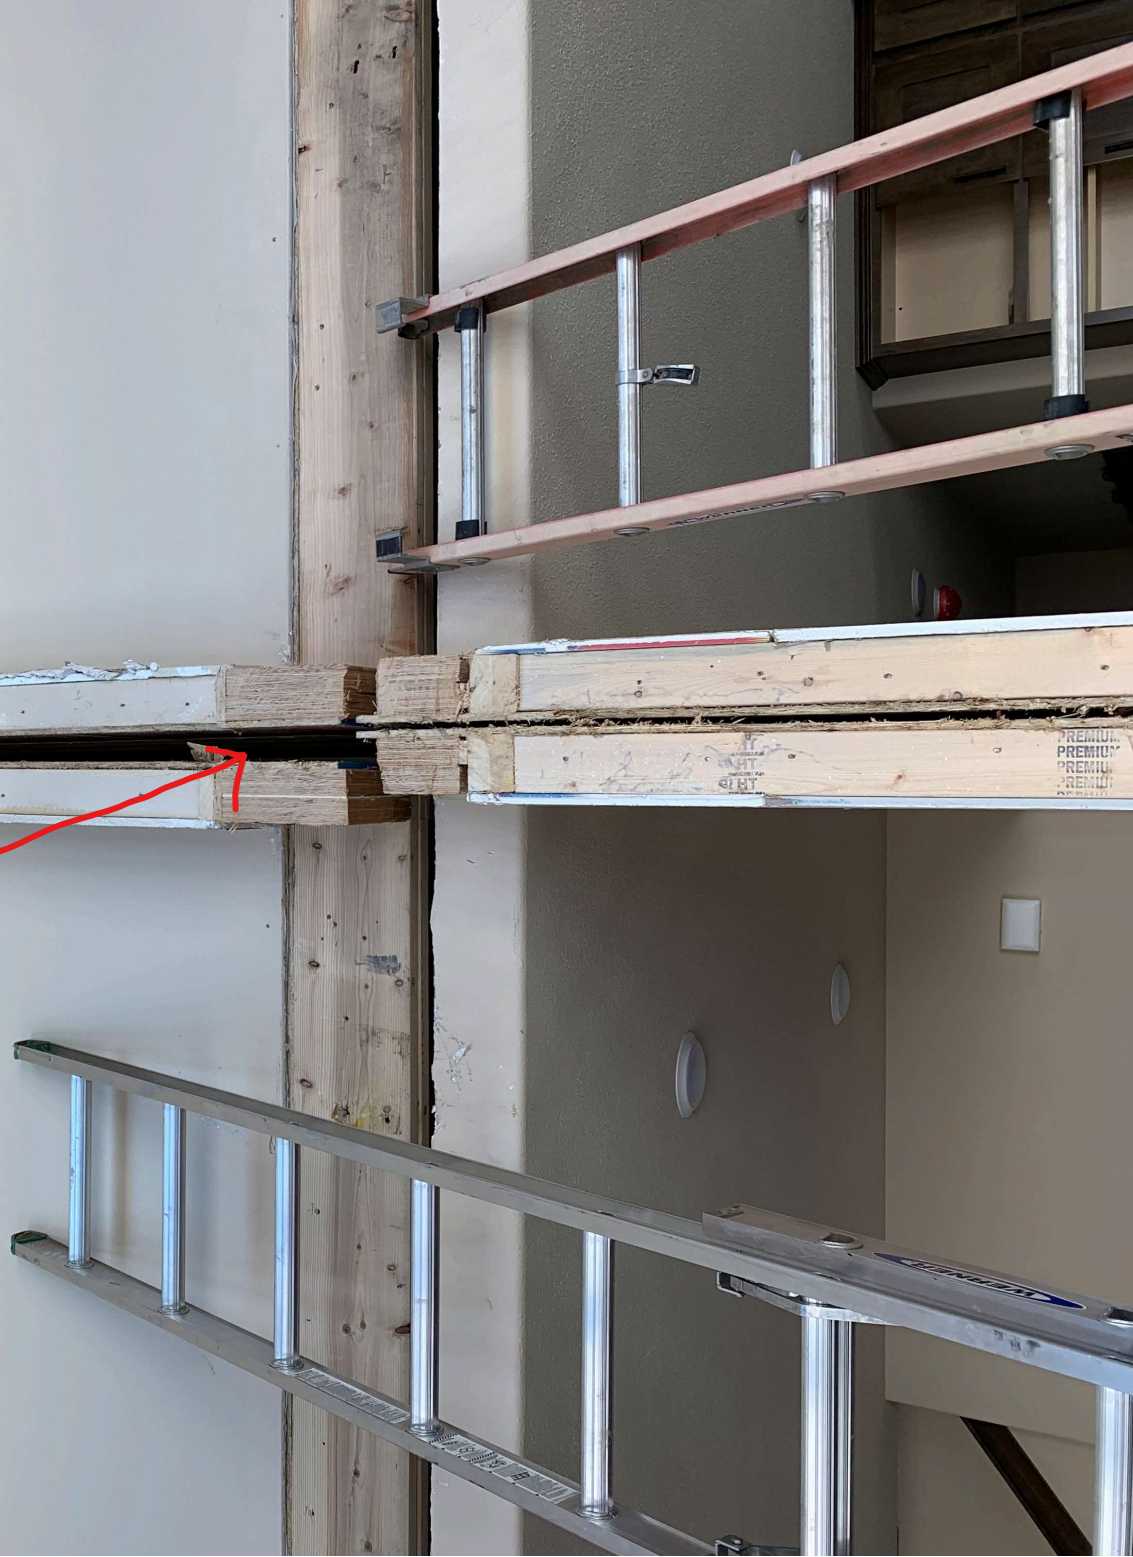
This image is an interior shot showing just how far apart and out of square the modules are from one another. Instead of properly solving this issue, Liscott just had their drywall crew cover this up. This image also demonstrates why the walls running down the centerline of the home are fully 1.5" wider at the bottom than they are at the top.
