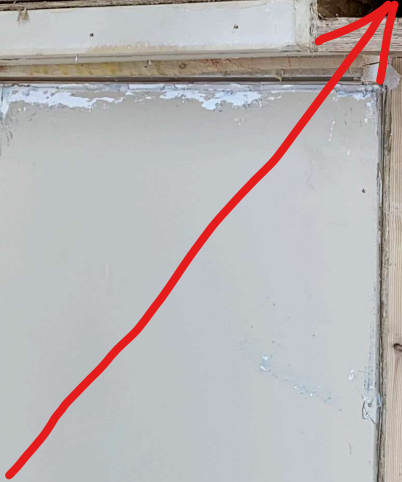
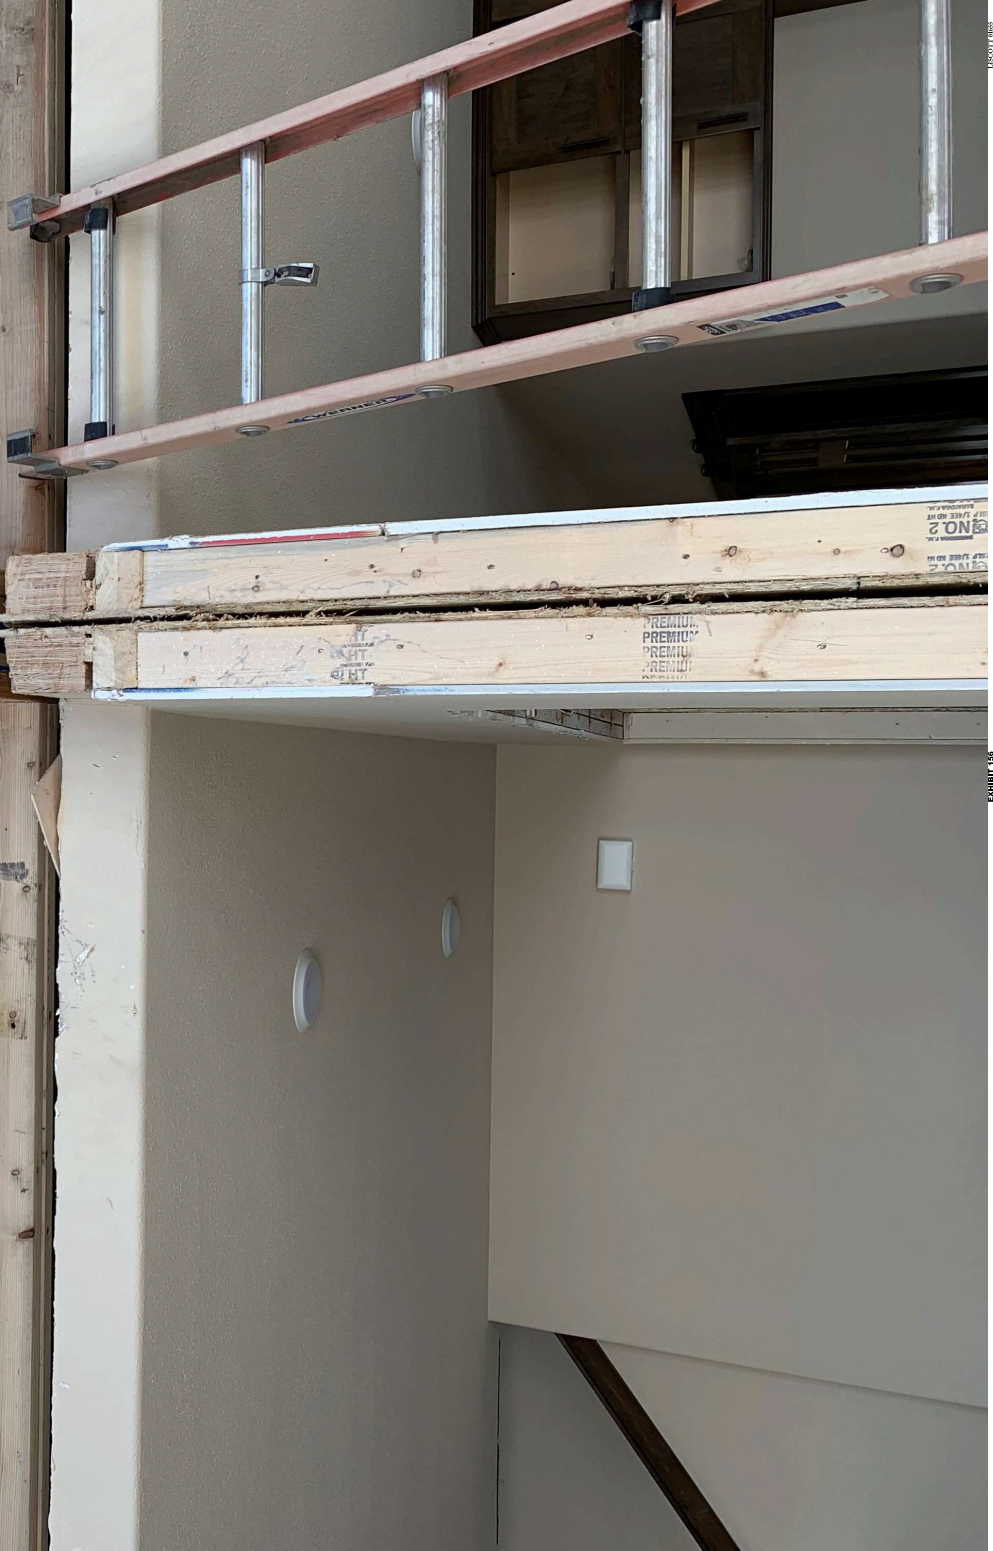
This photo shows how Liscott attempted to hide the fact that the modules weren't properly mated. Liscott simply had the drywall crew cut out and reframe this one small stub wall. The large gap indicates how far apart the modules still remain.
