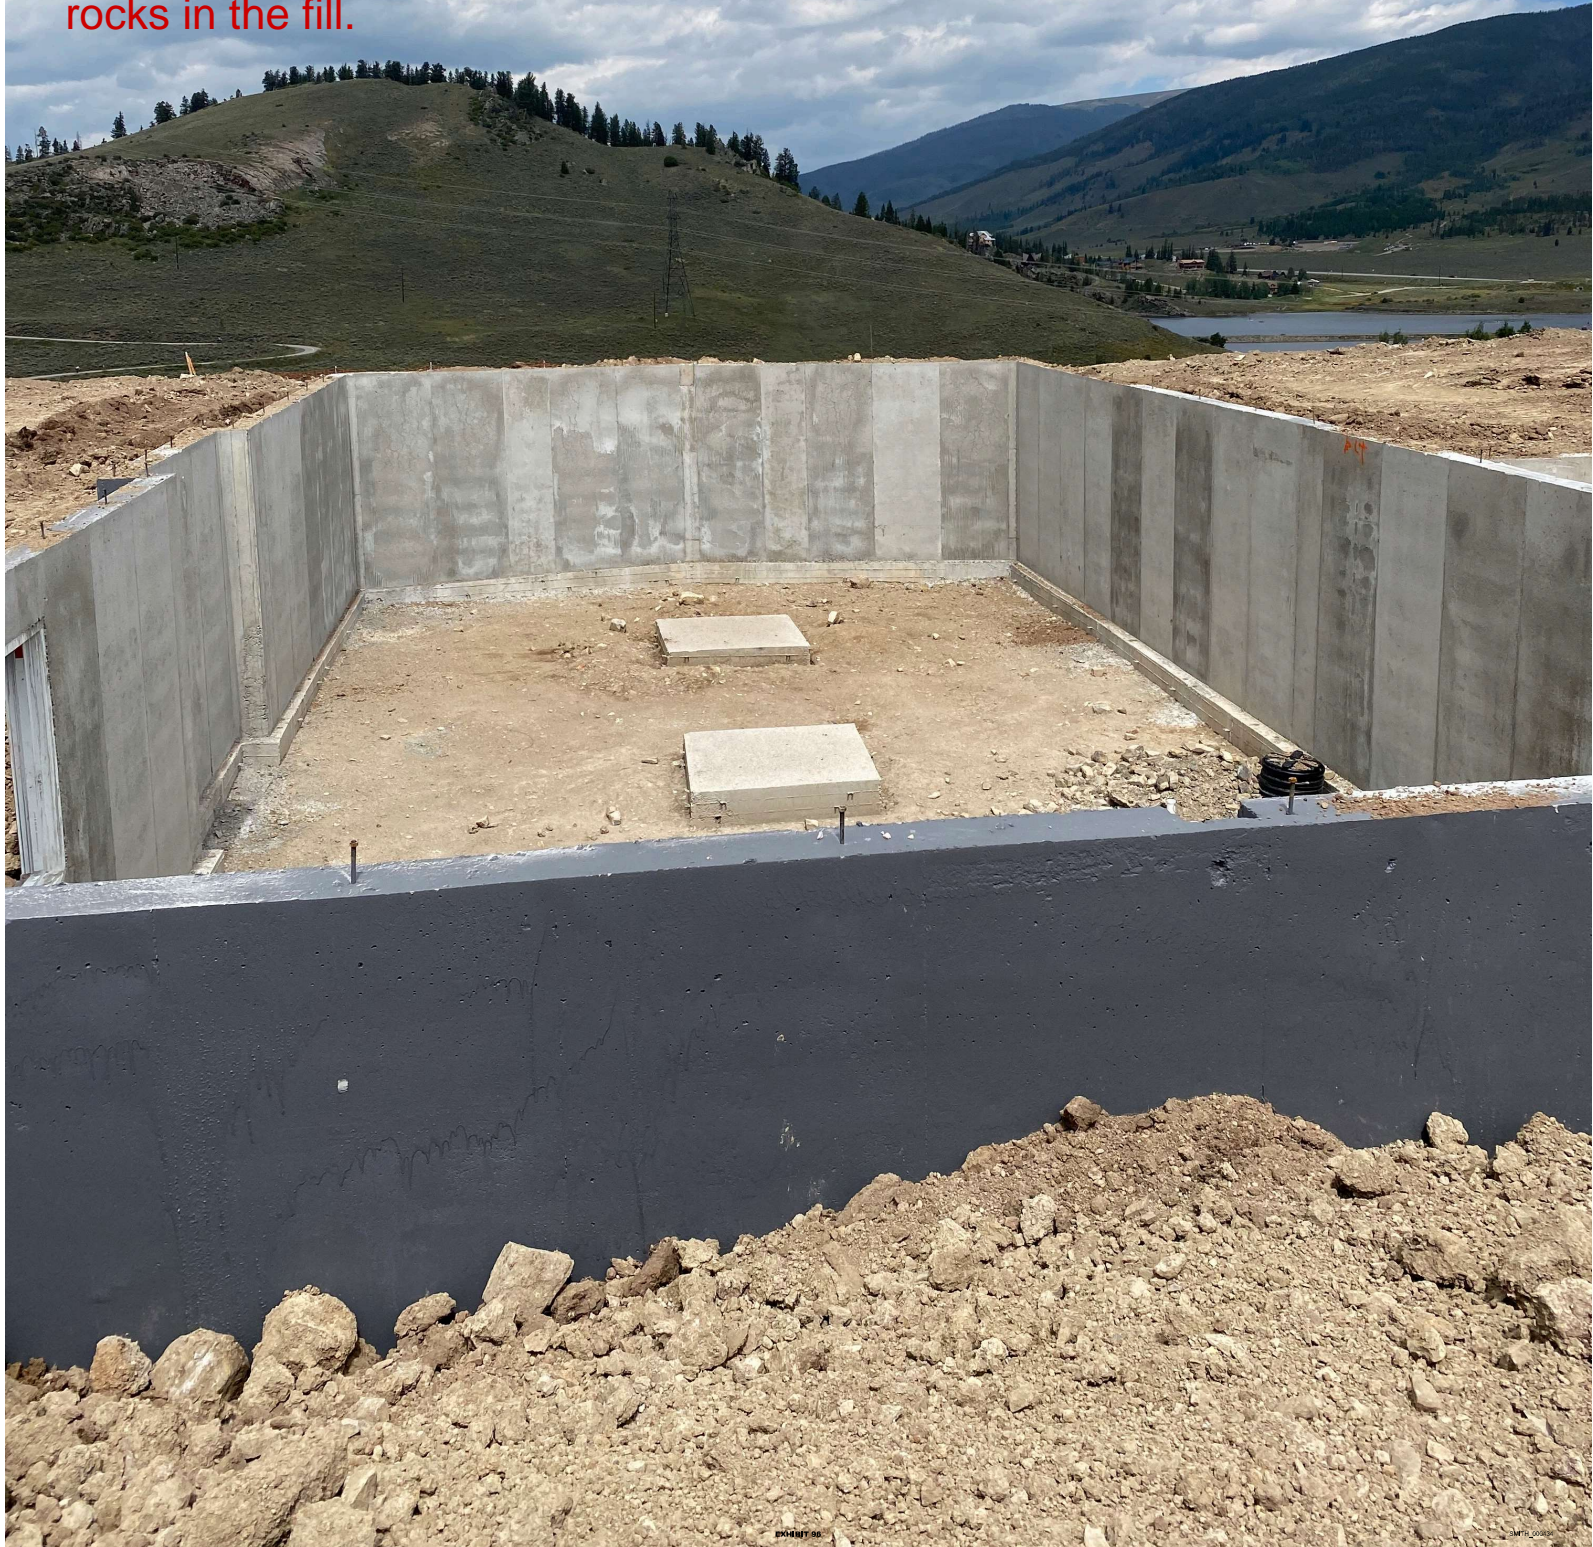
Foundation being backfilled. Notice that the walls are not supported from movement. Also notice the lack of compaction and native soils and large rocks in the fill.
