# 1990 JEEP WRANGLER YJ

## Reconditioning, Inspection & Service Report

RECONDITIONING PLAN COMPLETE

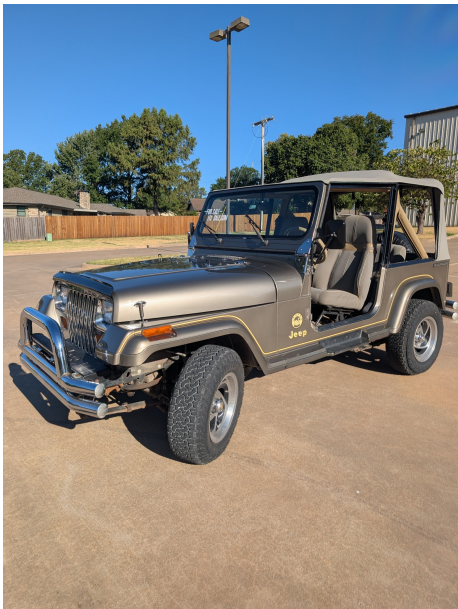
Completed reconditioning - front three-quarter exterior view.

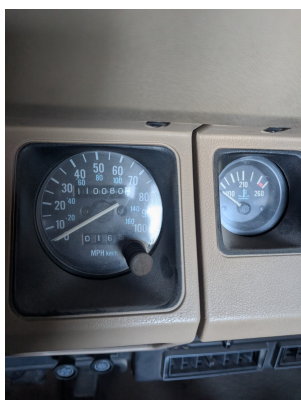
*Odometer reading documented during the project.*

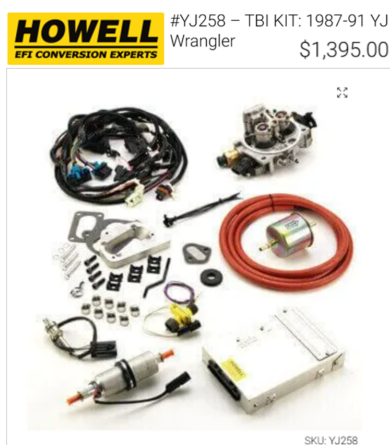
Howell #YJ258 kit identification image.

- Howell Engine Developments #YJ258 TBI Kit for 1987-91 YJ Wrangler 4.2L applications.
- Installation confirmed as having been performed by Sam's 4x4 in Tulsa, Oklahoma.
- Fuel tank removed during recommissioning and found completely dry.
- Fresh ethanol-free 87-octane gasoline added.
- Failed inline Howell fuel-pump fuse diagnosed and replaced; fuel-pump operation restored.
- Howell inline EFI fuel filter replaced.
- Fuel-tank cap replaced to provide a fresh seal.
- After fuel-pump power was restored, engine started promptly and idled normally.

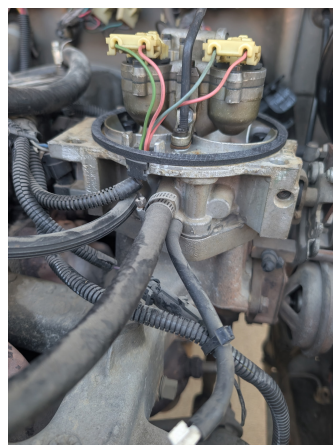
Installed Howell throttle-body injection system.

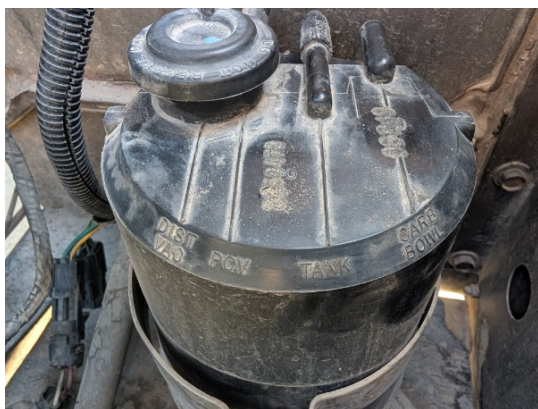
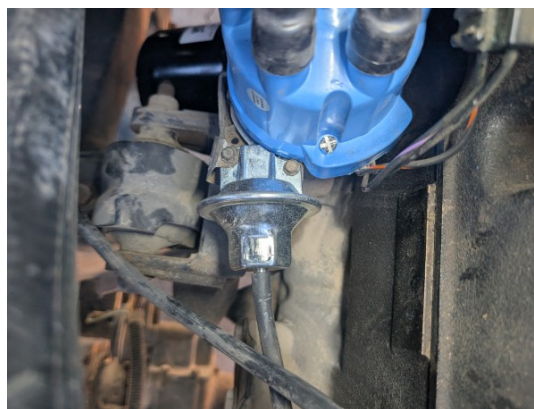
- Broken/disconnected EVAP canister vacuum/vapor lines were identified and proper routing restored.
- Fuel-tank vapor connection restored; PCV/purge connection verified; obsolete carburetor-bowl port remained capped for the Howell conversion.
- Distributor/purge vacuum signal circuit restored to the Howell ported-vacuum arrangement.
- One additional vacuum hose with a hole was found and repaired.
- A previously noticed rich exhaust/fuel odor was likely associated with the disconnected EVAP tank-vapor plumbing.

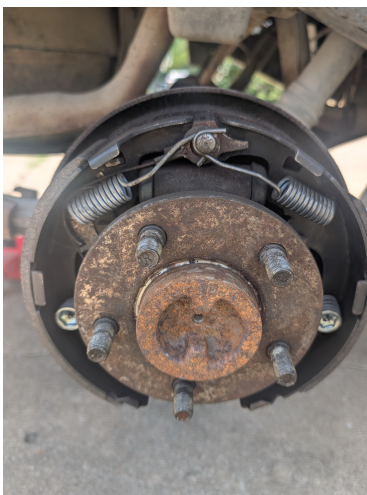
*Rear brake assembly during inspection. Shoes retained substantial lining and no visible fluid contamination was found.*

- Brake booster replaced.
- Master cylinder replaced.
- Brake system bled.
- Booster pushrod measured with a dedicated adjustment gauge; loose locknut and incorrect rod length were identified, corrected, and secured.
- Front rotors inspected with no obvious glazing or damage; front pads approximately 70% remaining.
- Rear brake assemblies inspected; shoes approximately 70% remaining with no visible wheel-cylinder leakage or fluid contamination.
- Both rear brake drums replaced because the original drums were significantly scarred.
- Rear brakes adjusted and the complete brake system bled again.
- Parking brake tested and working properly.
- No recurrence of the earlier front-brake overheating condition during subsequent road testing.

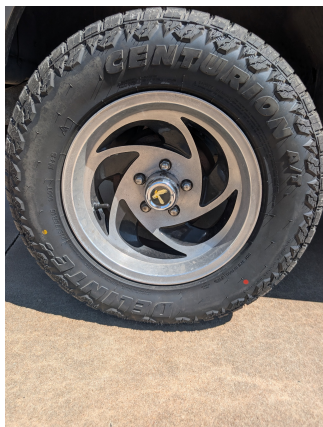
*New OEM-size 215/75R15 all-terrain tire installed on the Jeep.*

- Original tires dated from 2002-2004 and exhibited age-related tread-groove cracking despite good tread depth.
- All four aged tires removed.
- Four new OEM-size 215/75R15 All-Terrain tires installed.
- Tire pressure set to 32 PSI cold per vehicle door placard.

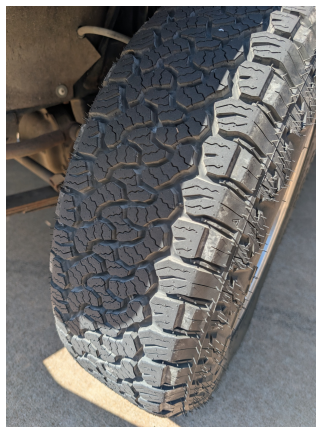
*Close-up of the new all-terrain tread.*

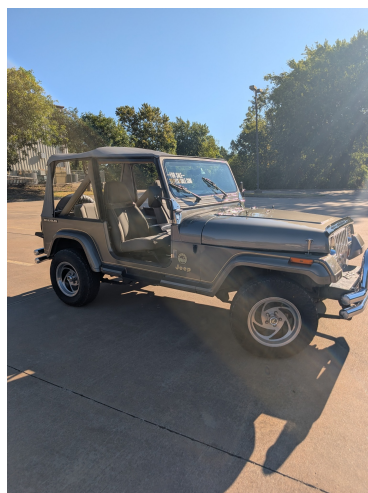
*Completed Jeep following reconditioning, new tires, shocks, and alignment.*
