**Agenda Meeting Notes 6/5/2021**  
**Updated 6/7/2021**  
**[Navasotaflooding.com](http://Navasotaflooding.com)**

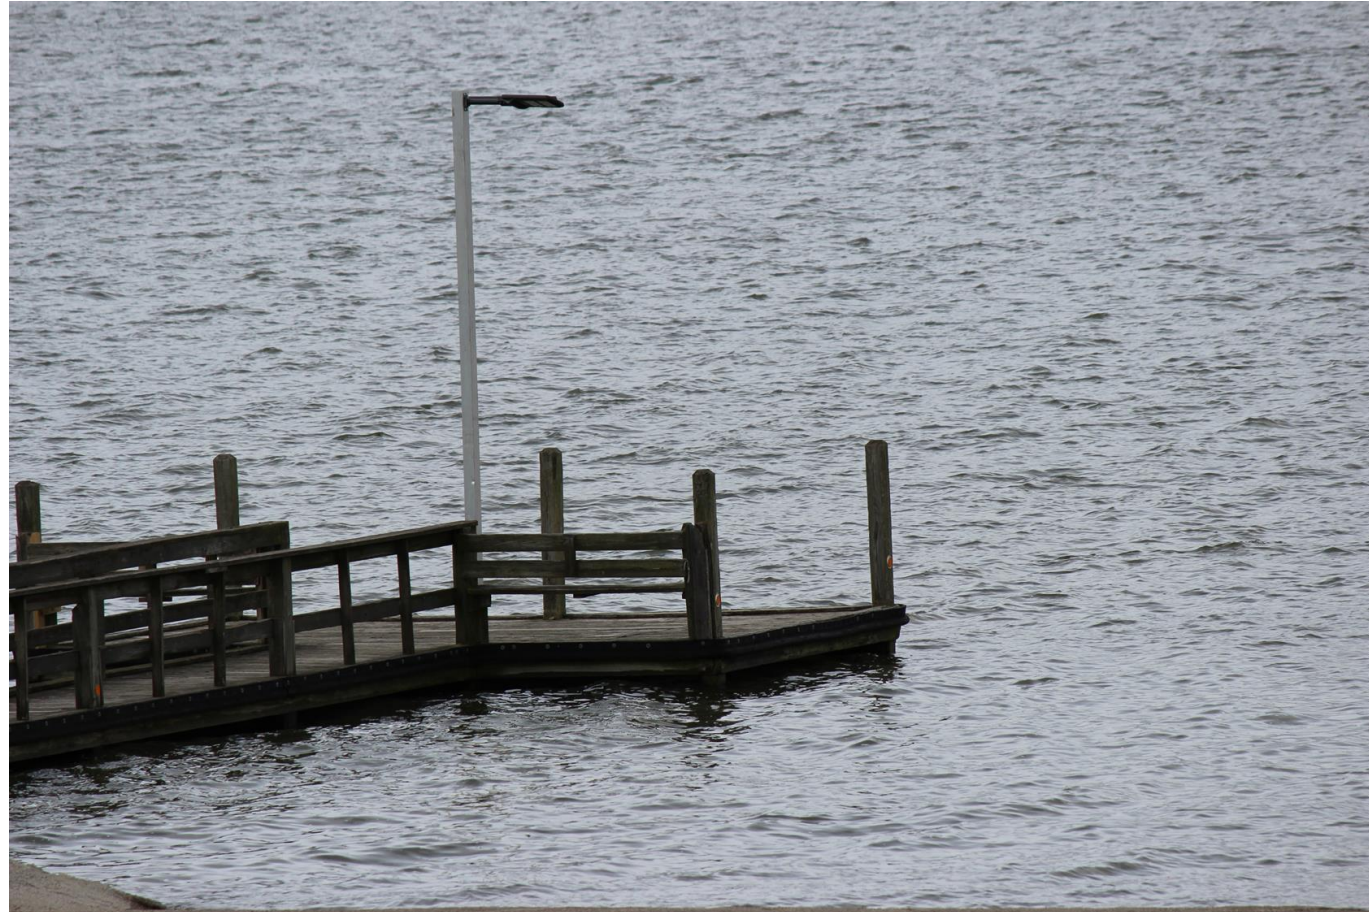
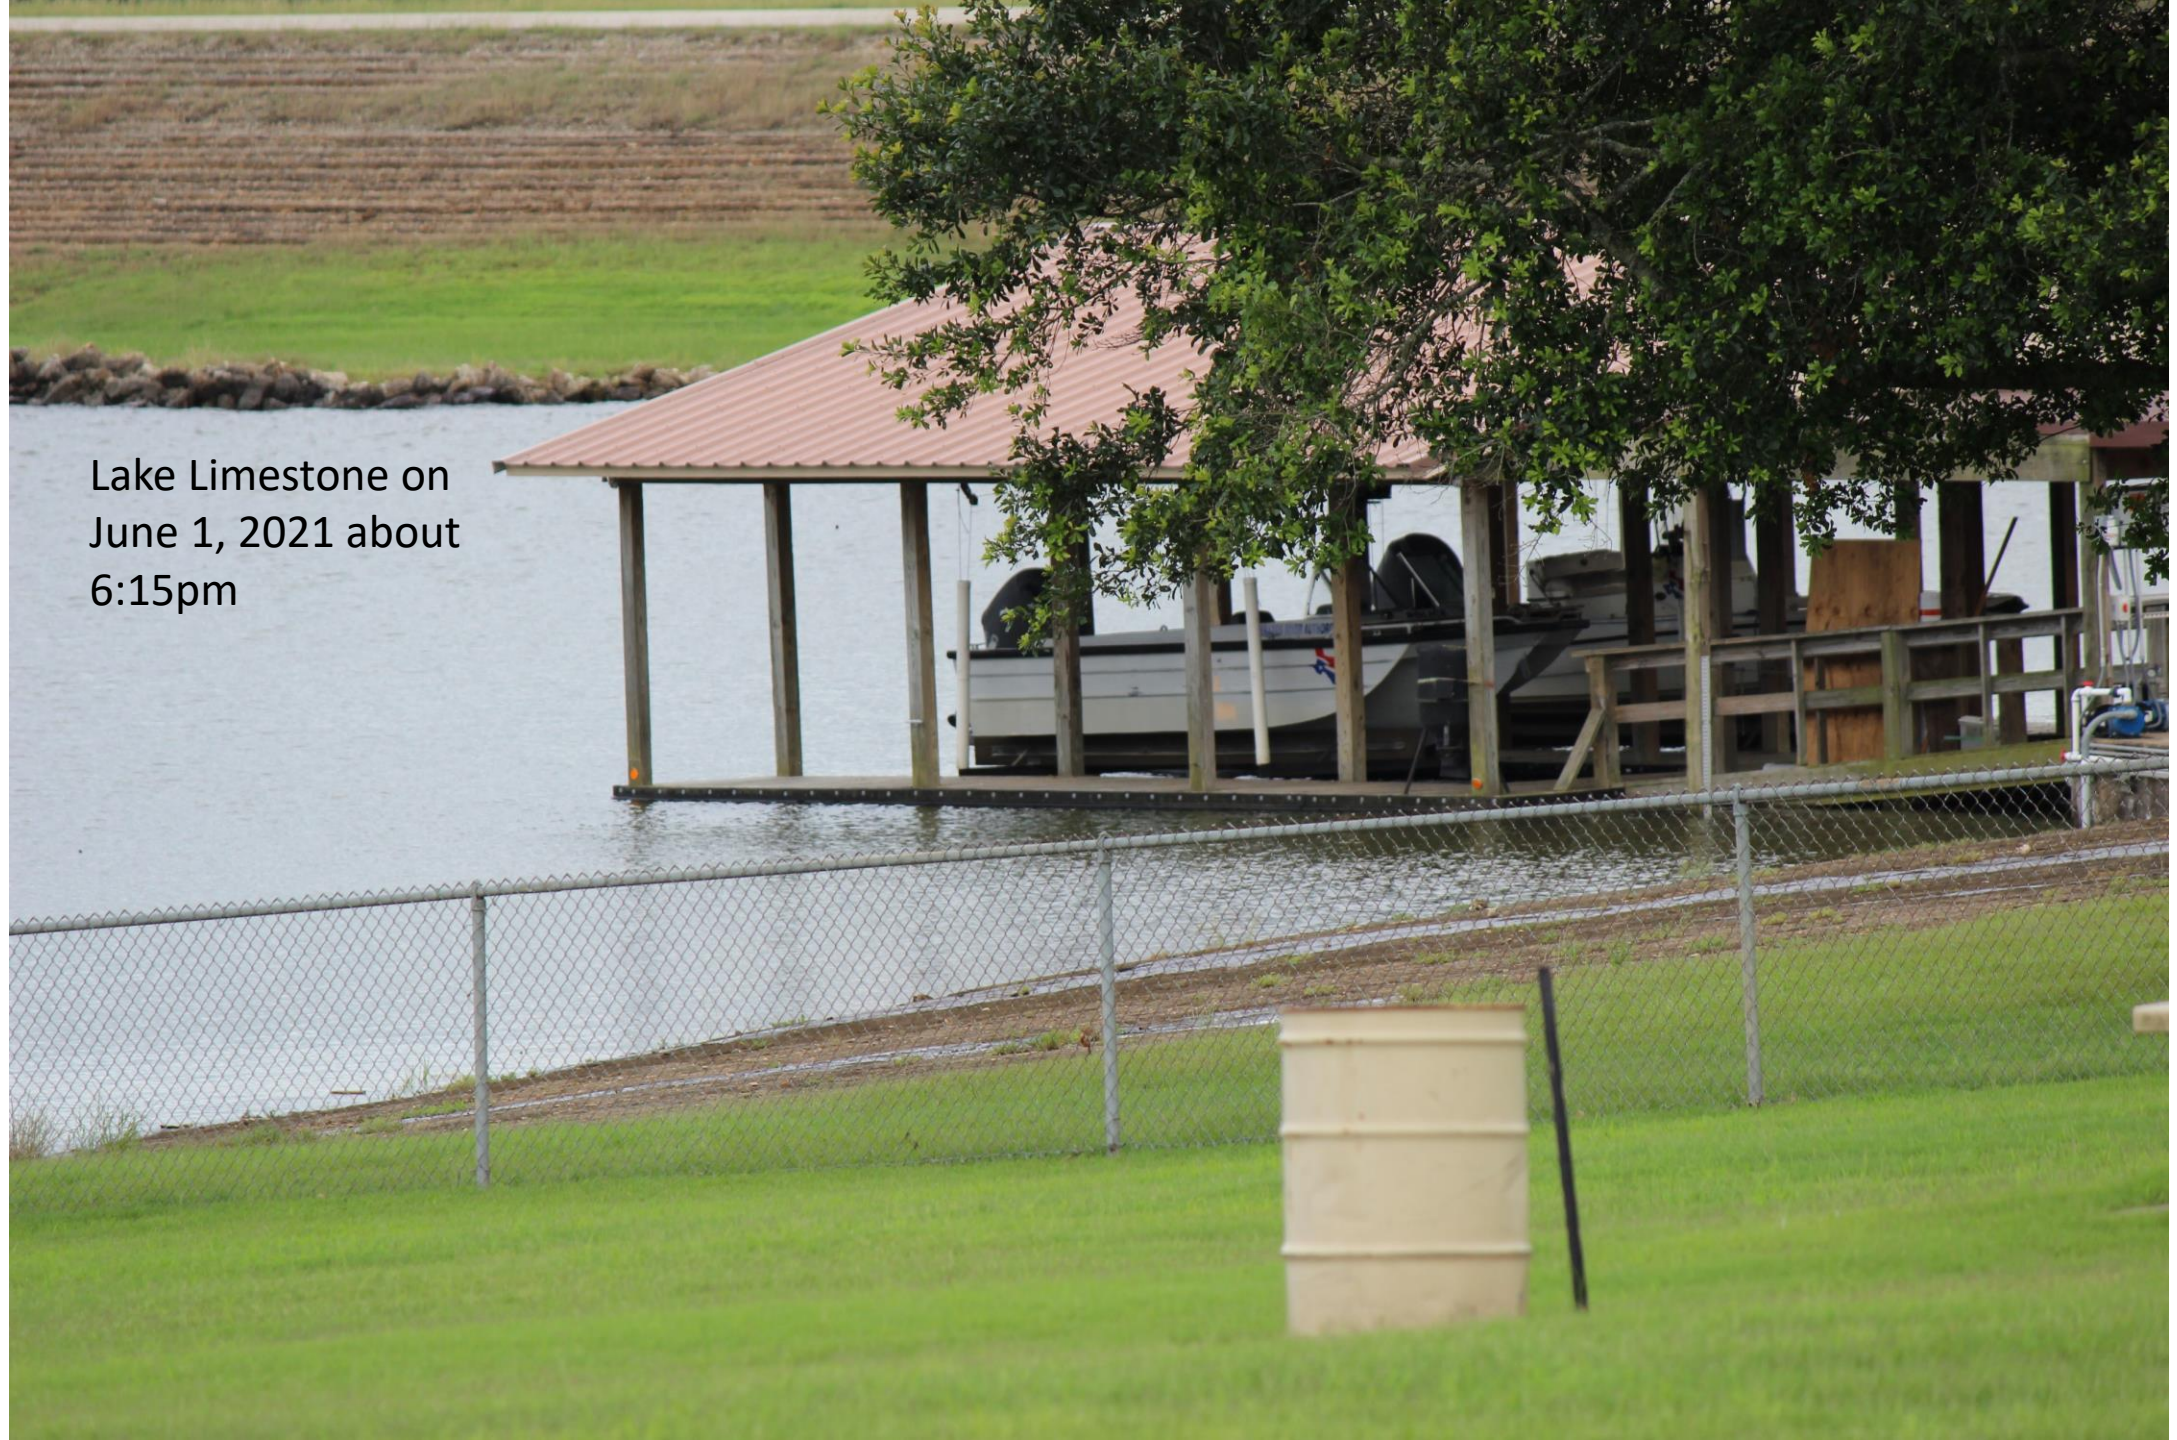
The 2 pictures that follow were taken at the dam at Lake Limestone on June 1, 2021 about 6:15pm during the height of the June 2021 flood notice these docks are still not flooded while land downstream is totally inundated!

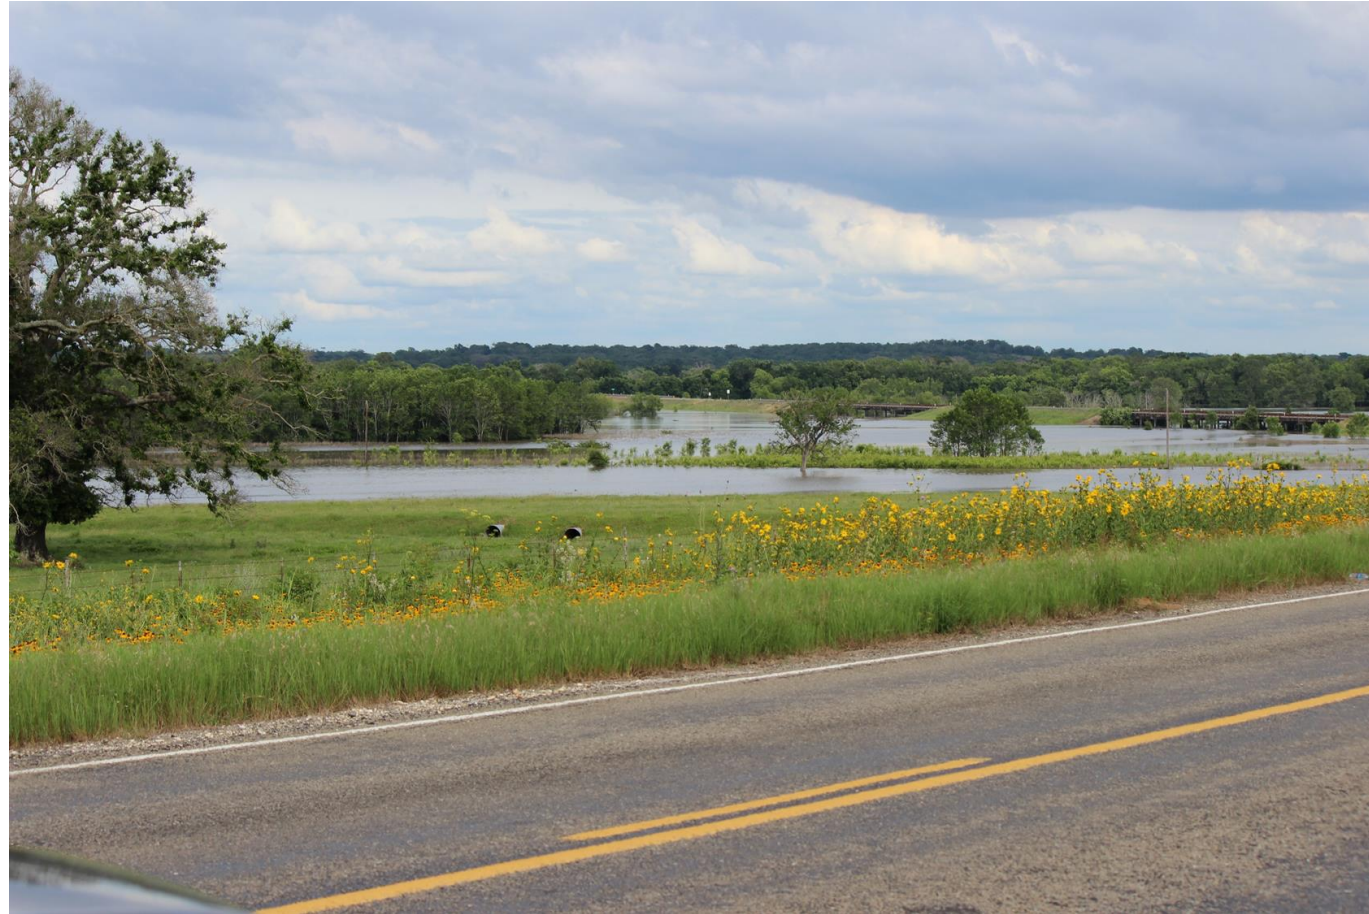
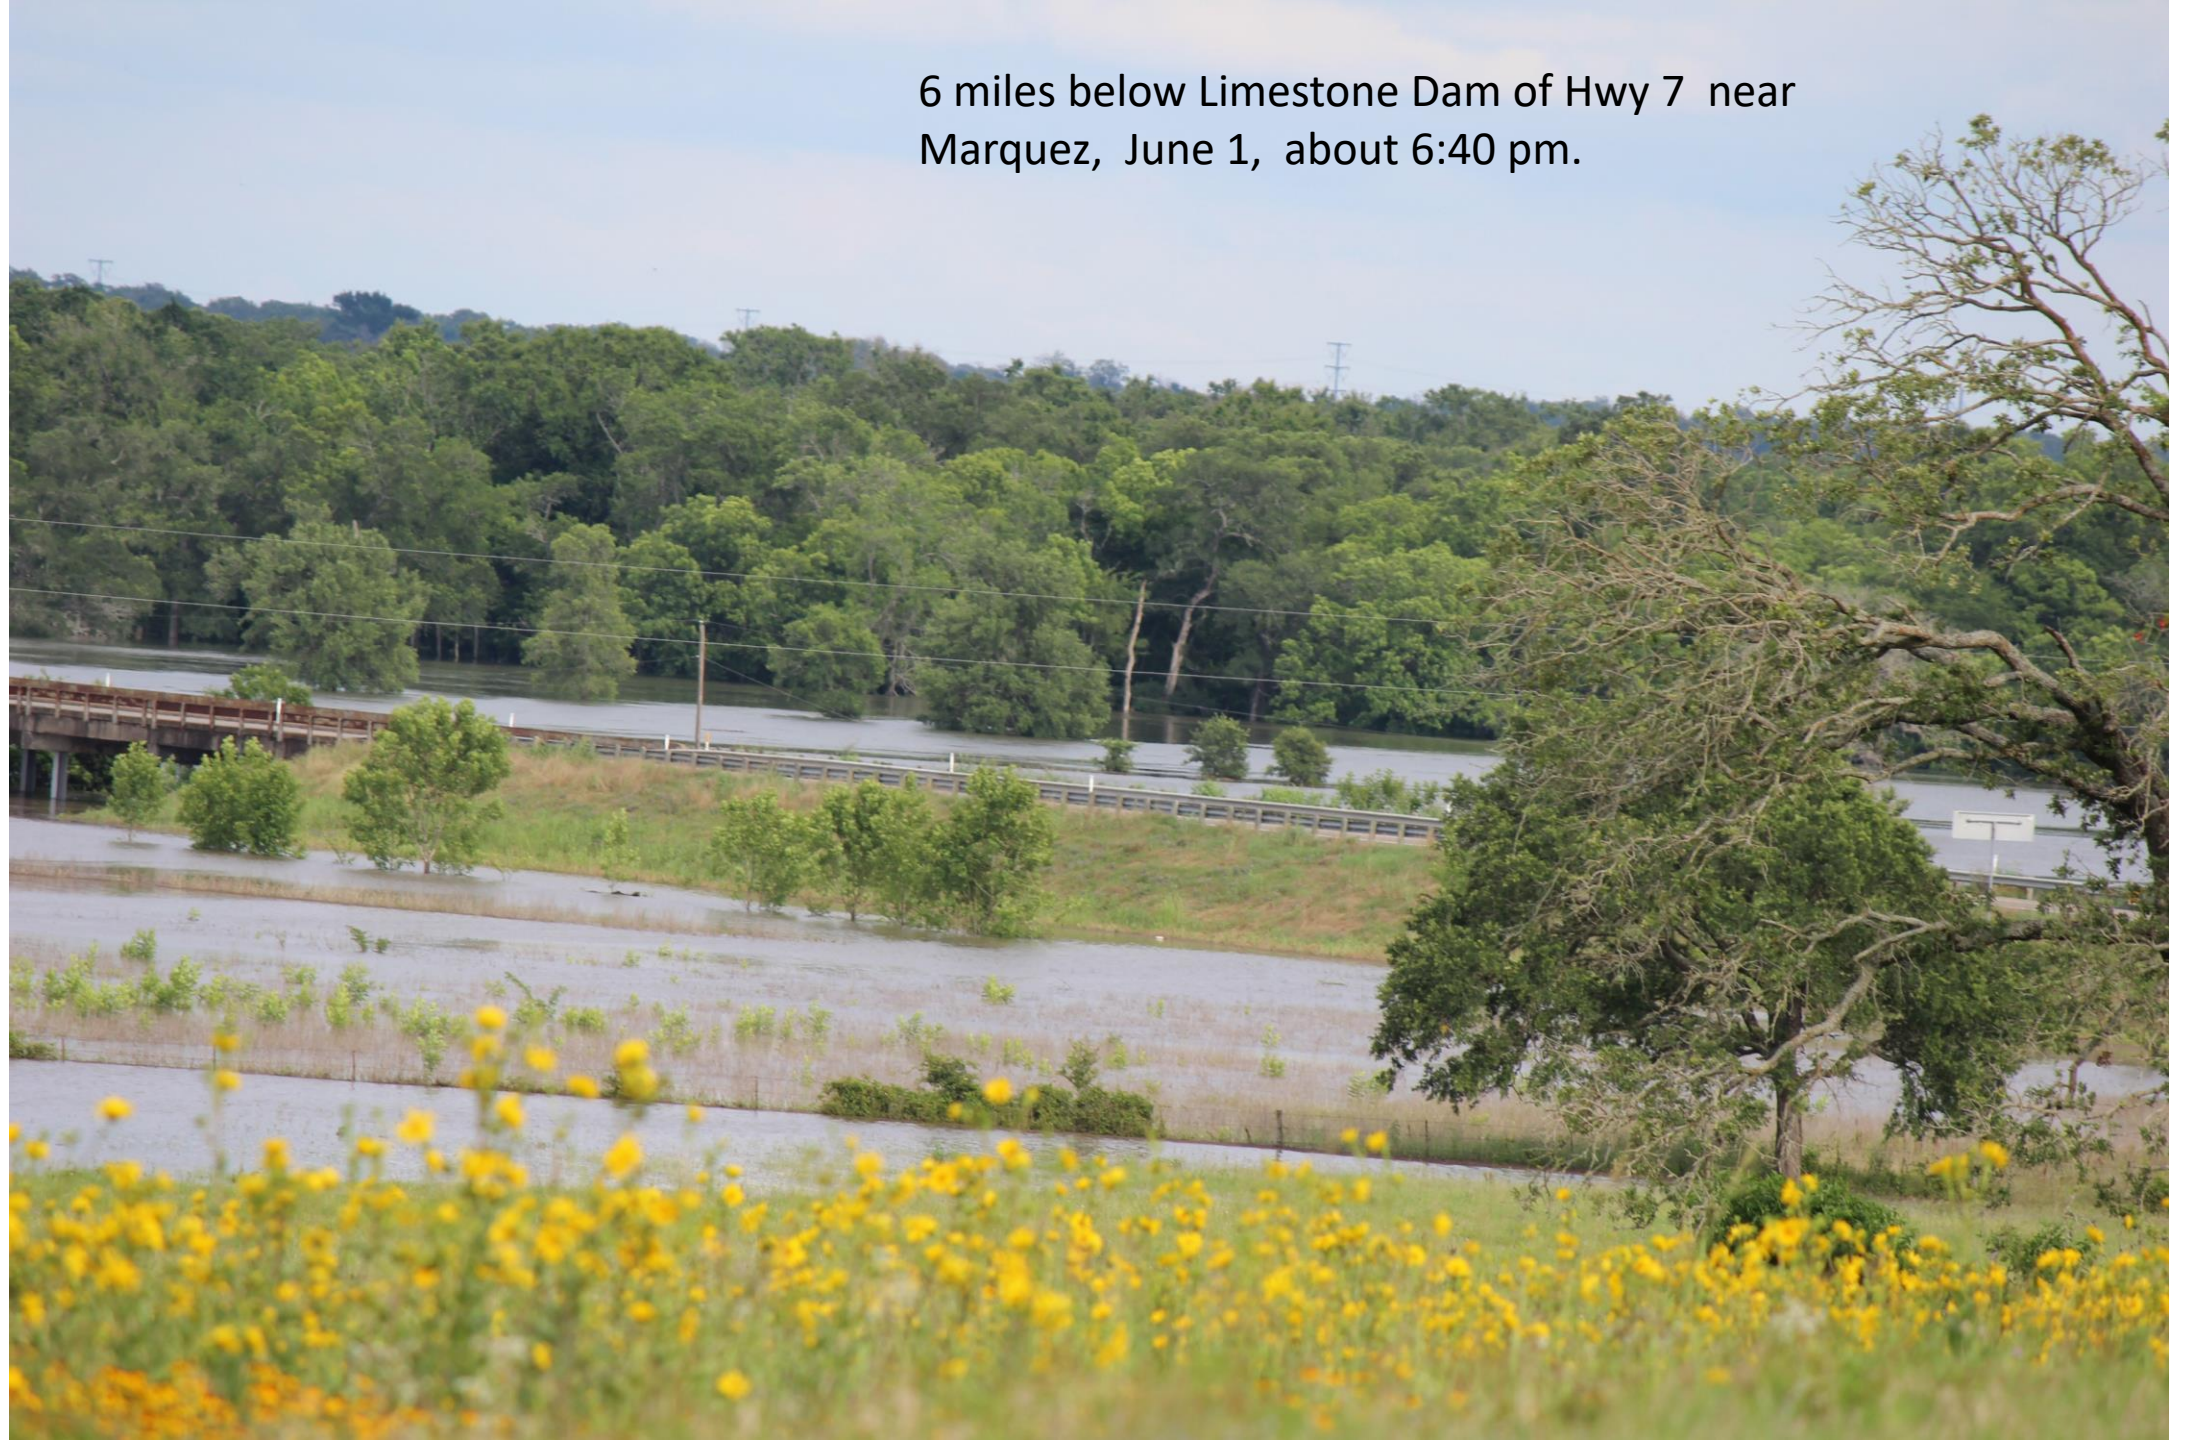
These pictures were taken 6 miles below Limestone Dam of Hwy 7 near Marquez, June 1, about 6:40 pm. They depict the massive water releases from Limestone into 1000's of acres just below the dam also covering gas wells in this area. These photos are proof that the water flooding south of HWY 7 is NOT from rain run off from the downstream counties. It is totally from the rain fall upstream of the dam.

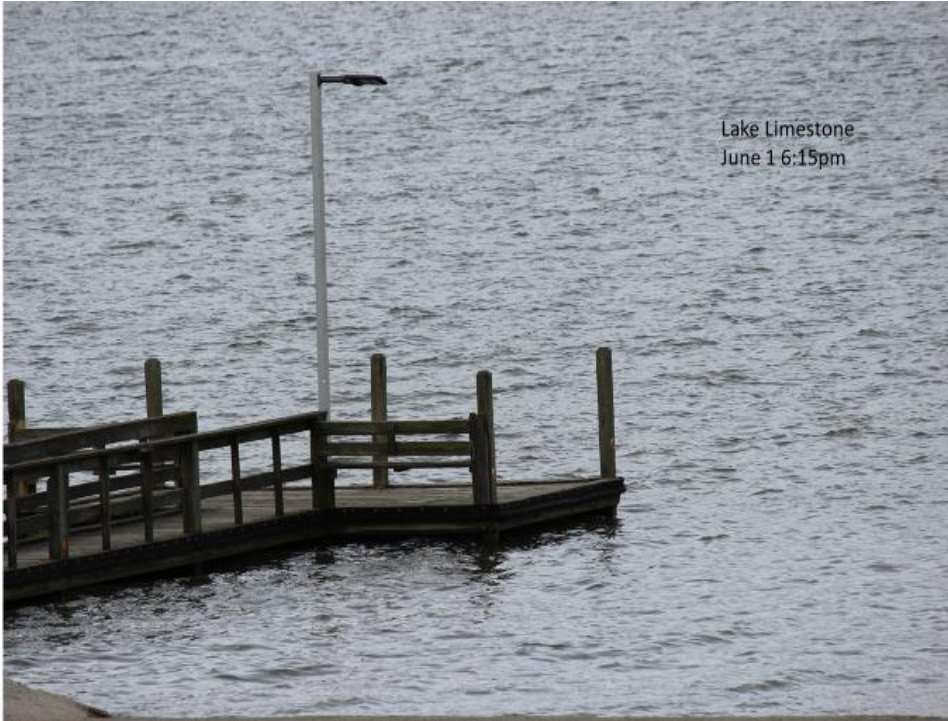
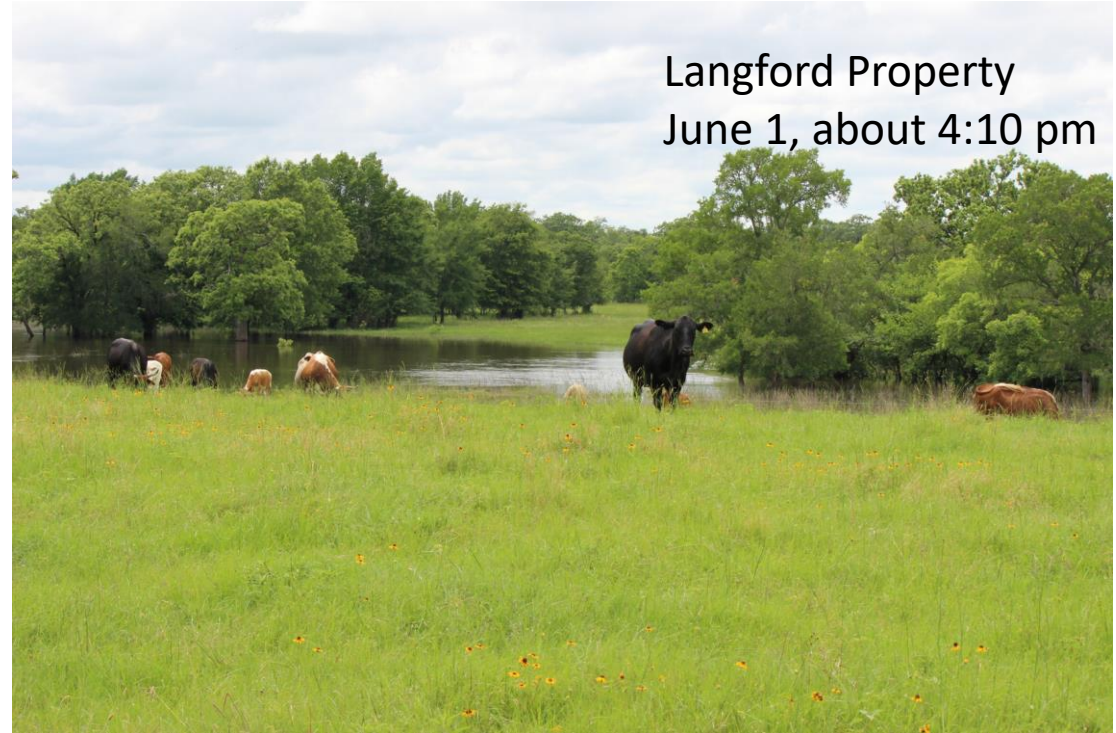
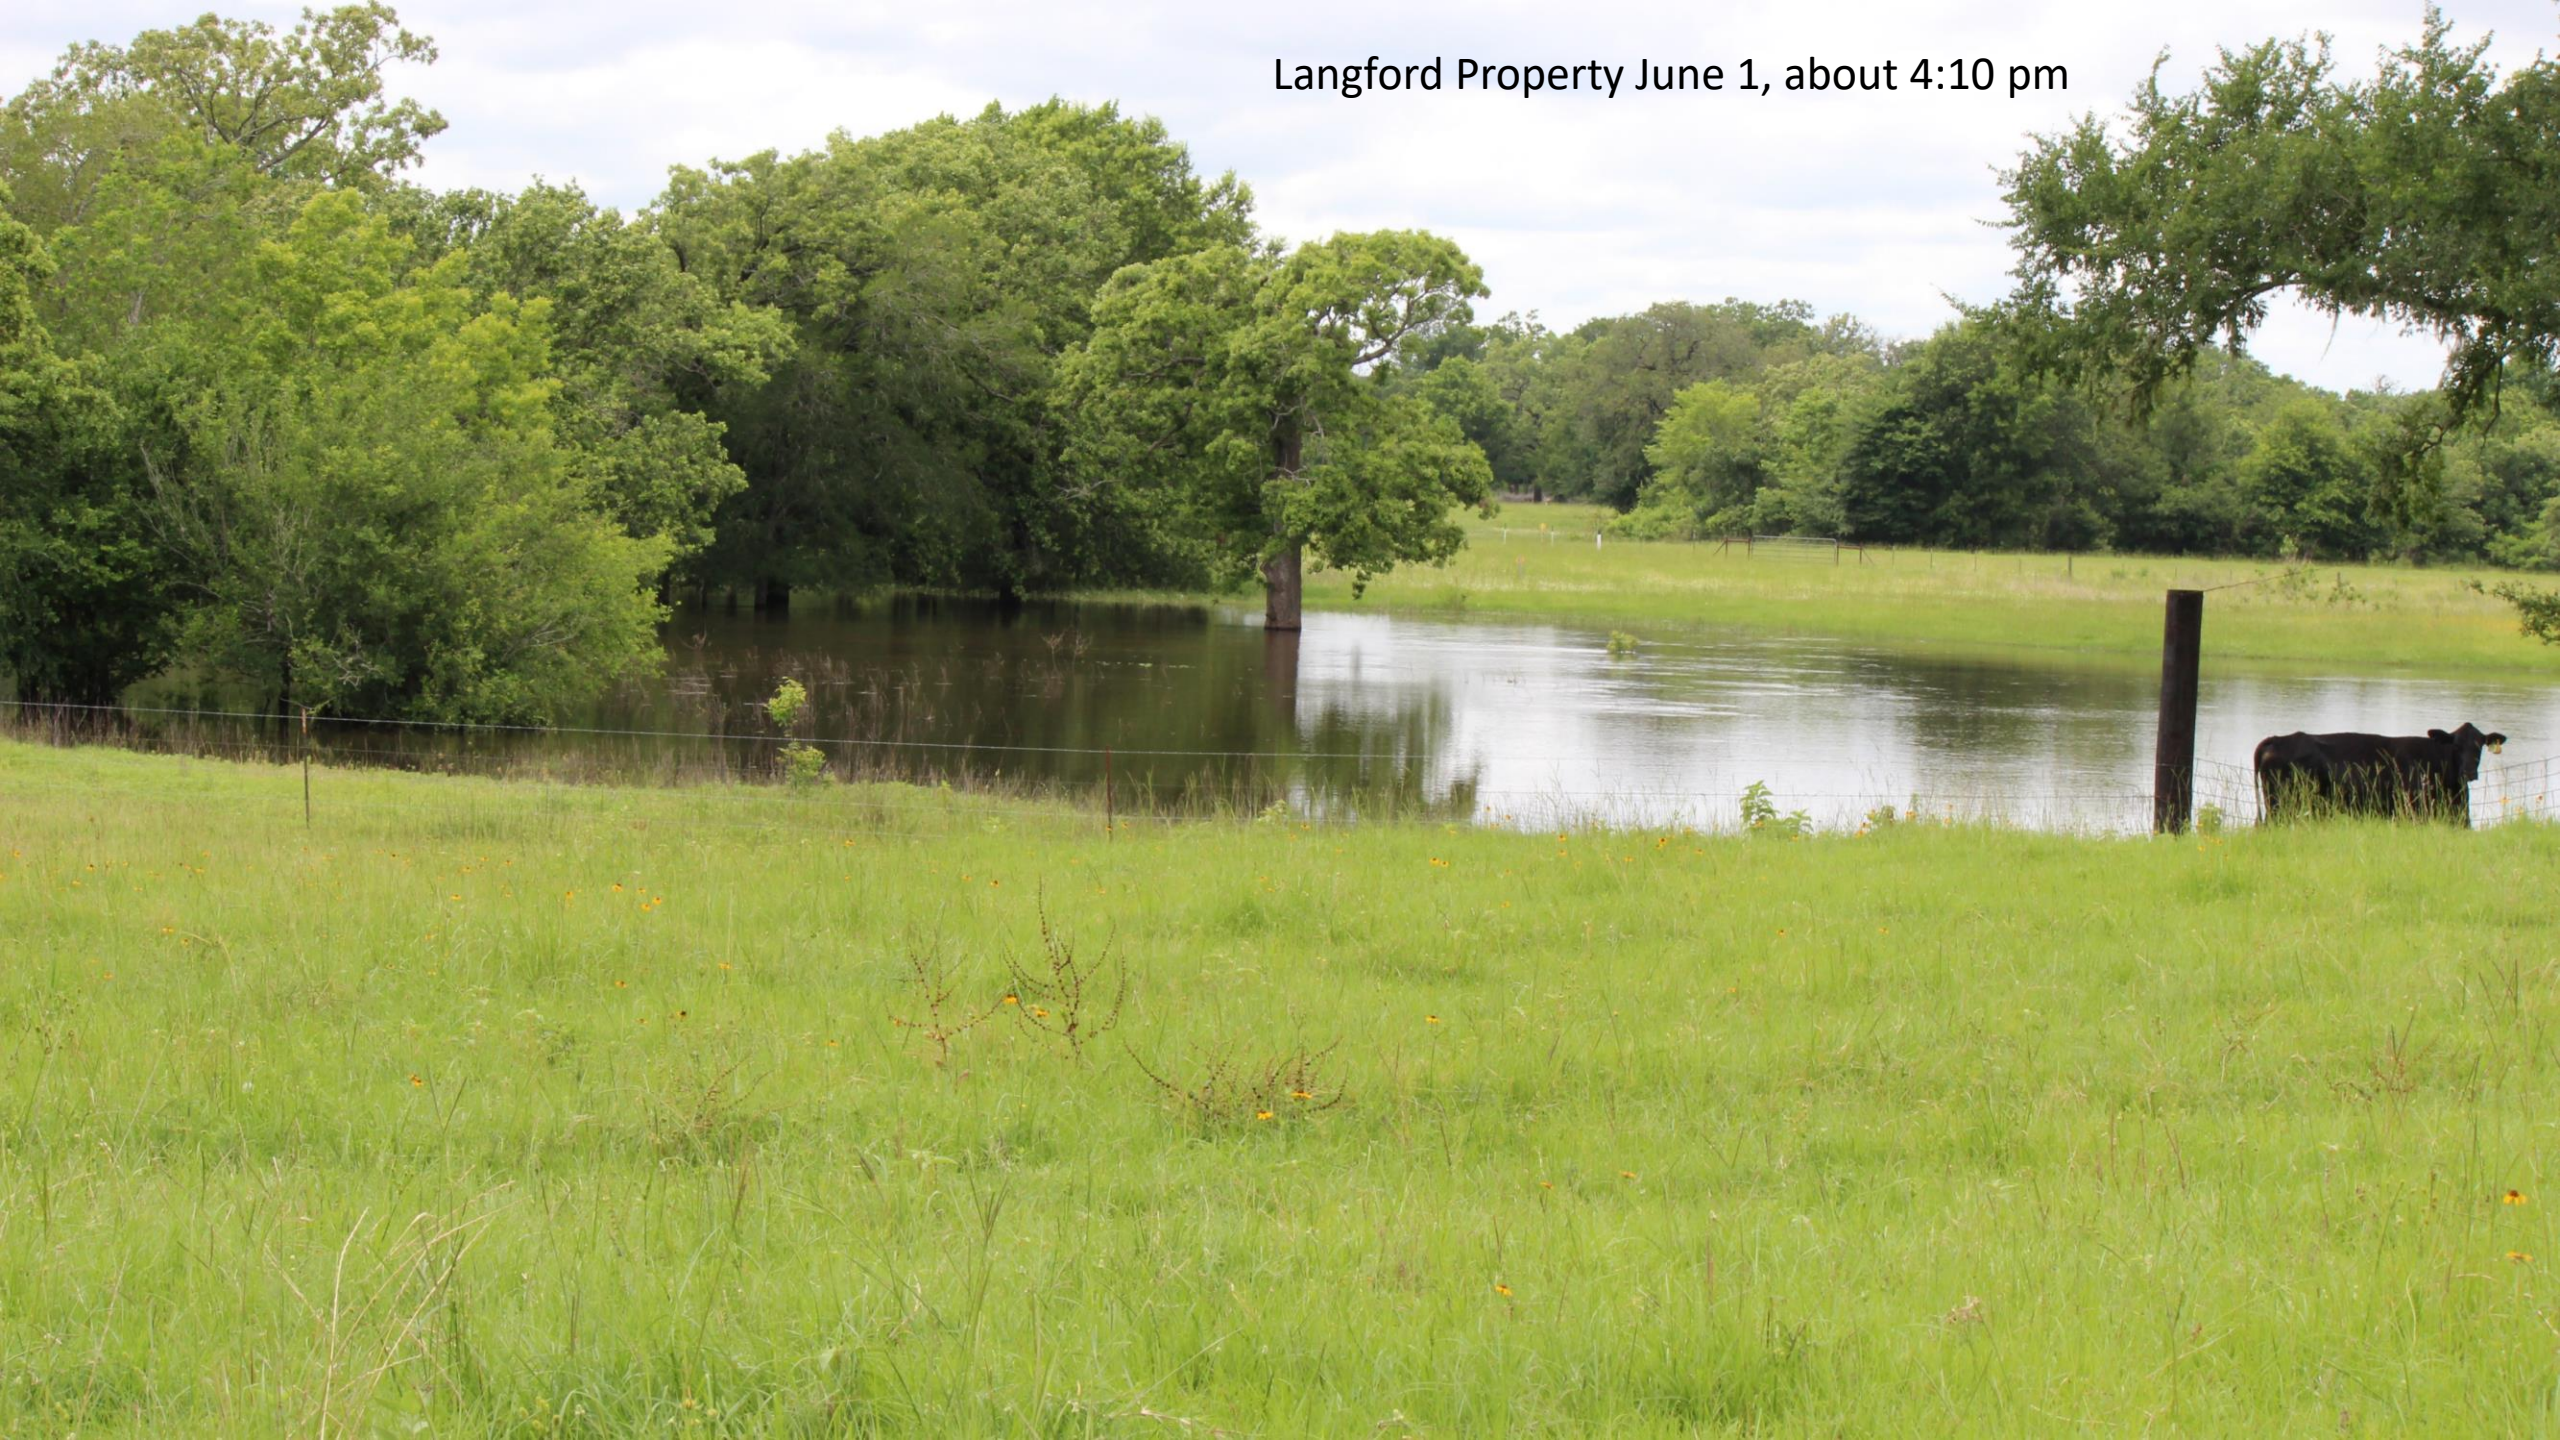
Langford Property June 1, about 4:10 pm

This is a picture showing Limestone conditions (left) while a landowner in Grimes County is already having property inundated and cattle confined to 76 acres of the about 400 available normally. The massive releases shown above have not reached here yet. By Noon on June 6, 2021, all but the 76 of the 400 acres were TOTALLY covered with about 3 feet of water. All from the Limestone water releases.

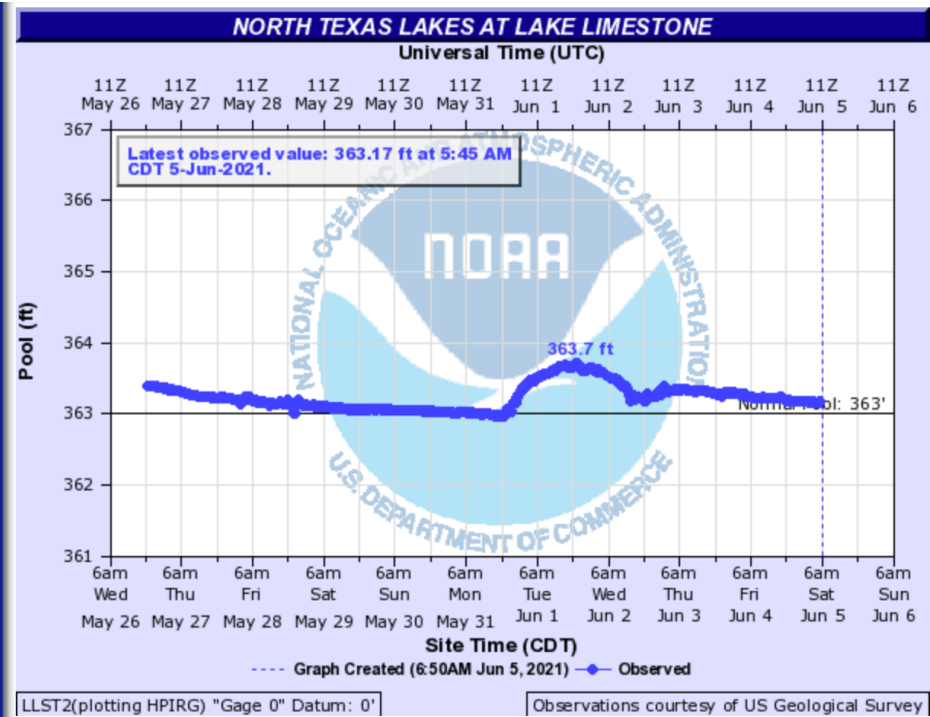
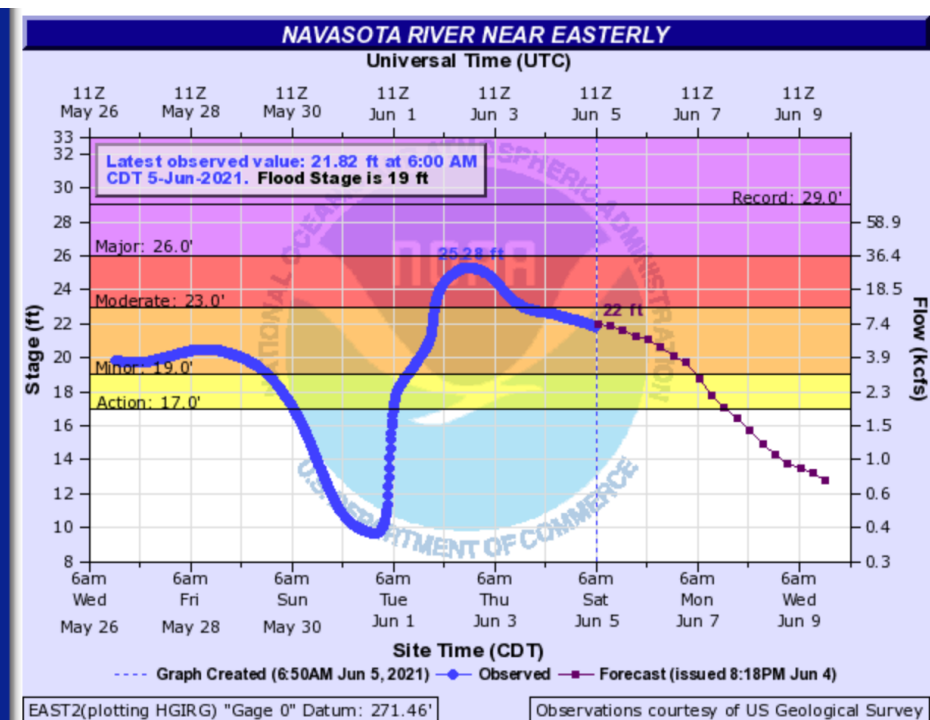
This slide shows the levels at the lake are only rising about 8 inches while the levels at Easterly are increasing about 15 FEET.

The 2 bars to the right of the graphs show the historic crests of the lake and the river. While the show no flooding conditions. The bar for the Easterly Gauge shows 5 serious flooding conditions since 4/2021 to 1/2021 which does not include 6/2021 flooding.

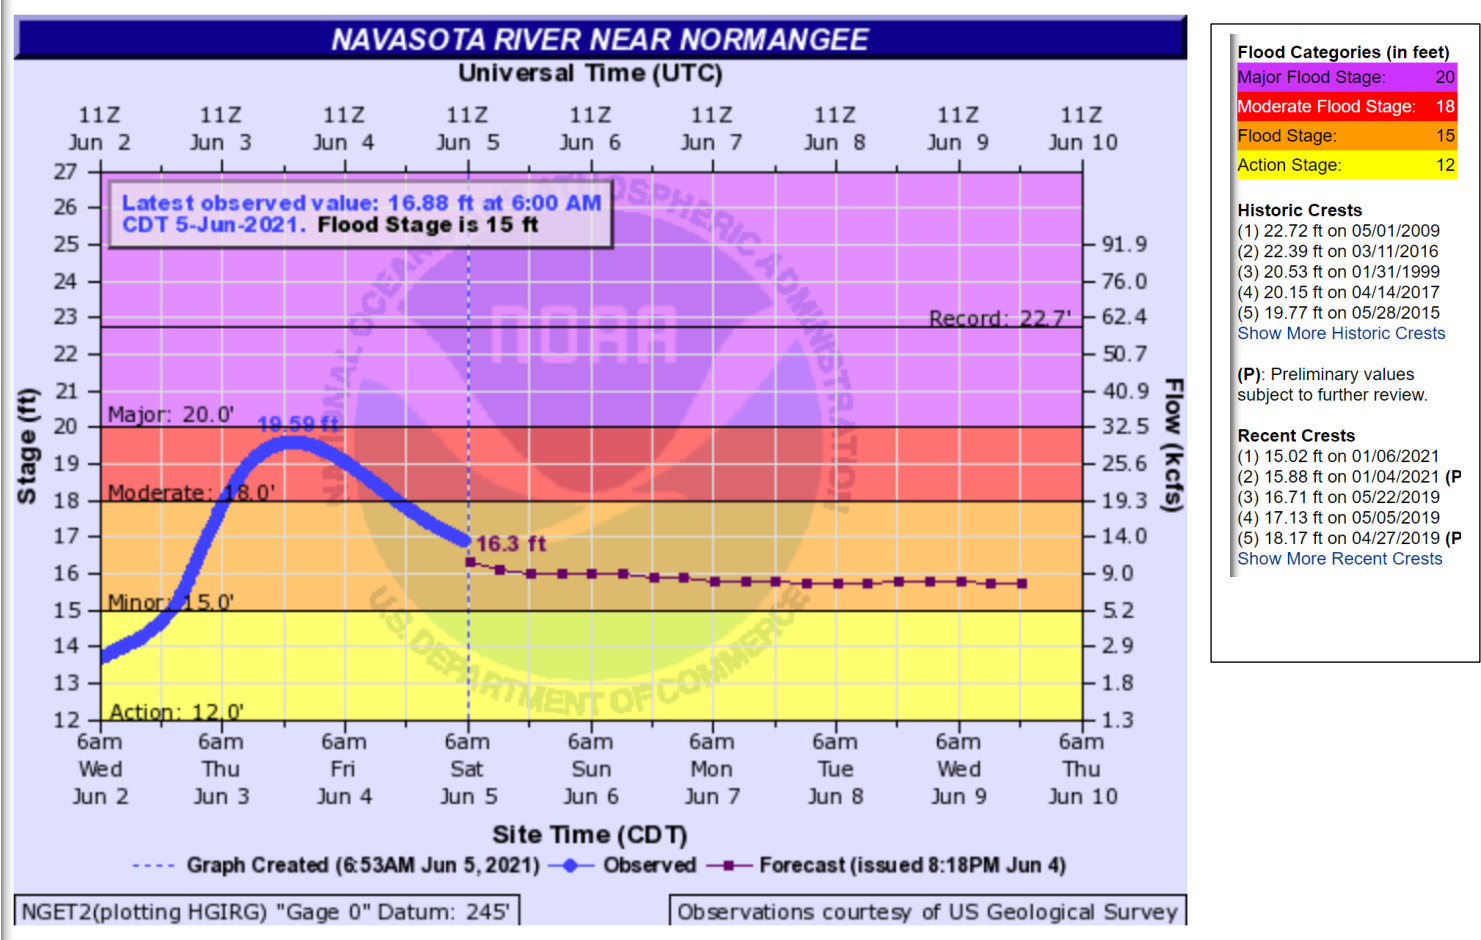
This slide is of the Normangee Gauge at the same time of the previous slides.

This slide shows 5-foot water rise but the prior week the river level was about 2.5 feet which yields about a 17-foot rise now.

When the gauge at Normangee gets to 12 feet the properties below begin to be unusable.
