Inspection Report

Property Address:
123 Main St.
Edmond Oklahoma 73012

Timber and Stone Home Inspection

Date: 8/1/2017	Time: 0800	Report ID: 8-1-2017-1
Property: 123 Main St. Edmond Oklahoma 73012	Customer: Mr. Joe Smith	Real Estate Professional: John Doe

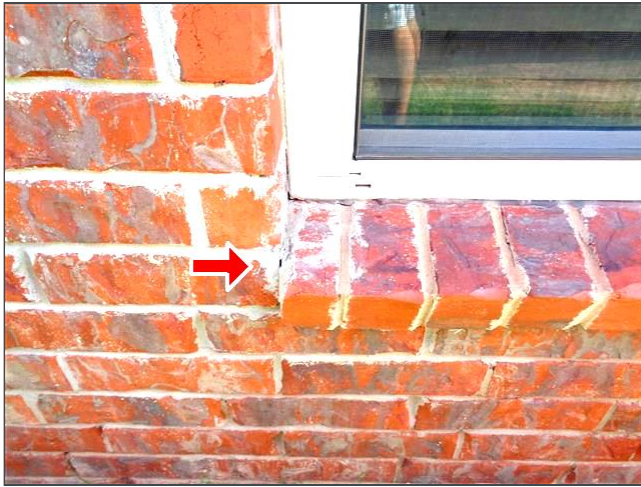
2.2 Item 1(Picture)

The wood trim weathered at most windows. This is a maintenance issue and is for your information. I recommend repair as desired.

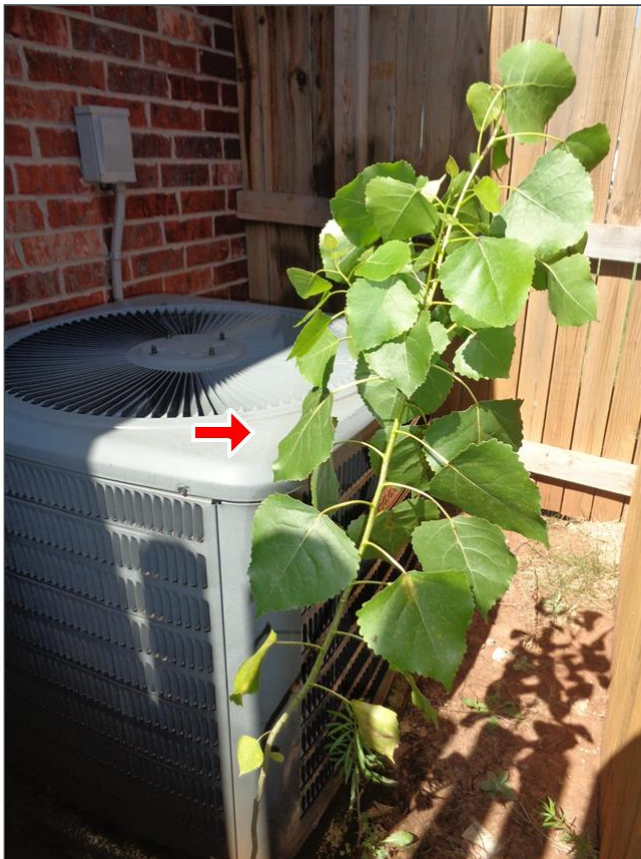
2.4 Item 1(Picture)

Recommend trimming all vegetation that is touching the house.

Recommend removing the vegetation growing adjacent to the AC unit.

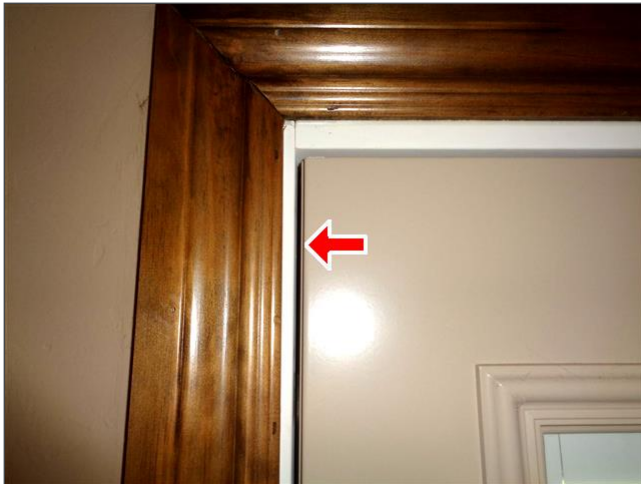
4.5 Item 1(Picture)

The Entry door reveals daylight when latched at areas missing weather-stripping at the Living Room. This is a maintenance issue and is for your information. I recommend repair as desired.

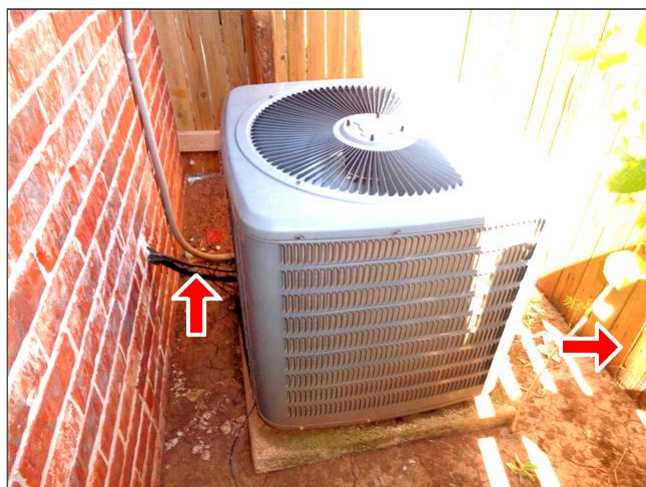
8.8 Item 1(Picture)

Condensing unit on the N. side of the house. Recommend re-insulating the suction line. There is a gate that is occluding access to unit. Recommend removing gate. Recommend removing the tree on the right side of this picture.

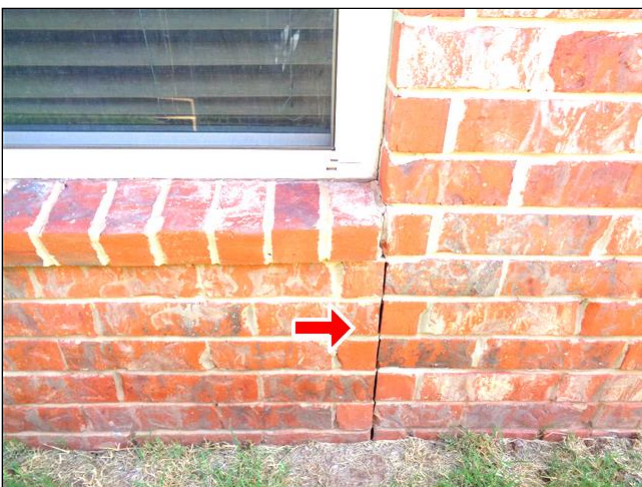
2.0 Item 1(Picture)

2.0 Recommend expansion joints be caulked. Possible water penetration area.

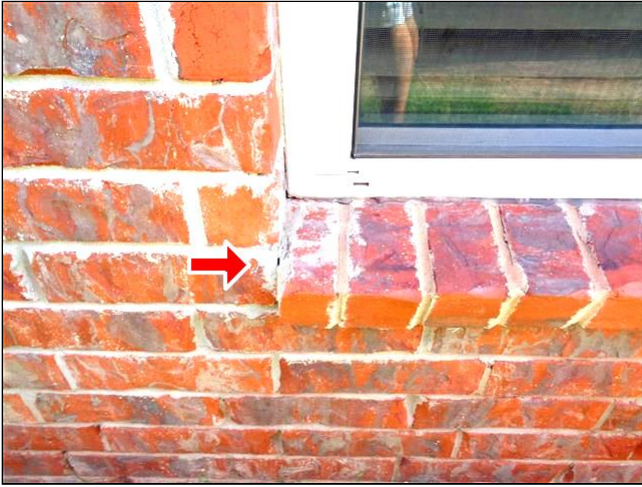
2.2 Item 1(Picture)

2.2 The wood trim weathered at most windows. This is a maintenance issue and is for your information. I recommend repair as desired.

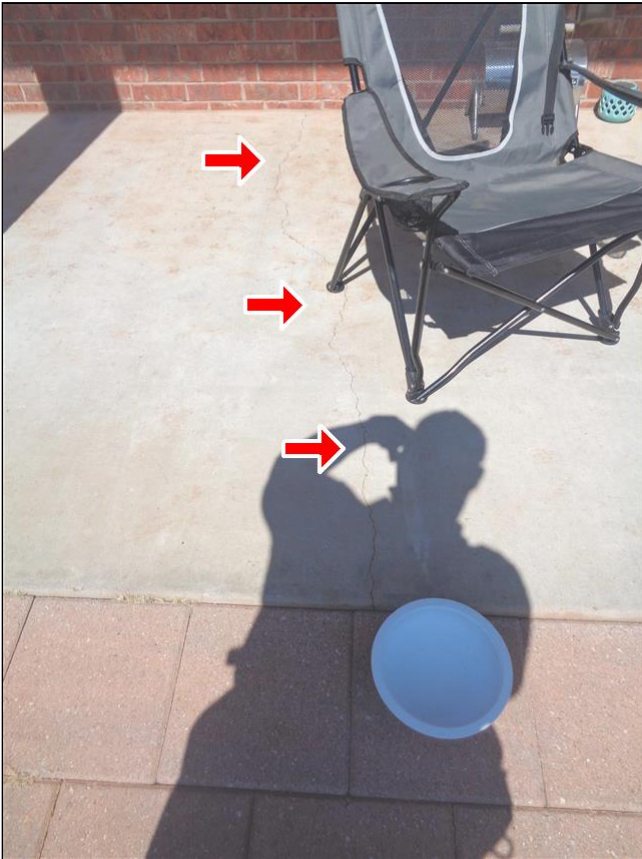
2.3 Item 1(Picture)

2.3 Recommend caulking cracks in back patio. This will help prevent further cracking and deterioration of the patio surface.

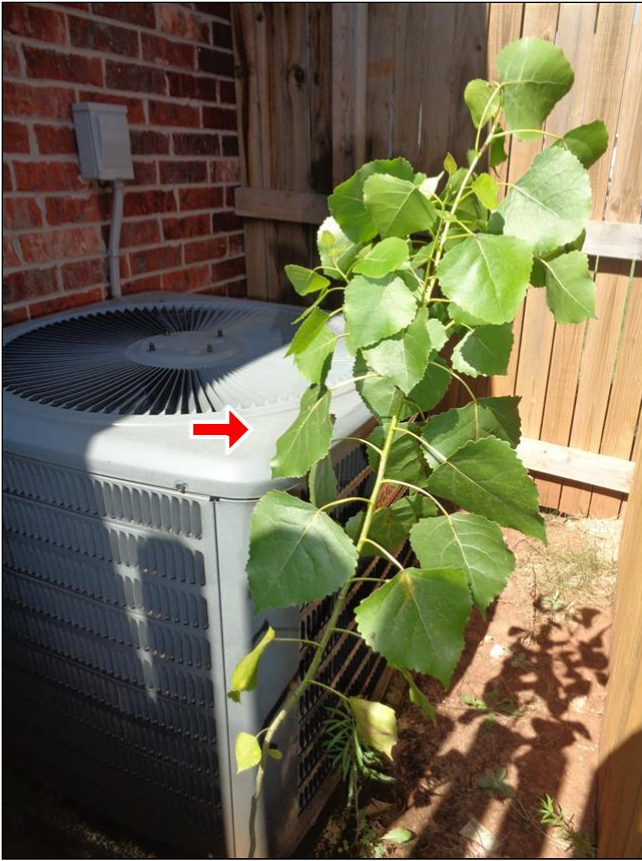
2.4 Item 1(Picture)

2.4 Recommend trimming all vegetation that is touching the house.

Recommend removing the vegetation growing adjacent to the AC unit.

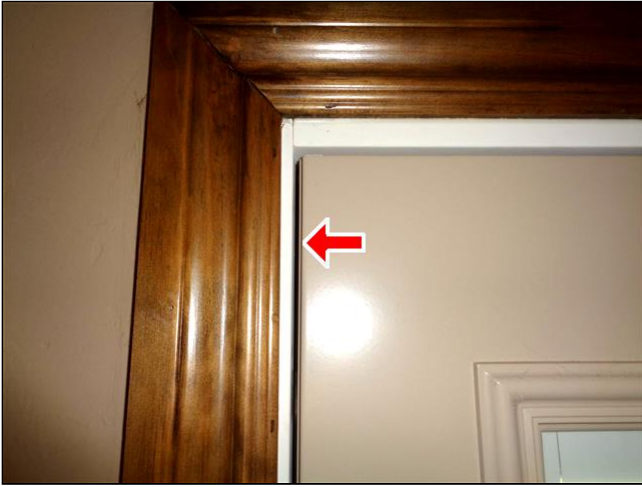
4.5 Item 1(Picture)

4.5 The Entry door reveals daylight when latched at areas missing weather-stripping at the Living Room. This is a maintenance issue and is for your information. I recommend repair as desired.

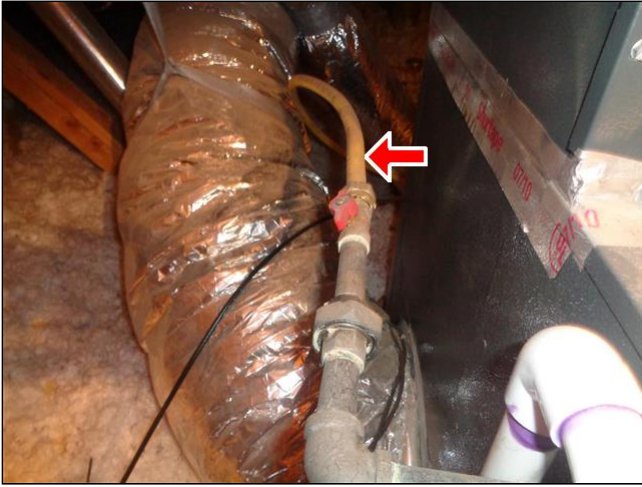
6.4 Item 1(Picture)

6.4 CSST (corrugated stainless steel tubing) is used in the house. There is a junction box cover in the garage that shows this system is grounded and bonded. It is always a good idea to have it checked by a licensed electrician.

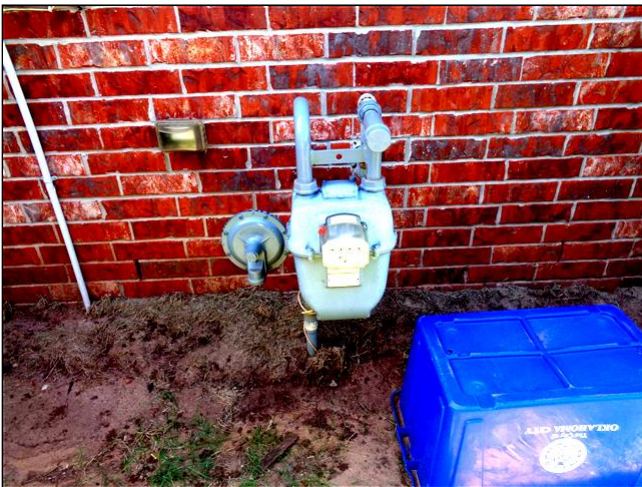
6.5 Item 1(Picture)

6.5 Natural gas distribution source. Main shut off to house on the backside.

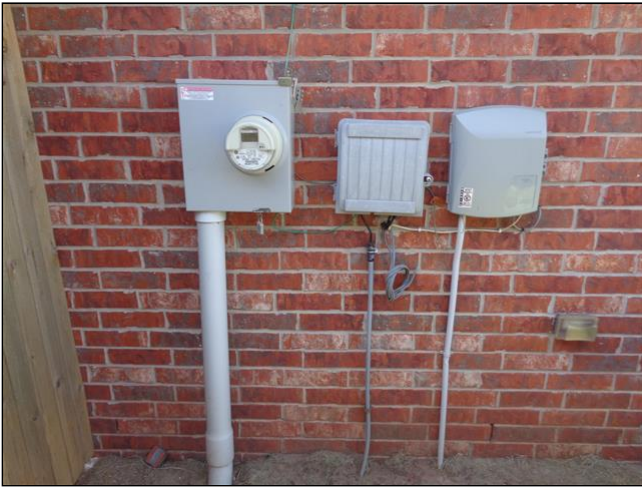
7.0 Item 1(Picture)

7.0 OG&E meter on far left.

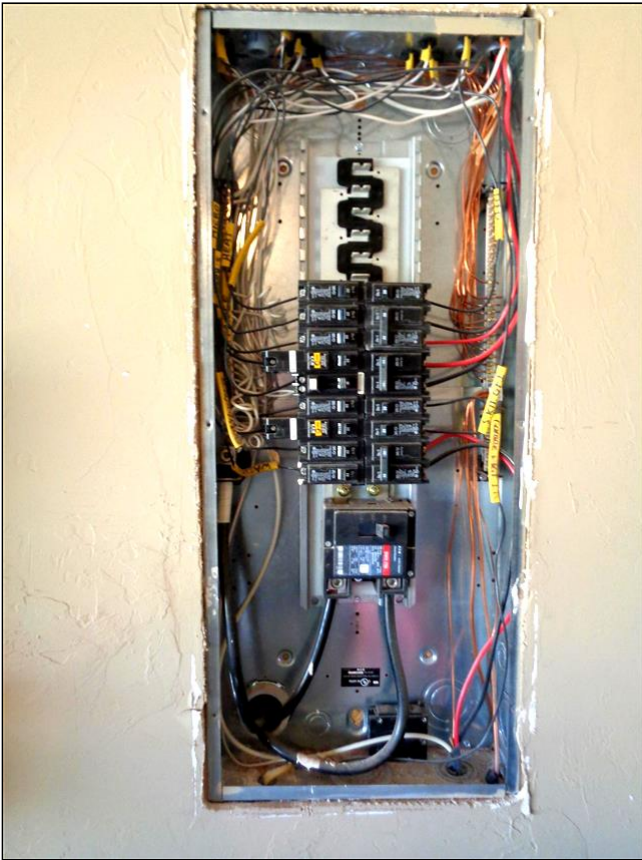
7.7 Item 1(Picture)

7.7 Distribution panel is located in the garage on the N. wall.

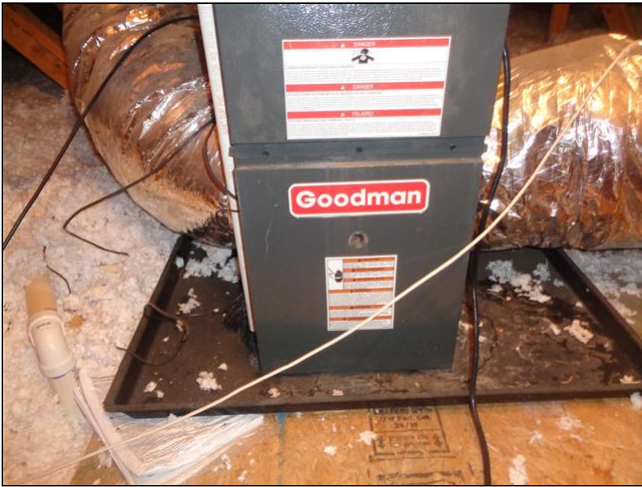
8.0 Item 1(Picture)

8.0 (1) Heating unit and air handler are in the attic.

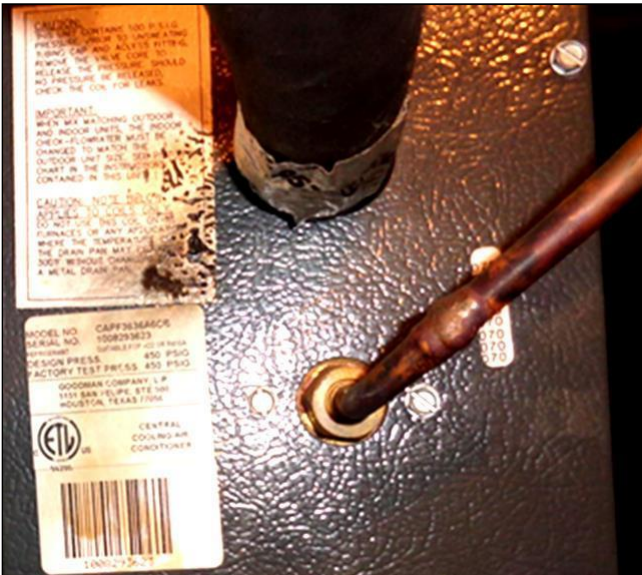
8.0 Item 2(Picture)

8.0 (2) Serial number.

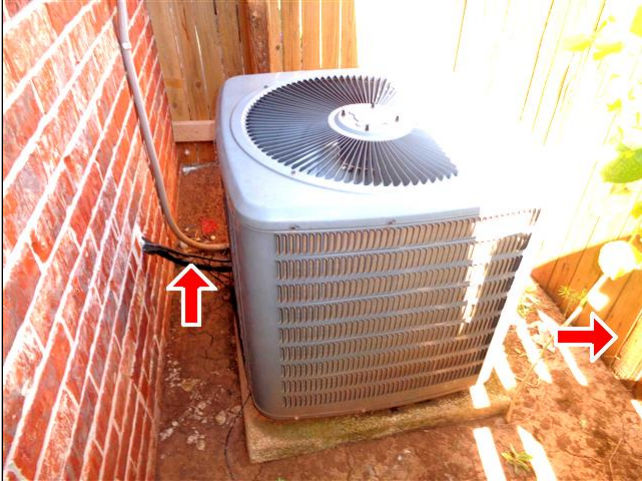
8.8 Item 1(Picture)

8.8 Condensing unit on the N. side of the house. Recommend re-insulating the suction line. There is a gate that is occluding access to unit. Recommend removing gate. Recommend removing the tree on the right side of this picture.
