CHAPTER 2

CONSTRUCTION

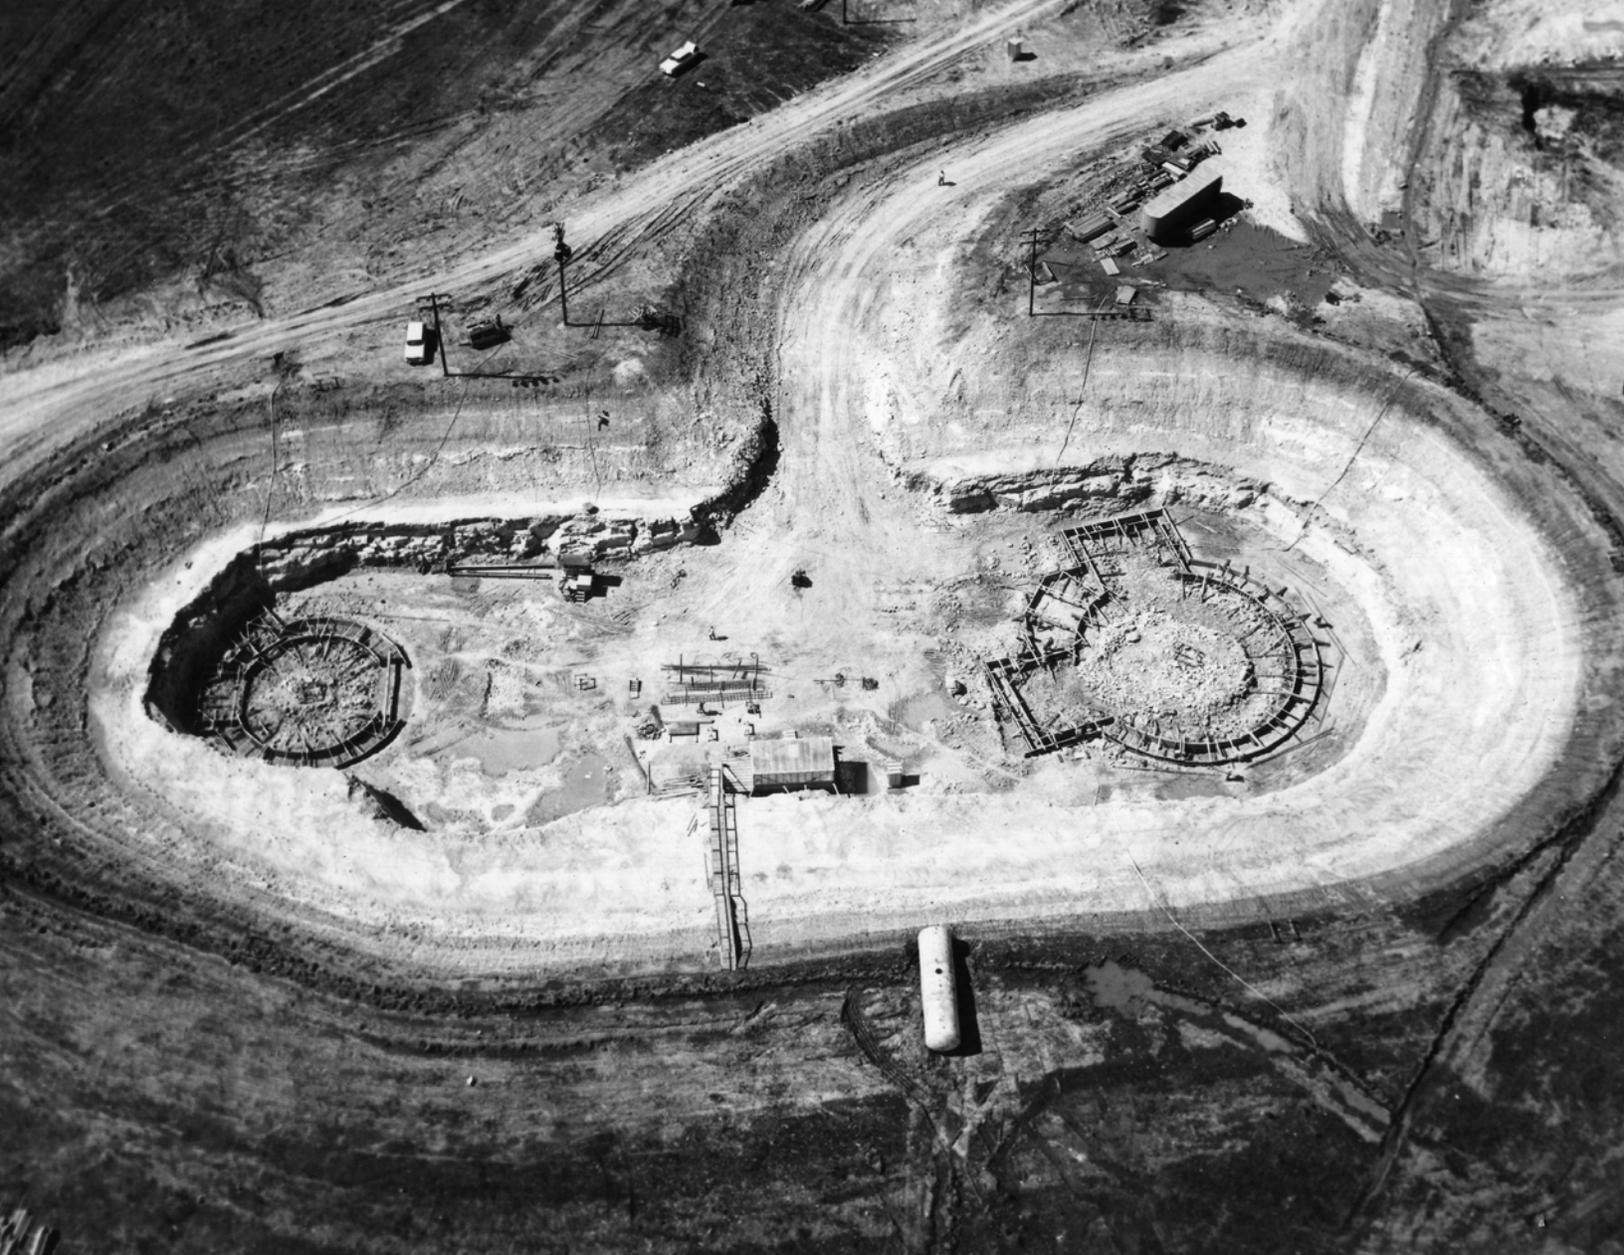
▲ The “bathtub” with outline of the silo (right) and control center (left).

Construction of the launch sites began with the excavation of what was referred to as the “bathtub.” The bathtub was a large oblong cut into the ground, typically some 400 feet (120 m) long, 200 feet (60 m) wide, and about 40 feet (12 m) deep.⁹ The actual size depended to some extent on the difficulty encountered in digging. For example, at hard rock sites the bathtub was often much smaller.¹⁰ The major components of the complex—the access portal, blast lock, control center and silo—were all located within the bathtub. Once the bathtub was completed, further excavation of the silo and control center began.

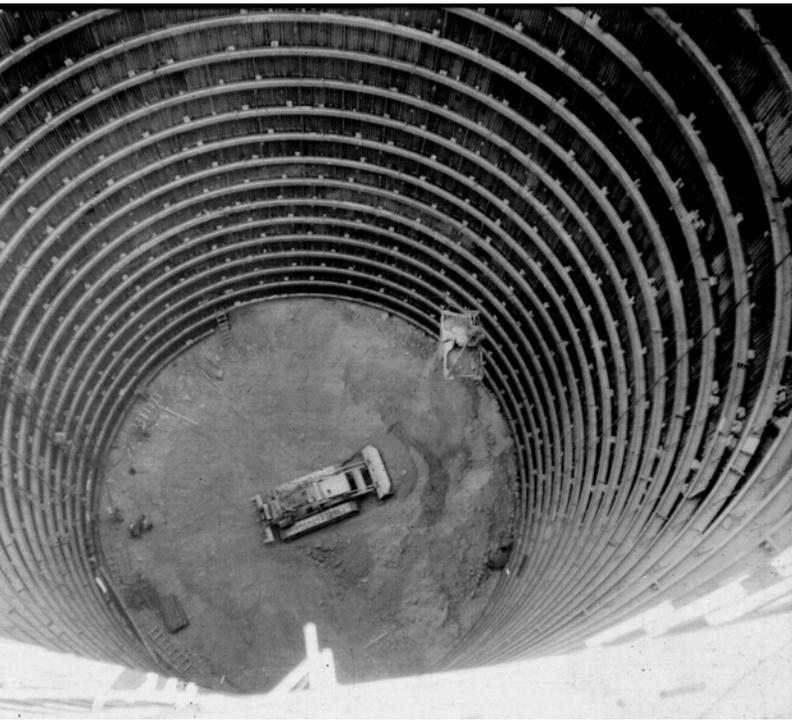
▲ Ring beams formed the outline of the silo wall, and supported the silo's exterior steel shell. Note bulldozer at bottom, and lift bucket.

On the way down, steel ring-beams were installed every few feet to form the basic outline

and structure of the silo wall. At the bottom of the silo, a ¼-inch (6 mm) thick steel plate floor was installed for electromagnetic pulse (EMP) shielding. Extending up from this floor, steel plates were attached to the ring beams to form a metal cylinder that extended all the way to the surface.¹²

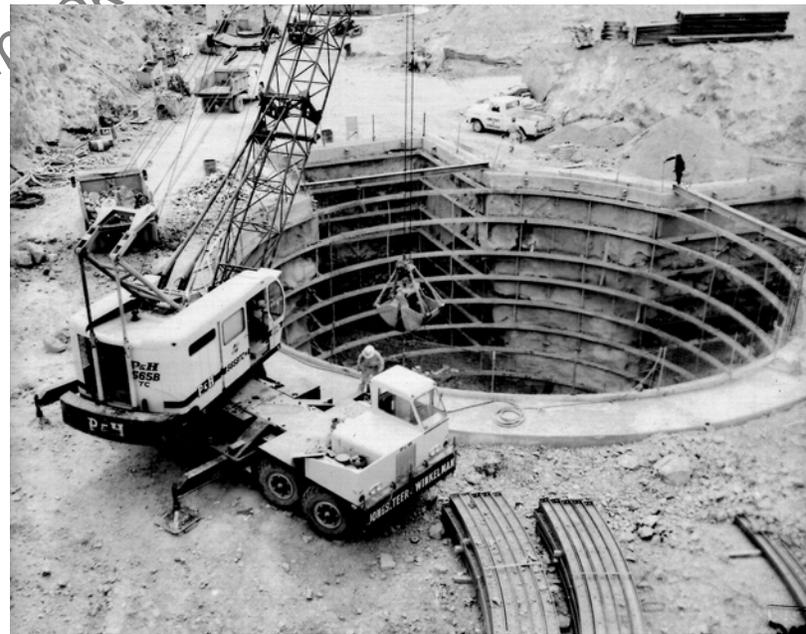
▲ Another view of the silo ring beams. The two “wings” will permit installation of air shafts and shock delay pipes.

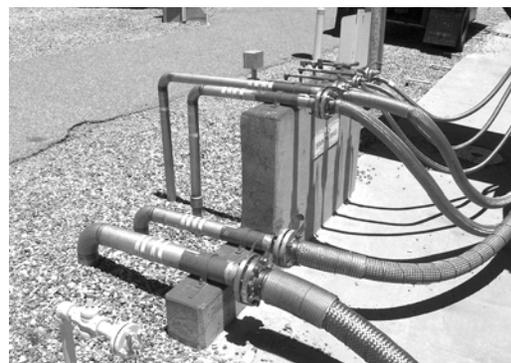
◀ Propellant was loaded into the missile by gravity via stainless steel piping. The larger of the two pipes in the foreground is for stage one, the smaller one for stage two.

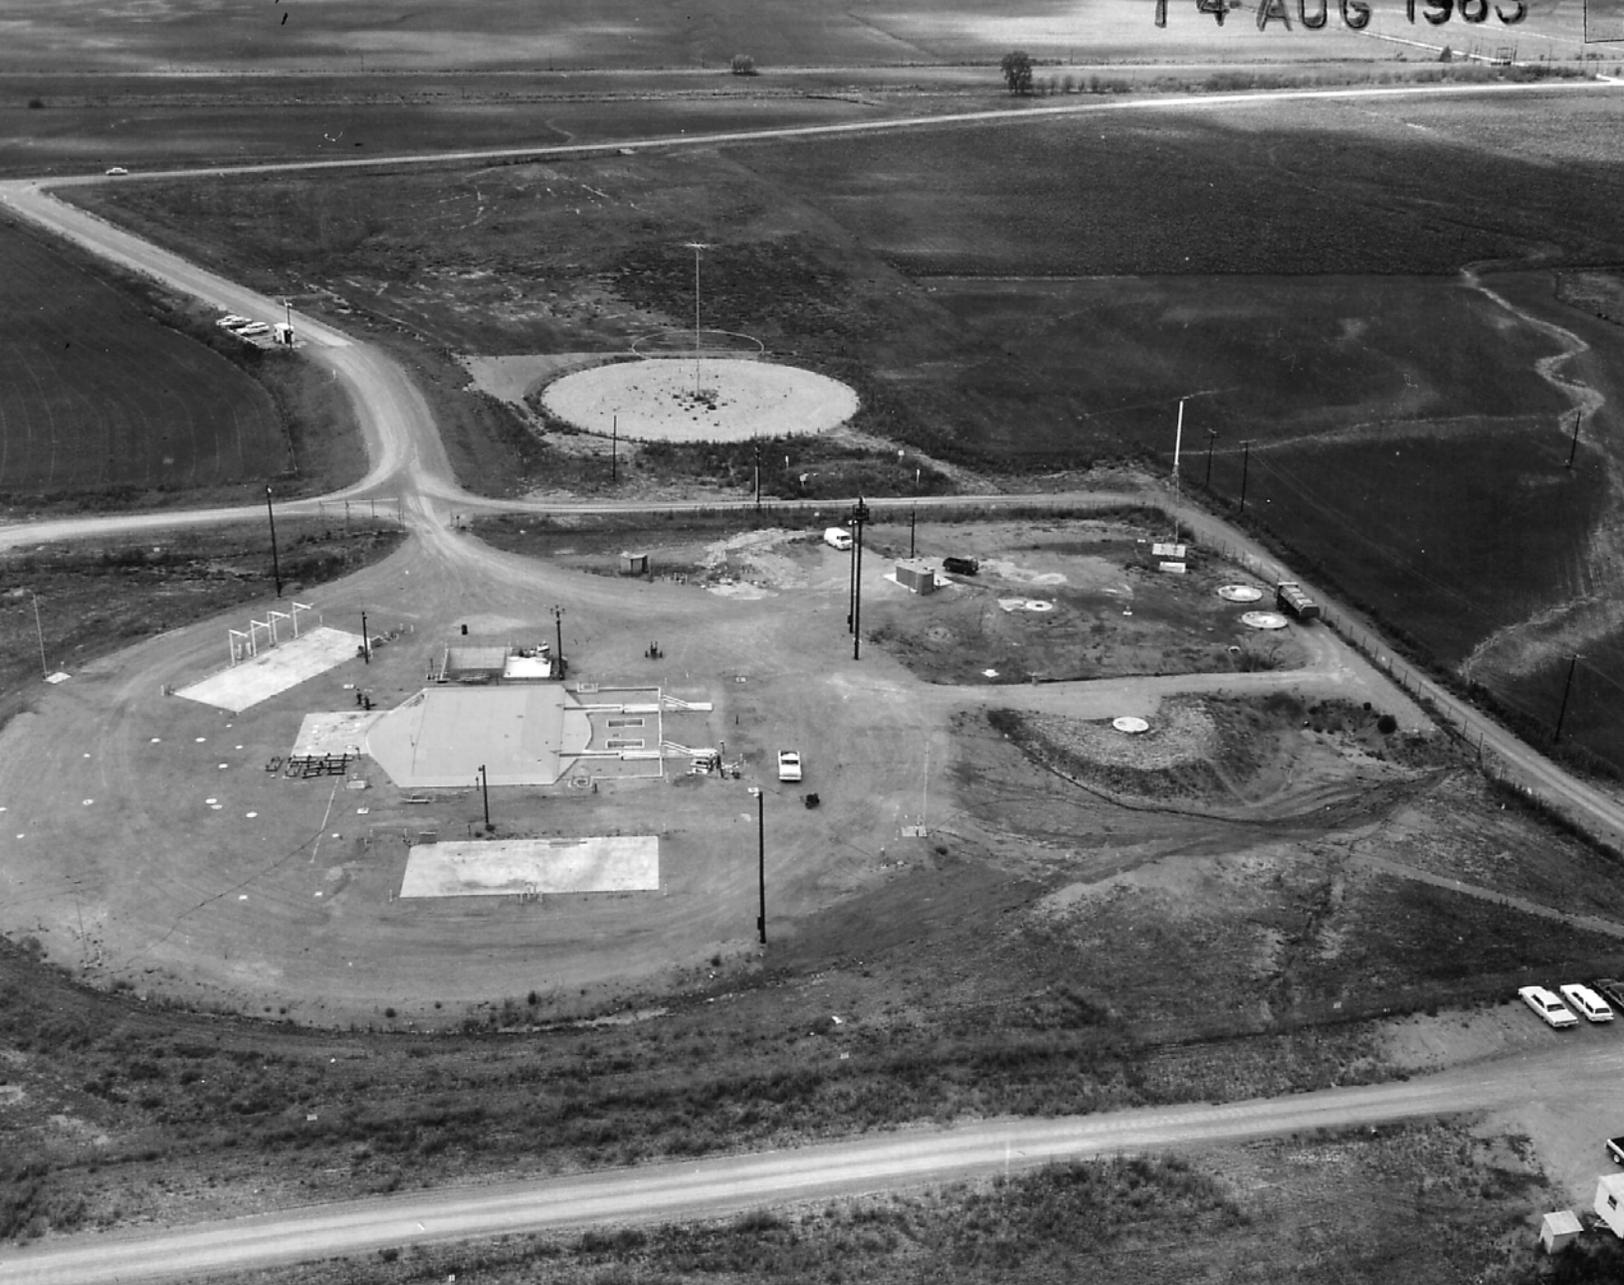
► Water spray nozzles on the fuel hardstand for dilution of spills or fire suppression. No such nozzles were present on the oxidizer hardstand.

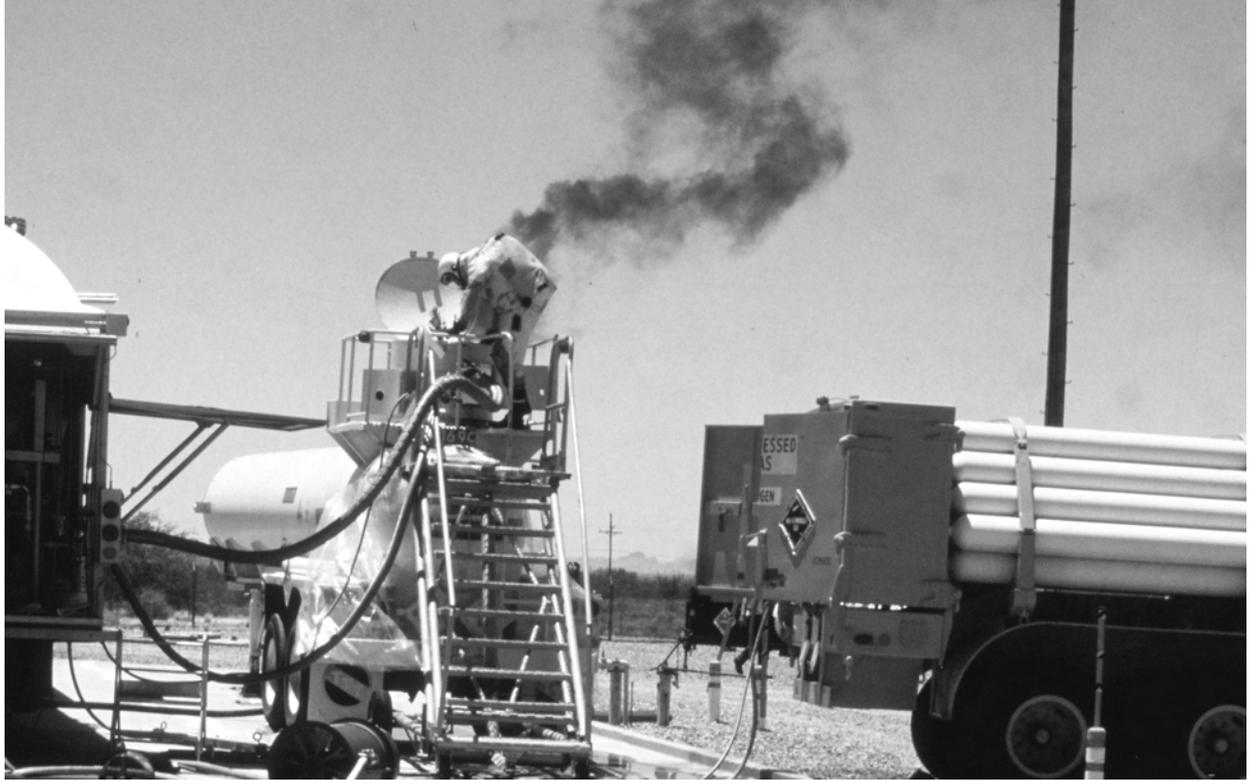
► A plume of highly toxic nitrogen tetroxide vapor wafts away from an oxidizer transport trailer during a PTS operation. A certain amount of venting was unavoidable.

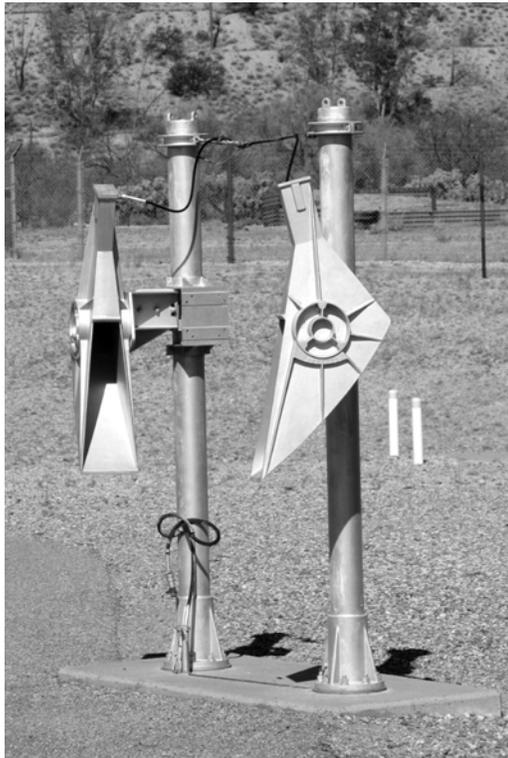
► The “tipsie” security system projected a motion-sensing radar beam around the silo and over the control center air intake shaft.

Pairs of tipsie units were located at each corner of the silo, and also over the LCC air intake shaft. Radar beams sent between these units created an electronic motion sensor. If a moving object disturbed any of the beams, the system set off an alarm in the control center. The crew on alert would not come topside to investigate. They would call the wing command post (WCP), and the WCP would dispatch the security police. The launch complexes were associated into groups of three sites called sectors. The sites were located such that security police were rarely more than 20 minutes away from any complex in a given sector.

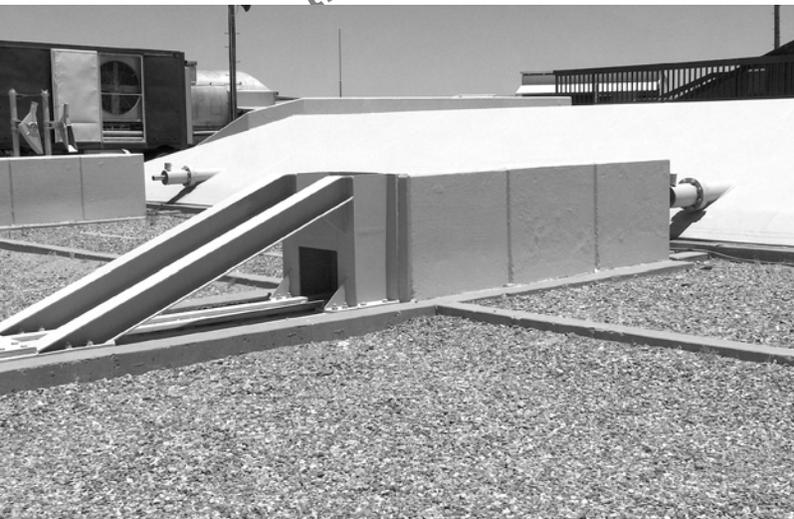
▲▲ Silo door being moved from fabrication site to silo.

▲ Bumpers and shock-absorbing pistons brought the door to a stop. The large concrete cubes were installed by the museum to assure the Soviets that the door could no longer be fully opened.

The silo door weighed an estimated 743 tons (674 metric tons) and could be fully opened in about 20 seconds. At 571-7 the silo door is exactly halfway open. Large exhaust ducts on the north and south sides of the silo, which vented the missile's exhaust during launch (see photo page on 89) have been covered with concrete, as have the rails on which the silo door rode. Part of the rails can still be seen where they emerge from under the west side of the door. When 571-7 became a museum large concrete blocks were installed on the rails to ensure that the door could no longer be opened all the way. The blocks were added as part of an agreement with the Soviet Union to help establish the site as a "non-

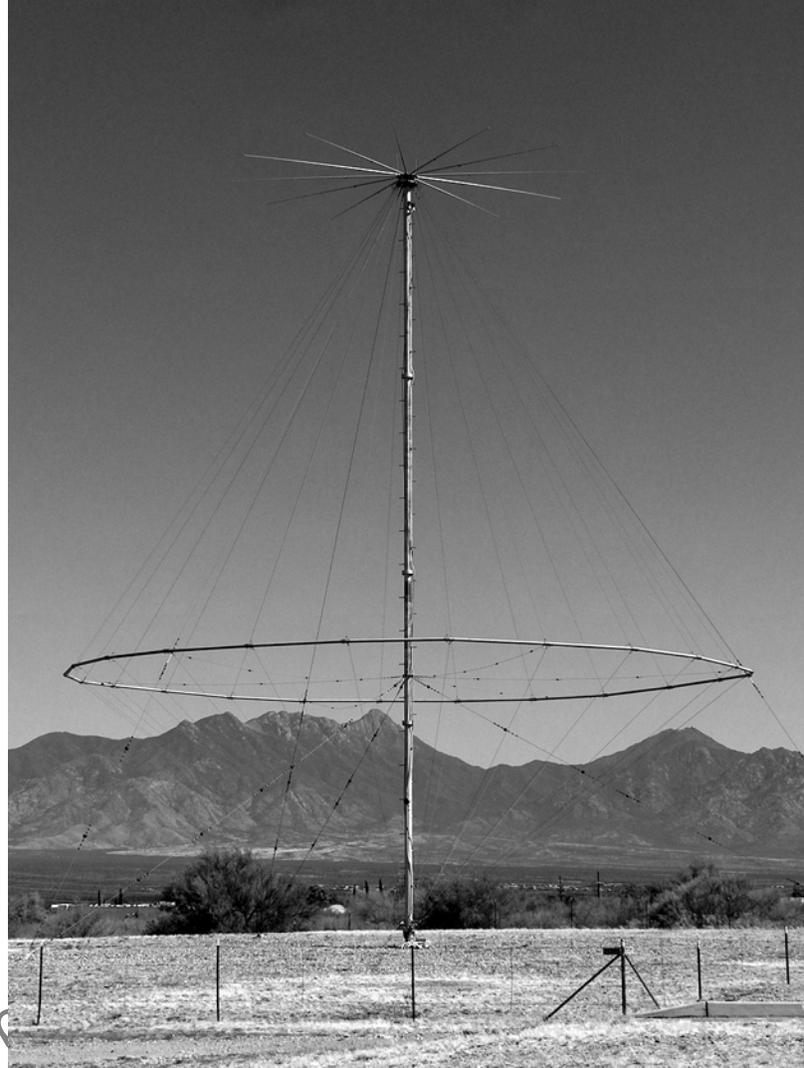
▲ The notoriously hard-to-photograph HF discage antenna was made by Collins Radio and covered from 3 to 30 MHz.

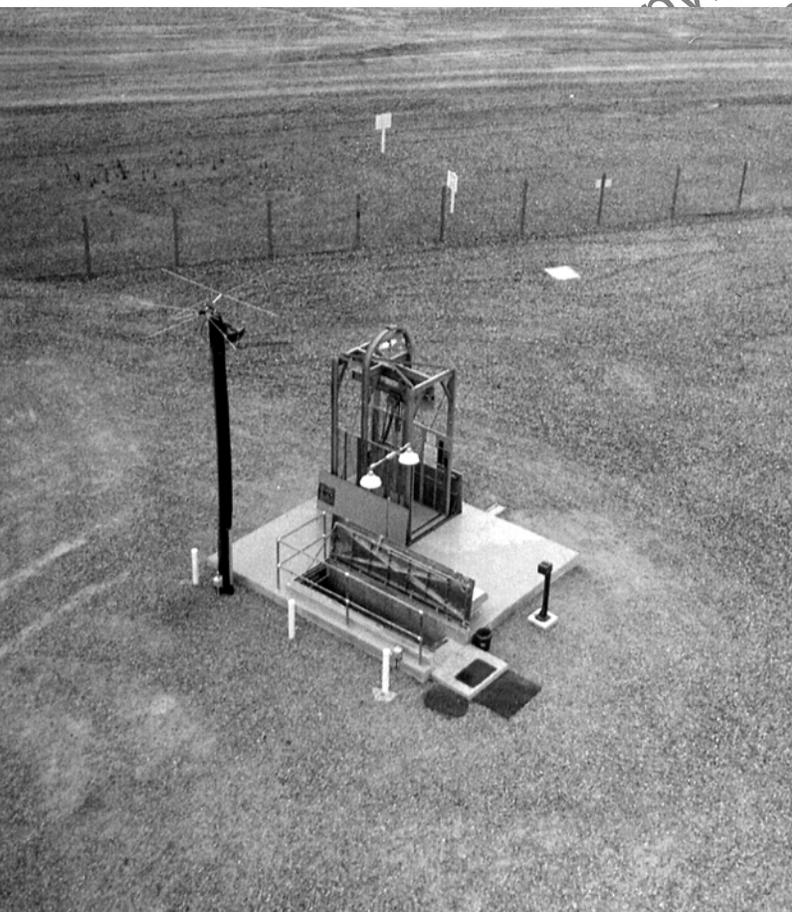
► The underground portion of the launch complex was composed of four separate structures: the access portal, the blast lock, the control center, and the silo. Two steel tunnels, called cableways, connected the silo to the control center by way of the blast lock, while the blast lock was connected to the outside world via the access portal.

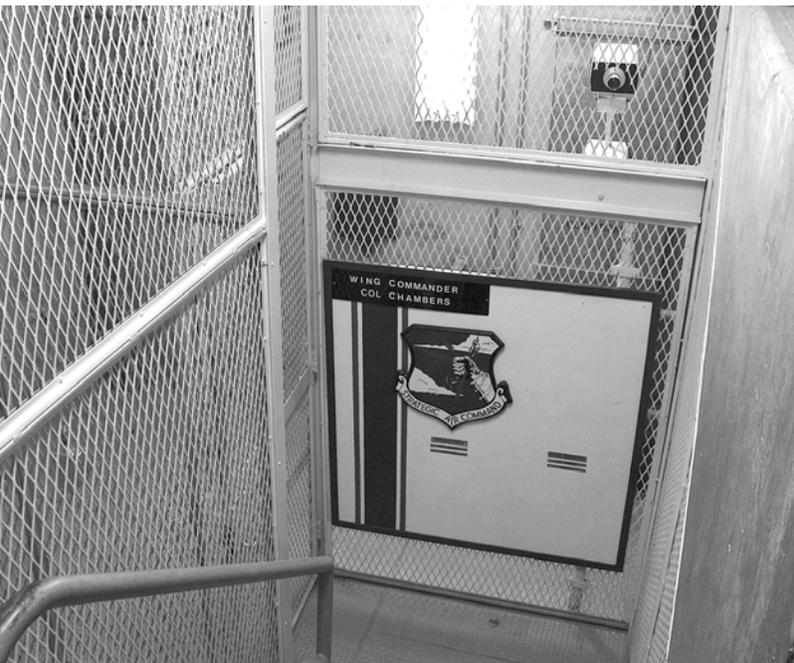
▲ Looking into the entrapment area from the outer portal door. Note TV camera.

the entrapment area, which confined those entering until their authorization to enter could be confirmed. The entrapment area consisted of two electrically locked doors, one at each end of a short stairway. When the outer door closed, those inside were trapped between it and the inner door. Both doors had to be buzzed open with a button in the LCC, but both doors could not be unlocked at the same time.

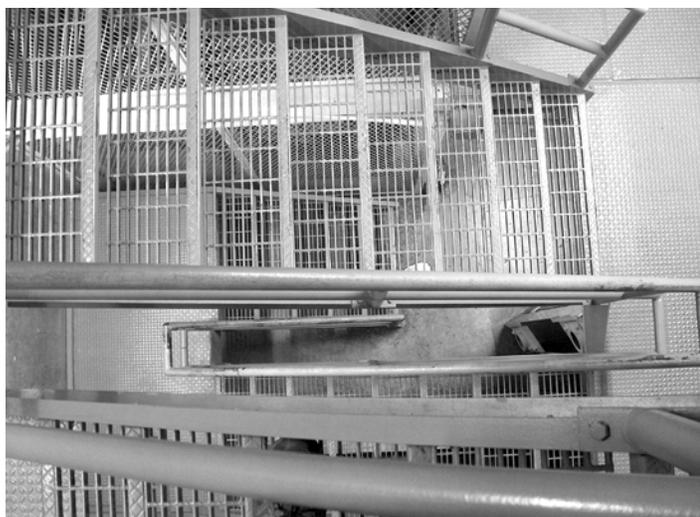
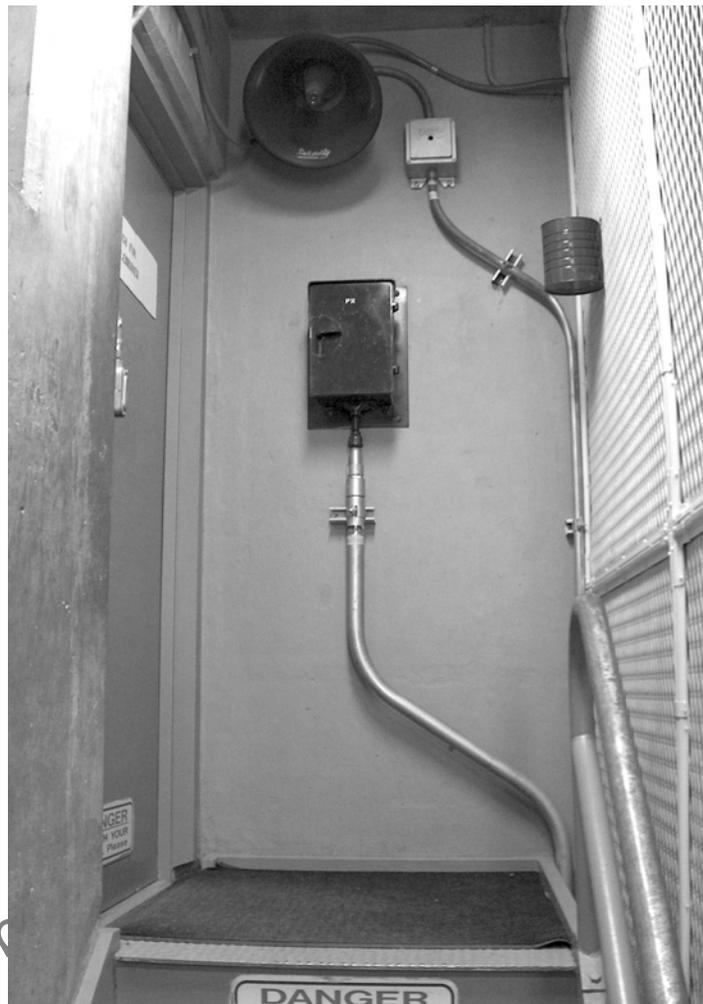
▼ Access portal stairway leading to blast door 6.

▲ Looking up from inner door. Note telephone and VSS speaker at top of stairway, and burn can at right.

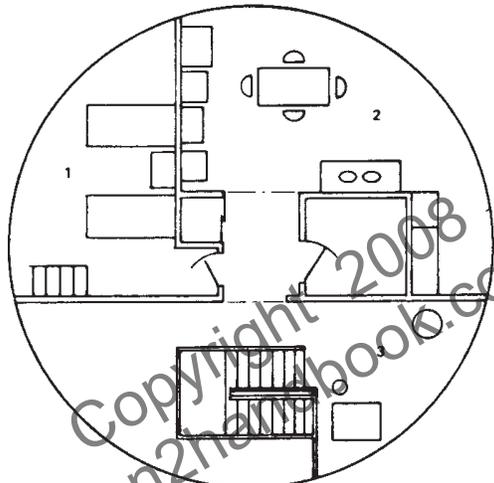
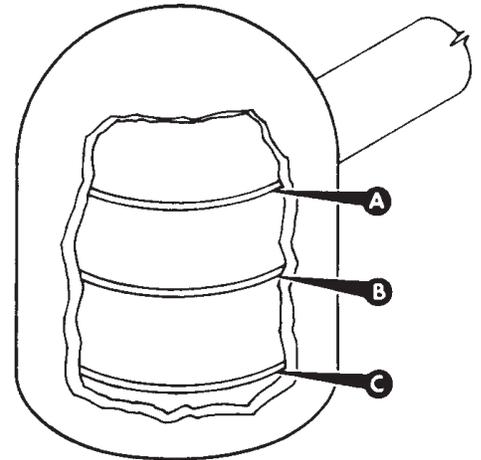
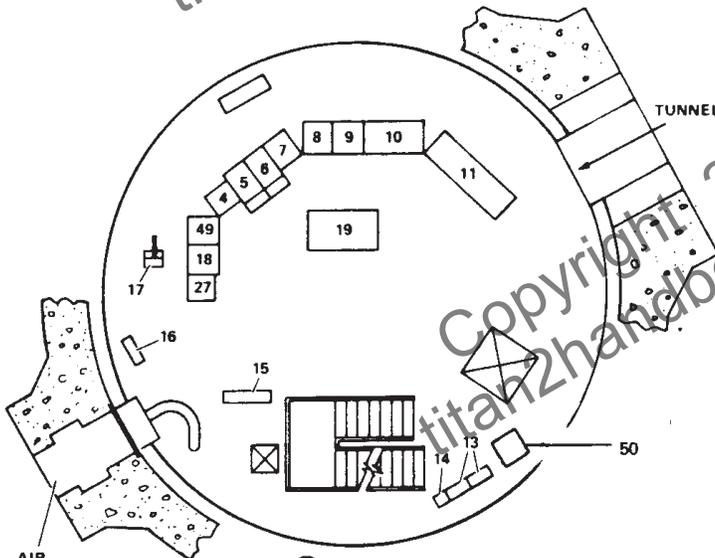
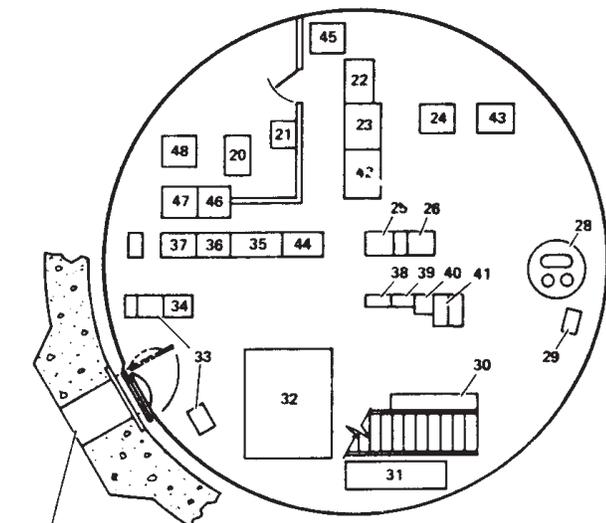
A LEVEL 1

B LEVEL 2

C LEVEL 3

1. SLEEPING QUARTERS
2. KITCHEN AND DINING AREA
3. STAIRWAY AND EQUIPMENT AREA
4. PRIMARY ALERT SYSTEM
5. ALTERNATE LAUNCH OFFICERS CONSOLE
6. VHF AND SSB RADIO

7. FACILITY POWER CONTROL BOARD
8. MISSILE SYSTEMS FAULT LOCATOR
9. CONTROL MONITOR GROUP
10. CONTROL POWER DISTRIBUTION
11. ALIGNMENT CHECKOUT GROUP
12. (DELETED)

13. LIGHTING PANEL
14. CONTACTOR PANEL
15. HEAT AND VENTILATION CONTROL PANEL
16. DISTRIBUTION PANEL
17. HYDRAULIC HAND PUMP
18. SUBSCRIBER C
19. LAUNCH CONTROL COMPLEX FACILITIES PANEL

20. WIRE PROTECTION AND DISTRIBUTION CABINET
21. TELEPHONE CO. EOPT. CABINET (DMAFB ONLY)
22. MOTOR GENERATOR (DEACTIVATED)
23. BATTERY POWER SUPPLY 1
24. POWER SUPPLY 1

25. VOICE SIGNALING SYSTEM (VSS) CABINET
26. RADIO-TYPE MAINTENANCE NETWORK (RTMN) CABINET
27. HF-UHF RADIO
28. SANITARY LIFT
29. LIGHTING AND CONTROL TRANSFORMER

30. MOTOR CONTROL CENTER
31. AIR FILTER
32. A/C UNIT
33. FACILITY TRANSFORMER
34. CARRIER BAYS
35. COMMUNICATIONS 24-VOLT POWER EQUIPMENT BAY
36. WIRE CONTROL AND TRANSMISSION (WCT) EQUIPMENT BAY (ALOC)

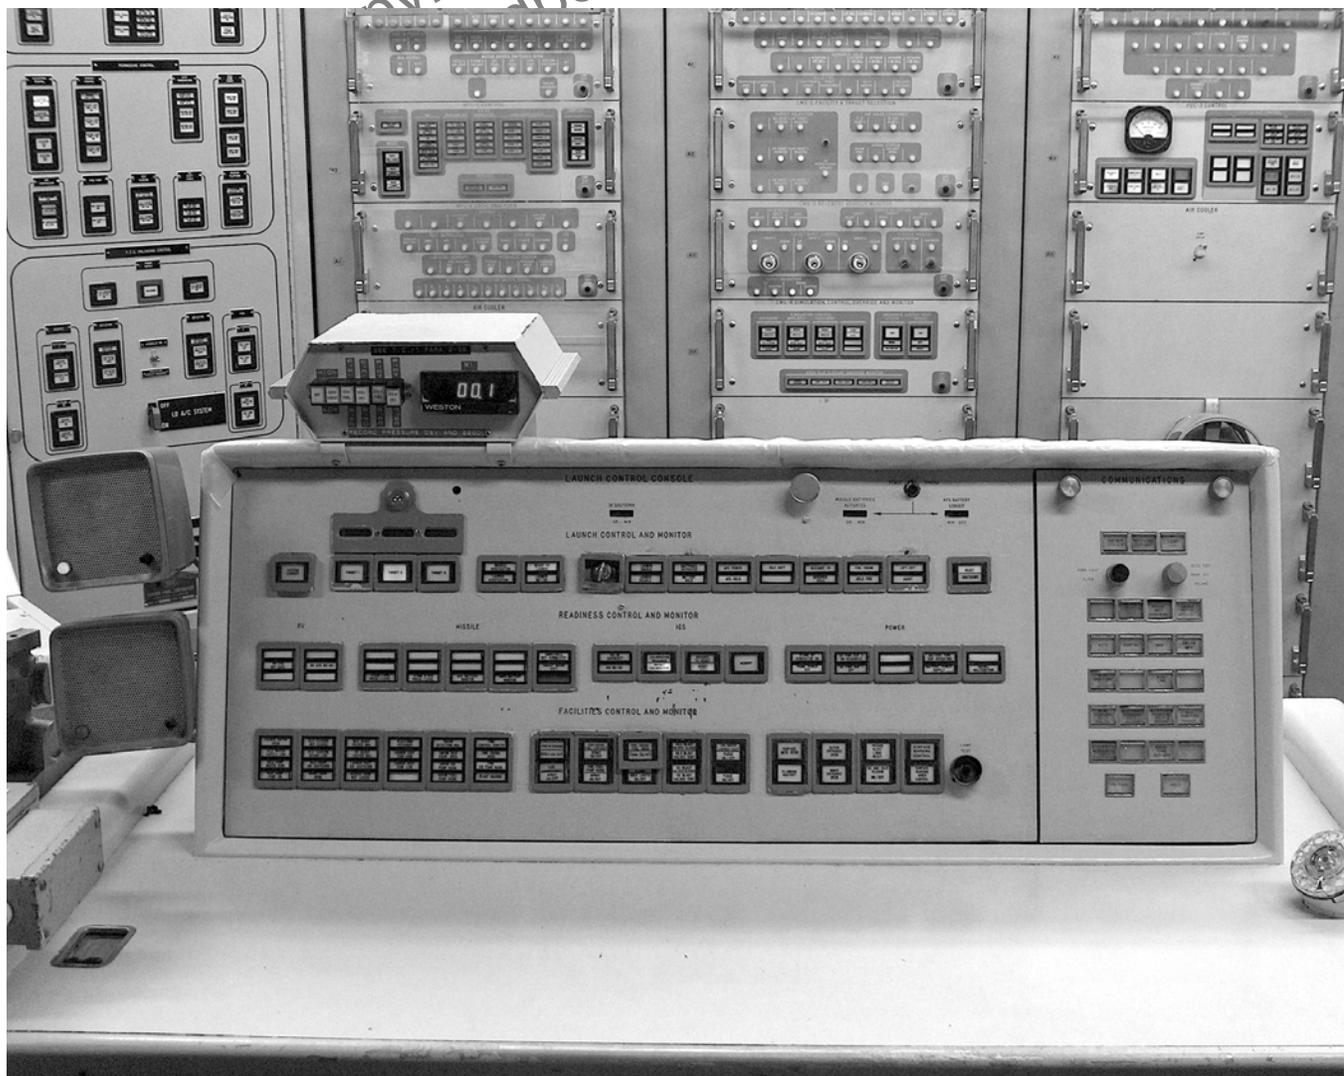
► The LCCFC. Think of it as the “dash board” of the complex.

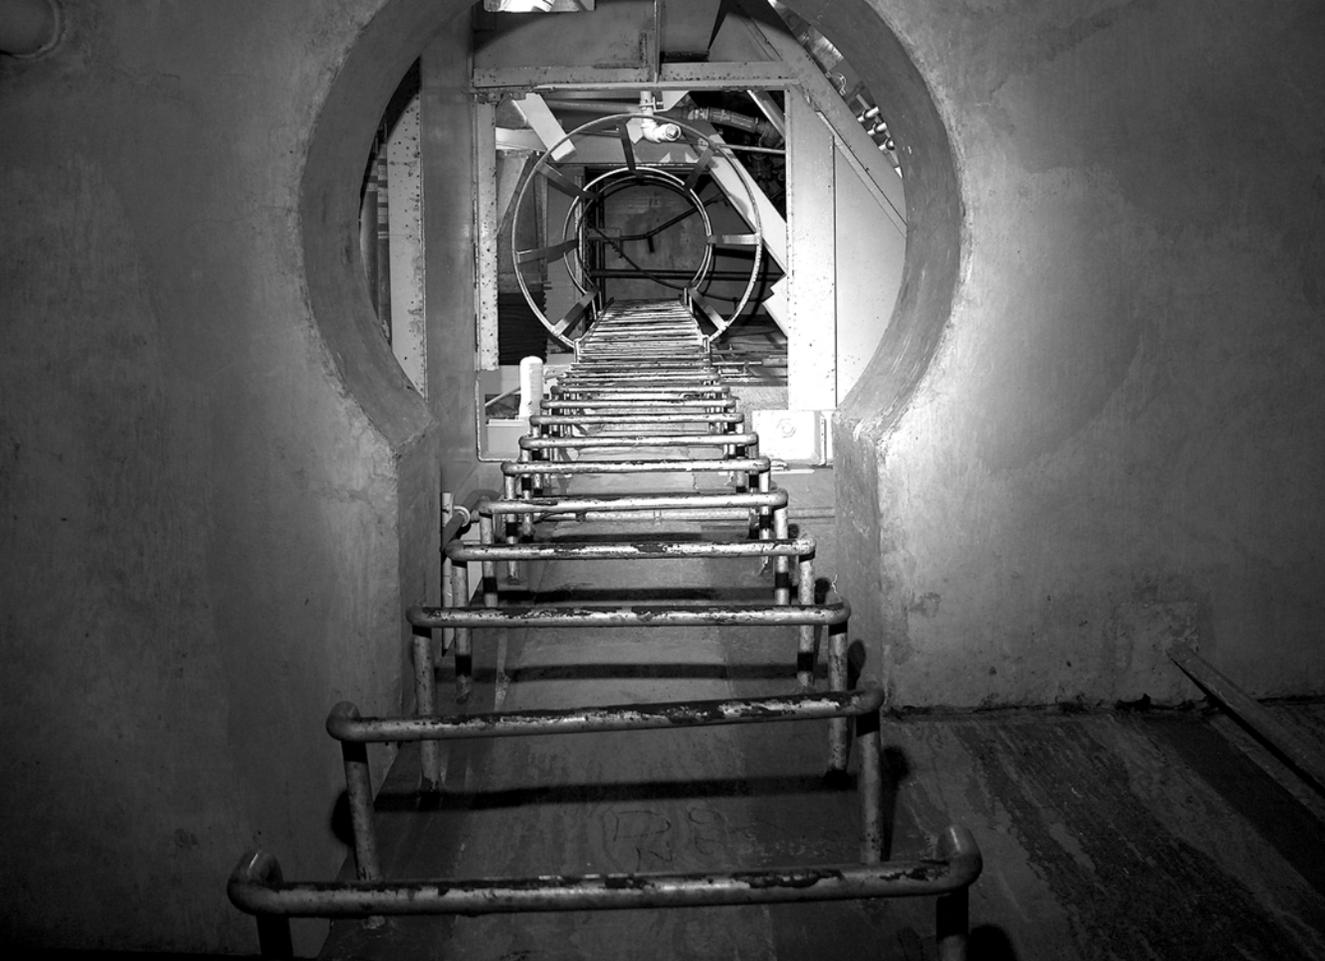
◀ A portion of the silo ladderway. This view looks up from level 4 to level 2.

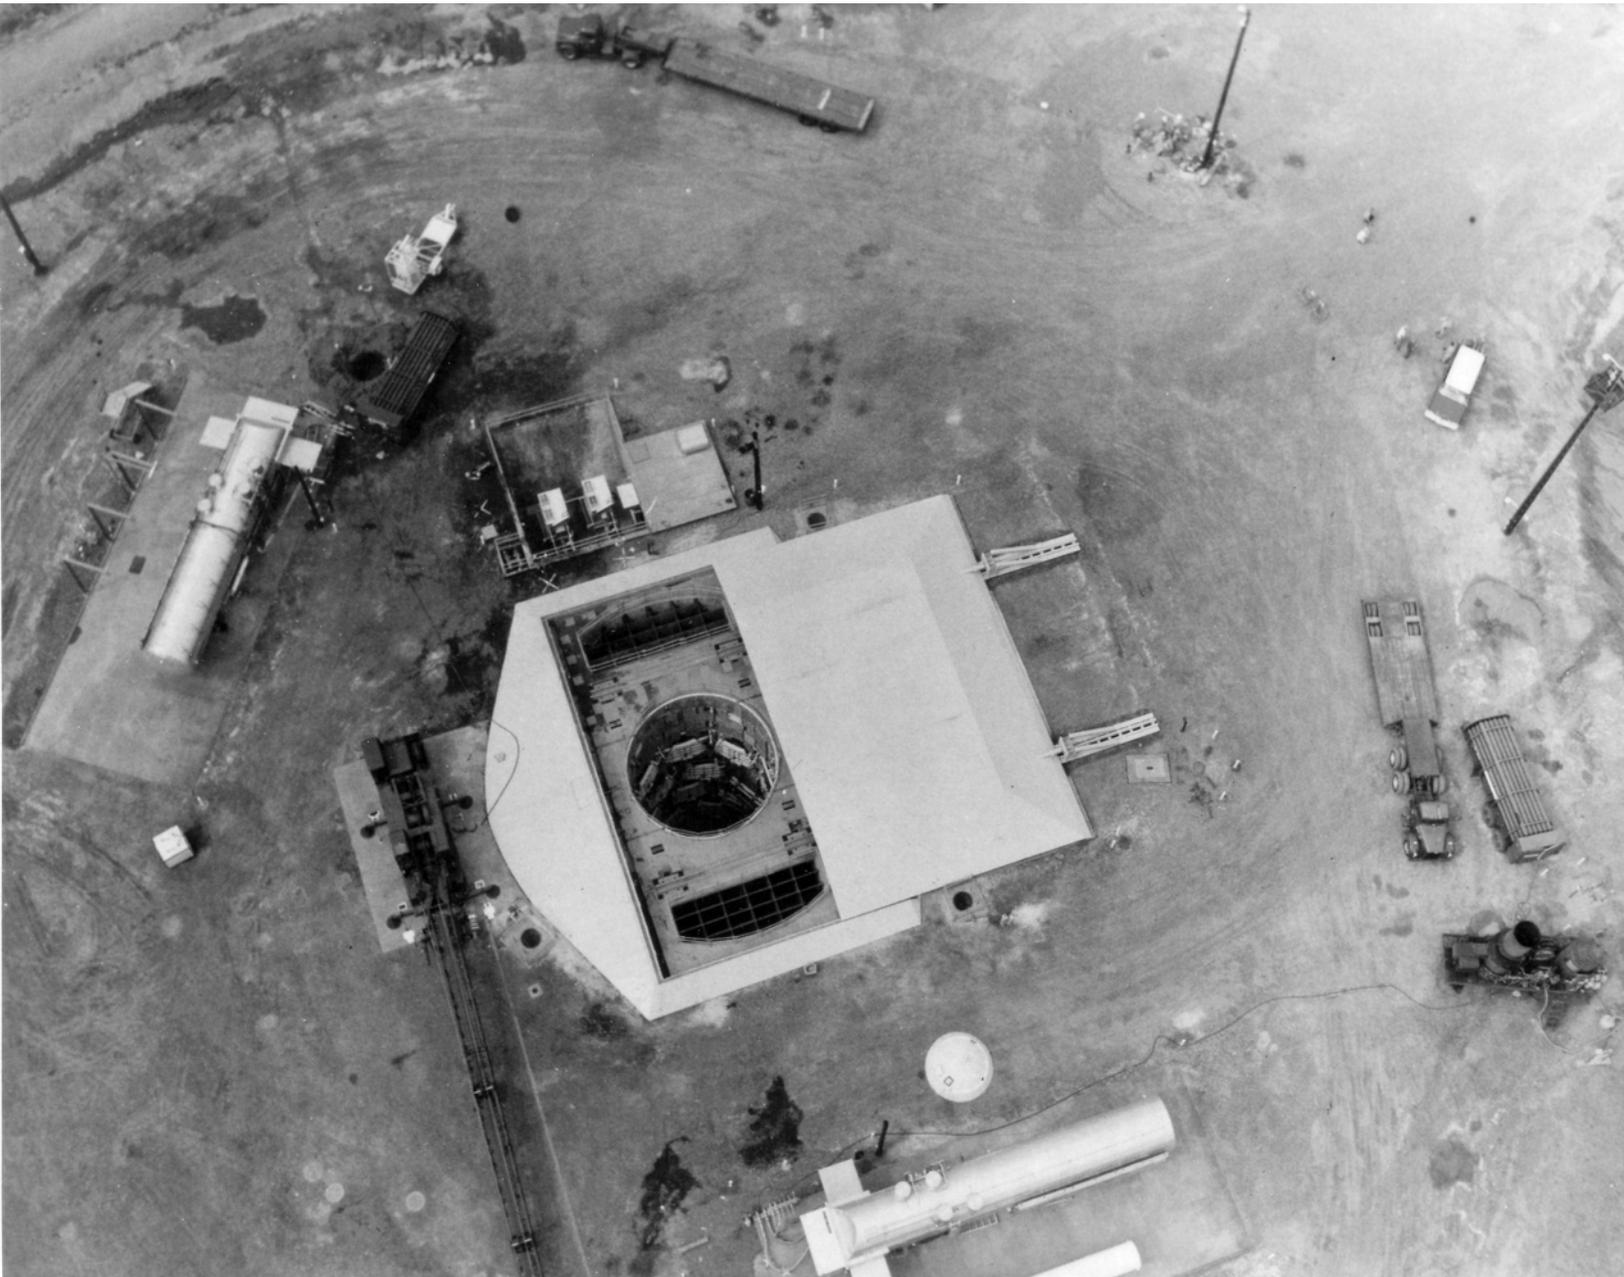
▼ This aerial photo provides a splendid view of the launch duct and exhaust shafts. Note cooling towers and hardstands.

The launch duct was a continuous uninterrupted shaft surrounding the missile. At the top was the silo closure door, and at the bottom were two exhaust ducts and the flame deflector plate, usually referred to as the "W" because of its shape. At six levels between the top and bottom (levels 1 through 5, and 7) retractable waffle-like work platforms could be lowered to give maintenance crews direct access to the missile. Levels 1 through 4 and level 7 each had eight platforms while level 5 had only

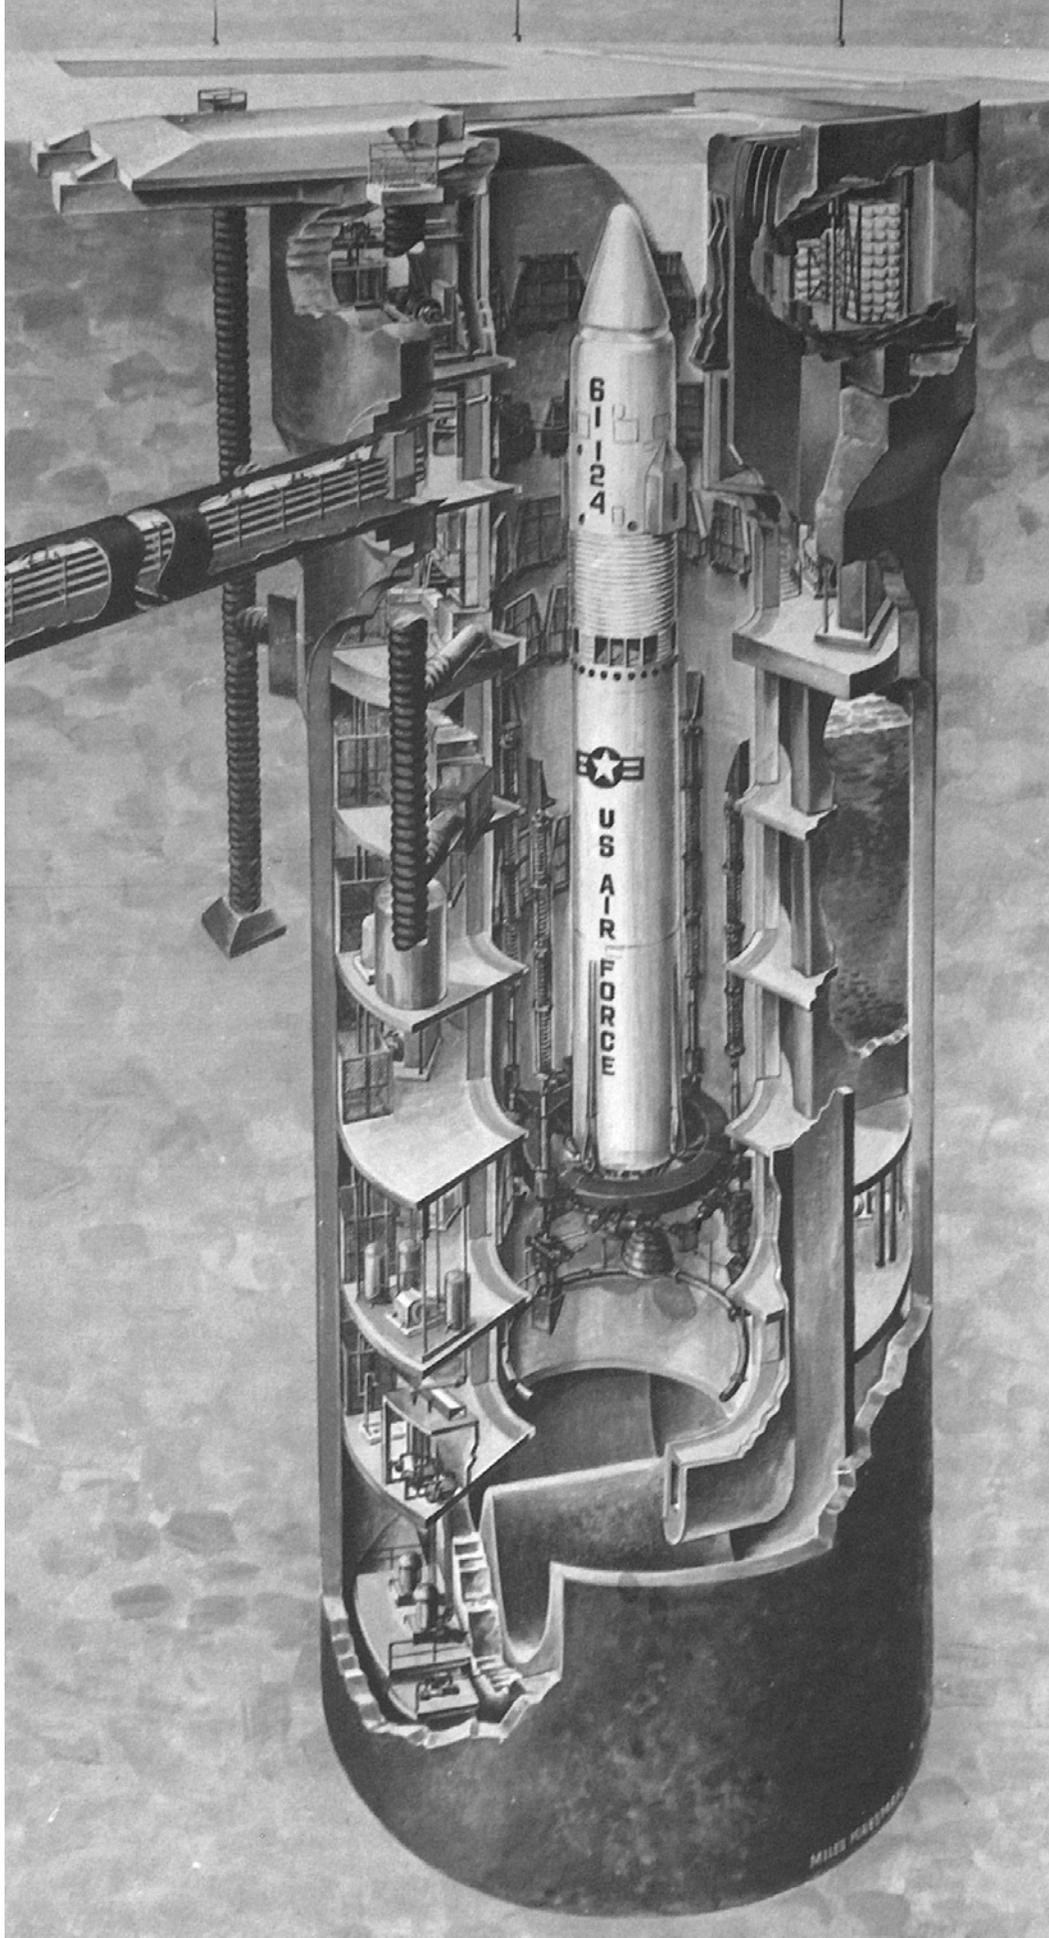
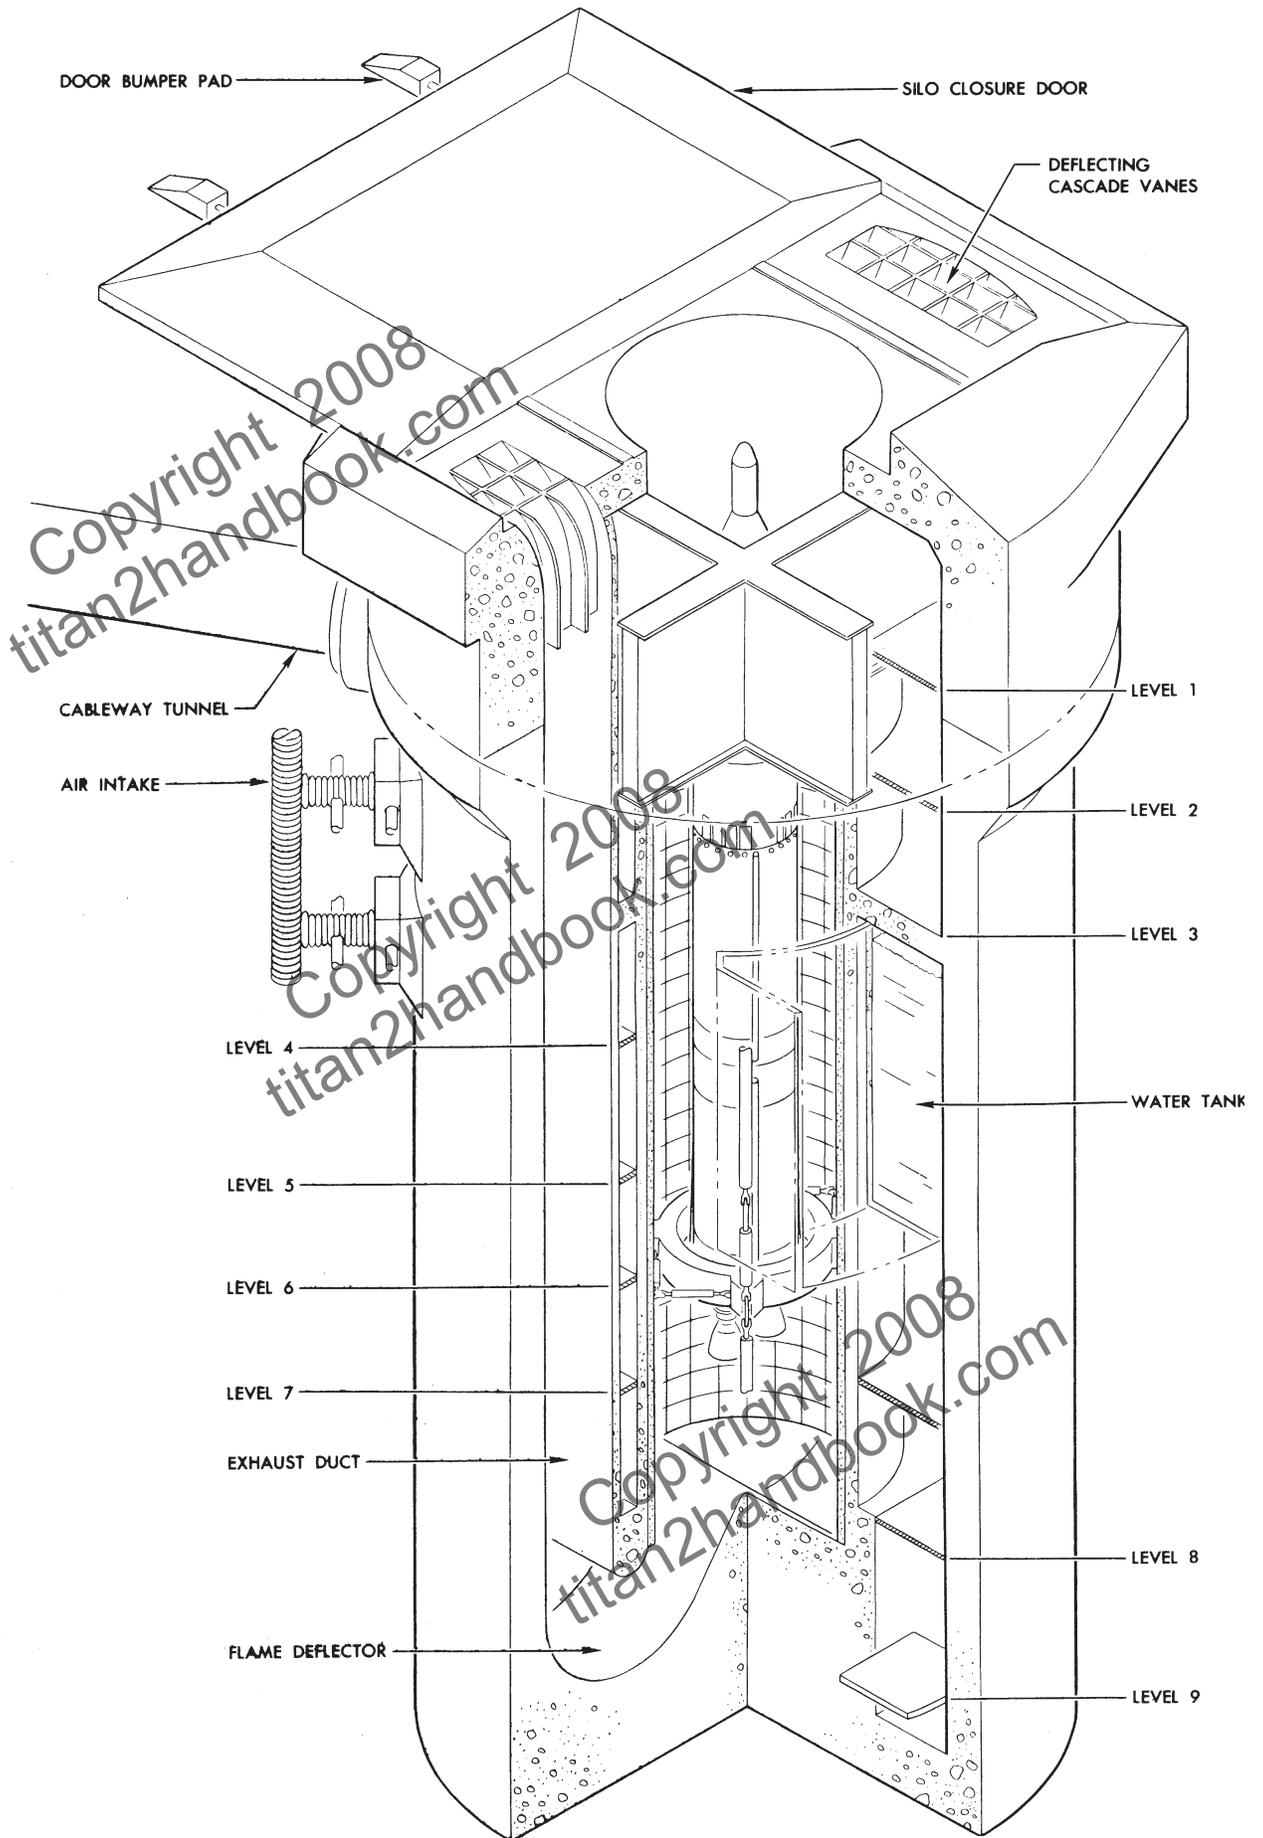
Two views of the silo and launch duct.

◀ At left, a detail from a Martin Company illustration.

▶ At right, a drawing from the Dash One. The Dash One image is rotated about 90 degrees from the Martin drawing and provides an additional perspective of the flame deflector and exhaust shafts. Curiously, the newer Dash One image shows the missile fitted with the older Mark IV reentry vehicle, which was never deployed on Titan II.

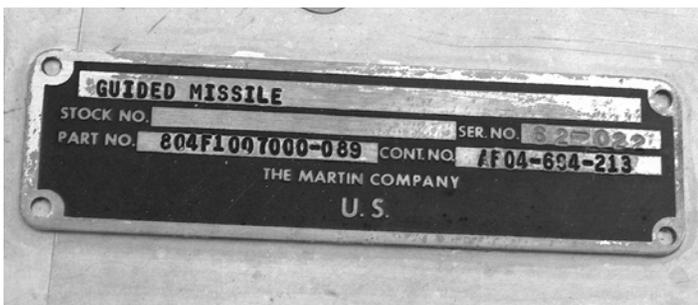
▲ Nameplate on underside of aft skirt.
