CHAPTER 2

CONSTRUCTION

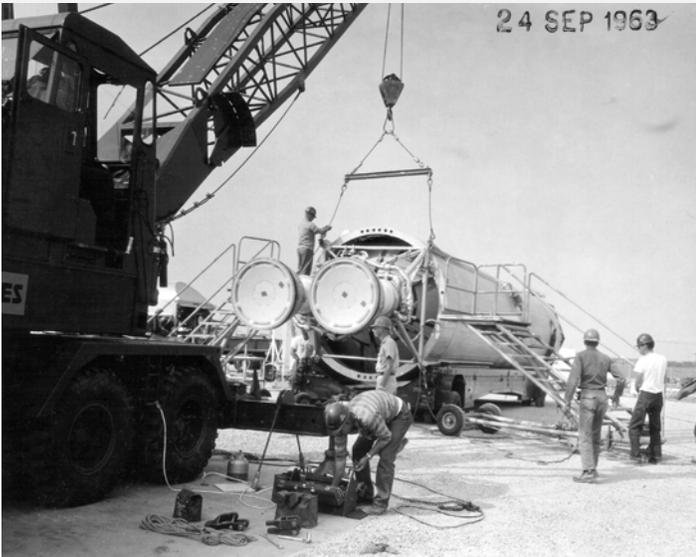
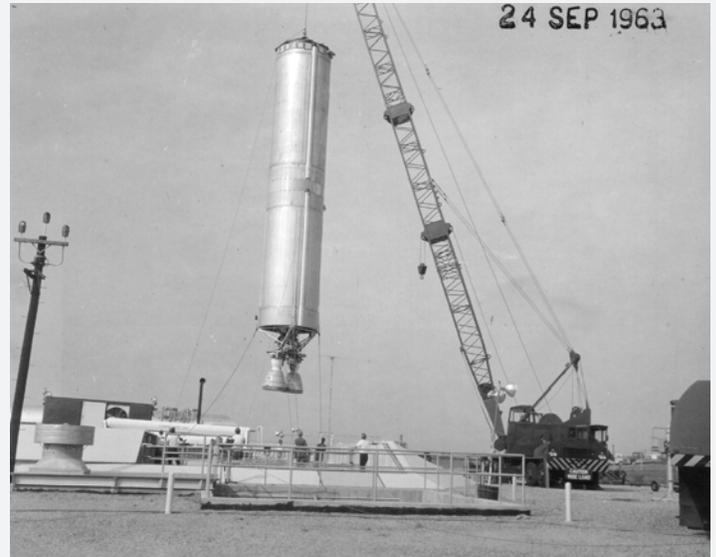
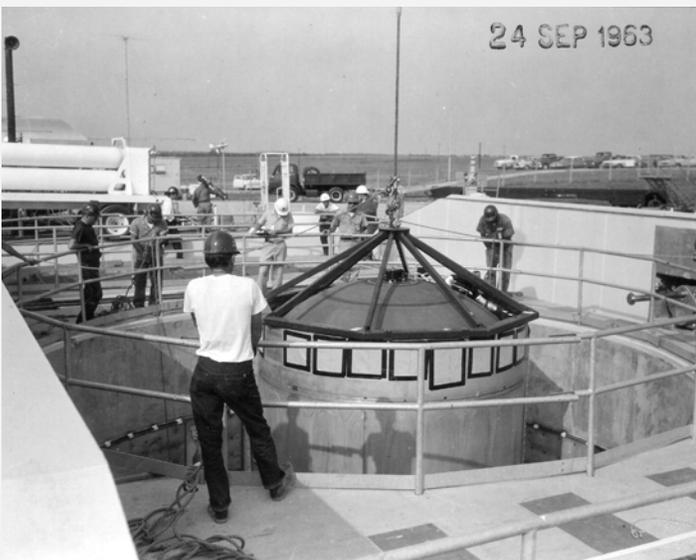
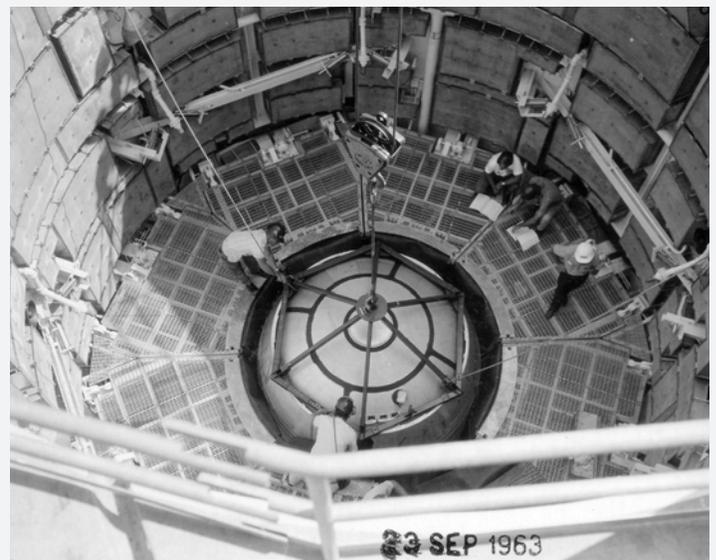
▼ The missile was transported to the complex by truck and lowered into the silo with a large crane. Stage one was installed first, followed by the stage two. The propellant was then loaded, and finally the RV was installed. This sequence of photos was assembled from two separate installations.

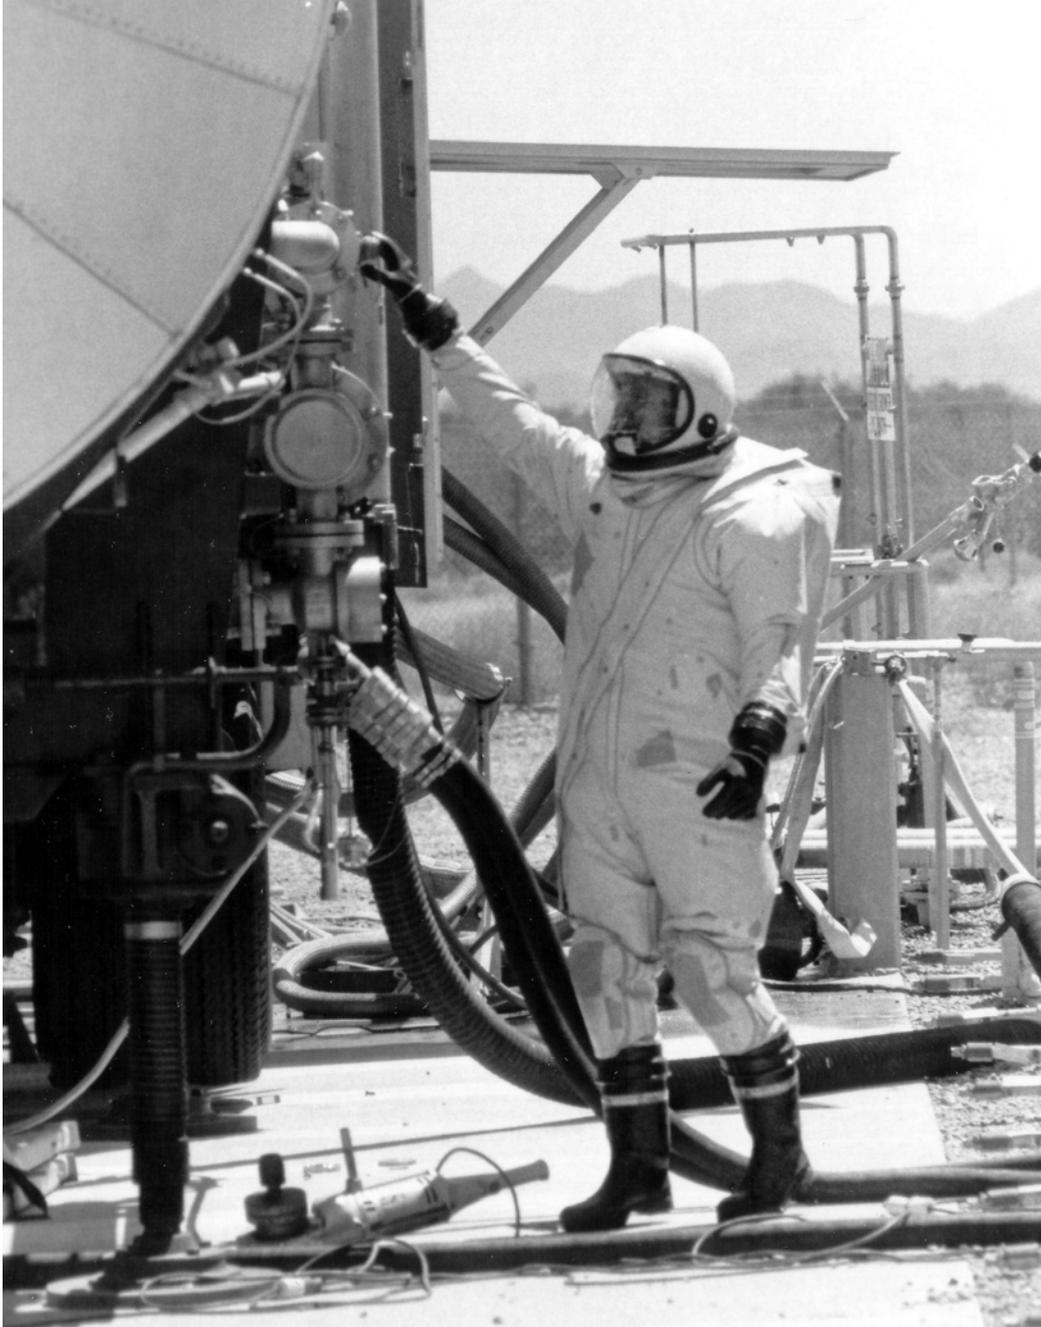
◀ The rocket fuel handler's clothing outfit, or RFHCO, worn to protect against the highly toxic vapors of the propellant. The suits were not air-conditioned.

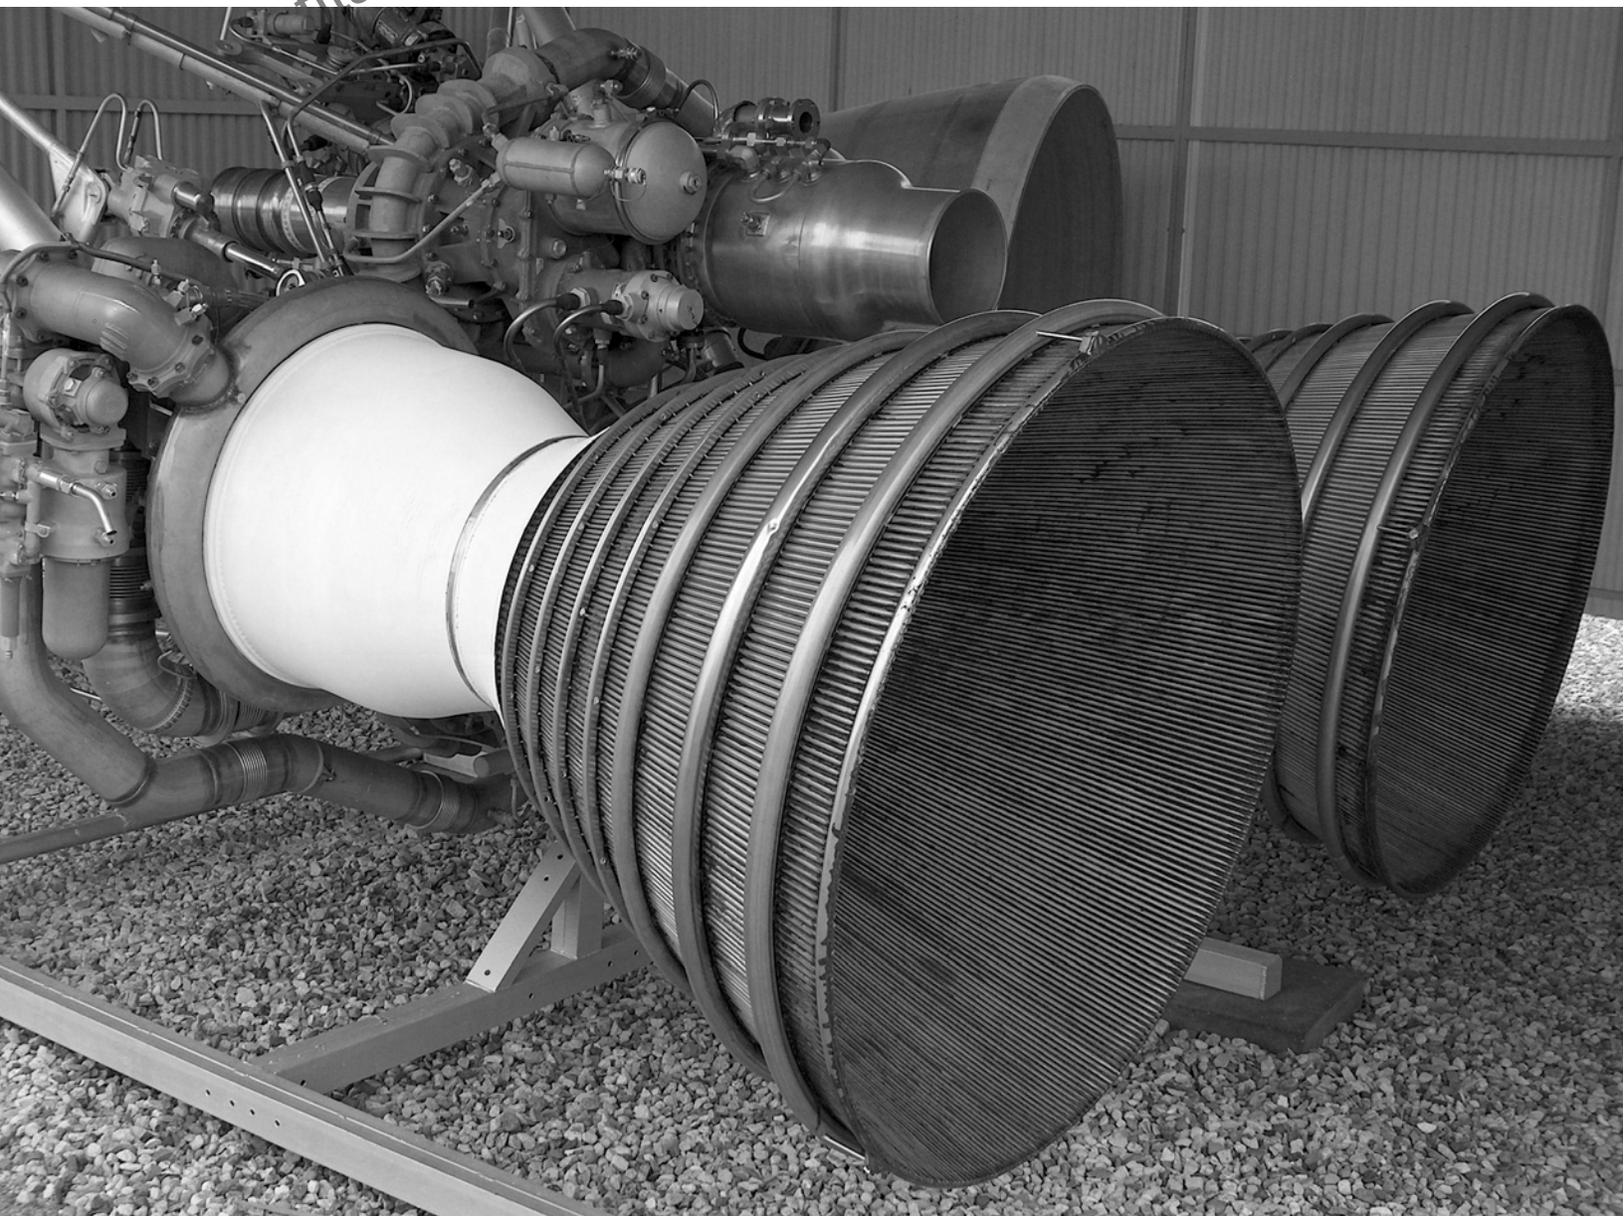
▼ The LR-87-AJ-5 stage-one rocket engine. It had no throttle control or "off switch" and burned at full power until the propellant ran out. Its thrust was roughly equivalent to that of two Boeing 747s.
