PROPERTY INSPECTION REPORT

Any Street, Any City, 44444

Report ID: 11 Month Warranty Inspection

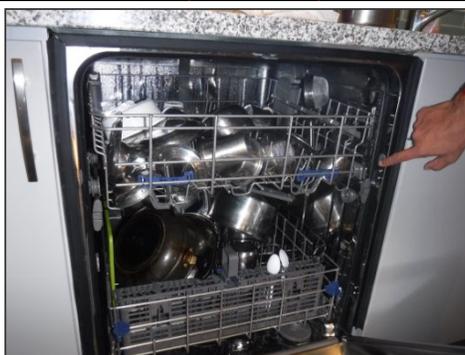
Page 15 Item: 4	Dishwasher (Life Expectancy 9 years)	4.1. Dishwasher was not properly fastened to the underside of counter, recommend securing to counter top to prevent tip when loading or unloading.
--	-----------------	--------------------------------------	--

Example Of Dishwasher Not Attached To Counter

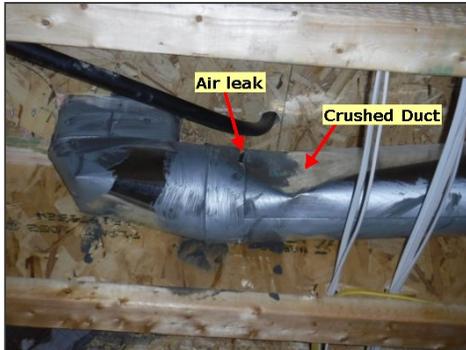
Page 20 Item: 6	Air Distribution System / Air Filter	6.2. Basement, heating duct was damaged (crushed) to make room for the flexible gas supply pipe. The damaged created a gap/leak between the duct joint. Recommend correction and sealing. 6.3. Upstairs common bathroom, air register lever was obstructed by drywall which prevent opening louvers to full range.
---	-----------------	--------------------------------------	---

Damaged duct / air leak at joint

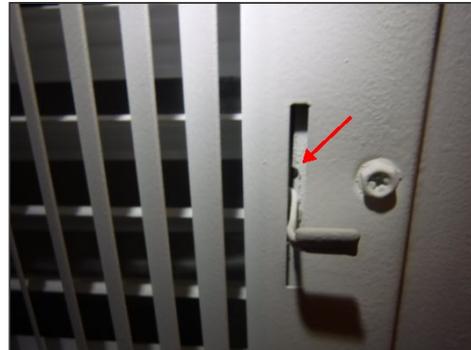
Common Bathroom, vent lever obstructed by drywall/ vent will not open to full range

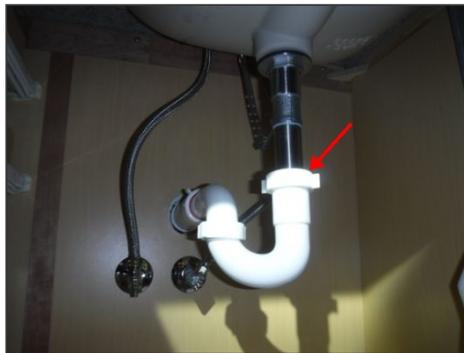
Page 24 Item: 7	Sink(s) / Back Splash	7.1. Upstairs common bathroom (right sink), leak under the sink at the drain tailpiece washer/lock nut. Recommend correction to prevent damage to the cabinet floor.

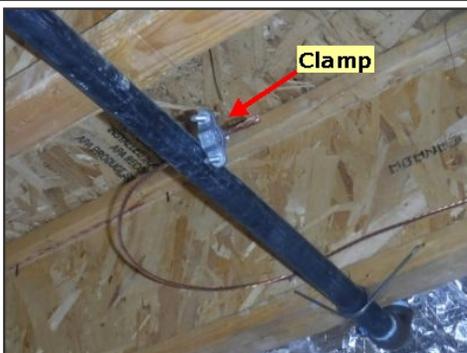
Page 26 Item: 2	Service Panel / Over-Current Protection	2.3. The bonding clamp was not clamped to the gas pipe. Clamp was loose and hanging. This is a safety hazard. Recommend a qualified and licensed electrical contractor secure the clamp. Service can uncover problems not discovered or that are beyond the scope of home inspection standards.
---	-----------------	---	---

Bonding clamp not clamped to gas pipe

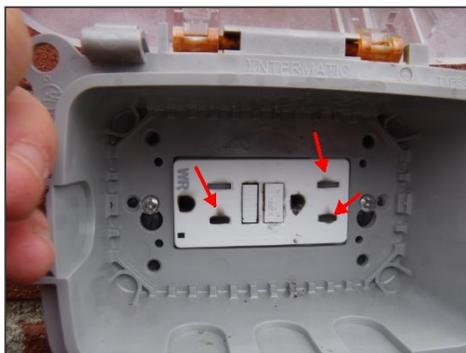
4.2. Back side, the GFCI protected outlet had burnt marks and would not reset (no power). This is an indication of an electrical short. This is a safety hazard. Recommend service and correction by a qualified electrical contractor to ensure safety of the occupants and to uncover problems not discovered or that are beyond the scope of home inspection standards.

Burnt marks, No Power, would not reset

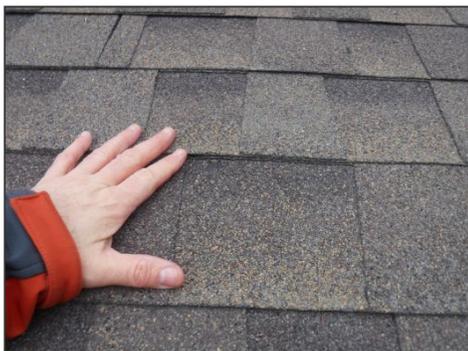
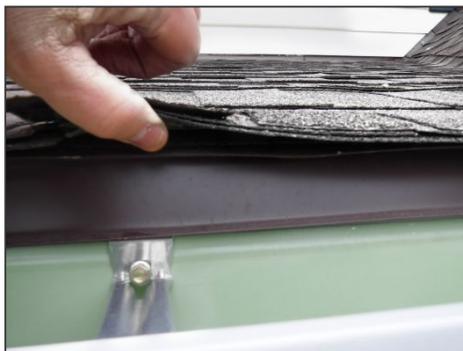
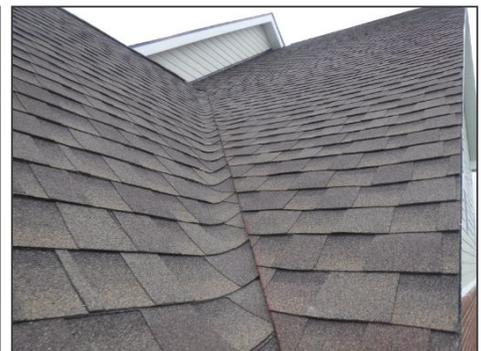
1.1. Roof covering that I could see was in good condition on the day of the inspection. I did not observe any indication of major damage such as cracked, damaged, missing shingles during my inspection. Recommend annual preventive maintenance inspection to maintain a water tight structure.

Example Of Roof Covering

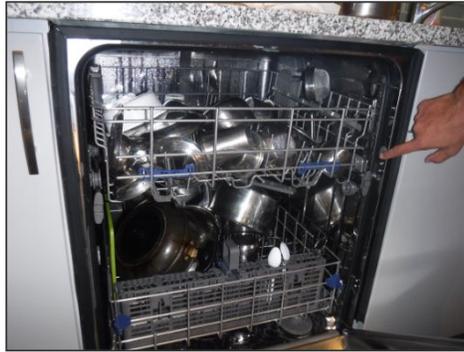
4.1. Dishwasher was not properly fastened to the underside of counter, recommend securing to counter top to prevent tip when loading or unloading.

Example Of Dishwasher Not Attached To Counter

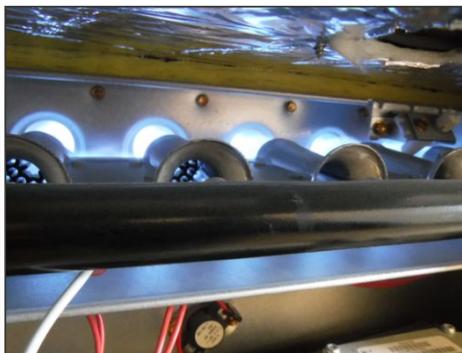
2.1. The furnace(s) burners responded and provided heat when turned on by the wall thermostat controller in manual mode on day of inspection. Good flame color and pattern noted. Heat source, where necessary was available to each room. If a water catch pan was installed, it is not possible for us to check its performance. Recommend service check-up and cleaning to ensure safe and proper operation. Servicing can also uncover problems not discovered or that are beyond the scope of home inspection standards.

Example Of Furnace Burner In Operation

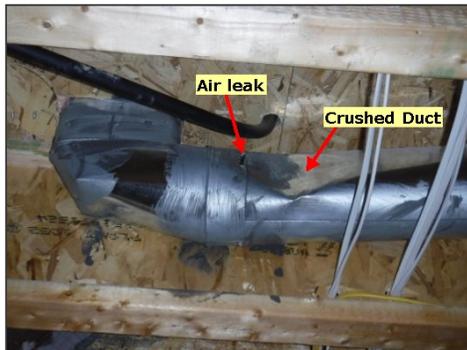
6.2. Basement, heating duct was damaged (crushed) to make room for the flexible gas supply pipe. The damaged created a gap/leak between the duct joint. Recommend correction and sealing.

Damaged duct / air leak at joint

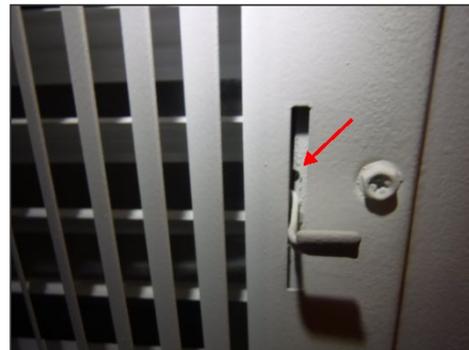
6.3. Upstairs common bathroom, air register lever was obstructed by drywall which prevent opening louvers to full range.

Common Bathroom, vent lever obstructed by drywall/ vent will not open to full range

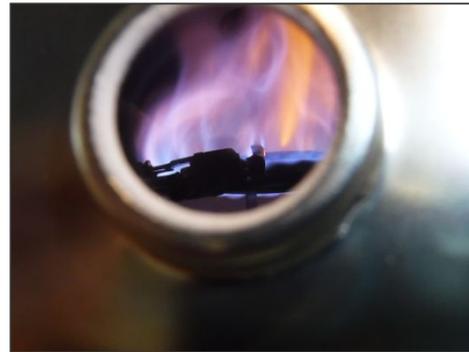
- 4.1. The burner responded when tested. Good flame color and pattern observed. There was no active leaks from the water heater today.
- 4.2. The water heater is equipped with a pressure-temperature relief valve (TPRV). The TPRV discharge tube extends to the proper height above the floor.
- 4.3. Gas and water shut-off valves were within same room and within 6 feet of appliance.
- 4.4. The water heater temperature was greater than 120 degrees F which is too high and will cause 3rd degree burns. This is a safety hazard. The Consumer Product Safety Commission (CPSC) recommends setting to 49 °C (120 °F).

Example Of Water Heater Burner In Operation

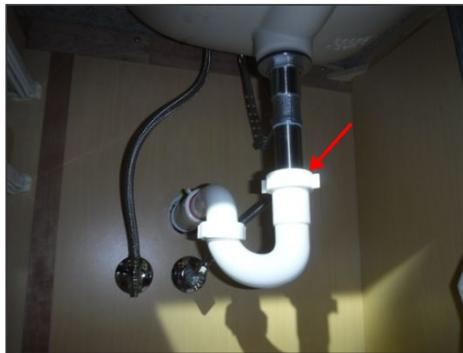
7.1. Upstairs common bathroom (right sink), leak under the sink at the drain tailpiece washer/lock nut. Recommend correction to prevent damage to the cabinet floor.

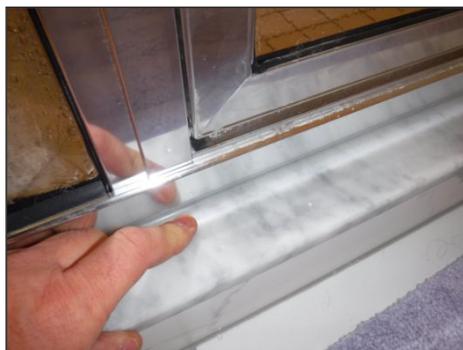
8.1. Owner mentioned the shower surround leaks. I did not see any leak after running shower for several minute.

Master bathroom, Location of leak

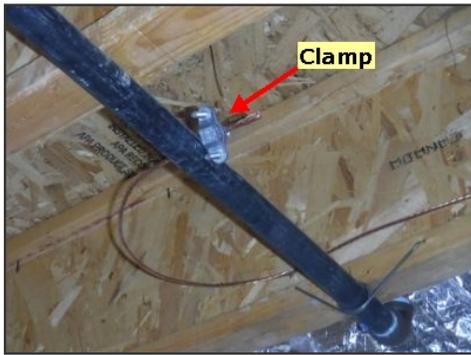
2.3. The bonding clamp was not clamped to the gas pipe. Clamp was loose and hanging. This is a safety hazard. Recommend a qualified and licensed electrical contractor secure the clamp. Service can uncover problems not discovered or that are beyond the scope of home inspection standards.

Bonding clamp not clamped to gas pipe

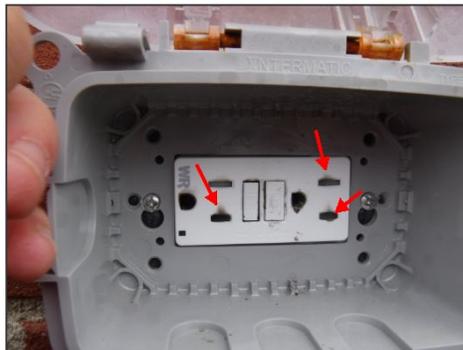
4.2. Back side, the GFCI protected outlet had burnt marks and would not reset (no power). This is an indication of an electrical short. This is a safety hazard. Recommend service and correction by a qualified electrical contractor to ensure safety of the occupants and to uncover problems not discovered or that are beyond the scope of home inspection standards.

Burnt marks, No Power, would not reset
